SEISMIC BEHAVIOUR OF ORDINARY MASONRY BUILDINGS DURING THE 2016 CENTRAL ITALY EARTHQUAKES

Sorrentino L., Cattari S., da Porto F., Magenes G., Penna A.

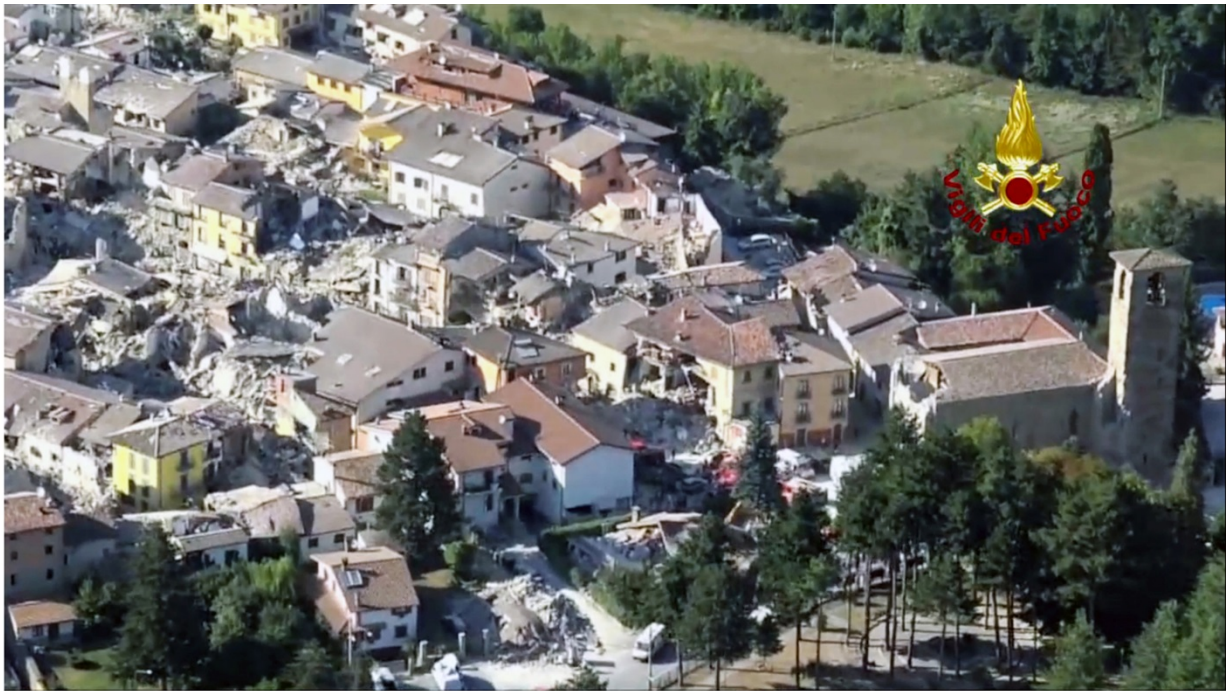
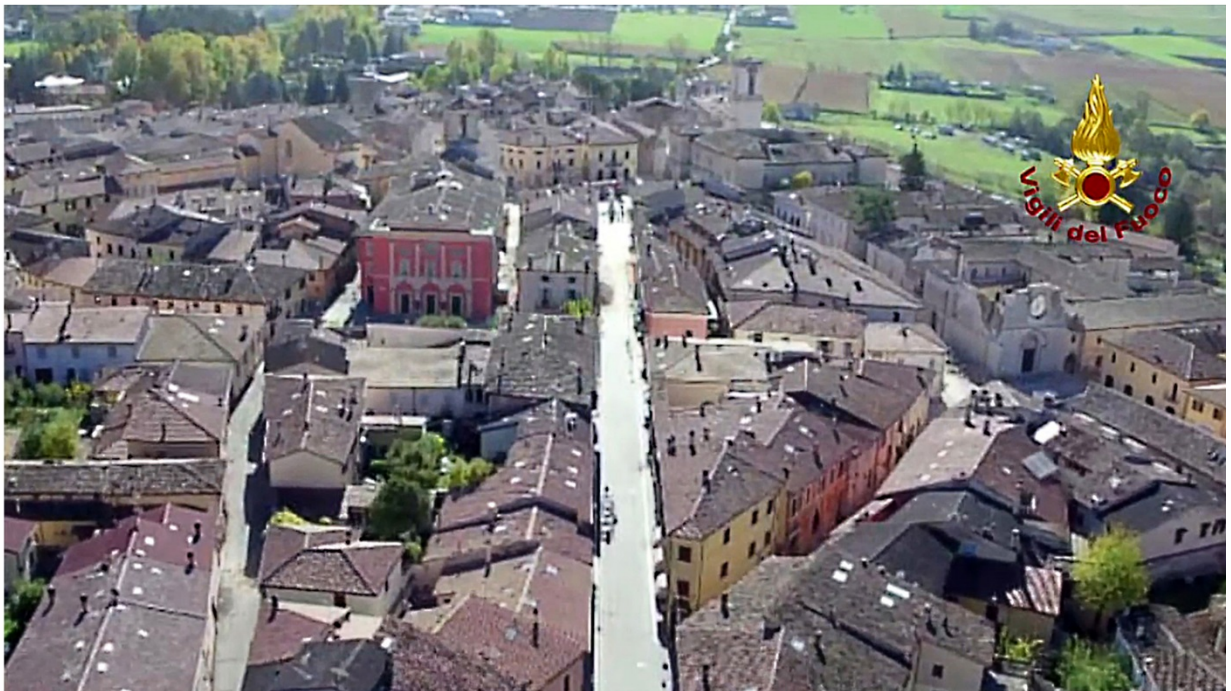
Field surveys in the most affected area have shown catastrophic collapses, with the historical centres of some settlements being almost completely destroyed. However, such dramatic performance was observed in Amatrice (Fig. 9a) and Arquata d/T, whereas residential buildings in the historical centre of Norcia have shown a much better performance (Fig. 9b), despite ground motion being similar or even more severe in the last settlement (Table 1, Fig. 2).

Fig. 9. a) Amatrice, after the 24th August event. b) Norcia, after the 30th October event. Snapshots from the movies released by the Firefighters Corps (www.vigilfuoco.tv).

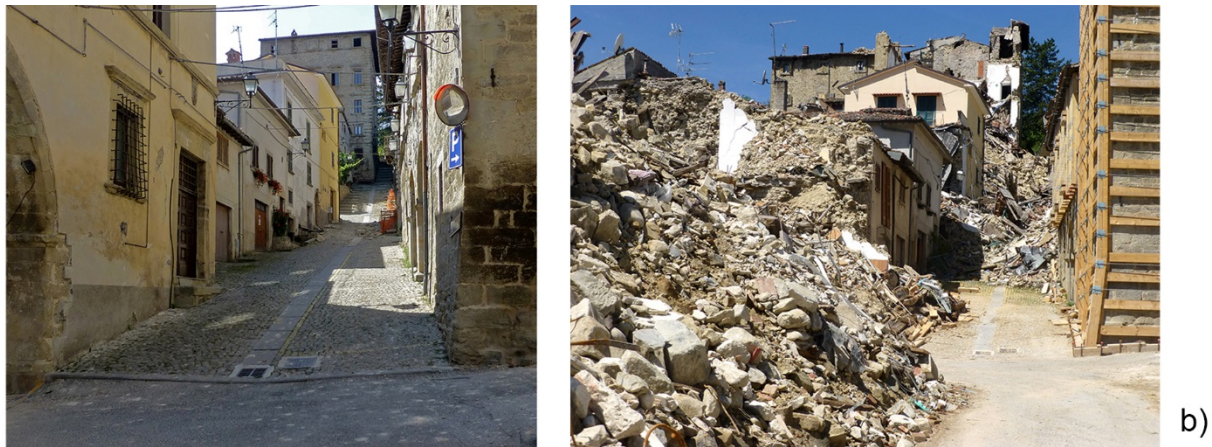
The effect of damage accumulation played a significant role in defining the actual destruction situation of some settlements, although the difference in the quality of structural details and masonry illustrated in § 2 is decisive for the seismic response of buildings to repeated shocks. For instance, being comparable the ground motion experienced in Norcia and Accumoli on the 24th August and the 30th October (Table 1, Fig. 2), the final state is completely different leading to the almost total destruction of ordinary historical buildings in Accumoli (Fig. 10).

Fig. 10. Damage accumulation in Accumoli, via Tito Vespasiano: a) After August 24th, b) After October 30th.

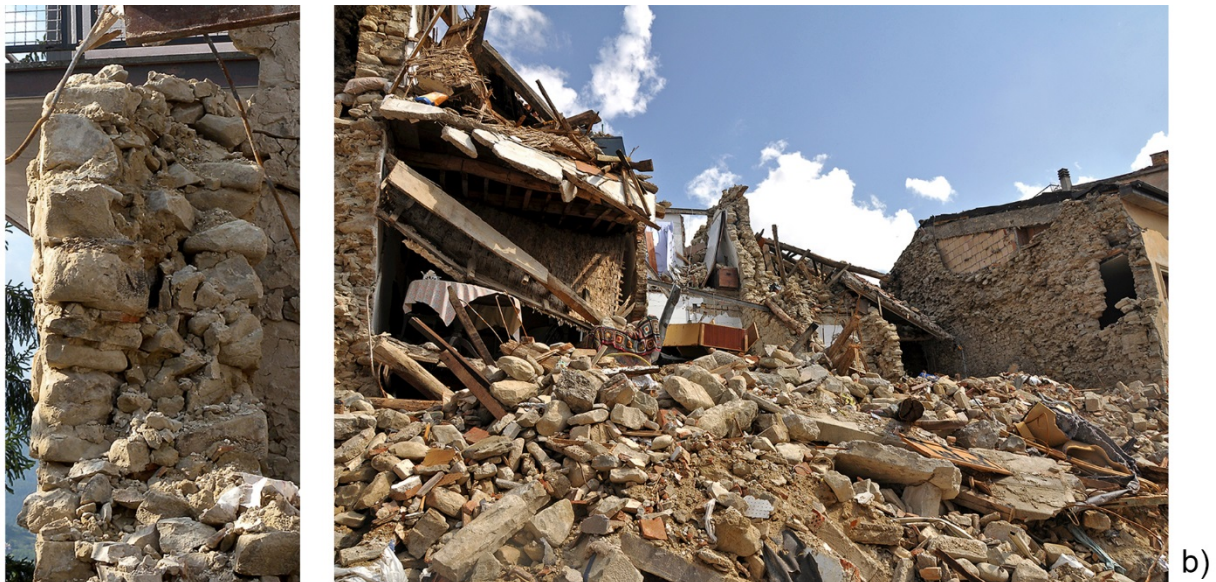
In several cases the main damage mode of the buildings has been the disintegration of masonry, due to a combination of undressed units and very poor mortar quality (Fig. 11). Although delamination of external masonry leaf has been reported in other Italian earthquakes (e.g., Decanini et al. 2004; Augenti and Parisi 2010), it has been extremely common in some settlements of Amatrice, Accumoli and Arquata d/T involving large portions of whole blocks.

Fig. 11. Poor performance of undressed natural stone buildings in: a) Accumoli, Illica and b) Amatrice, corso Umberto I.

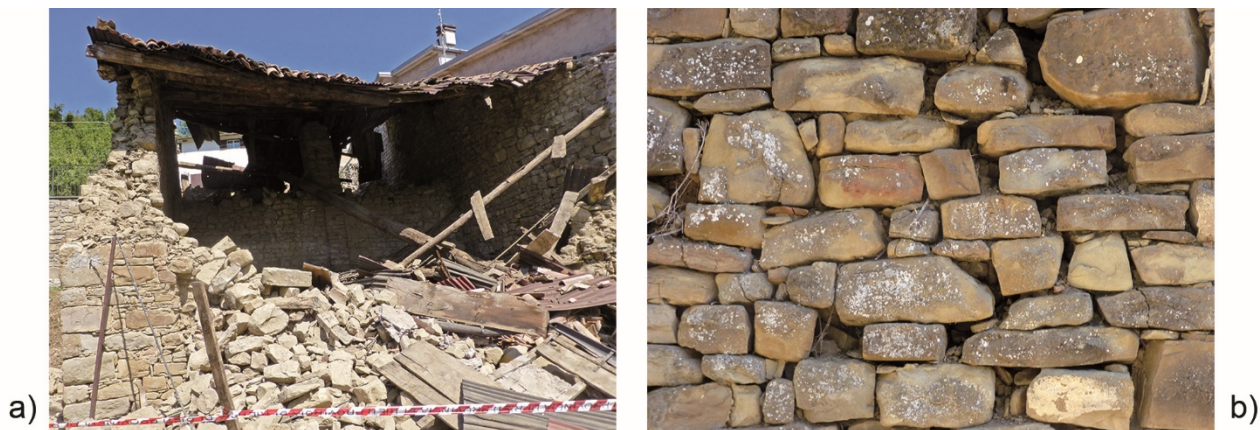
Therefore, the critical role of mortar has been clearly highlighted by this sequence, with collapses occurring even when the units' assemblage was reasonably accurate at least on the external leaf (Fig. 12), and mortar composition and strength should be always investigated to make an exhaustive assessment (Artioli et al. 2010; Liberatore et al. 2016).

Fig. 12. Masonry disintegration due to poor quality mortar in a reasonably accurate units' assemblage of the external leaf. Amatrice, Cossito: a) Front view, b) detail of masonry on the left-lateral wall.

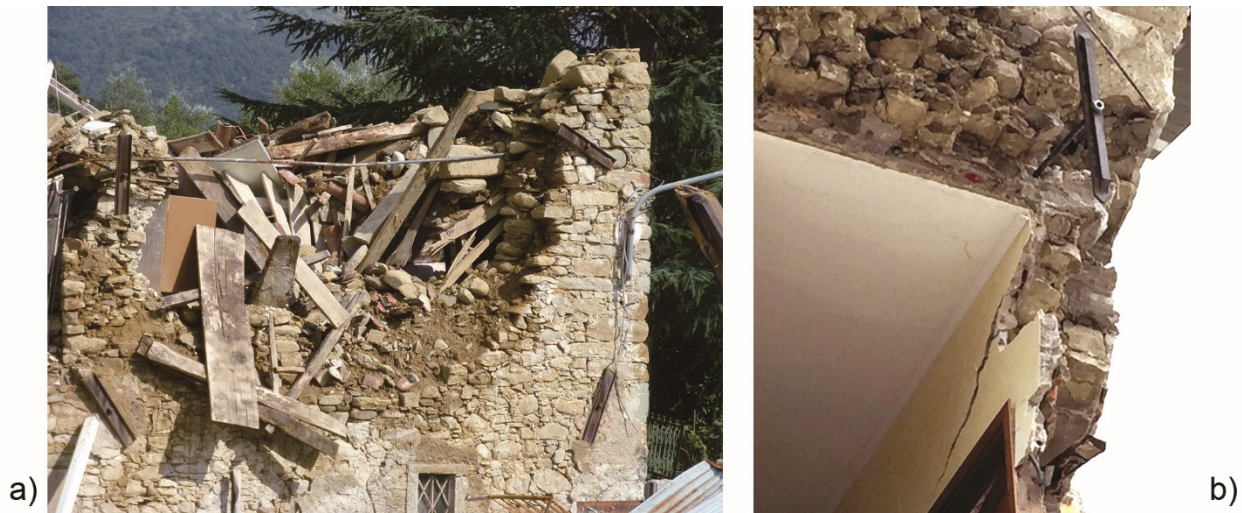
Fig. 13. Collapse of a masonry building having steel ties combined to poor mortar. a) Amatrice, Petrana; b) Arquata d/T, Piazza Umberto I.

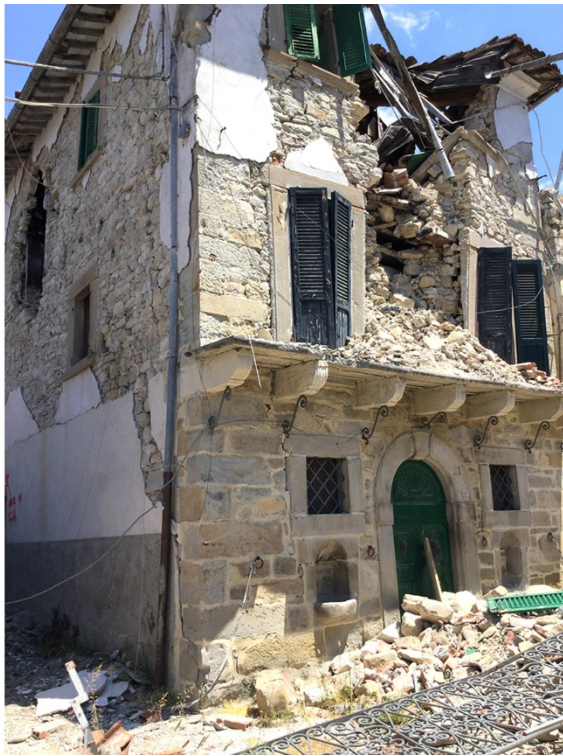
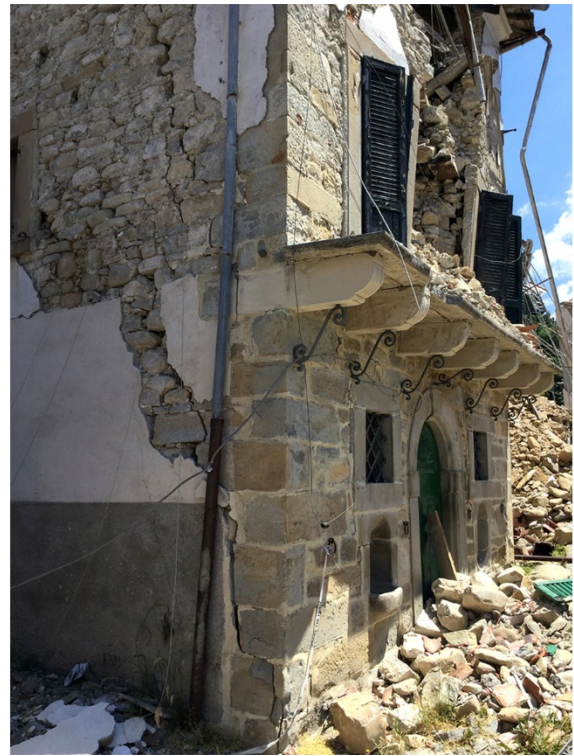
Fig. 14. Reduced strength of lateral walls compared to large-units wall intersections, Amatrice, Retrosi.

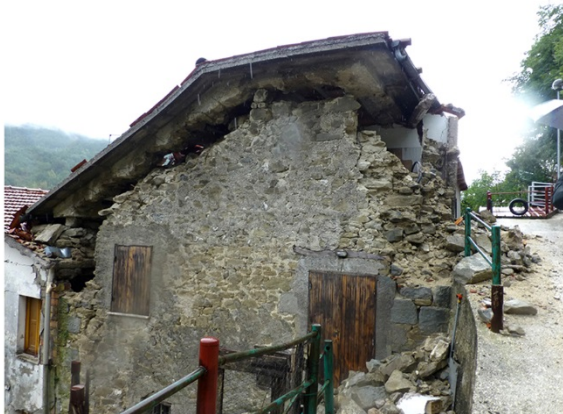
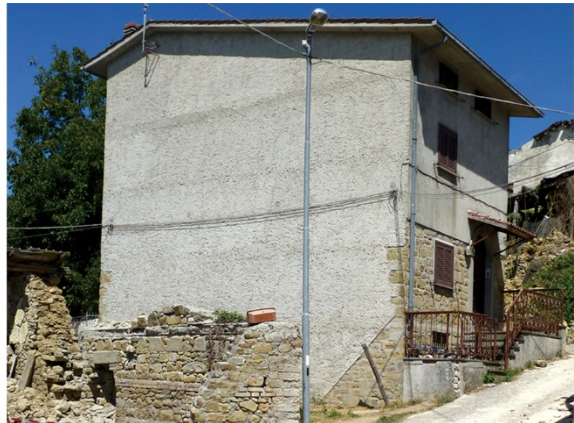
Media attention immediately after the August event blamed buildings with original roofs replaced with reinforced concrete structures. After being compulsory in case of structural interventions for more than two decades after the 1976 Friuli and 1980 Irpinia Earthquakes, building codes assumed a more careful approach after the performances observed in the 1997-1998 Umbria-Marche sequence (Penazzi et al. 2000). The current seismic swarm has shown again similar responses, with complete collapses of buildings under still monolithic roofs (Fig. 15a) or local effects associated to the compressive failure or out-of-plane response of masonry at the contact with reinforced concrete ring beams. However, there are several examples, such as that in Fig. 13 and in Fig. 16a, of very high damage despite the original timber structures were not replaced. On the opposite side of possible performances there are several cases, such as that of the house in Fig. 15b, which have a replaced reinforced concrete roof but no visible damage. Similarly, there are examples of houses with a timber roof that survived the earthquake (Fig. 16b), especially if timber elements were properly designed and connected to walls (Senaldi et al. 2014). Therefore, it seems that although replacing a timber roof by a reinforced concrete roof has been motivated by past lack of confidence in the original structural, rather than real limitations, such intervention alone cannot explain most of the observed collapses. These failures seem related to a very poor quality of masonry, especially of the mortar (Fig. 12), frequently combined to low maintenance conditions of timber roofs and lack of proper connections in traditional structures.

Fig. 15. Replaced reinforced concrete roofs: a) Arquata del Tronto, Pescara del Tronto; b) Amatrice, San Tomasso.

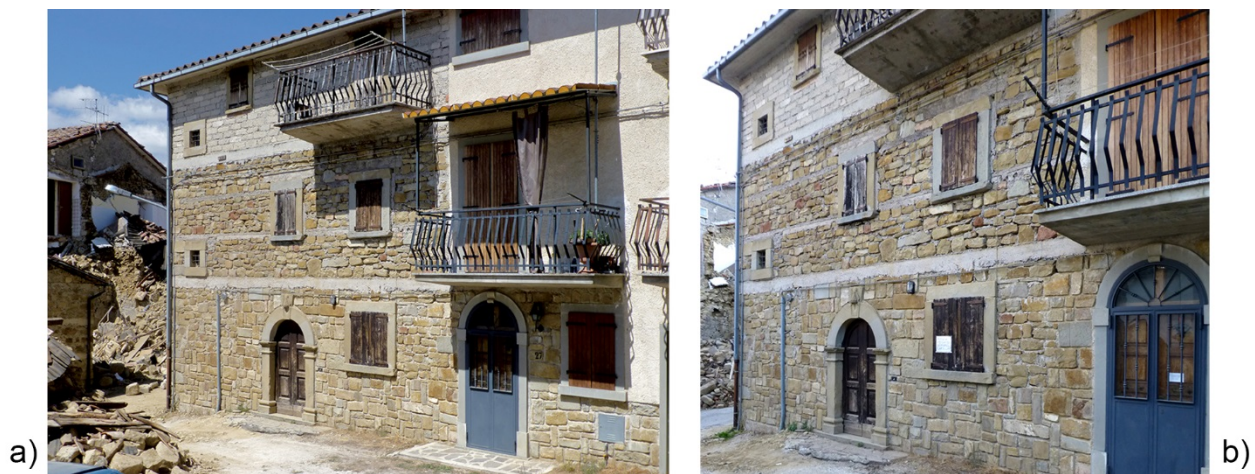
A more radical building activity is that highlighted by the structure in Fig. 17, which has been completely demolished around 1985 and rebuilt using the same natural stone units but a modern mortar. To the satisfactory earthquake performance certainly contributed the ring beams, present at each floor and at opening height at the first storey, but the lack of evident damage suggests an adequate strength of the stonework as well.

Fig. 17. Demolished and rebuilt natural stone masonry, resorting to modern mortar and ring beams. Amatrice, San Capone. a) Post 24th August; b) Post 30th October.

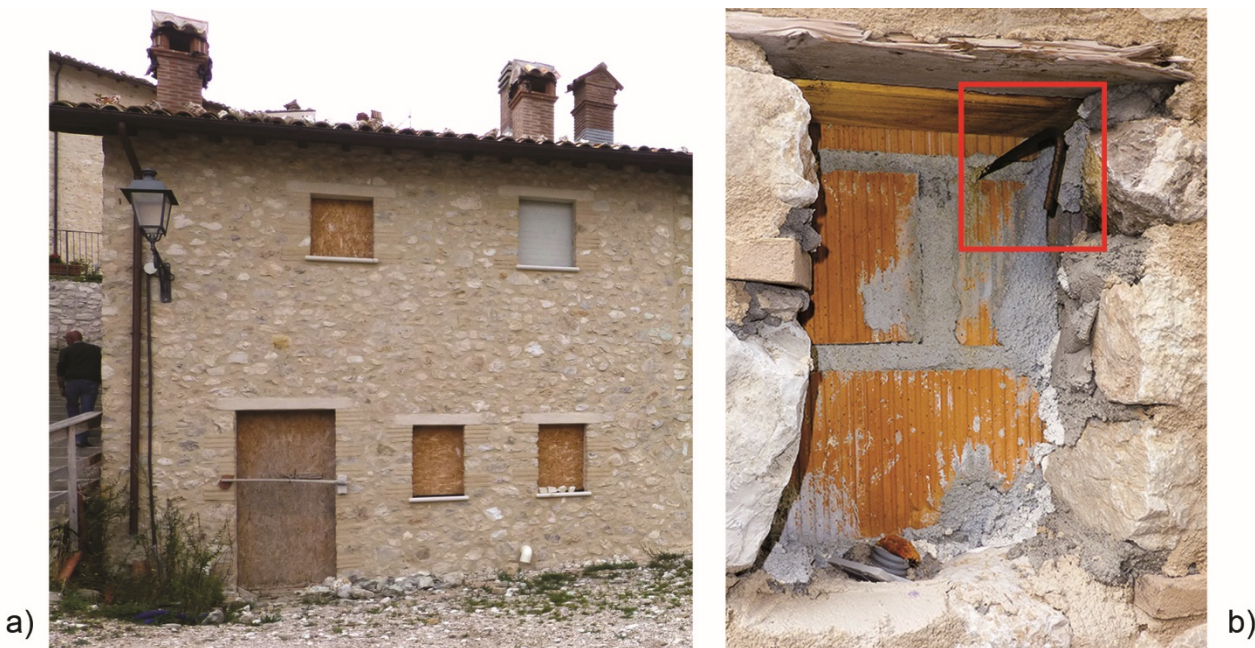
Demolition and reconstruction has been observed also in other instances. In Castelluccio di Norcia the building in Fig. 18a presents a natural stone masonry veneer. However, the actual structure is made of hollow clay blocks, as visible in a local gap (Fig. 18b), as observed also in Montegalgo and as documented by a previous research on another building

damaged by the 1979 earthquake (Binda et al. 2005). The building in Fig. 18 has survived undamaged the August events and despite a second inspection was impossible because the whole historic centre has been made off limits, aerial views after the October events showed that it still stands. The veneer is connected to the blockwork by means of carbon steel rebars (Fig. 18b), which proved effective in the current seismic sequence occurred just after construction, but could be corroded over time. Hence, stainless steel reinforcement is to be recommended.

Fig. 18. Demolished and rebuilt clay block masonry with connected natural stone veneer. Norcia, Castelluccio di Norcia. a) General view, b) close up of a cavity, with clay block and connection rebar visible within the red frame.

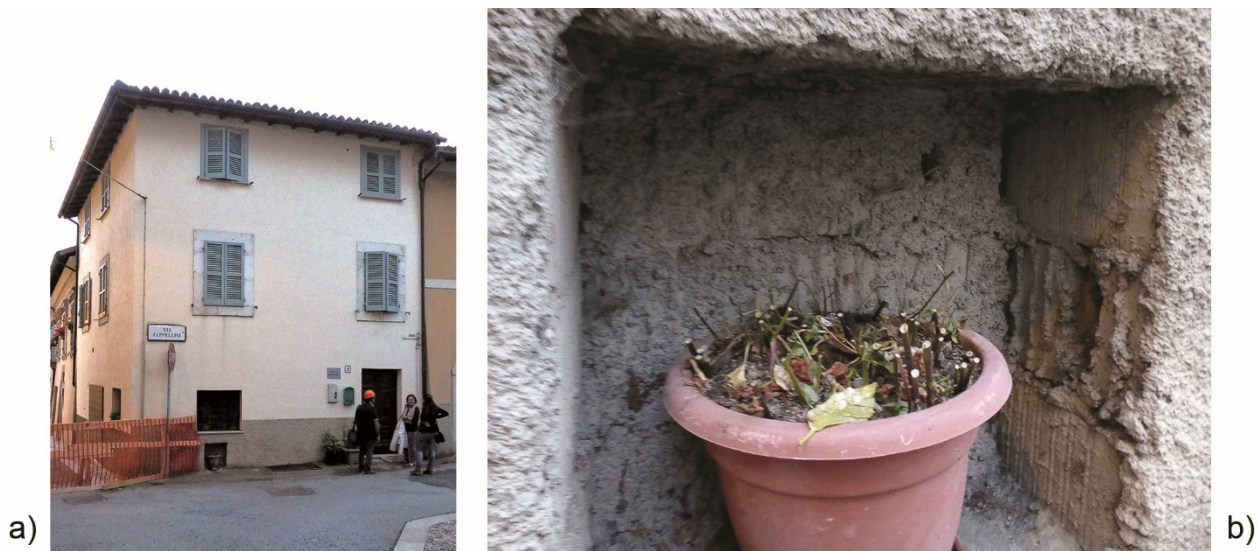
A somewhat similar example is that in Fig. 19a, located in the very historical centre of Norcia. The building seems a typical vintage construction, but its plaster finishing covers a hollow clay block structure (Fig. 19b) as a result of a mid 1980s demolition and reconstruction. Interventions such as those just documented have been considered in the past as unacceptable, but the extremely poor performance of entire historical centres and the very high toll in terms of lost human lives suggest that a general reconsideration is necessary. Preservation of environment values (shape and surface aspect of the buildings), while internal structure is replaced, should not be considered out of question, both in the case of collapsed buildings as in the case of documented very poor characteristics of masonry in slightly damaged buildings.

Fig. 19. Demolished and rebuilt plastered clay block masonry. a) General view, b) close up of a cavity, with clay block visible. Norcia, via Anicia intersection with via Cappellini.

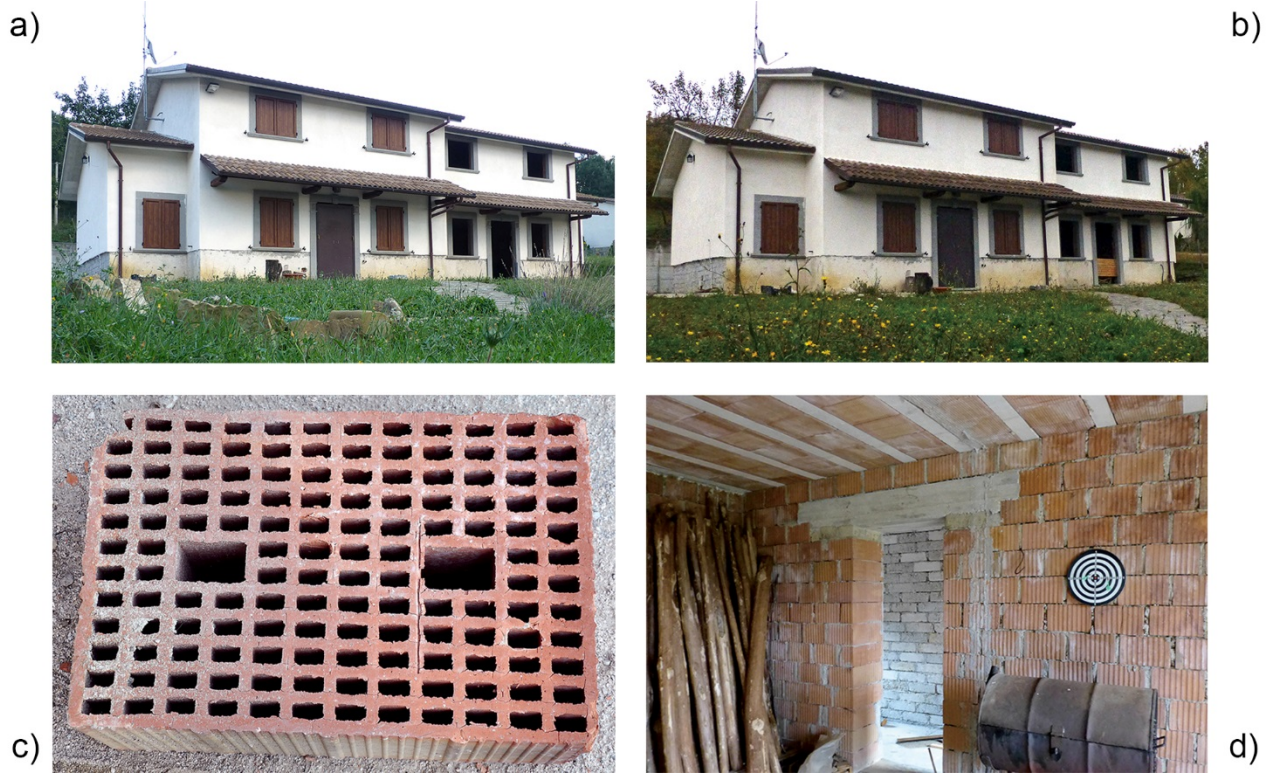
It is worth mentioning that, as shown in Table 1, these buildings repeatedly experienced a ground motion severity in excess of those recommended by the Italian code for the life safety limit state (DMI 2008), without suffering the significant damage to structural components and the partial collapses to non structural components accepted by the building standard. Therefore, these building techniques protected not only human life, but also the monetary cost of construction and the continuity of use. Such more than satisfactory performances have been observed also in Emilia in 2012 (Penna et al. 2014), as a consequence of proper masonry quality, adequate construction details, as well as wall density in plan and elevation. Although hollow clay blocks are the most used units in the last years, other solutions have been resorted to in the recent decades. An example is given by solid concrete units visible in the top floor of the house in Fig. 17, as well as in the building adjacent to Amatrice historical centre in Fig. 21. This last building, dating back to the mid 1980s, has 600 mm thick walls in the basement, 450 mm walls at ground floor, and 300 mm walls at first floor. It survived the August events without any damage, despite the widespread collapses of nearby standing structures. The October events, on the contrary, caused a heavy rocking response in the piers of the ground floor and moderate shear cracking at the first floor. Overall the performance can be certainly considered code compliant, bearing in mind the severity of the shaking in Amatrice. Similar success histories have been observed in Accumoli and Casale (municipality of Amatrice), whereas in San Lorenzo a Flaviano and Saletta (municipality of Amatrice) performance has been much poorer.

Fig. 20. Clay block masonry building. a) After the 24th August event, b) after the 30th October event, c) close up of a block, d) view of bare wall and floor. Amatrice, San Capone.

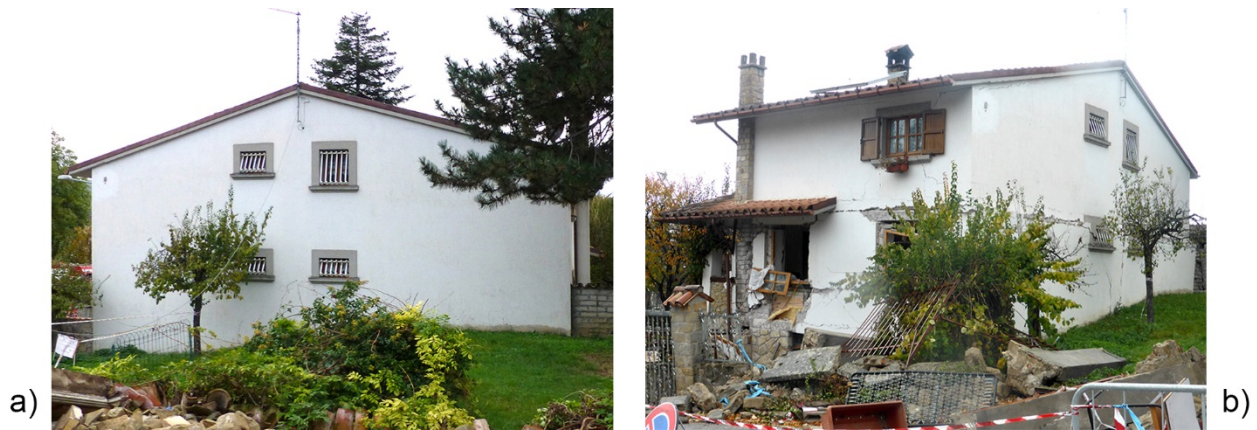
Fig. 21. Solid concrete block masonry building. a) After the 24th August event, b) after the 30th October event. Amatrice, viale Saturnino Muzii.

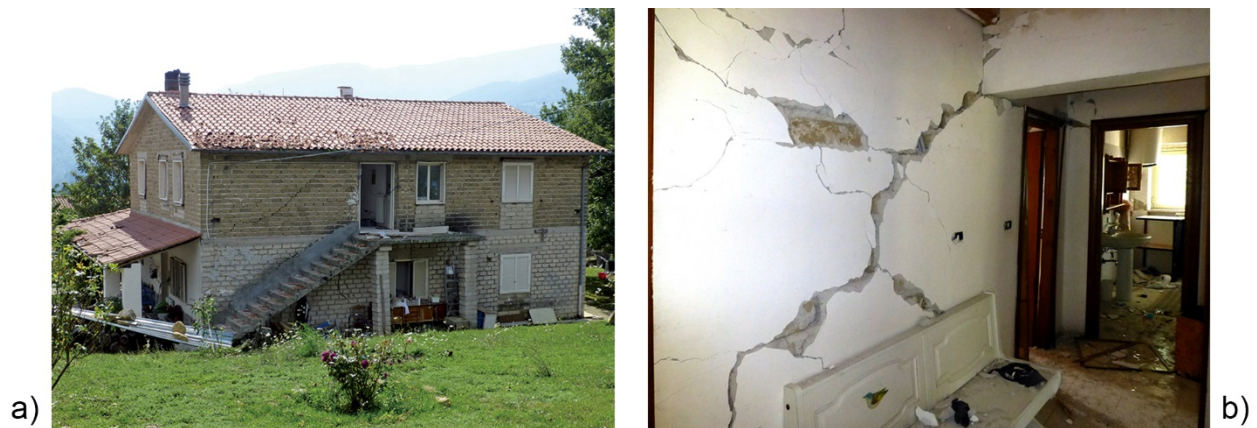
Fig. 22. Solid concrete block masonry (ground floor) and tuff masonry (first floor) building. a) External view, b) Internal view at first floor above ground. Accumoli, Illica.

In Illica there is a modern masonry building, having a ground floor made of solid concrete units, and a top floor made of tuff solid blocks (Fig. 22a). Whereas the bottom floor survived the August events with just slight damage, the top storey suffered heavy stair stepped shear cracks (Fig. 22b). This response seems to indicate that mortar had a lower strength of stone units, but the overall performance is still acceptable although less satisfactory of that of the concrete block masonry at ground floor, which is also usually where in plane seismic demands are higher. A better response in a tuff masonry construction has been observed in Accumoli and a somewhat worse in Saletta (municipality of Amatrice), but again without unit cracking and without any collapse.
