II Fabre Conference – Existing bridges, viaducts and tunnels: research, innovation and applications (FABRE24)

Half-joints degradation: analysis of some case studies

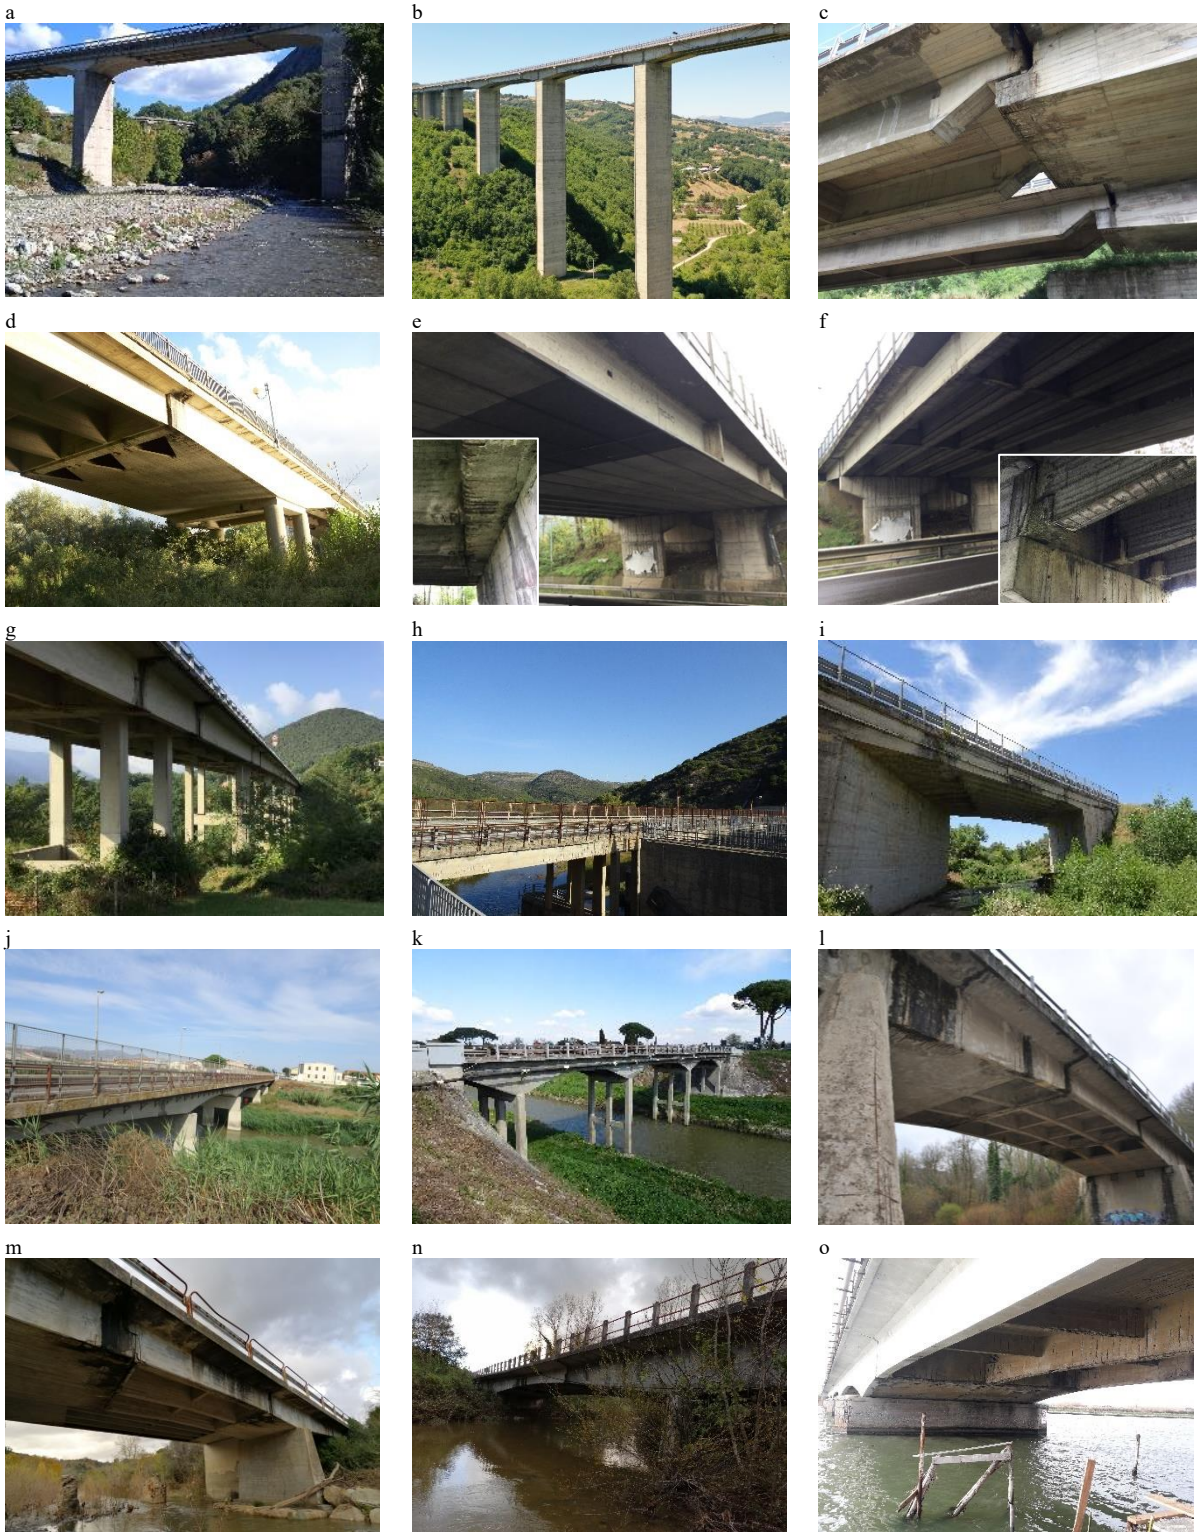
Fig. 2. (a) – (o) Bridges considered in this study.

As for the cantilevers, except for *Bridges e, f, g* and *h* (Fig. 2e, f, g, h), they have a RC box girder having also, in some case, a section with variable height. In no. 7 bridges, that are *Bridges* from *a* to *d* and *i, l*, and *n* (Fig. 2a-d, i, l, n) the considerable bridge span lengths is covered by long RC cantilevers (≥ 5 m). While, in the remaining bridges, *Bridges e-h, j, k, m, o* (Fig. 2 e-h, j, k, m, o), RC cantilevers have a short length (< 5 m).

As far as the half-joints’ typology, in all bridges analyzed lower nibs are always connected with a cross-beams, making possible for each bridge the visual inspection only of lower nibs intrados, and of coupled half-joints lateral surfaces on external deck beams. On the contrary, half-joints were fully inspectable only in the case of *Bridge e* (Fig. 2e) where the cross-beam is absent.

Finally, according to Italian Guidelines, only in no. 3 bridges, that are *Bridges a, k, n* (Fig. 2a, k, n) no defect of ‘high gravity’ G5 was detected on half-joints. While, in the case of remaining ones, G5 defects were found. Details about the defects detected on the half-joints are discussed in the next paragraph.

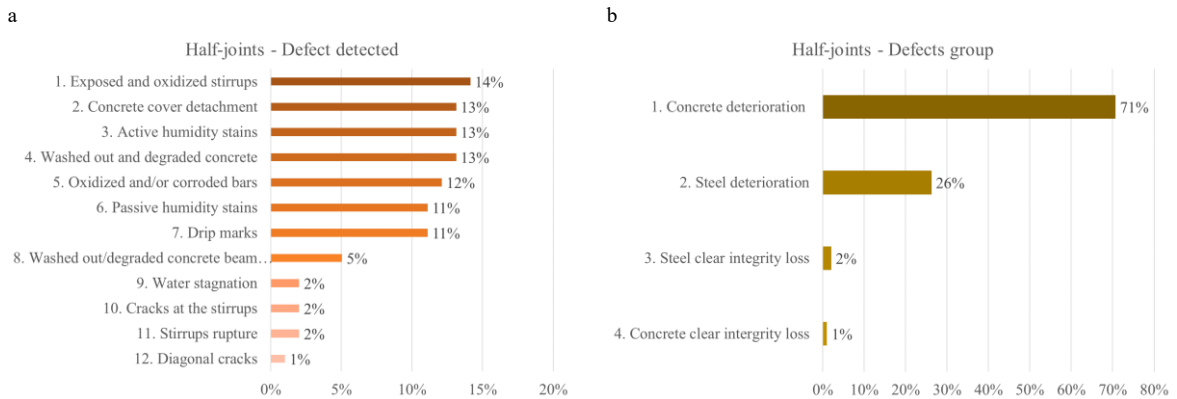
Fig. 4. Recurring defect percentages for half-joints: (a) defects detected; (b) defects group.

As it is possible to note in Fig. 4a, the main defects occurred with the related gravity of defect (MIT, 2020) are: *exposed and oxidized stirrups* (G3) with 14%; *concrete cover detachment* (G2), *active humidity stains* (G3) and *washed out and degraded concrete* (G3) with 13%; *oxidized and/or corroded bars* (G5) with 12%; *passive humidity stains* (G1) and *drip marks* (G3) with 11%. Note that most of detected defects are mainly due to water infiltration (defects from no. 1 to no. 9 of Fig. 4a, having in total a percentage of 95%.

As for the groups division, Fig. 4b shows that defects group owing to *concrete deterioration* is the most frequent one in the cases analyzed with a percentage of 71%, following by *steel deterioration* with 26%, *steel clear integrity loss* with 2% and *concrete clear integrity loss* with 1%.

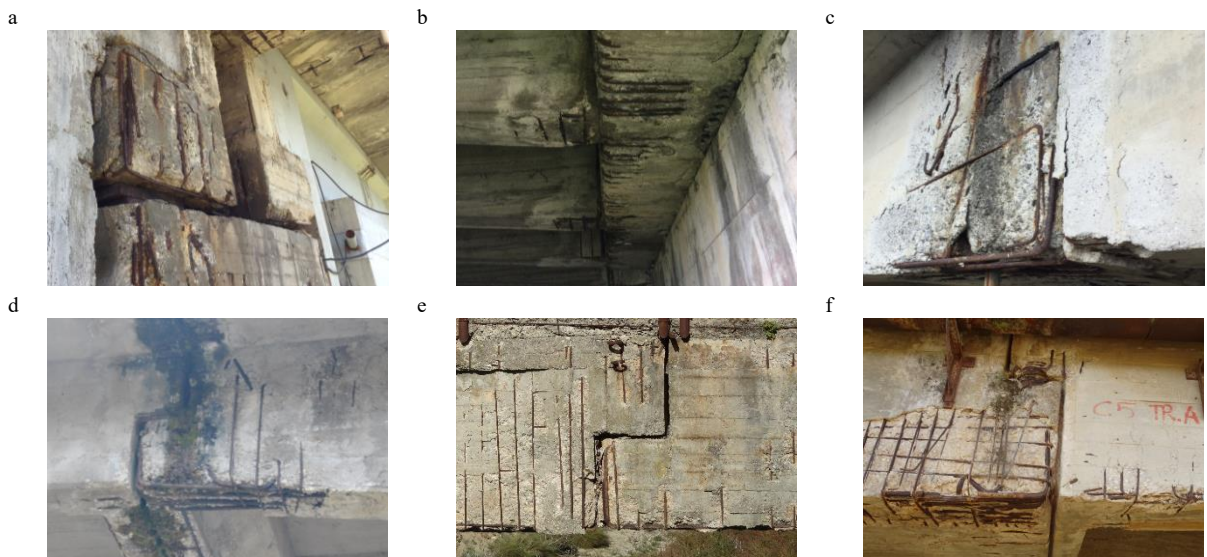
Fig. 5. Half-joint defect on: (a) Bridge b; (b) Bridge f; (c) Bridge g; (d) Bridge l; (e) Bridge h; (f) Bridge j.

More in detail, Fig. 5 depicts pictures of the current status of some half-joints, having a marked deterioration. In particular, those reported from Fig. 5a to Fig. 5d are mostly affected by water infiltration from the expansion joints, but they differ in the defect extension. In fact, Fig. 5a reports defects due to water action with also *diagonal cracks* probably due to traffic loads. On the other hand, Fig. 5b, Fig. 5c and Fig. 5d show half-joints affected by *oxidized and/or corroded bars*, *exposed and oxidized stirrups*, *drip marks* and *active/passive humidity stains* propagating along the entire upper and lower nibs length. It is pointed out that half-joint in Fig. 5d also reports the *water stagnation* defect, since biological patina proliferates along the whole joint. Fig. 5e and Fig. 5f report *stirrups rupture*, as well as a general degradation of concrete and reinforcement. Finally, Fig. 5f shows concrete cover detachment principally located on the half-joint lower nib edge.

It is important to note that all the defects reported in Fig. 5 lead to defects of gravity G5, coherently with the Italian Guidelines for existing bridges (MIT, 2020), and consequently, to High defect level, since half-joints are defined as ‘critical elements’. Definitely, this implies a high SF vulnerability, and a High Overall Class of Attention (O-CoA) independently on other risks involved in the methodology (Seismic, Hydraulic, and Landslides). In the cases analyzed, 80% (Table 1) of the existing RC bridges analyzed have a defects of gravity G5, and therefore an O-CoA.
