Analytical Investigations of XIX–XX Century Paints: The Study of Two Vehicles from the Museum for Communications of Frankfurt

This work is focused on the study of the protective paints of two vehicles belonging to the Museum für Kommunikation in Frankfurt and used by the German postal service at the turn of the two centuries. The first one is a cart for telecommunications services and is dated approximately 1920–1940 (Figure 1). This cart was constructed in the Reichspost era and was continuously used by the postal service also during the German Democratic Republic (GDR). The cart was found in the garden of a former postal employee in 2015. It was partially sunk into the ground, where it presumably stood for decades after having been taken out of service.

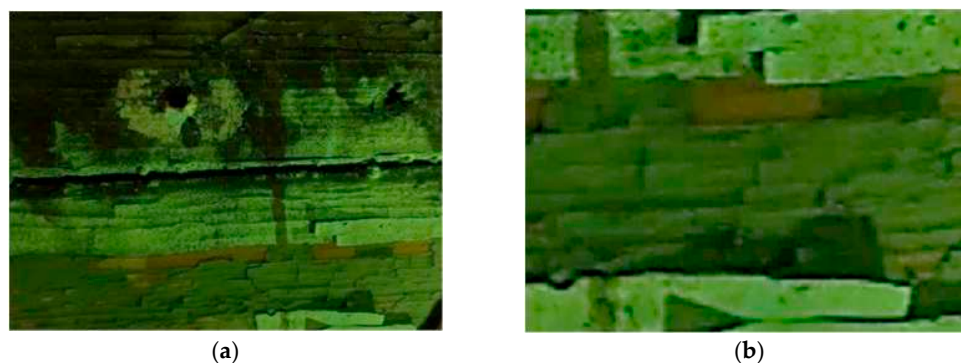
The outermost layer, which is light grey in VIS light, is characterized by a low yellowish fluorescence that contrasts with the fluorescence induced on the surface of the intermediate grey-greenish layer. The dark grey layer in contact with the wooden support does not show any fluorescence (Figure 3).

Figure 3. (a) Details of the UV fluorescence image of the paints on the right panel; (b) Enlargement (10×) of the area.

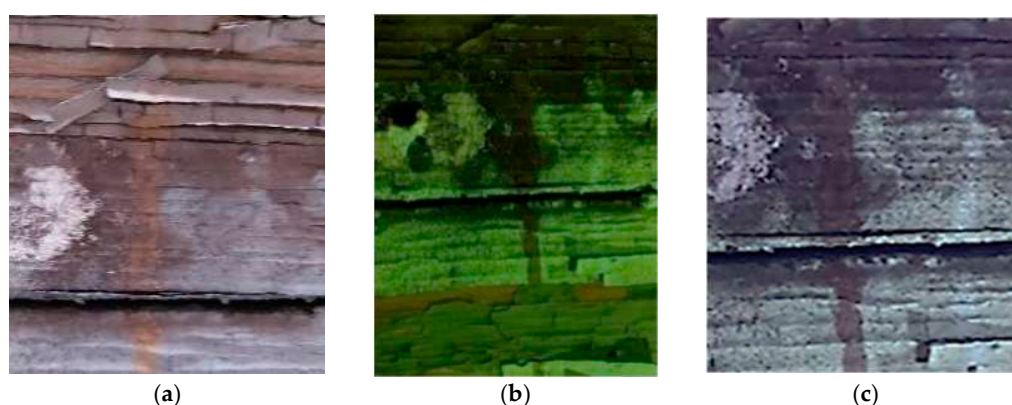
Moreover, the investigation allowed the presence of some areas to be highlighted that appeared reddish in both visible and UV light while showing a black color in IR reflectography (Figure 4).

Figure 4. Details of the iron cart structure: leakage due to corrosion; (a) Image in visible light; (b) Image in UV fluorescence; (c) Image in IR reflectography.

These areas are related to the leakage that resulted from the degradation of the cart's iron structure, the solubilization of corrosion products, and the pouring of iron-ions-rich solutions.

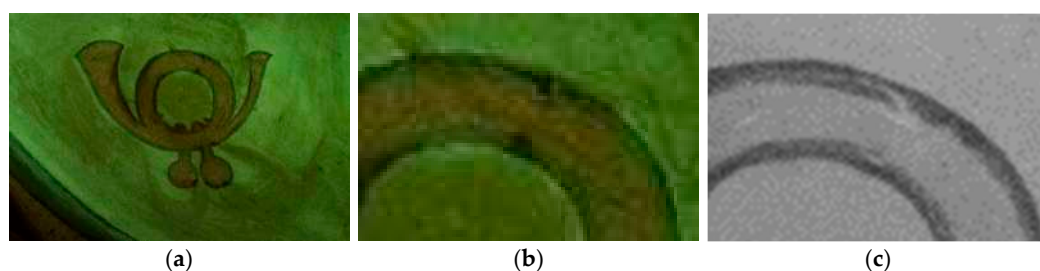
The multispectral investigation performed on the symbol present on the right and left side of the carriage underlined an uneven response under UV radiation (Figure 5a,b). Indeed, darker areas could be noticed, which appeared to be lighter in IR reflectography (Figure 5c). The areas in which the fluorescence is less marked (darker in the photo) present a greater reflection of the IR radiation, and these areas appear lighter. These differences can be presumably related to the loss of the finishing layer.

Figure 5. (a) Symbol panel of the right side of the carriage in UV fluorescence; (b) Enlargement (10×) of the area in UV fluorescence; (c) Enlargement (10×) of the area in IR reflectography.

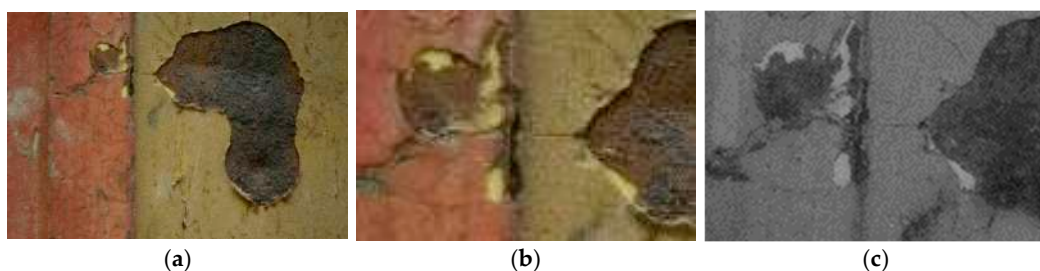
On the rear panel (Figure 6), the IR reflectography allowed the presence of two yellow paints to be noticed that are characterized by different reflections of the IR radiation.

Figure 6. (a) Image of the rear panel of the carriage collected under visible light; (b) Enlargement (10×) of the area in VIS; (c) Enlargement (10×) of the area in IR reflectography. The chromatic differences between the two yellow paints, in visible light and their different reflection of the IR radiation are highlighted.

The more superficial layer appears darker in IR, while the underlying one shows a lighter tone due to the greater reflection of infrared radiation. These characteristics are attributable to the use of different paints. The same feature was also found in the rear axle of the wheels.

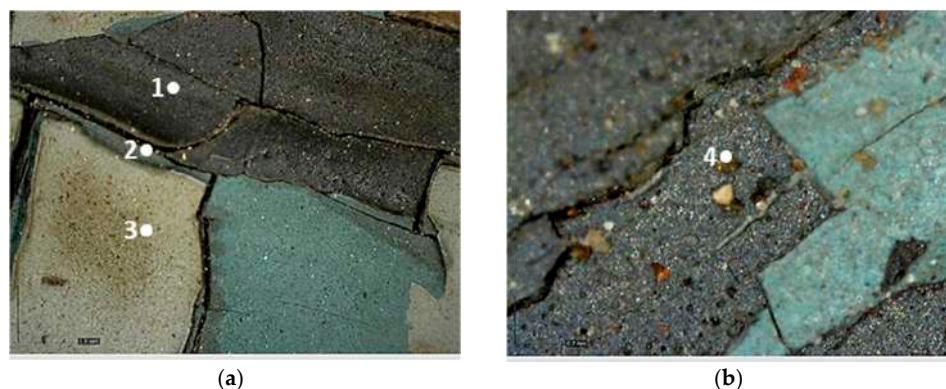
The investigation was performed using the optical microscope and allowed the stratigraphy of the grey cart to be identified alongside the presence of a deposited particulate on the surface (Figure 7a).

Figure 7. Optical microscope images of the cart's stratification. (a) Image collected at 50× magnification in which the dark grey (1), greenish grey (2), and light grey (3) layers are visible; (b) Image collected at 200× magnification where the deposited particulate is present (4).

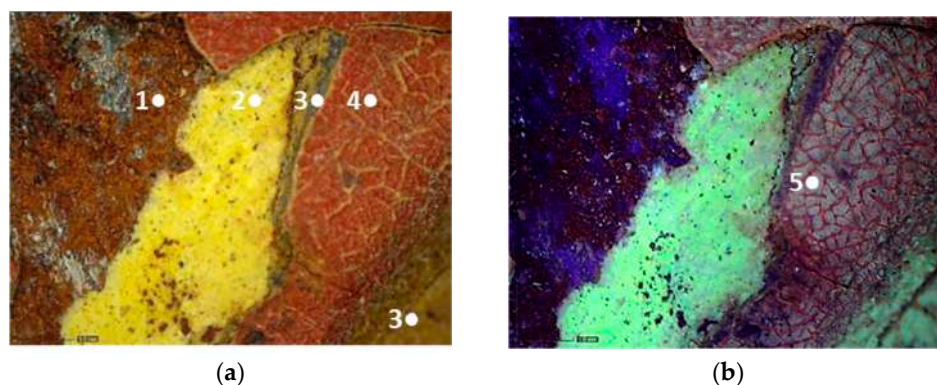
The analysis that was carried out with optical microscopy made it possible to observe the complex stratigraphy of the carriage's paints, which was mainly characterized by the superimposition of four paint layers (Figure 8).

Figure 8. Optical microscope image of the layering on the carriage: (a) Image collected in VIS light, showing the substrate (1), the bright yellow layer (2), the yellow-brown layer (3), that is above or under the red layer, and the red layer (4); (b) Image collected in UV light, where the finishing layer-with a bluish fluorescence can be observed (5) above the colored layers.

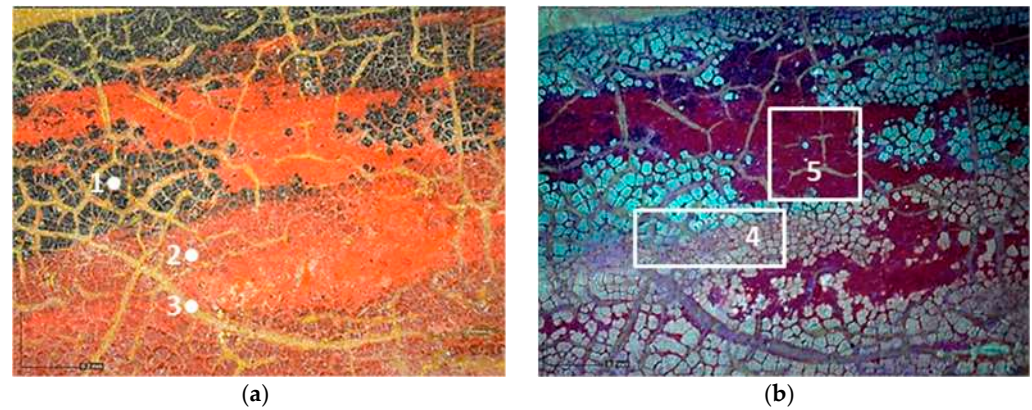
The finishing layer is characterized by a bluish-yellow fluorescence. It shows widespread cracking and degradation signs which seem to be due to anomalous contractions of the material itself (Figure 9).

Figure 9. Optical microscope image ($200\times$ magnification) of the area corresponding to the postal service's symbol. (a) Image collected in VIS light showing the cracking process with thinner (1–2) and thicker cracks (3) that reach the yellow paint; (b) Image collected in UV light highlighting the islands of different sizes and shapes where the finishing layer is present (4), and an area with different fluorescence in which the layer is absent (5).

The craquelure was presumably induced by the imperfect adhesion between the finishing layer and the underlying ones but also by exposure to UV radiation and a high level of relative humidity [34]. In the overlapping areas of the red paint on the yellow one, such cracks are not limited to the surface only, but reach the underlying yellow layer. All types of branched cracking are according to variable, straight, or concentric crosslinks. These crosslinks intersect each other, forming islands of various sizes and shapes. Some areas of the carriage, such as the panels, show that the symbols are characterized by the absence of the finishing layer (Figure 10). Indeed, in these areas, it is possible to detect the underlying paints, which have a different fluorescence when observed in ultraviolet light (Figure 10b).

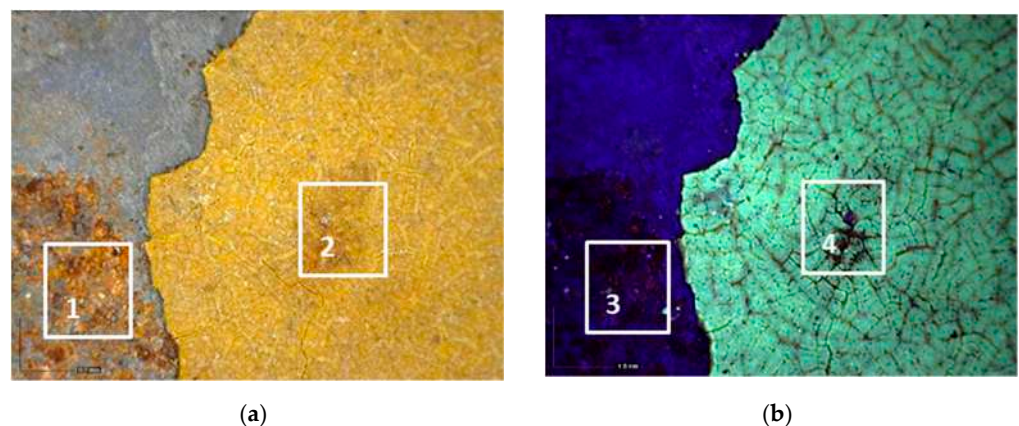
Moreover, the metal support of the carriage appears to be corroded, and some areas of the superimposed paint layers appear darker, presumably due to corrosion products of the underlying laminate (Figure 10).

Figure 10. Optical microscope images ($200\times$ magnification) of one of the metal panels: corrosion of the laminate (1–3), causing the darkening of the yellow paint (2–4). (a) Image collected in VIS light; (b) Image collected in UV light.

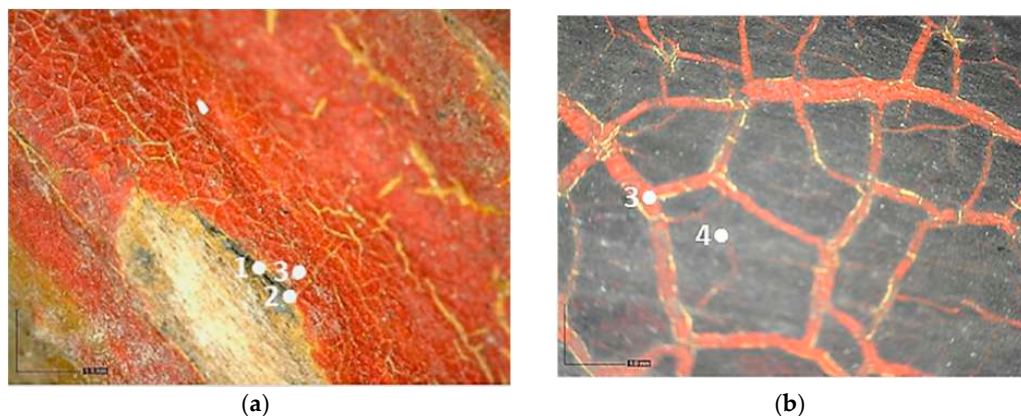
Black paint was used exclusively for decorations (Figure 11).

Figure 11. Optical microscope images of the areas showing the black paint. (a) Image ($50\times$ magnification) collected in VIS light showing the black paint (1) under the yellowish brown (2) and red (3) layers; (b) Image ($50\times$ magnification) collected in VIS light showing the black layer (4) above the red one (3).
