THE ANALYSIS OF THE TIMBER ROOFS OF THE LORETA IN PRAGUE

Bledian Nela¹, Jiří Bláha², Michal Kloiber² and Jiří Kunecký²

Abstract

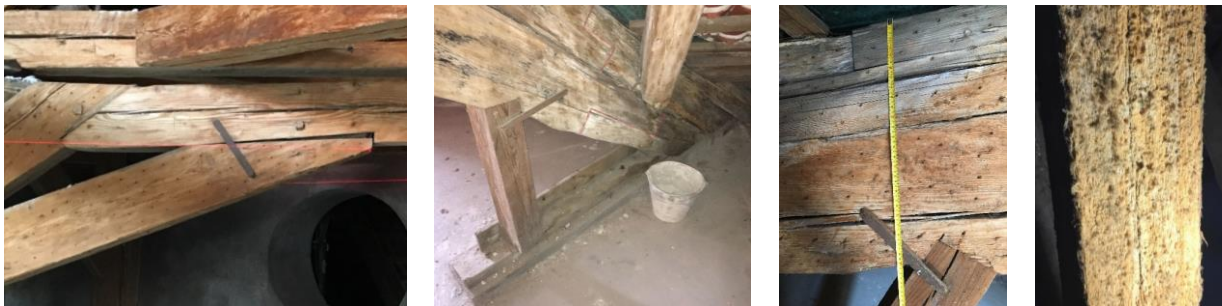
Following the [4], a visual inspection was carried out in the southern part of the west wing. The structural timber elements were classified into classes, namely S1, S2 and S3 and according to [4] are obtained the mechanical parameters. The authentic joint connections of the structural timber elements are carpentry joints with some minor late modifications. There are not many archival reports on the past interventions carried out in the roof therefore many statements are made from observation only. Strengthening short columns are seen to reinforce the lower ends of the roof rafters, which are connected to an embedded timber beam on the concrete floor (Figure 4). Additionally, small diameter holes are seen in the majority of the timber elements which can be due to the injections as a manner of protection against insects (Figure 4). Furthermore, fireproofing is identified in some elements and metal connectors are detected in some other as measures of joint reinforcement (Figure 4). Afterwards, in order to perform the timber grading as per [4] the features examined were the wane, growth rate, knots, slope of grains, fissures and other geometric features. The final class found for the timber elements as per these norms was found to be S1 leaning towards S2. This classification gives a range of values to be further assessed and verified with other tests.

Figure 4 – Characteristic features on the elements from the visual inspection

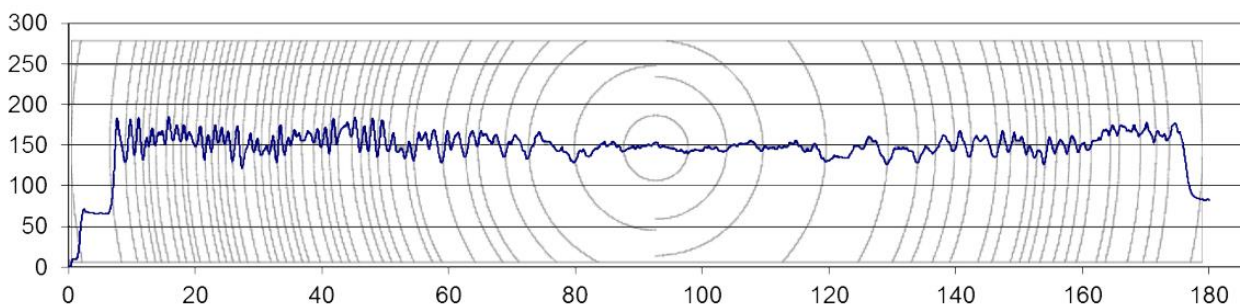
From the output profile of the timber cross-section the damage and decays were able to be observed. Furthermore, following the peaks of the resistances in the results from the Resistograph the rings of the tree are constructed hypothetically and utilized for the qualitative categorization of the element. An example can be seen in Figure 5.

Figure 5 – Ring trees and possible damage obtained from resistance microdrilling

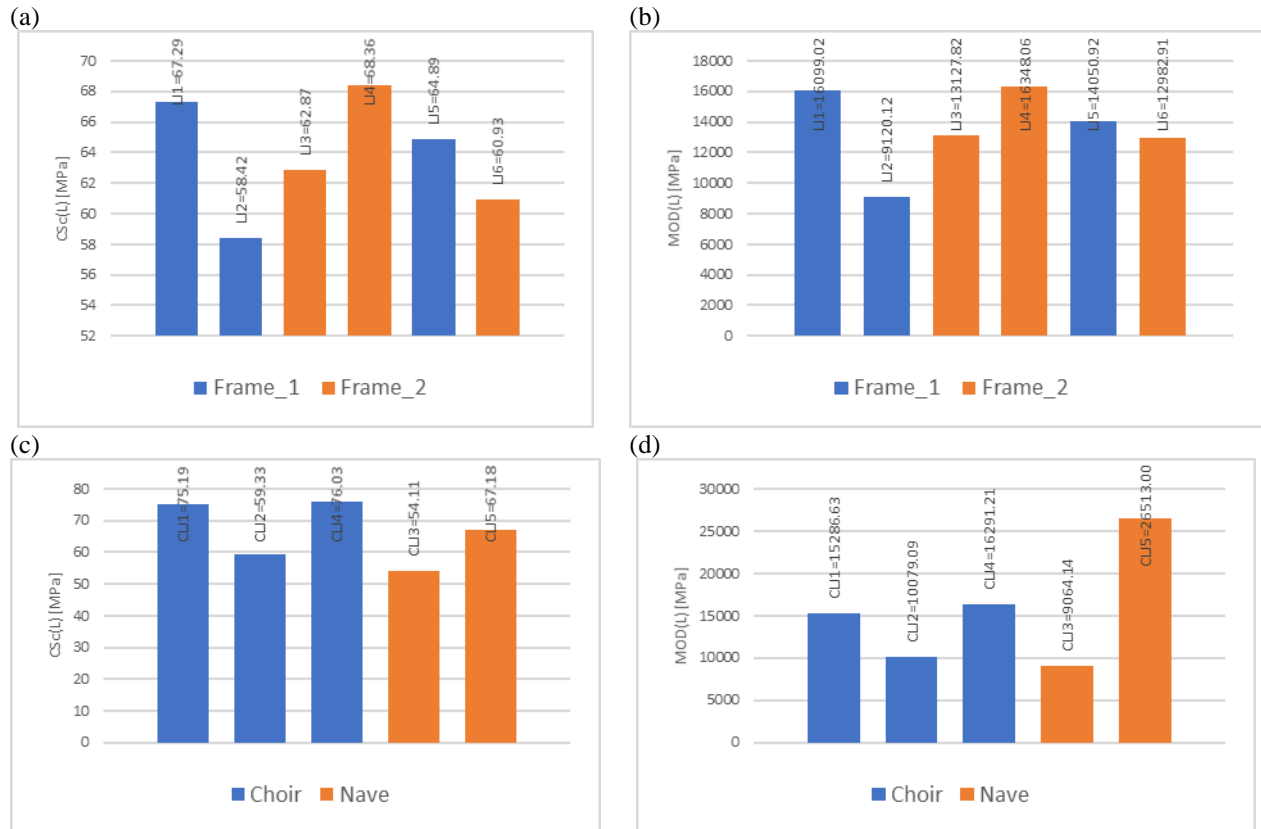
Figure 6 – Loading jack results for south part of the west wing CSc (a) and MOD (b) and the church CSc (c) and MOD (d)

[9] provides correlation between the loading jack results and the compressive strength, modulus of elasticity and the density. The correlation follows the results from specimens with 12, 18 and 24 % moisture content. However, only the correlation for 12 % is used since the moisture measured and shown in the subsequent section, in the frames does not exceed 12%. The correlation between conventional strength measured from loading jack (CSc) and the compressive strength (S_c) with a correlation factor of $R^2=0.887$ is shown in equation (3). The correlation between the modulus of deformability (MOD) from the loading jack and the modulus of elasticity (MOE) with a correlation factor of $R^2=0.679$ is shown in equation (4). Lastly, the correlation between the conventional strength (CSc) and the density (ρ) with a correlation factor of $R^2=0.840$ is shown in equation (5). The results are shown in Table 3. From the Czech annex of Eurocode [7] the elements are classified as C20 structural timber class.

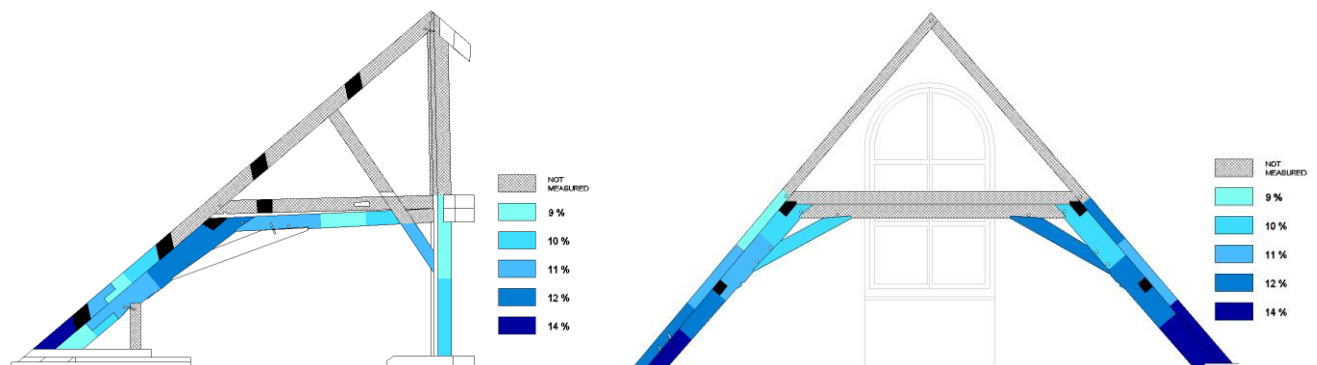
The moisture content provides a significant qualitative measurement of the level of decay and strength of the timber elements. The durability of timber decreases with the increase of moisture above fiber saturation point. This due to the vulnerability of timber towards insects and fungi. Furthermore, the strength and elasticity are reduced, and the elements swell. The moisture content is measured on some elements of interest and is shown in Figure 7. The internal moisture content is measured on the 6 predrilled holes used for the loading jack. Therefore, the moisture is measured at four depth levels on 3 locations per frame, a total of 6 locations. Additionally, the superficial moisture is also measured with the help of a hygrometer, on both sides of the frame no.1 (Figure 7-left) and on the internal side of the frame no.3 (Figure 7-right) because the other side was embedded in the wall. The moisture levels on the timber elements do not present any threat to the health of wood.

Figure 7 – Moisture content for the Frame no. 1 (left) and Frame no. 3 (right)

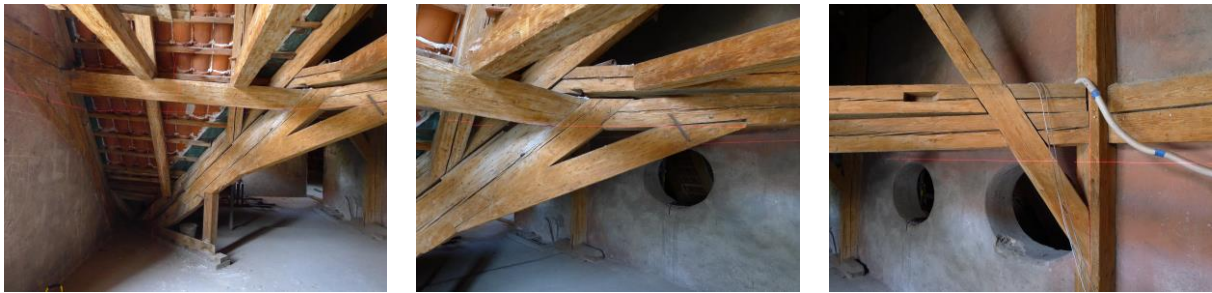
The different construction phases of Loreta present many challenges for the health assessment and structural stability of the structure. The cause of damage and decay may be from different reasons and the evaluation is not always accurate and many hypotheses are to be constructed to achieve the most probable cause. The main focus of this paper is the cause of deformation of the frame in the south part of the west wing (Figure 8) and the evaluation of its

safety, stability and a possible strengthening measure. This deformed timber frame is the supporting element for both pitches of the southwestern roof and therefore attracts the majority of forces. The frame presents a rather complex element in means of numerical modeling since the forces are mainly distributed through deformations of the members and the connections are made of carpentry joints. The frame consists of a vertical column attached to a masonry wall and at the top attached to the principal rafter which forms the connecting edge of the two pitches of the roof. A supporting substructure is formed under the principal frame which reduces the span of the main structure. On the lower end of the principal rafter can be seen the strengthening means which were later added to the frame. Additionally, a metallic fastener can be seen on the diagonal truss connecting the secondary rafter and the horizontal beam, which is added later to avoid slipping of the joint.

Figure 8 – The deformed frame of interest in the south part of the west wing

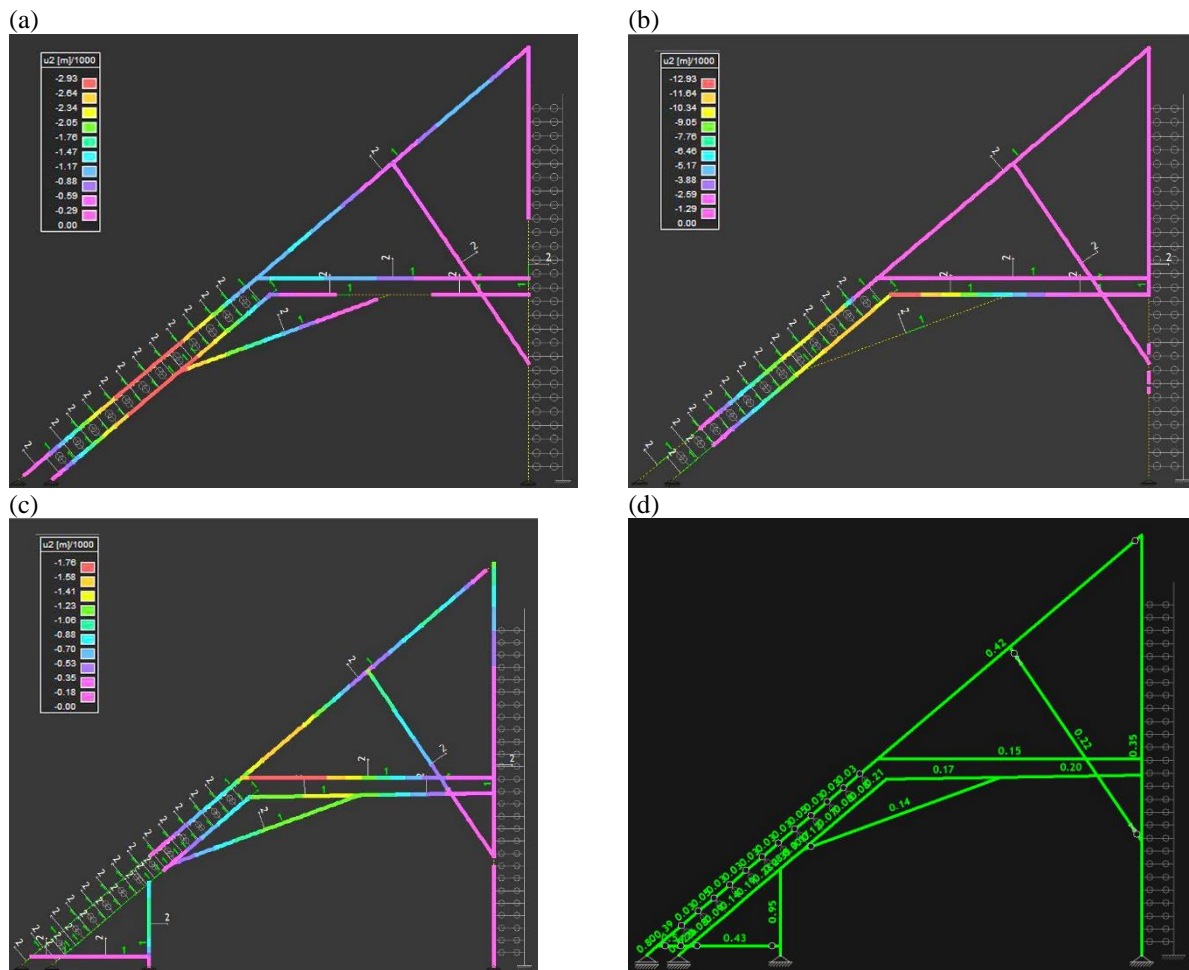
Figure 9 – Results for: Scenario 1 deflections (a), Scenario 2 deflections (b), Scenario 3 deflections (c) and structural stability evaluation (d)

The loading conditions at the time of Scenario 1 are unknown and therefore the results are only relative. A large deflection is seen in Figure 9 (a) in the middle of the principle rafter which can justify the need for a strengthening. In Scenario 2 after the removal of the tie beam the diagonal truss starts acting on tension and loses its function and the horizontal beam on the left side can be seen to suffer a large deflection Figure 9 (b), which is still present on the frame. Scenario 3 shows a strengthened frame and reduced deflections seen in Figure 9 (c) and the same scenario is evaluated to be stable for the actual level of forces acting on it presented in Figure 9 (d). This hypothesis presents a high level of reliability for the cause of deformation. Nevertheless, if more hypothesis can be formed a comparative analysis can be done to assess the most reliable one. After this assessment the frame does not require excessive strengthening measures. A possible strengthening proposal can be the placement of a tie beam at the bottom to take the horizontal thrust.
