XXIII Italian Group of Fracture Meeting, IGFXXIII

Pipeline corrosion failure in an absorption chiller

Andrea Brotzu*, Ferdinando Felli, Stefano Natali, Daniela Pilone

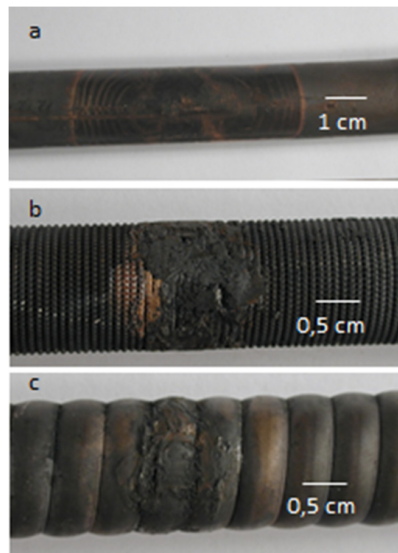
Fig. 5 shows the appearance of the external surface of copper pipes. It can be noticed that all pipes are covered by a black oxidized patina. Macrographs have been taken in correspondence of the sections where the copper pipes are in contact with the steel (C40) supports. Fig. 5a shows the surface of the copper plain pipe used in the condenser. On this surface the water vapor produced in the generator condenses. Fig. 5b shows the surface of the copper mini finned pipe employed in the absorber section. On this surface the LiBr solution, which heats up when it absorbs the water vapor produced in the evaporator section, is cooled down. It can be noticed again that in correspondence of the support a corrosion scale is developed. Fig. 5c shows the surface of the copper corrugated pipe employed in the evaporator section. The water flowing inside it, is cooled down from the flashing water that comes from the condenser. A close observation of its surface highlights that also in this case a corrosion scale is formed in the contact points between the pipe and the supports.

The presence of these corrosion products initially suggested that the failure of the pipes could be due to the galvanic coupling between the steel support and the copper pipe and worsened by the development of crevice corrosion.

Fig. 5. Macrographs of the external surfaces of copper pipes: a) Condenser, plain pipe, b) Absorber, mini finned pipe, c) Evaporator, corrugated pipe.

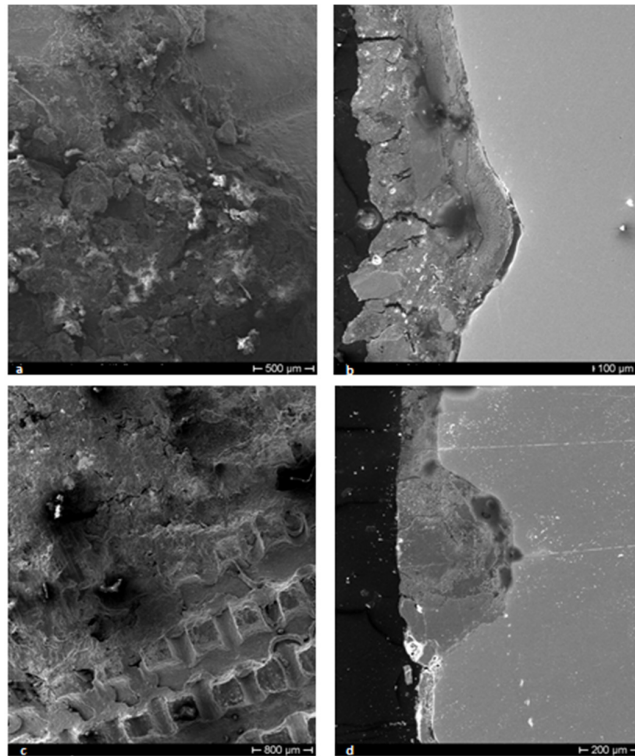
In order to verify this hypothesis metallographic analyses have been carried out on specimens taken from those areas. They have been observed by means of a scanning electron microscope (SEM) equipped with energy dispersion spectroscopy (EDS) microanalysis. In addition to this, the corrosion scale has been analyzed by x-ray diffraction. Figs. 6a and c show the surface of the corrugated and mini finned pipes, while Figs. 6b and d show the metallographic transverse sections of specimens taken from the same areas. It can be observed that, at high magnification, the scale is only laid down on the external pipe surfaces, in fact Figs. 6b and d reveal that the profile of the external surfaces of both mini finned and corrugated pipes is almost intact. The scale is localized in correspondence of the supports and its thickness decreases moving away from them. Figs. 7 and 8 show the EDS spectrum and the x-ray diffraction pattern

Fig. 6. SEM micrographs of the external surface of copper pipes: Condenser, plain pipe (a, b); Absorber, mini finned pipe (c, d).

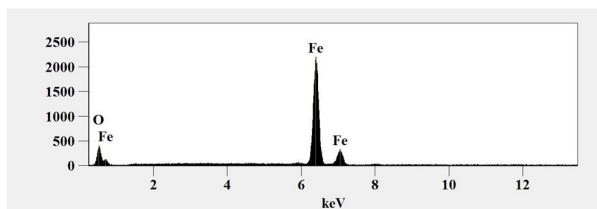
of the corrosion scale respectively. As it can be seen the corrosion product is iron oxide coming from the corrosion of the steel supports. From this preliminary examination it can be inferred that the failure did not occur in this area.

Fig. 7. EDS spectrum of the corrosion scale found in correspondence of the steel supports.

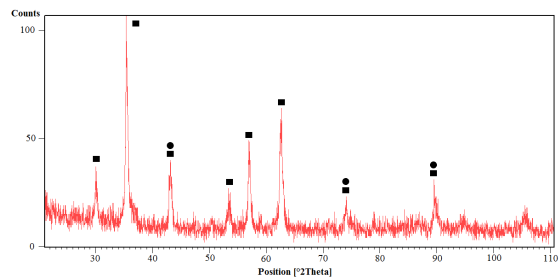
Fig. 8. X-ray diffraction pattern of the corrosion scale found in correspondence of the steel supports (●Cu ■ Fe_3O_4).

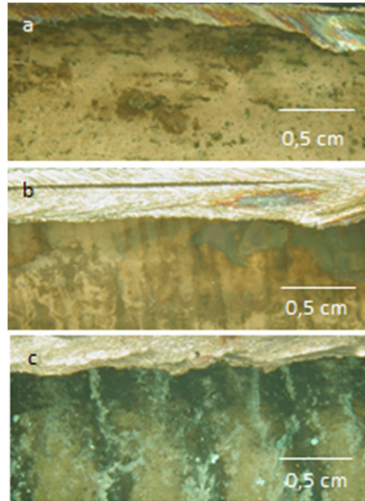
During the pipes' analyses it has been noticed that the corrugated pipe internal surfaces were completely covered by a green layer, while the other copper pipes were almost clean (Figs. 9 a-c). The green compound has been removed and analyzed by x-ray diffraction, moreover several samples were taken along the whole length of the pipe and the polished cross sections observed by SEM/EDS.

Fig. 9. Macrographs of the internal surfaces of copper pipes: Condenser, plain pipe (a), Absorber, mini finned pipe (b), Evaporator, corrugated pipe (c).

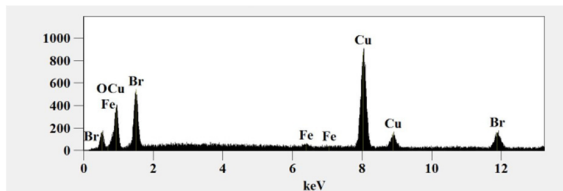
Figs. 10 and 11 show that this green layer was formed by a mixture of iron and copper oxides and by copper bromide hydroxide ($\text{CuBr}_2(\text{OH})_3$). SEM observations of the polished cross sections (Fig. 12) revealed that deep corrosion pits developed from the internal surface of the corrugated pipe; in some cases they developed through the whole pipe section. EDS analyses carried on the compounds present inside the pits showed that they were constituted by copper chloride and/or copper bromide hydroxide.

Fig. 10. EDS spectrum of the deposit found inside the corrugated pipe

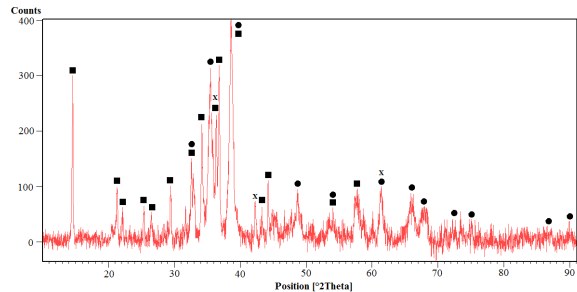
Fig. 11. X-ray diffraction pattern of the deposit found inside the corrugated pipe(■ $\text{Cu}_2\text{Br}(\text{OH})_3$, ● CuO , X FeO)

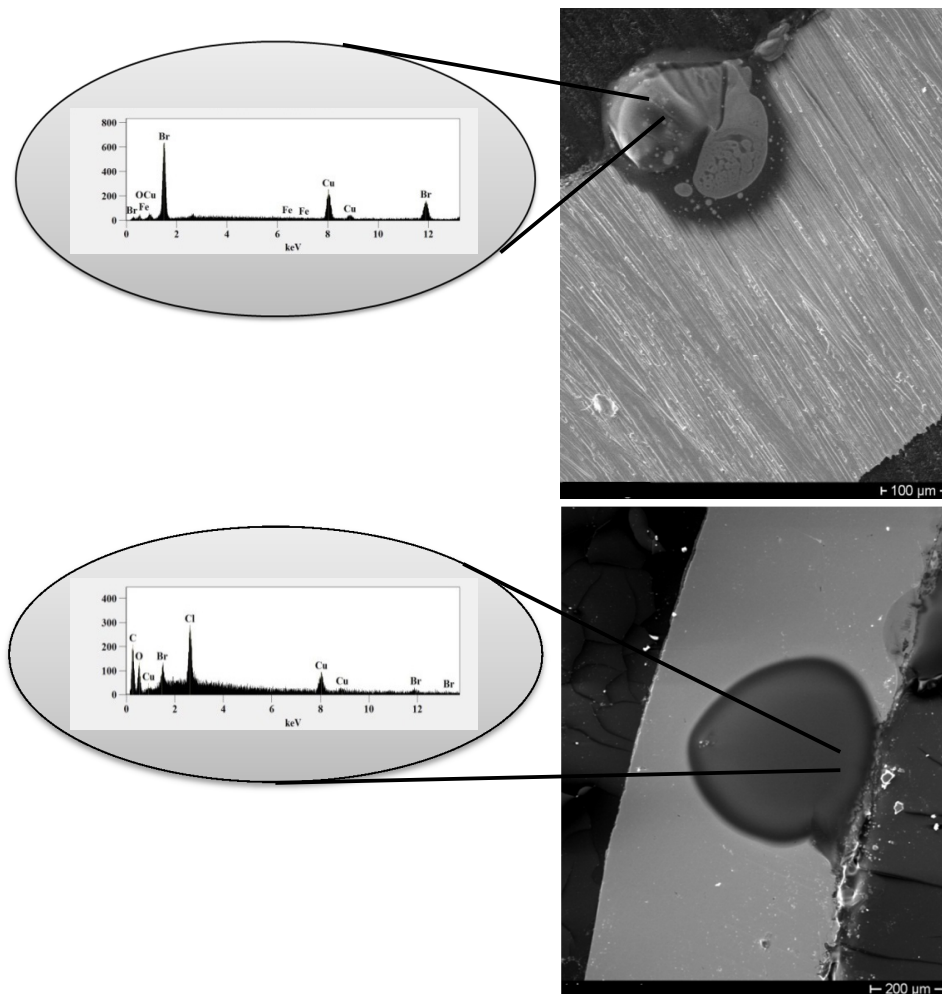
SEM observation of the polished cross section of the corrugated pipes showed that these pipes were subjected to a deep localized corrosion attack that started from the internal surface. Fig. 12 shows deep pits that in several cases developed almost through the whole pipe section. These pits are full of corrosion products. The presence of halides inside these pipes was unexpected, in fact chlorine is virtually absent in this plant and only traces of this element could be found in the softened water flowing in the chilled water circuit. However it must be considered that the chiller was stored for about a year near the sea and that during this time span the coupling flanges remained open allowing moisture and chloride to enter the pipes. The occurrence of localized corrosion phenomena has just been noticed after the first plant stop during a visual inspection carried out with an endoscope. It showed the presence of pits inside many copper pipes both in the evaporator and in the absorber sections. Some pipes had also the internal surface covered by a thick layer of a corrosion product deposit. As it can be seen from the plant schema reported in figure 1 bromine should be present only in the absorber zone of the chiller that should be separated by a septa from the evaporator section where the failed corrugated pipes are placed. Bromides can enter the evaporation section only if there is a

sudden increase of the LiBr solution level due to a plant malfunction. This probably happened as a consequence of the first chilled water circuit failure, when pressurized water from this circuit flooded the chiller.

Fig. 12. SEM micrographs showing two deep pits developed in the corrugated copper pipes.

The storage of the chiller in proximity of the sea, where the concentration of chlorides in the air is high, probably creates the conditions for a localized corrosion attack that started from the pipe internal surface. Generally speaking halides generate a very aggressive environment for copper [1-3] that in halide solutions exhibits an active behavior. Chloride ions in fact tend to form soluble chloride complexes ($CuCl_2^-$ and $CuCl_3^{2-}$) that are easily dissolved. The deep pits developed and the high pressure difference between the inside and the outside of the pipes probably caused the first observed failure. The external surfaces of copper pipes were protected because pipes were placed in the closed chiller vessel and kept under inert gas (nitrogen) overpressure.

Once the causes of failure have been identified all copper pipes were replaced with new ones.

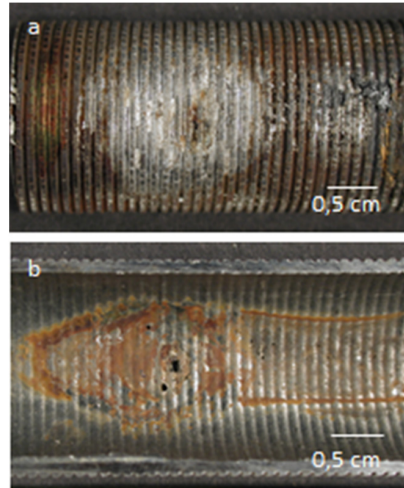
A naked eye observation of the corroded pipes revealed that there are defects developing from the internal surfaces through the whole section of the pipes. Figs. 13 a and b show the macrographs of a defect observed on the external and on the internal pipe surface respectively. On the external surface a crevice is clearly visible, while on the internal surface this defect appears as a deep hole surrounded by red corrosion products (iron oxide). In this area several pits have been observed and some of them were rather deep. Figures 14 and 15 show the SEM micrographs of these defects. EDS microanalysis carried out on the metal surface inside the pits show a low oxygen content.

Fig. 13. Macrographs of the stainless steel pipe external (a) and internal (b) surfaces.

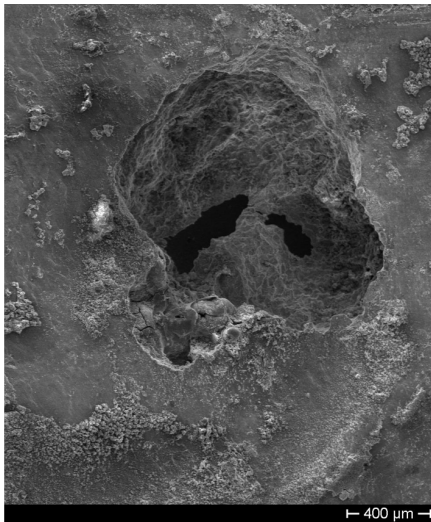
Fig. 14. SEM micrograph showing a deep pit on the surface of the stainless steel pipe.

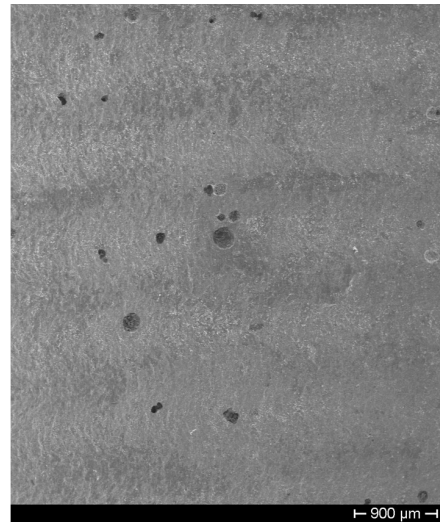
Fig. 15. SEM micrograph showing small pits developed on the internal surface of the stainless steel pipe.

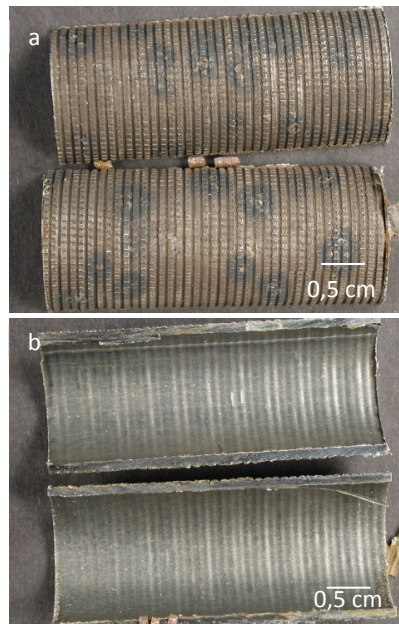
Fig. 16. Macrographs of the stainless steel pipe external (a) and internal (b) surfaces.

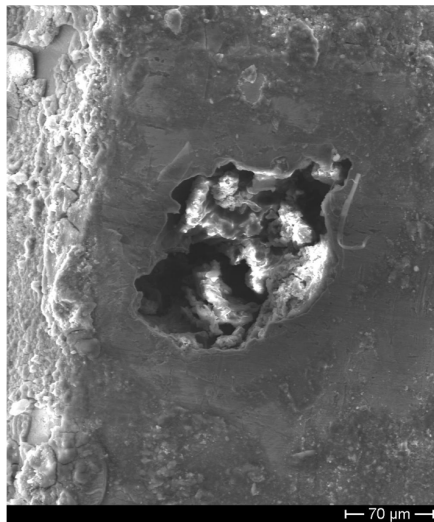
Fig. 17. SEM micrograph of a pit developed on the stainless steel pipe external surface.

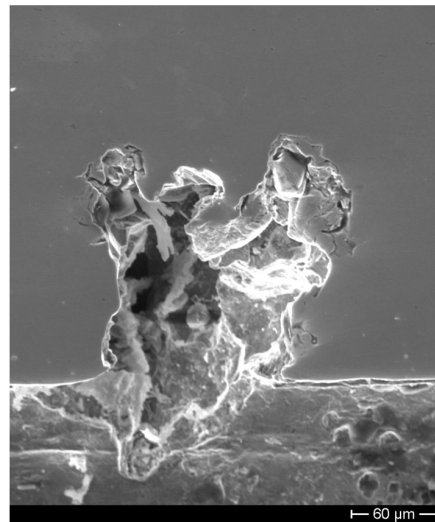
Fig. 18. SEM micrograph of a pit on stainless steel pipe external surface (metallographic section).
