# Sonic tomography of the stone pillars of a 17<sup>th</sup> century church

L. Zanzi<sup>1</sup>, A. Saisi<sup>2</sup>, L. Binda<sup>2</sup> & E. Cardarelli<sup>3</sup>

Pulse sonic tests were applied to 8 massive stone pillars of a 17<sup>th</sup> century church (S.Nicolò all'Arena at Catania, Italy). The data were processed to obtain 28 tomographic sections showing the distribution of the elastic wave velocity within the tested pillars. The results of the tests are compared in order to check the morphology and the state of damage of the pillars. A preliminary frequency analysis of the data seems to indicate that these experiments can be used to extract the energy absorption distribution.

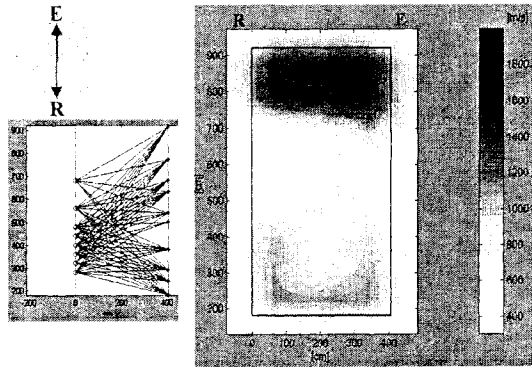
A typical distribution of the velocity on the pillars 1 and 2 shows average velocities at the base and at the top of the pillars and very low velocities in the middle. This is very clear in the vertical tomography of both pillars even if the vertical sections have a lower density of ray as shown in Fig. 7 and Fig. 8.

Fig. 7. Vertical tomography of the pillar 1

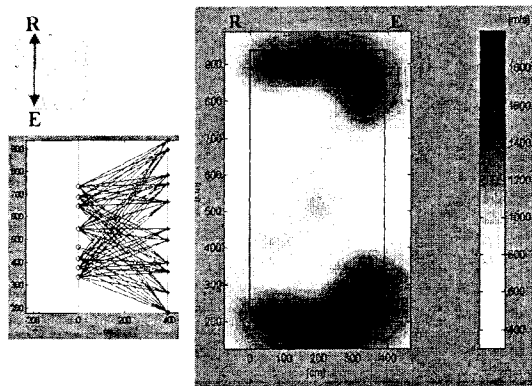
Fig. 8. Vertical tomography of the pillar 2

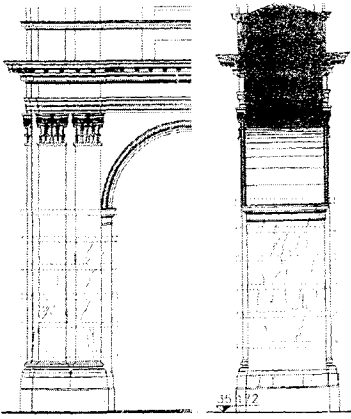
After an earthquake, which struck the Eastern part of Sicily in 1990, the structural elements of the church as the dome and the vaults were damaged and the appearance of vertical cracks on the original pillars were detected. It is not clear whether those cracks were already visible and were simply propagating during the earthquake. An investigation programme (including sonic, radar, flat jack, coring, boroscopy, etc.) has been recently planned to design the preservation and

It is also worth remembering that these pillars show a dangerous crack pattern (Fig. 9). From coring of the pillars it was also clear that the internal mortar was very weak.

Fig. 9. Crack pattern of pillar 2.

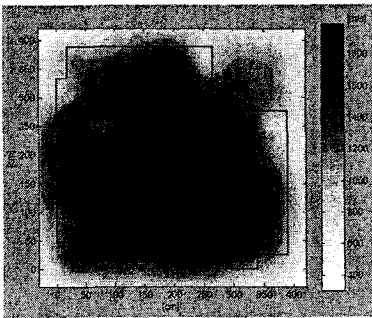
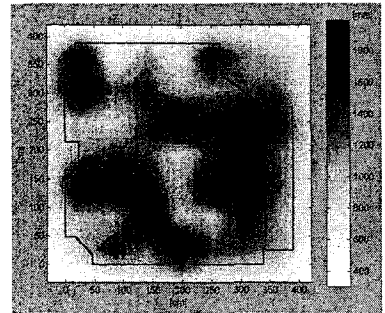
The other pillars that have been investigated generally present much higher velocities indicating a less alarming state of conservation (Fig. 10).

In particular the pillar 6 seems characterised by the better quality material. The observation of the masonry texture reveals a large block stonework, rather regular.

Fig. 10. Horizontal sections of pillar 6 and pillar 10 at 5.8 m.

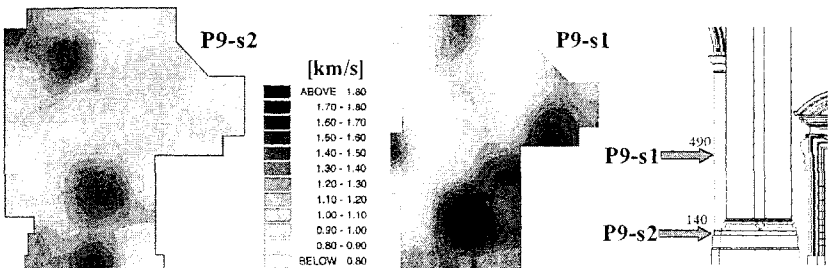
Some results on two very large pillars characterised by a complex geometry are worth of attention (pillars 9 and 12). They show higher velocities on the narrow side of the pillar and lower velocity on the large side (Fig. 11).

This trend is symmetrically observed on both the pillars and might be related to a specific construction design or to a non homogeneous state of degradation of these elements.

Fig. 11. Horizontal sections of pillar 9 at 1.40 and 4.90 m.
