21st European Conference on Fracture, ECF21, 20-24 June 2016, Catania, Italy

Analysis of the fracture criticality of biphasic brass

Abstract

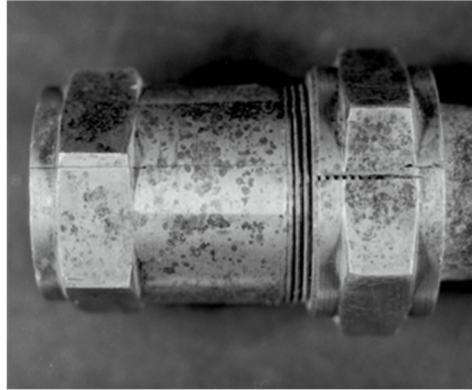
Fig. 1 shows the crack developed unhindered in the longitudinal direction. The crack orientation is normal to circumferential stresses acting on the component that are induced by tightening forces. Even assuming clamping overstressing, a close observation of the broken joint highlights that the crack propagated in a clear way along the cylindrical generatrix of the component.

Fig. 1. Macrograph of the broken hydraulic joint

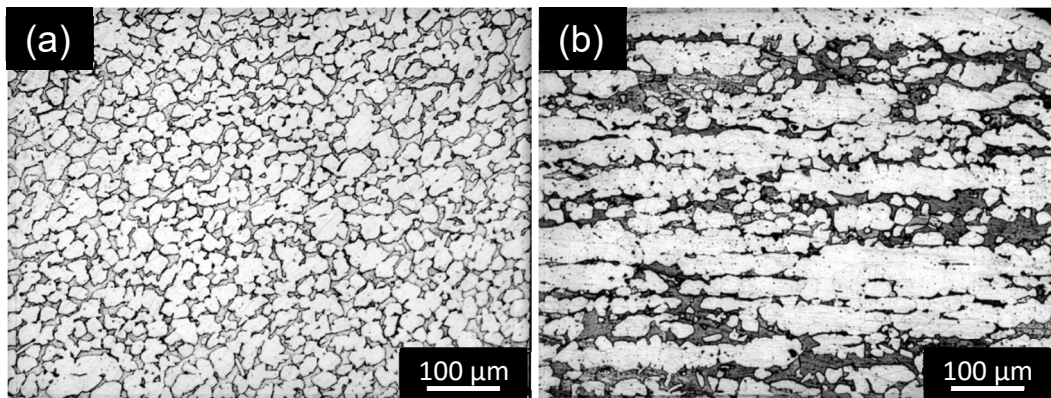
Figures 2 and 3 show the alloy microstructure along the transverse and longitudinal sections, both characterized by the presence of α and β phases. As far as the microstructure in Figure 3 is concerned EDS analyses of the bright

phase (55% Cu, 45% Zn) revealed that it is the β phase, while the dark phase (62%Cu, 38% Zn) is the α phase. The small white areas, visible in this figure, are lead reach phases. In the optical micrographs (Fig. 2) the α phase is bright, while the β phase is dark. The quantity of β phase, which is about 25%, is the typical value characterizing these alloys. By observing the alloy microstructure in Fig. 2b it is also evident that the β phase has a preferential orientation along the longitudinal direction. In fact, being the studied component obtained by machining an extruded bar, grains are oriented in the extrusion direction.

Figure 2. Optical micrographs showing the alloy microstructure perpendicular (a) and parallel (b) to the extrusion direction.

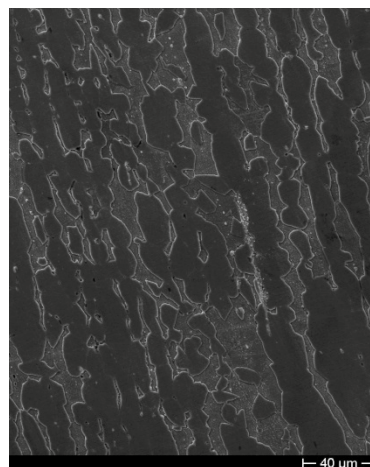
Fig. 3. SEM micrograph showing the alloy microstructure of as-extruded alloy parallel to the extruded direction.

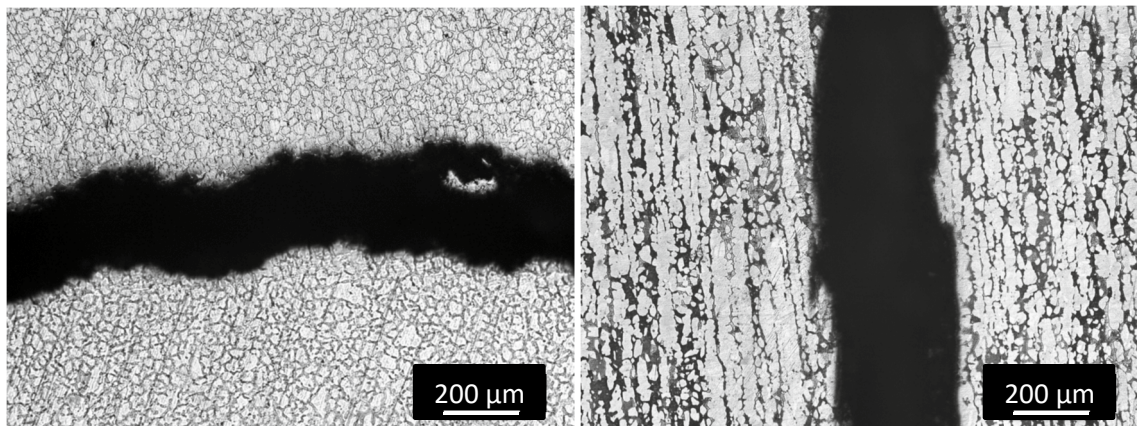
A careful observation of crack paths reported in Figs. 4 and 5 highlights that cracks developed prevalently through the β phase, which is brittle, by following an intergranular path (Fig. 5). Crack propagated throughout the component from the inner toward the outer part, as demonstrated from secondary crack paths (Fig. 6).

Generally speaking stress corrosion cracking induces the formation of branched cracks characterized by a high number of thin secondary cracks. In this study we observed only few secondary cracks with blunt tips: this indicates that the mechanical applied load is the main cause of the failure.

Figure 4. SEM micrographs showing the crack path perpendicular (a) and parallel (b) to the extrusion direction

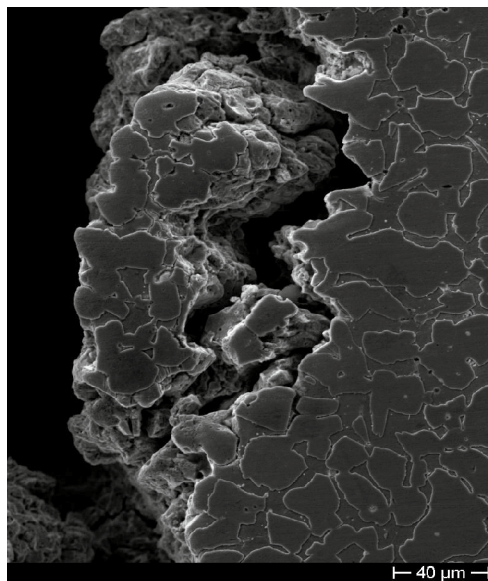
Figure 5. SEM micrograph showing the crack path perpendicular to the extrusion direction.

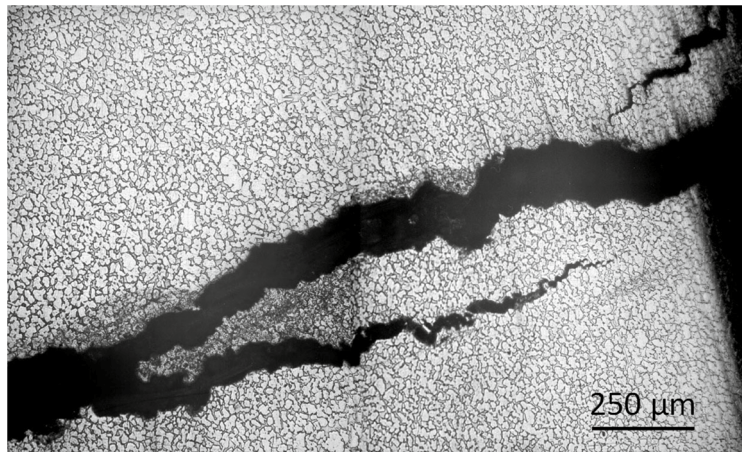
Fig. 6. Micrograph showing primary and secondary cracks.

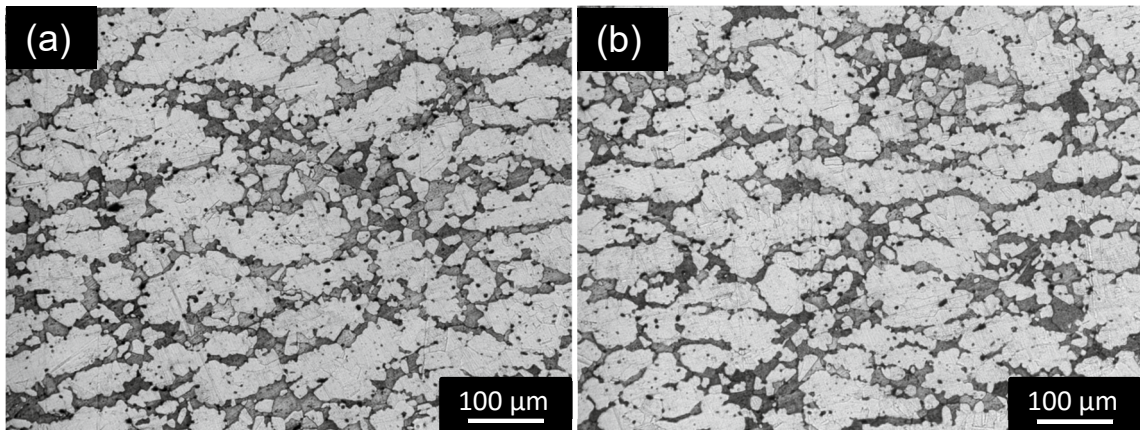
In order to verify the effect of the alloy microstructure on the component behavior in service, the same type of component has been produced by means of hot forging. In this case the microstructure appears homogeneous without any preferential orientation (Fig. 7). This hydraulic joint was used in the same conditions of the failed one, but it did not fail in service.

Figure 7. Optical micrograph showing the forged alloy microstructure: transversal (a) and longitudinal (b) sections.

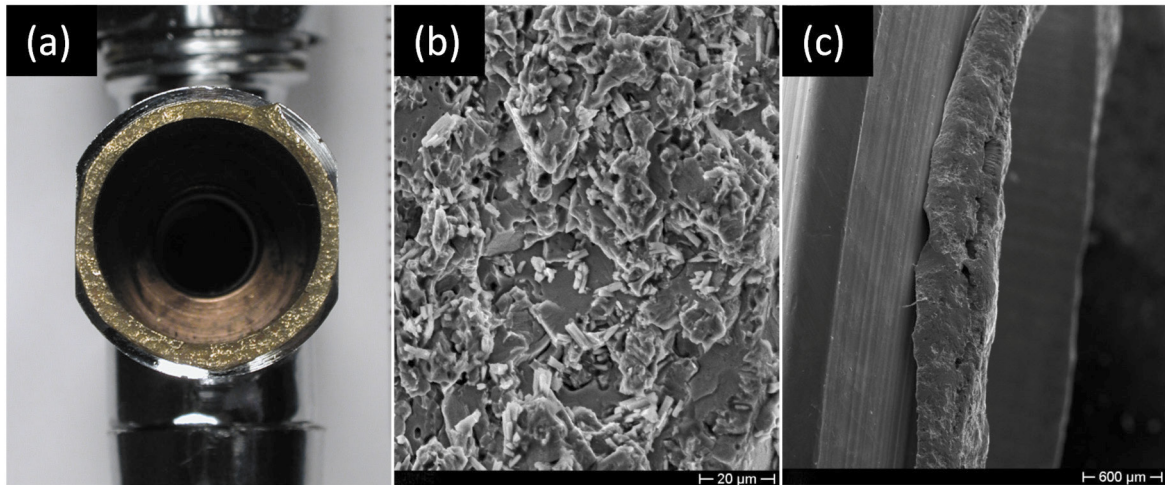
Figure 8 shows a tap that failed due to the application of a flexural stress. In this case fracture initiation occurs in the threaded area of the component where there is stress intensification at the tip of the thread. The fracture surface is characterized by a brittle morphology (cleavage) in the crack initiation area (Fig. 8b) and by a mixed morphology with some dimples in the propagation area, while the final fracture shows a considerable plastic deformation (Fig. 8c).

Figure 8. Tap failed by applying flexural stress: macrograph of the fracture surface (a), SEM micrograph of the final fracture area (b), SEM micrograph of the fracture surface (c).

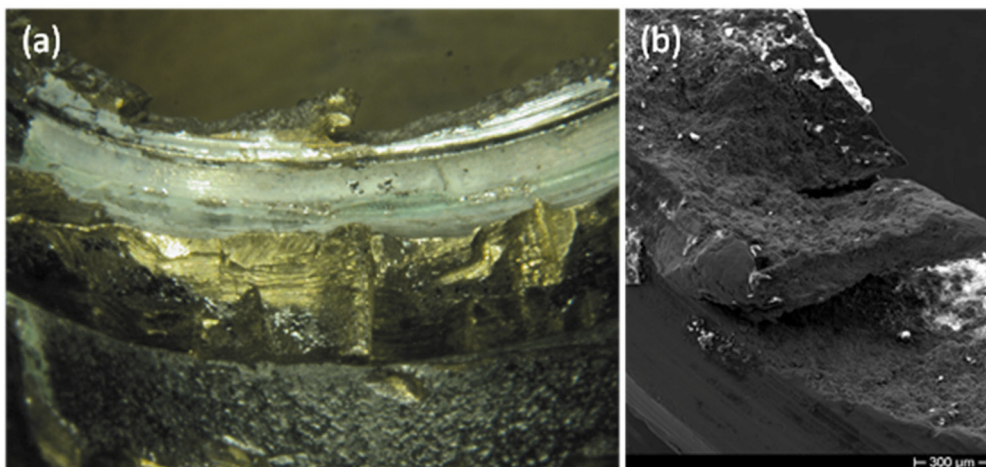
In Fig. 9 the fracture surface of another brass tap that failed because of torsional stress is shown. This surface shows circular grooves due to the used tool (Fig. 9a) and material curls (Fig.9b) that are generated by torsional stress and that are inclined relative to the fracture plane. In this case the fracture is almost ductile throughout the all component.

Figure 9. Macrograph (a) and SEM micrograph (b) of the fracture surface of a tap failed by applying a torsional stress.
