## Performance of a school hosted within a historical complex affected by the 2016 seismic sequence

Luigi Sorrentino<sup>a</sup>, Marco Pepe<sup>a</sup>, Domenico Liberatore<sup>a</sup>, Patrizia Trovalusci<sup>a</sup>

*Keywords: Structural damage, Non-structural damage, Cloister type complex, Teramo*

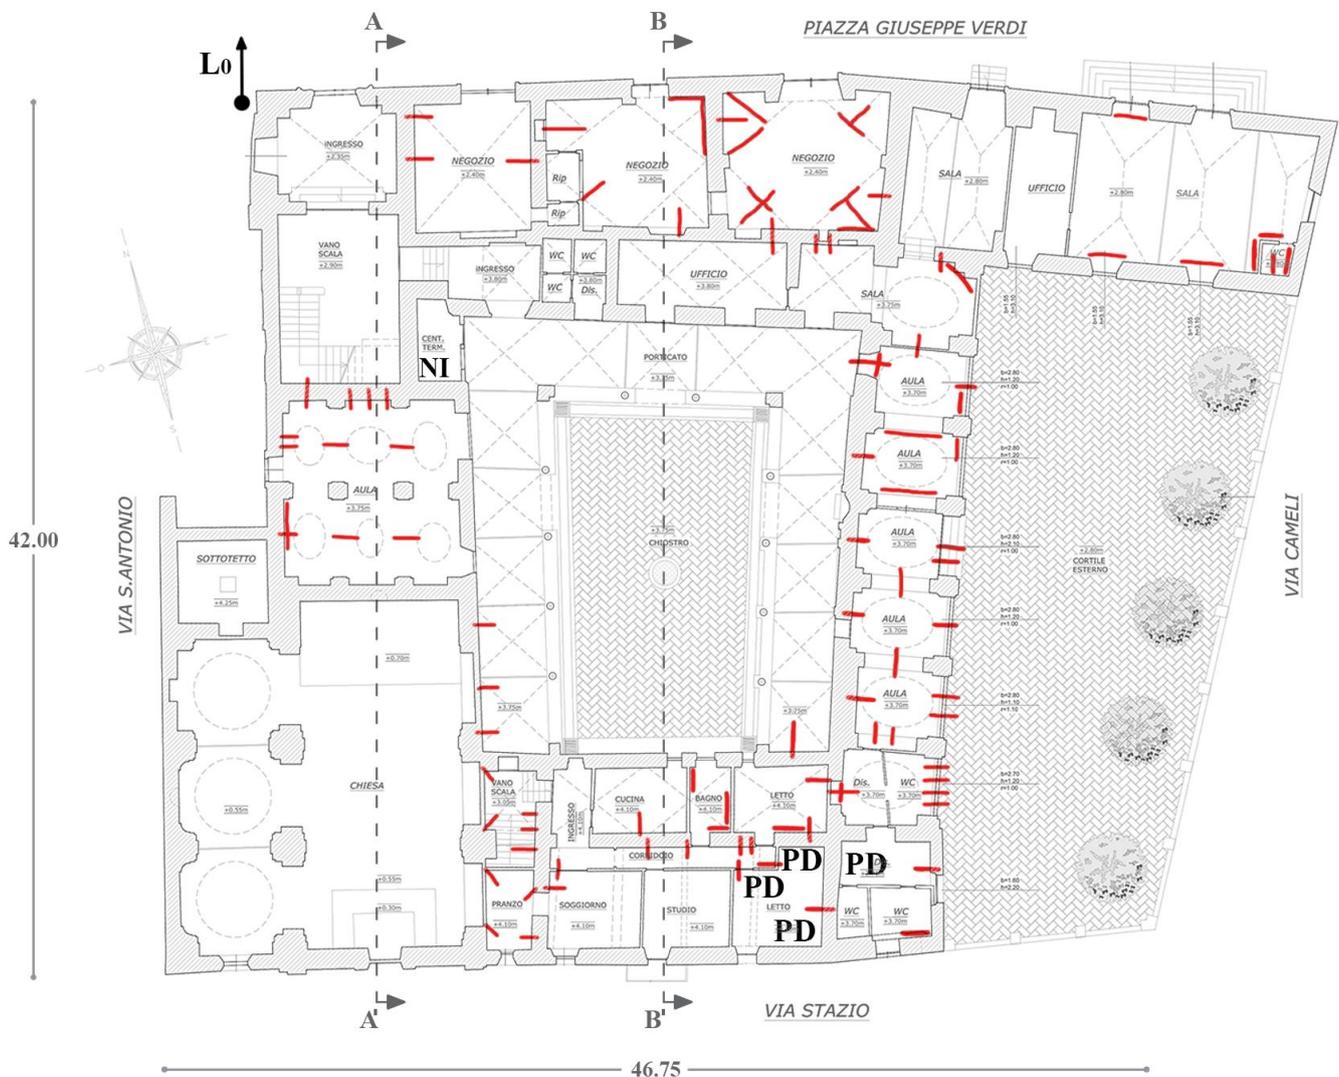
Figure 1. Ground floor (piazza Giuseppe Verdi) plan. Crack pattern after the October 30<sup>th</sup> event on the original survey by Ninni et al. (2014). All measures in m. NI = Not inspected, PD = plaster delamination, Li = acquisition point of ambient velocities

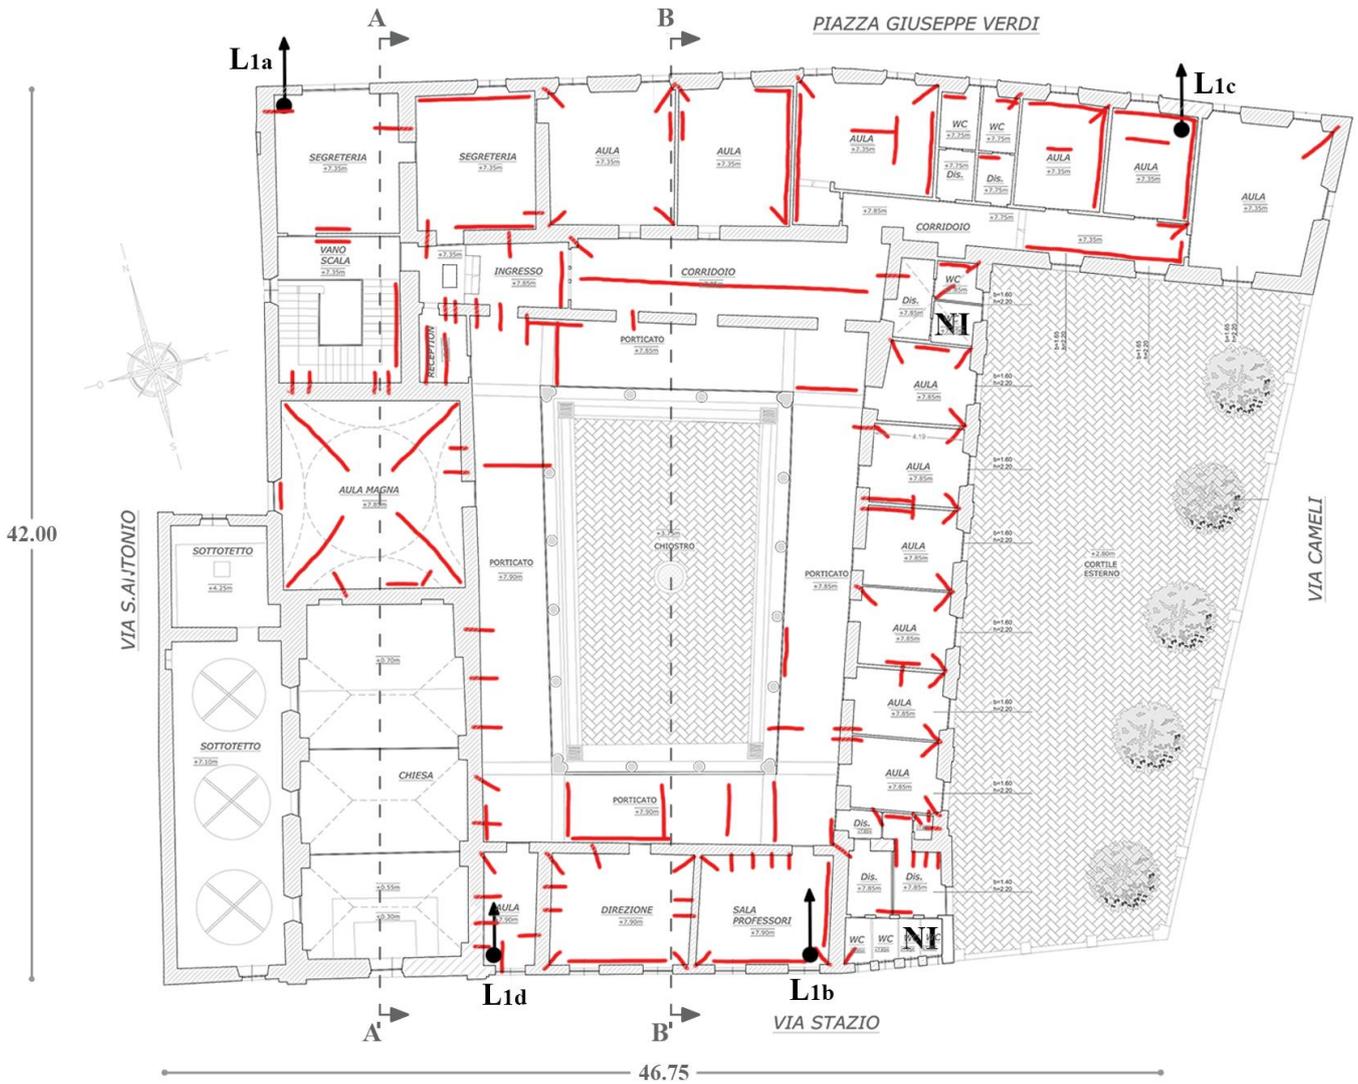
Figure 2. First floor plan. Crack pattern after the October 30<sup>th</sup> event on the original survey by Ninni et al. (2014). All measures in m. NI = Not inspected, Li = acquisition point of ambient velocities

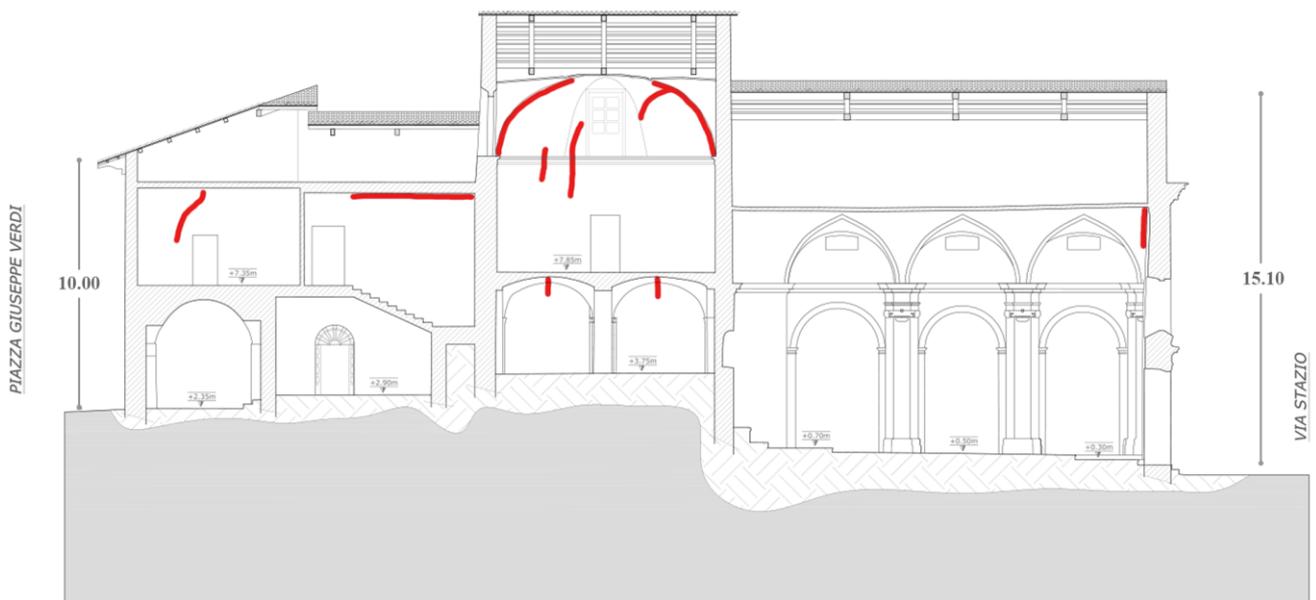
Figure 3. A-A' section across the main staircase, the lecture hall and the church of San Giovanni (refer to Figure 1 and Figure 2). Crack pattern after the October 30<sup>th</sup> event on the original survey by Ninni et al. (2014). All measures in m

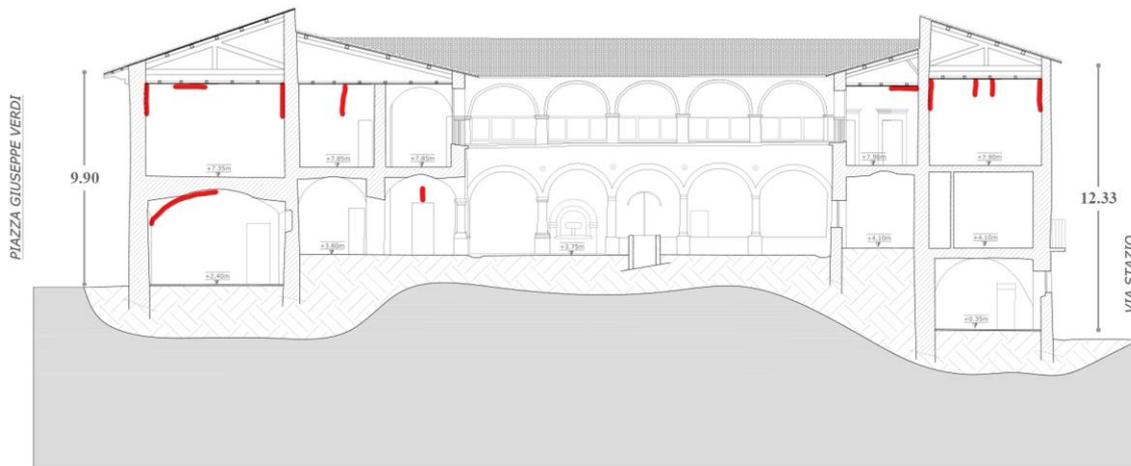
Figure 4. B-B' section across the cloister (refer to Figure 1 and Figure 2). Crack pattern after the October 30<sup>th</sup> event on the original survey by Ninni et al. (2014). All measures in m

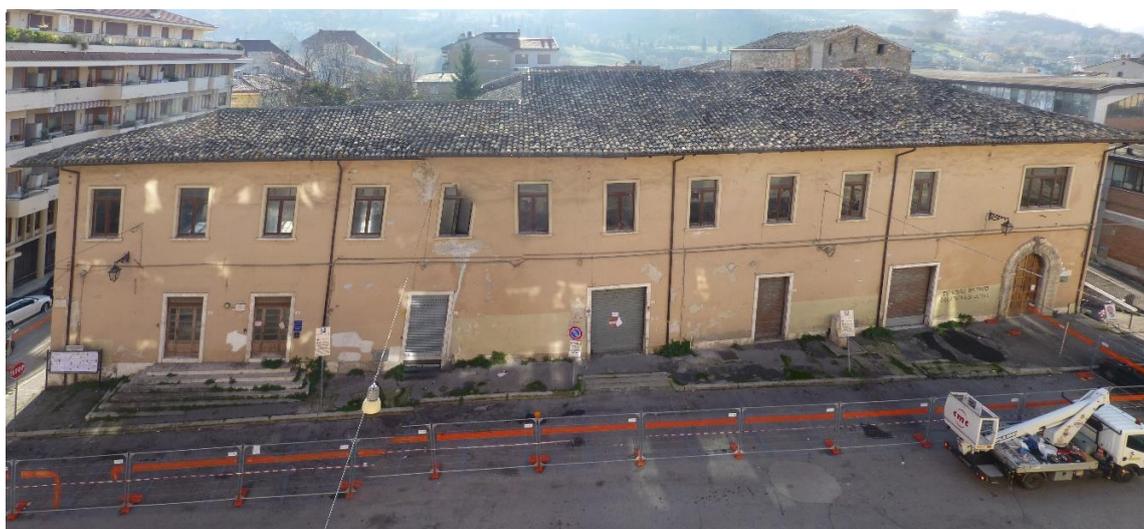
Figure 5. Photomerge of the façade on piazza Verdi (Figure 1) and related roof after the October 30<sup>th</sup> event

contrary, no damage to chimneys and tiles was observed, at least on the roof of the piazza Verdi wing (Figure 5).

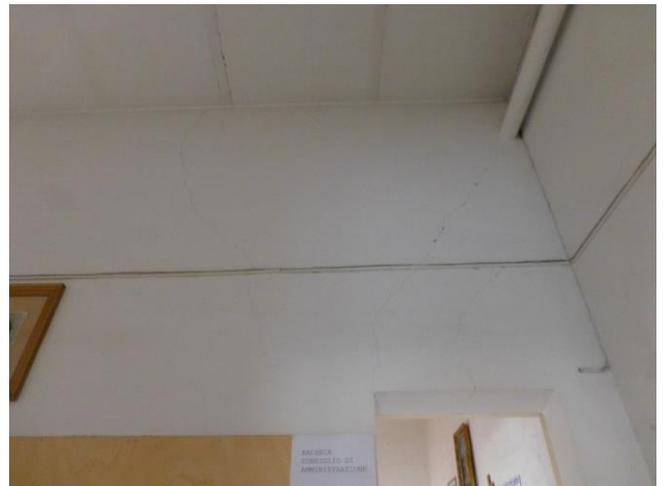
transversal section, were observed on more than 30% of the structural walls surfaces of the first floor (Figure 8). Evident separation between vertical and horizontal structures, as well as at wall intersections, were surveyed at same floor (Figure 9). According to OREM (2013) such damages qualify as significant but less than severe. Consequently, the damage level of the building is classified as 2 (Table 1.4 in OREM 2013). Additionally, widespread cracks having width smaller than 3 mm were observed on some structural walls of the ground floor and in some vaults between ground floor and first floor (Figure 10).

Figure 8. Widespread cracks having width smaller than 3 mm. First floor, wing on piazza Verdi

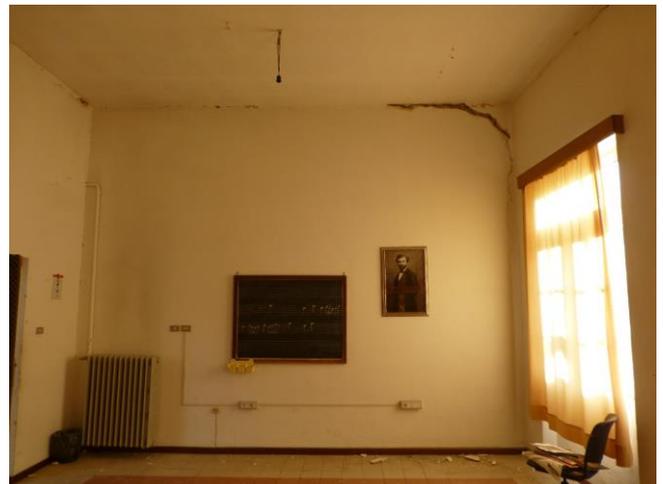
Figure 9. Evident separation between vertical and horizontal structures, as well as at wall intersections. First floor, wing on via Stazio

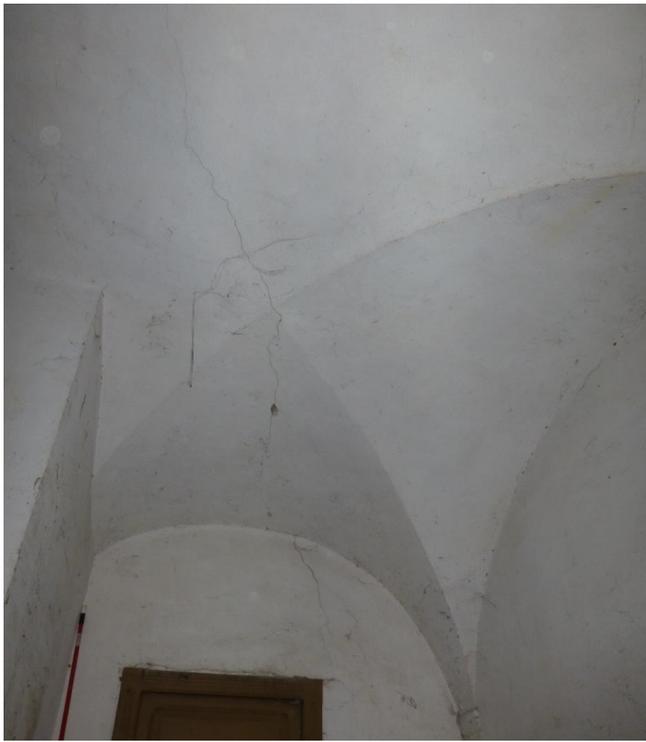
Figure 10. Widespread cracks having width smaller than 3 mm on a cross vault between ground floor and first floor. Shop on piazza Verdi

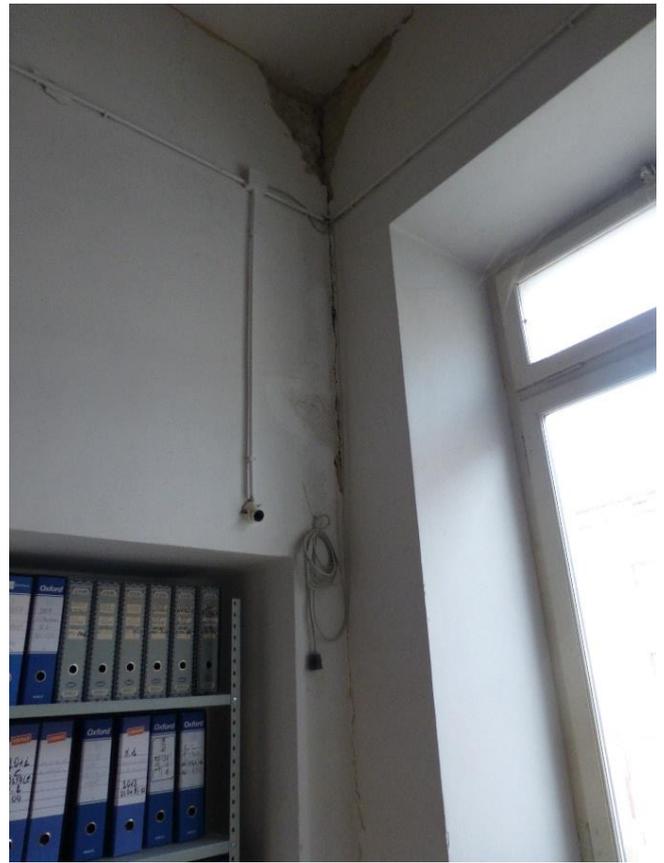
Figure 12. Separation between partition (left) and structural wall (right). First floor, room on piazza Verdi

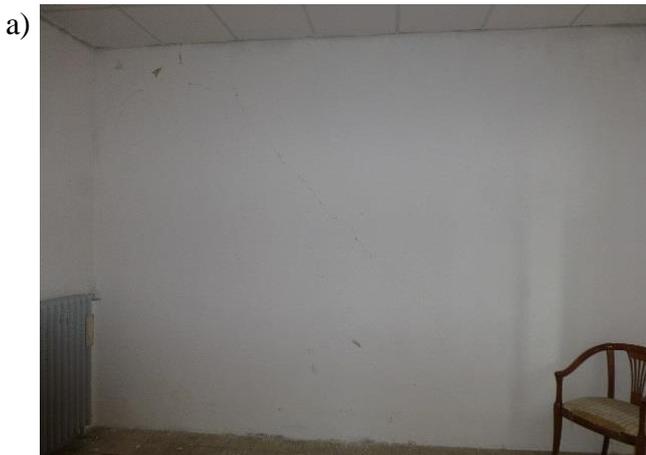
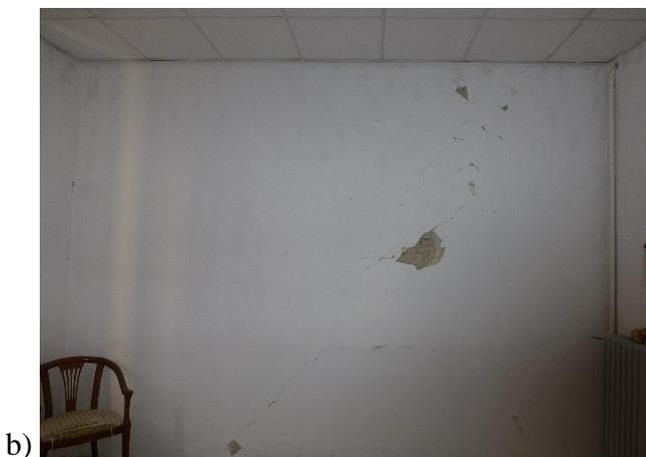
Figure 11. Inclined cracks crossing the whole thickness of a partition between two rooms on via Cameli garden

As observed also in other earthquakes (Penna et al. 2014), a number of significant damages to non-structural elements were visible in the aggregate. Inclined cracks crossed the whole thickness of some partitions of the first floor (Figure 11). Clear separations between partitions and structural walls were evident at first floor (Figure 12). Large plaster surfaces delaminated from the intrados of I-beams and hollow clay blocks floors (Figure 13).

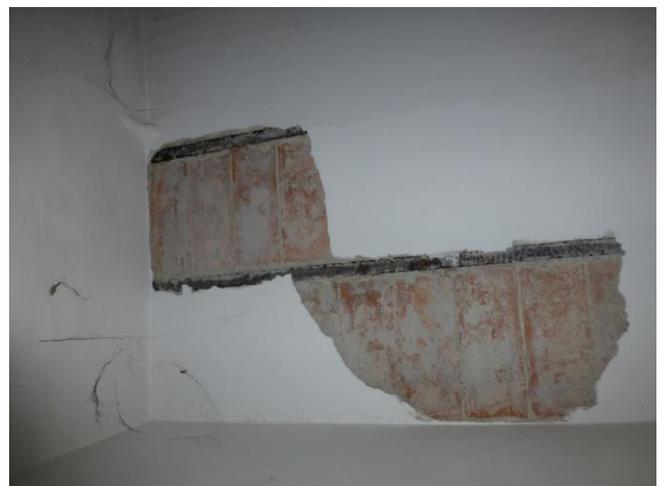
Figure 13. Plaster delamination from intrados of I-beams and hollow clay blocks floor. Ground floor, room on via Stazio

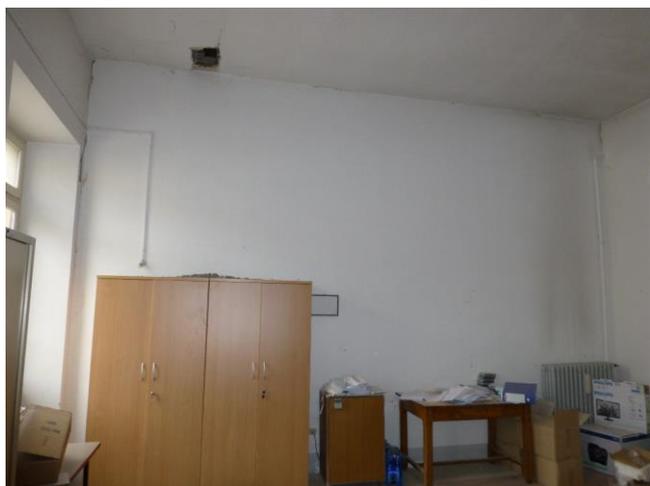
Figure 14. Cracks and local failure of the gypsum and timber ceiling. First floor, room on piazza Verdi

Widespread cracks, having width smaller than 3 mm, and local failures affected the gypsum and timber ceiling above the first floor (Figure 14). Widespread cracks, having width smaller than 3 mm, damaged also the reed mat vault of the reading hall, with an distinct increase of the damage level between the end of August and the end of October events (Figure 15). On the

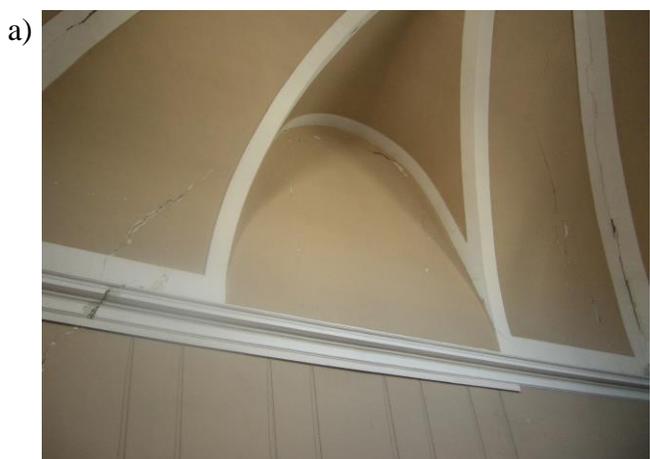
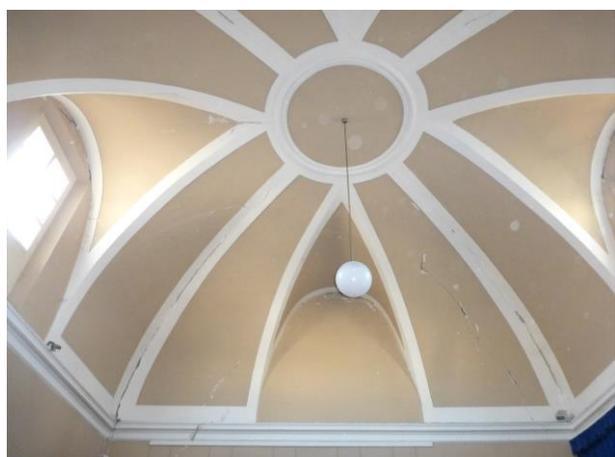
Figure 15. a) After August 24<sup>th</sup>; b) After October 30<sup>th</sup>. Cumulative damage is evident in the lune and in the right adjacent web
