The Basilica of Santa Maria di Collemaggio in L'Aquila: Modern Provisional Measures

Sabatino Cecchini and Francesca Curotti

Abstract: The case in analysis is Santa Maria di Collemaggio, the church symbol of the town of L'Aquila and the most important example of Romanesque style in Abruzzi, tragically damaged by the earthquake in 2009. The following paper starts with an accurate analysis of the Basilica, whose historical, stylistical cultural characteristics make it an unicum in the whole urban environment. The authors tried to identify in which way these values have been compromised or altered after the earthquake through several analysis (surveys, historical researches etc.) aiming at the recognition of collapses, the cracks profile, the structural transformations caused by the provisional measures: the goal is to provide a kind of Basilica "cognitive manual" that will be useful for the future interventions. This first analysis allowed to understand many aspects: on the one hand, the constructive phases and which damages were caused by past careless interventions of restoration, drawing attention to the vulnerability elements of the Basilica; on the other hand, the innovative te

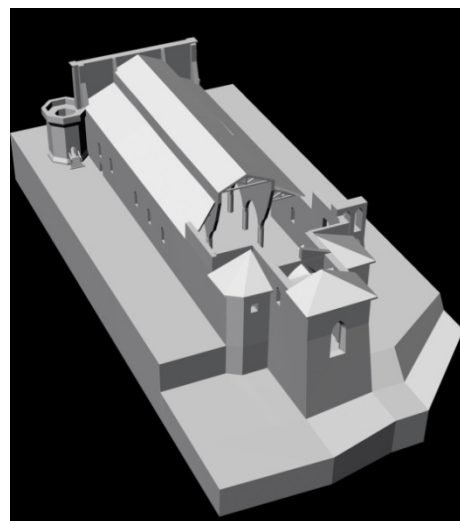
The most considerable damages, registered on April 6, 2009 (Fig. 5), are mainly imputable to wicked renewal works realized in the 1970s, in particular, the insertion of reinforced concrete structures caused:

Fig. 5 One of the Rhino models showing the damages of the roofing.

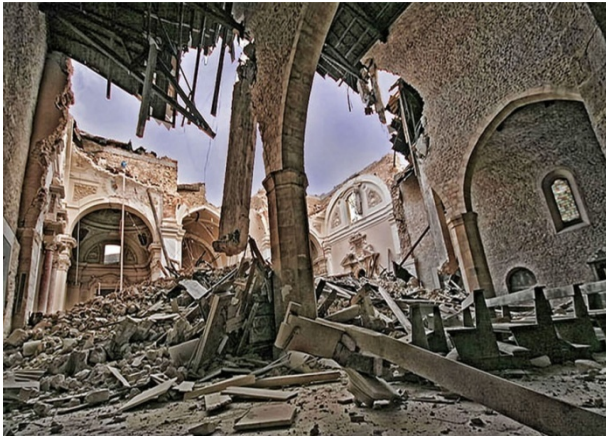
- the dome's collapse (Fig. 6);
- the partial tumbling down of the presbytery;
- the collapse of the barrel vaults of the transept;
- the collapse of the two monumental clustered pillars sustaining the dome and of the triumphal arch;
- the collapse of an half of the last span of the nave;
- the collapse of the whole wooden roofing of the transept [3].

Fig. 6 April 6th, 2009: the collapse of the dome.

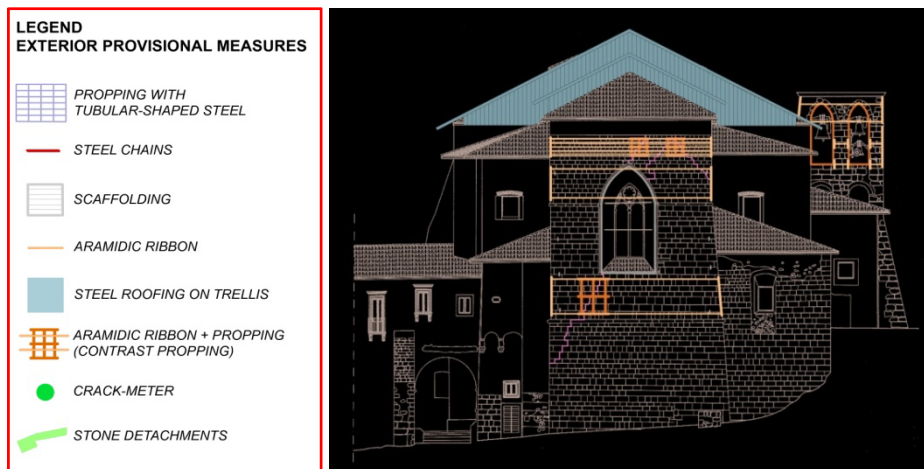
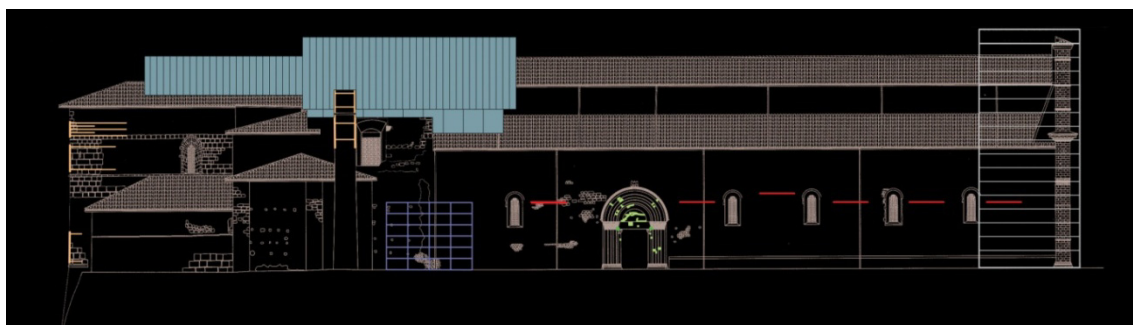
Fig. 7 The survey of the provisional measures on the east and north fronts.

The exterior (Fig. 7): the most used method is the wood propping to contrast above all the expulsion wedges and the steel propping of the openings (above all next to the bell tower and the windows of the apse), as the façade did not register huge damages (it is a sort of “slab” anchored to the main body of the church, and this has strongly strengthen it) in front of it there is only a scaffold to restore little localized damages to the sculptures.

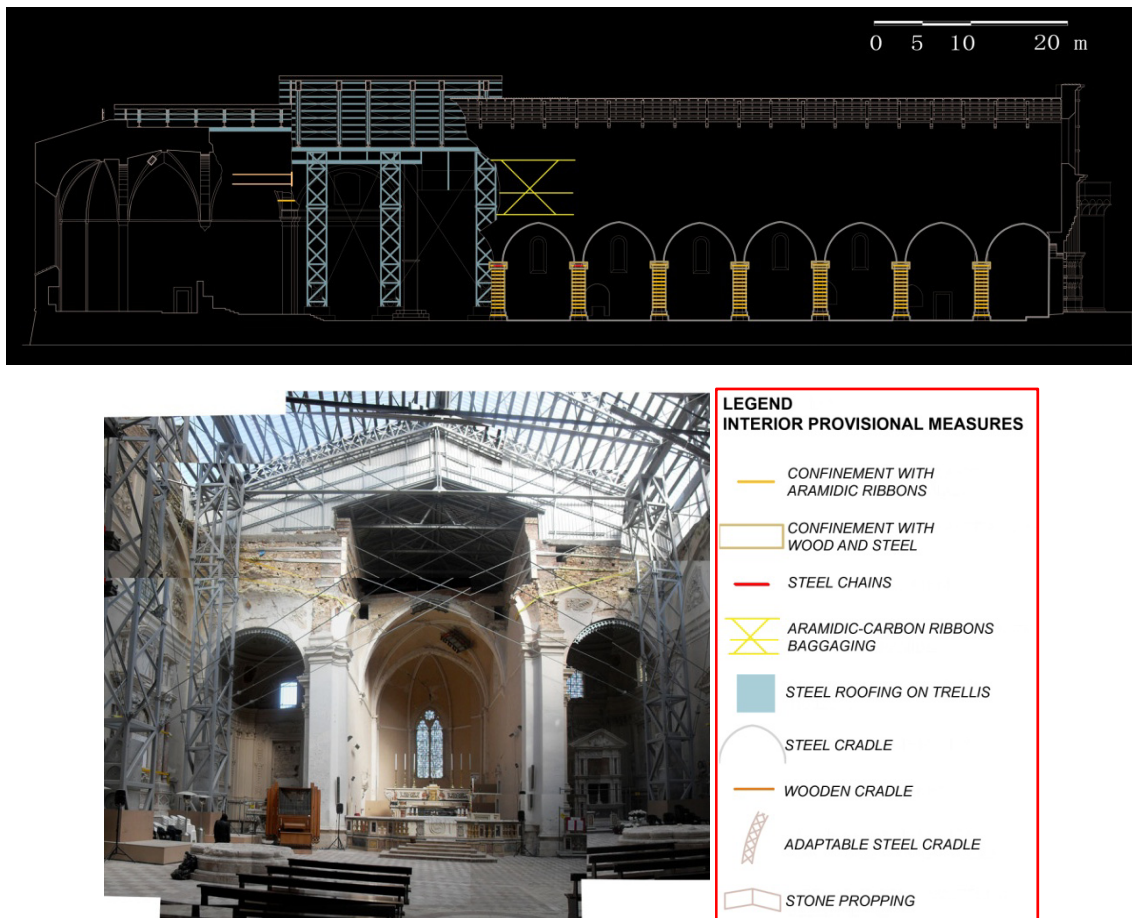
Fig. 8 The survey of the provisional measures on the nave's wall (section) and in the presbytery.

The interior (Fig. 8): the most used method is the steel propping and steel adaptable cradles of the arcades, steel chains to connect the perimeter walls of the aisles, the installation of a provisional roofing completely realized in steel and plastic materials to cover the portion of the church completely knocked down by the seism.
