Structural Investigations for the Refurbishment Project of the Municipal Building of Gjakova

Abstract. This paper presents the structural investigations performed on the existing municipal building of Gjakova, intended to be refurbished as part of the Refurbishment project by the European Commission. The municipal building of Gjakova built in the end of 1960s is a reinforced concrete structure with bearing masonry walls which are scattered without any logical pattern. This structural system presents a difficult approach for the seismic assessment of this building. To obtain the confidence factors and the mechanical parameters for the appropriate numerical modeling, a series of structural investigations is carried out in detail. Initially a visual inspection is conducted, and a photographic survey is carried out with a detailed marking of each picture to visualize the building and plan the detailed inspection. The detailed plan is organized according to the gathered information and the existing documentation, so that maximal information about the structure is acquired with the minimal possible intrusiveness. The detailed inspection is accomplished in a series of frequent site visit

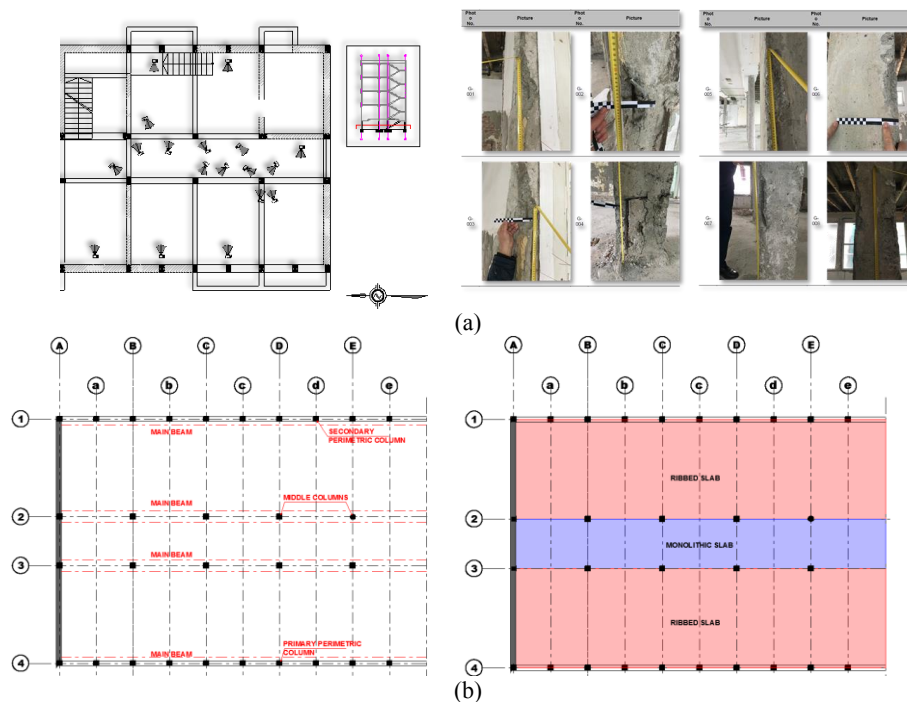
A preliminary inspection was carried out in the structure to perform a qualitative investigation in order to obtain information about the structural system, the actual damages and decide on the testing to be performed on the structure. Initially, original drawings from the archive were analyzed and then processed and regenerated into CAD drawings. A detailed geometrical survey was required to verify the existing structure to the original drawings. New and more detailed drawings of the existing situation were created with the geometrical in-situ data obtained. The geometrical survey was complemented with a photographic survey which was also mapped in the drawings (Fig. 3-a). The photographic survey included the documentation of the different damages in the structure. The damages were additionally gathered in a table where their nature and severity were categorized to have a better understanding. A major number of serious damages were found in the structure including structural

Fig. 3. (a) Example of the photographic survey and mapping on the drawings; (b) Structural system of the existing building;

cracks, spalling and pop-outs of the concrete, extensive segregation, corrosion and exposed rebars, misalignments, warping, rebar buckling and installations going through the structural members and so on, where some can be seen in Fig. 3 (a).

The structural system of the building can be seen in Fig. 3 (b), where the vertical bearing system consists of reinforced concrete (RC) columns in the middle and perimeter whereas on the lateral sides and for the stairs core structural masonry is observed, thus creating a mixed structure. The horizontal bearing system is made of a combination of monolithic RC slabs in the mid-span and RC ribbed slabs on the sides, all supported in RC beams which go only in the longitudinal direction of the building. The foundations consist of RC isolated footings for the mid-columns and RC strip foundations for the perimeter columns and walls with no tie beams to connect them.

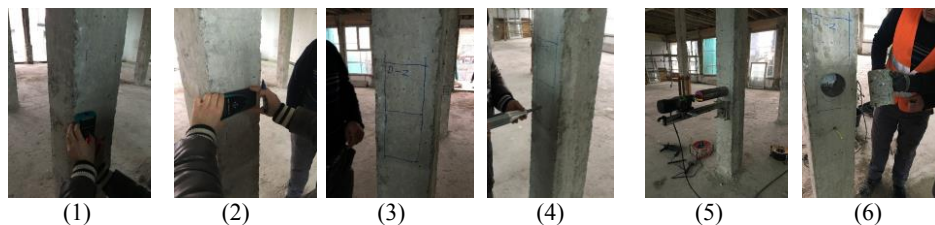
The detailed inspection included structural investigations in the structure utilizing the non-destructive testing (NDT) and destructive testing (DT). The main focus was to assess the in-situ compressive strength of the concrete conform [3] and to quantify the actual condition of the structural members. The method of obtaining the concrete strength includes coring of multiple concrete samples, but due to the fragility of the structure only 4 cores were taken, namely 3 columns and 1 beam. The core sampling procedure shown in Fig. 4 followed the localization of the rebars with a profoscope (1,2), surface preparation with abrasive stone (3), 9 rebound hammer readings in the coring location (4), fixation of the core drilling machine (5) and then the coring of a 10 cm diameter concrete sample with no reinforcement inside (6).

Fig. 4. Core sampling procedure;

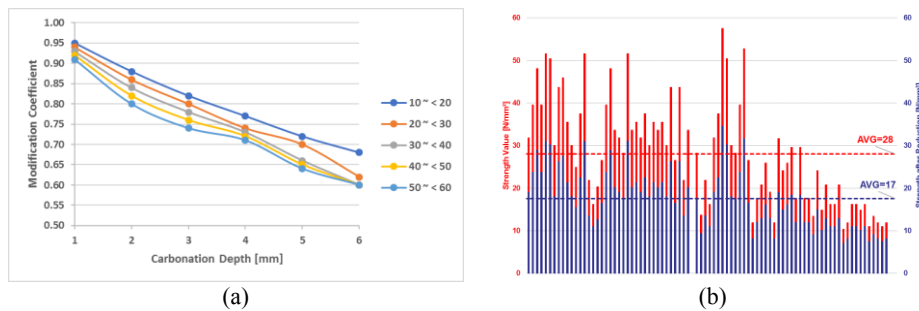
The concrete compressive strength in-situ conform [3] can be obtained by correlating the NDT results with results from DT of cores. Initially the NDT results from the rebound hammer readings are reduced depending on the carbonation results of the cores. The average carbonation depth in the samples was found to be 27.5 mm, which is a relatively high value. The reduction values (Fig. 5-a) are given by a modification coefficient which multiplies the rebound hammer reading depending on the detected strength in MPa. It can be seen that the theoretical value for 27.5 of carbonation reaches a modification coefficient of zero, but for practical reasons readings are done for 6 mm of carbonation. The rebound hammer readings are shown in Fig. 5 (b), where can be observed the reduction of the average compressive strength from 28 N/mm² to 17 N/mm².

Fig. 5. (a) Carbonation reduction factor according to strength detected; (b) Strength readings from rebound hammer and after reduction;

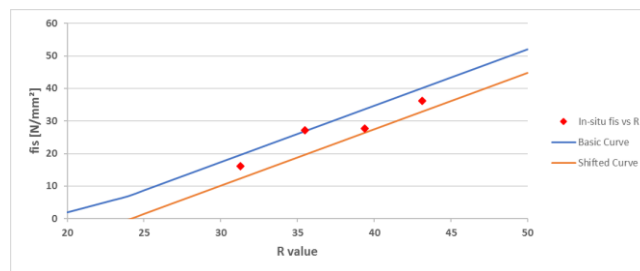
Following the procedure in [3], the correlation values are obtained by initially forming a basic curve and then shifting it as per the test results from the in-situ cores and the rebound readings. The final curve obtained, which correlates the rebound hammer readings to the in-situ compressive strength, is shown in orange in Fig. 6.

Fig. 6. The curve correlating rebound readings to the in-situ compressive strength;

The characteristic compressive strength of the concrete, which is directly related to the concrete class, is then obtained from the expressions available in the standard and the correlated values from the graph in Fig. 6. The characteristic compressive strengths are found to be 13.22 N/mm² and 17.78 N/mm² for the columns and the

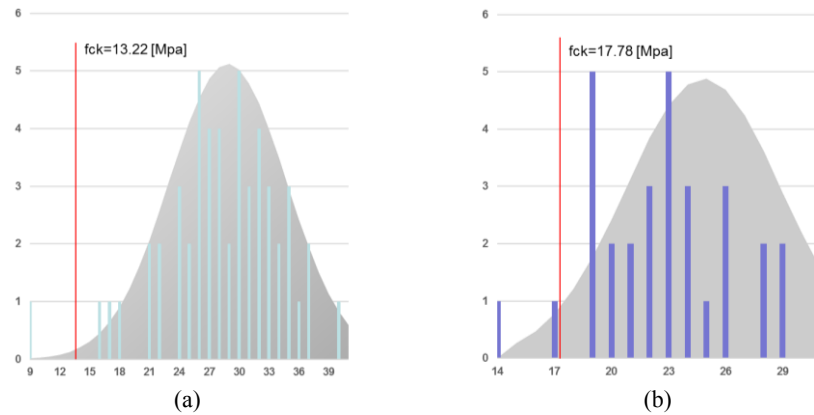
beams, respectively. A normal distribution of the compressive strengths for the columns and the beams which resulted from the graph above is shown in Fig. 7. It can be easily observed that the characteristic compressive strength values are at about 5% area that defines the characteristic compressive strength.

Fig. 7. Normal distribution of the compressive strengths for (a) columns and (b) beams;

From these relations it can be concluded that the concrete class for columns can be set as C12/15 and for the beams C16/20, which are way lower than the classes foreseen in the initial original design. The results for the steel samples are shown below in Table 2 and it can be seen that the class can be set to the original steel class of the design which was S 240/360 and be on the safer side.
