HUMAN-INDUCED VIBRATIONS ON MUSEUM ARTEFACTS: LITERATURE REVIEW AND CALCULATION EXAMPLE

3 CASE STUDY: THE CROSS OF SAN TEODORO

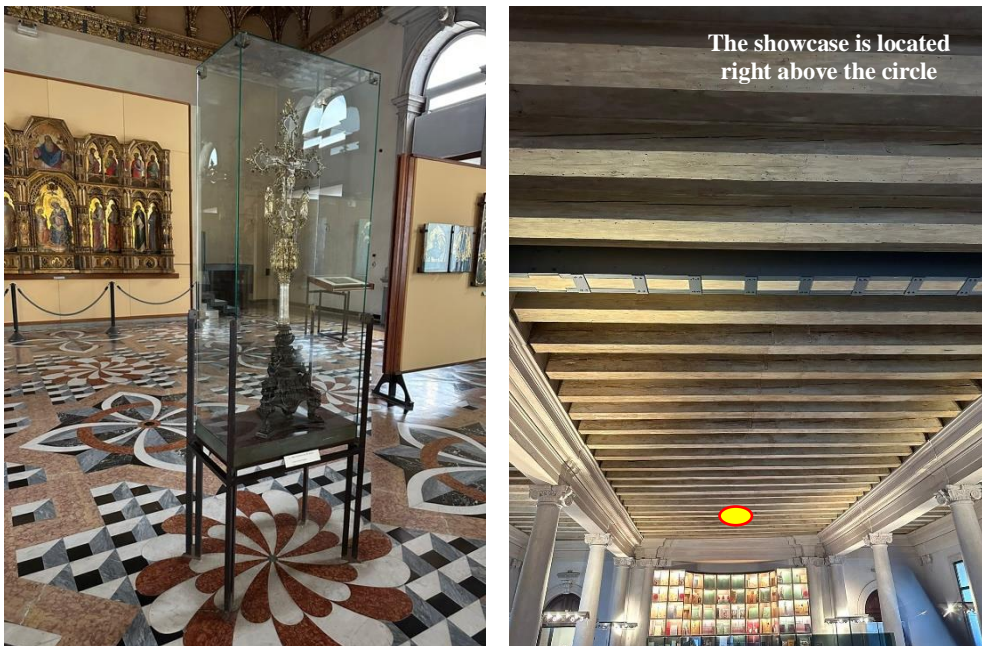
Figure 2 – Cross of San Teodoro (left) and supporting floor (right) at the Gallerie dell'Accademia, Venice.

The room where the Cross of San Teodoro is located has dimensions of 32 m by 12.5 m, placed right above the main entrance of the building. As already reported, the floor was re-built during the eighteenth-century refurbishing. It is made of primary wooden beams (supposed to be fir, $E \approx 10000$ MPa), with a cross-section of 550 mm by 850 mm supported by columns every 4 m, and secondary beams, measuring 180 mm by 300 mm with a span of 6.4 m (Fig. 2). The primary beams direction follows the lengthwise of the building, while the secondary beams are perpendicular to them. The exact composition of the topping slab of the floor is unknown, but it is believed to consist of a 10-mm-thick layer of wattled material, topped by a 100-mm-thick mixture of cement and sand, a 100-mm-thick screed layer and a 10-mm-thick layer of marble cladding (all the measures are approximated). The Cross of San Teodoro is positioned at the center of the shorter side of the building, 20 meters away from the perimeter wall of the entrance, in fact in the middle of the secondary beams system (see yellow circle in Fig. 2).

The Cross of San Teodoro, housed among many other works at the Gallerie dell'Accademia, drew attention due to the constant swinging of a decorative element (i.e. censer) resembling a pendulum on one of its arms. Although this does not pose a threat to the stability or preservation of the artwork, the continuous oscillation with an approximate period of 0.4 s does affect the enjoyment of the piece. Another factor that may disturb the enjoyment of the artwork is the visible trembling effect on the transparent materials of the cross (i.e. rock crystals) as a single visitor approaches. In fact, the human eye perceives more easily the vibration of reflective surfaces caused by the fluttering of light. Even the glass of the display case in which the object is located experiences visible oscillations as soon as a group of visitors walks nearby the object. The interest in this case study is not only limited to this particular manufacture but it can be extended to all other very flexible or reflective installations or artworks (e.g. slender reading desks, suspended items, crystal, glass, silver).

Due to these limiting factors, isolating the display case seems to be the best option: it is a cost-effective, feasible and non-intrusive solution to protect the Cross of San Teodoro from vibrations.

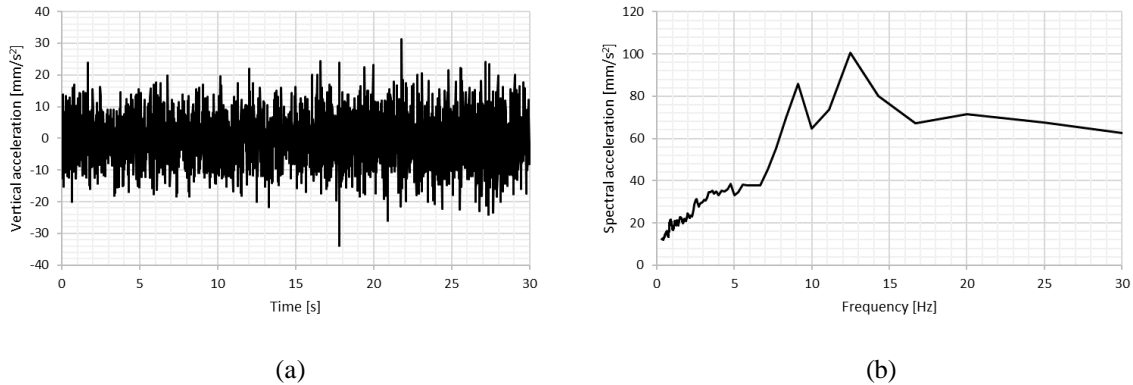
Figure 3 – Time-history of vertical acceleration (Fig. 3a) and correspondent elastic response spectrum (Fig. 3b).

Fig. 3 displays the time-history recording with a sampling frequency of 100 Hz as well as the elastic acceleration response spectrum (5% damping) of the vertical motion. From Fig. 3a is possible to observe a maximum vertical acceleration of approximately 35 mm/s^2 , and a maximum spectral acceleration between 90 mm/s^2 and 100 mm/s^2 (i.e. 0.1 m/s^2) in correspondence with the fundamental frequencies (first and second mode) of the floor (respectively 8 Hz and 12.5 Hz).

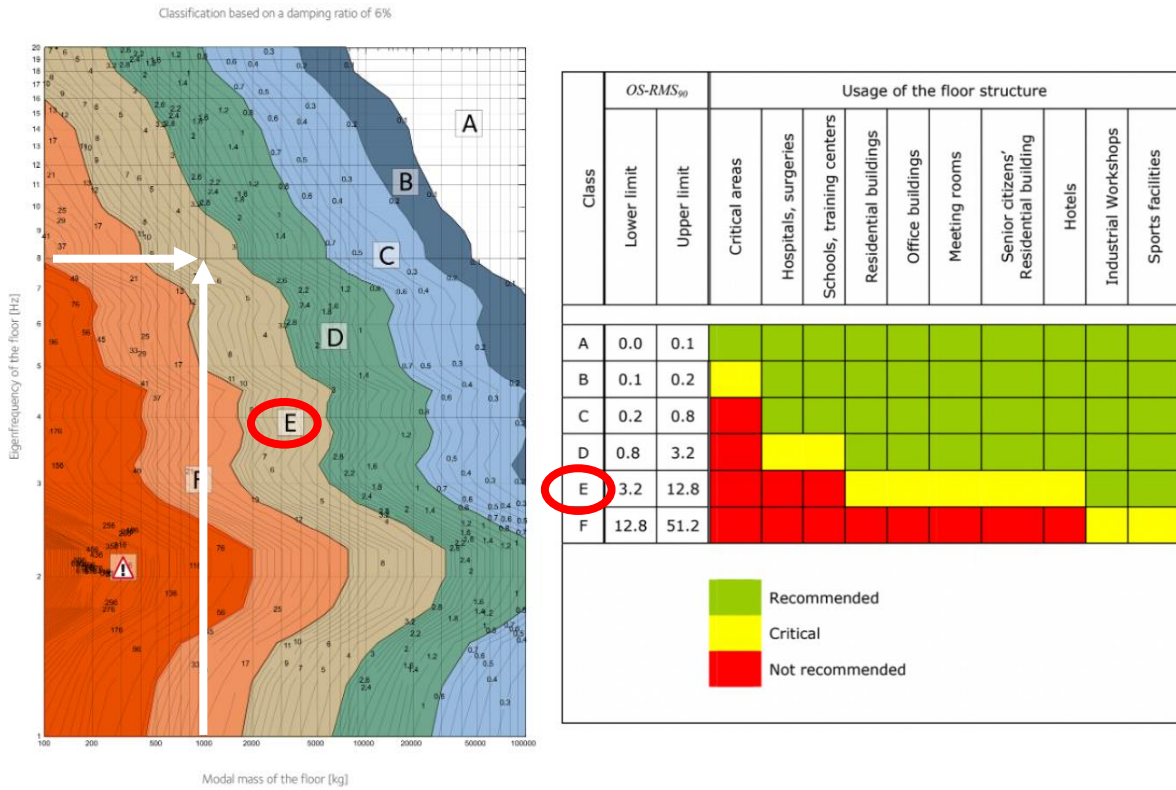
Knowing these two values allows the use of the abacus with a 6% damping ratio (a value commonly used for wooden floors) to determine the floor's classification according to Feldmann et al. [16]. The analysis revealed that the floor where the Cross of San Teodoro is located belongs to category "E", as reported in Fig. 4a. Fig. 4b also reports a table that establishes the acceptability of a particular floor classification for different usage of the building. Although the table does not indicate a specific category for museums, it is evident that, at least for objects particularly sensitive to vibration as the one herein present, a category "E" floor should be considered "not recommended" (as for example as per hospitals and schools). The table reports also the interval in terms of OS-RMS, value of the velocity (mm/s) for a significant step covering the intensity of 90% people's step walking normally [38].

Figure 4 – Abacus for the determination of class for a 6% damping floor (Fig. 4a [16]) and allocation of classes of perception A to F to threshold values and relation of occupancies of floor to comfort limits in terms of OS-RMS, value of the velocity (mm/s) for a significant step covering the intensity of 90% people's step walking normally (Fig. 4b [38]).

Further studies should be conducted on the ultimate and serviceability limit states for artefacts in terms of maximum vibrations; the limit threshold for artworks should be likely set not greater than the level of vibration corresponding to human perceptibility, even though smaller values could be appropriate in specific cases. In the scenario of this study, for example, a reduction of almost 8 times (to 4.5 mm/s^2) as depicted in Fig. 5 (green dot) would be required to reach this level. By following this approach, the values would also meet the acceptable criteria for class “C” in the graph presented in Fig. 4.

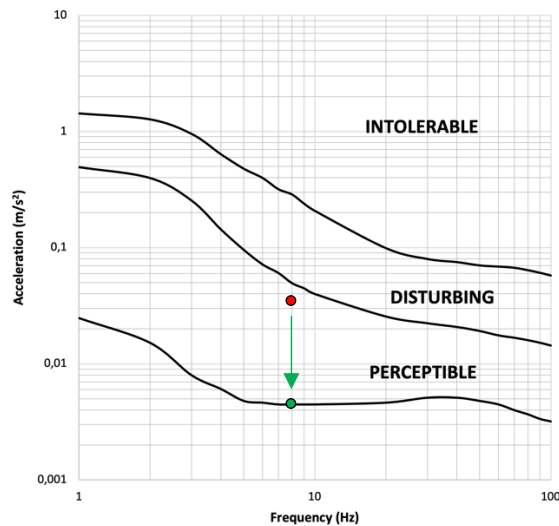
Figure 5 – Human perceptibility of vibrations and *in-situ* measurements (red dot), adapted from [13].

was plotted in terms of maximum accelerations vs. frequencies from [13]. It shows that the maximum recorded acceleration (approx. 35 mm/s^2) corresponds to a level of vibration “very perceptible”, “almost disturbing” for human perceptibility for the fundamental frequency of the floor of 8 Hz (see red dot of Fig. 5).
