# II Fabre Conference – Existing bridges, viaducts and tunnels: research, innovation and applications (FABRE24)

# Structural defects for condition assessment of existing bridges: some results of a territorial case study

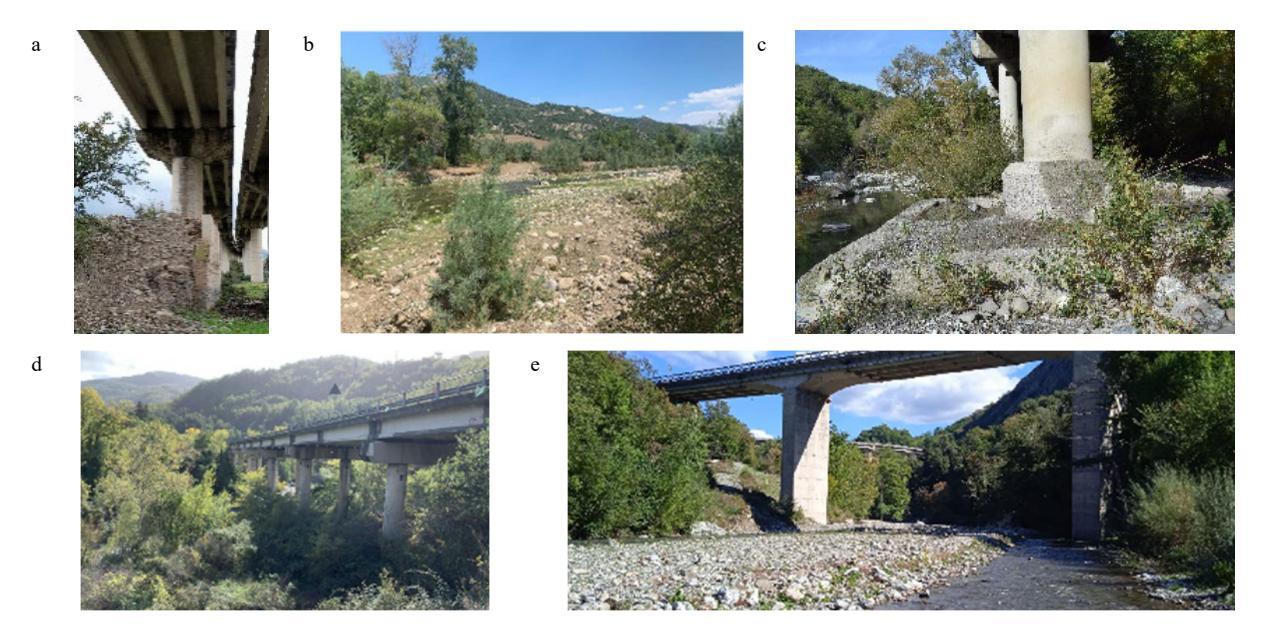
Fig. 6. Some examples of bridges located in areas with: (a), (b), (c) and (e) rivers; (b) and (d) landside bodies.

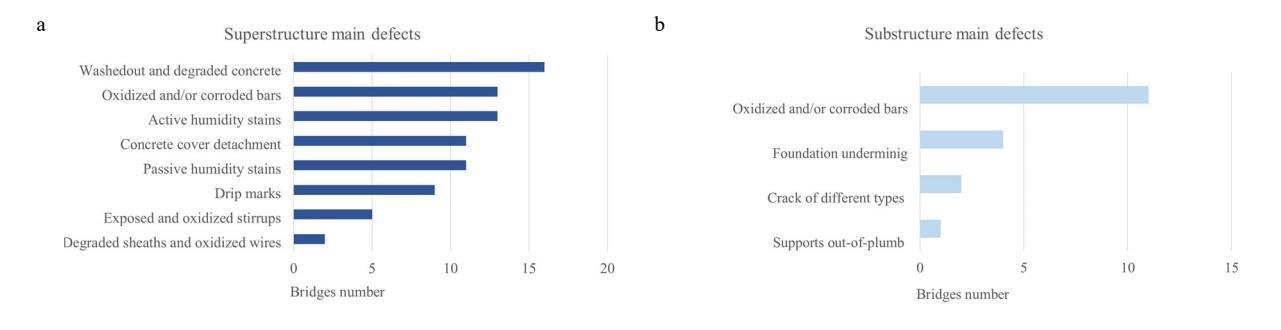
Fig. 7. (a) Superstructure principal defects; (b) Substructure principal defects.

Fig. 7 reports the main defects surveyed and the bridges number where they have been detected, considering the superstructure (Fig. 7a) and substructure elements (Fig. 7b), such as piers, abutments, bridge foundation and supports (ANSFISA, 2022).

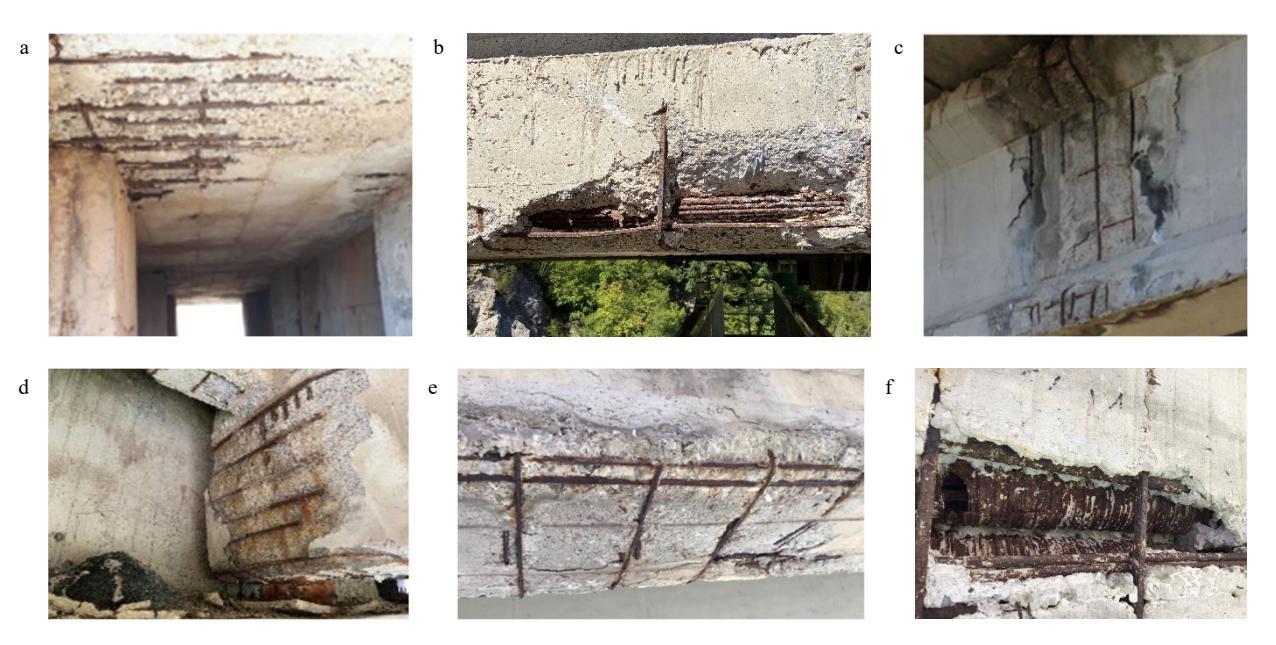
In particular, as for the superstructure elements (Fig. 7a), the main defects detected were: washed out and degraded concrete (G3), oxidized and/or corroded bars (G5), active humidity stains (G3), concrete cover detachment (G2), and passive humidity stains (G1). Examples of these defects are reported in Fig. 8. In detail: Fig. 8a and Fig. 8b show corroded bars with reduced section (third-level intensity K2); bars in Fig. 8c and Fig. 8d present only surface oxidation (first-level intensity K2); while in Fig. 8e the oxidation affects the bars cross-section (second-level intensity K2). Finally, Fig. 8f depicts an important, but rarely observed, defect for PCBs consisting of degraded cable sheaths and oxidized wires (G4).

Fig. 8. (a) and (b) corroded bars with reduced section; (c) and (d) only surface oxidation bars; e) oxidation affecting bars surface; f) degraded cable sheaths.

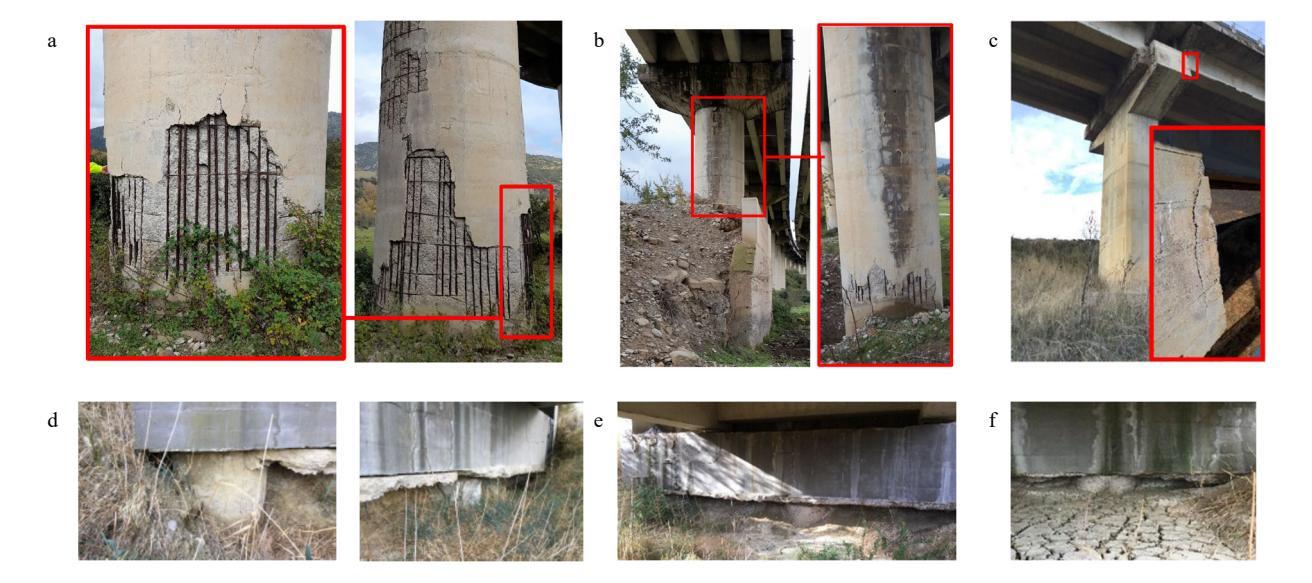
Fig. 9 shows main defects found on the bridge substructures. In particular, it has been detected: corroded and/or oxidized bars (G5, Fig. 9a and Fig. 9b), cracks (G4, Fig. 9c), and foundations scouring (G5, from Fig. 9d to Fig. 9f).

Fig. 9. Defects detected on substructure elements: a)-b) oxidized and/or corroded bars; c) cracks; d), e) and f) foundations scouring.

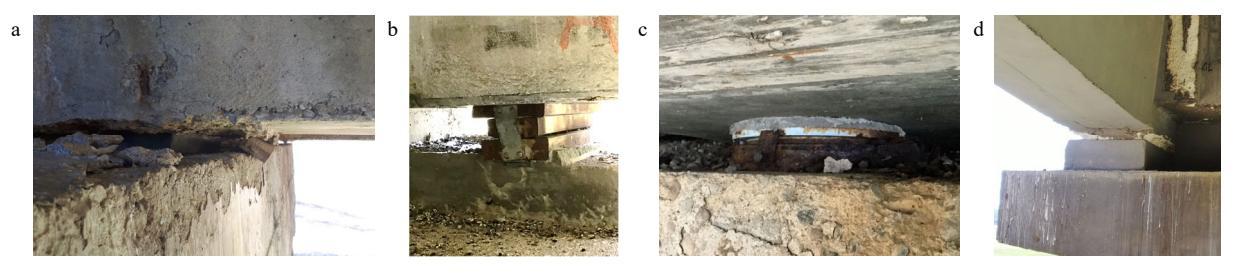
As far as defects on devices are concerned, they may be caused by material aging, such in the case of neoprene (G3 - Fig. 10a), oxidation (G2 - Fig. 10b) and Teflon deterioration (G3 - Fig. 10c), or by traffic loads action, such as neoprene crushing/leakage (G4, Fig. 10a) and permanent pendulum out-of-plumb (G4, Fig. 10b). Moreover, construction details may be source of vulnerability with respect to the seismic action, too. Fig. 10d illustrates small concrete supports and external beams placed near the pier cap perimeter. In these cases, during an earthquake, beams may suffer a loss of support.

Fig. 10. Supports principal defects: (a) neoprene crushing/leakage; (b) small concrete supports; (c) Teflon deterioration; (d) Out-of-plumb.
