# An investigation of the beneficial effects of adding carbon nanotubes to standard injection grout

Mortar grouting is often used in masonry constructions to mitigate structural decay and repair damage by filling cracks and voids, resulting in an improvement in mechanical properties. This paper presents an original experimental investigation on grout with added carbon nanotubes (CNTs). The samples were prepared with different percentages of CNTs, up to 1.2 wt% with respect to the binder, and underwent three-point bending tests in crack mouth opening displacement mode and compressive tests. The results showed that very small additions (up to 0.12 wt% of CNTs) increased not only flexural and compressive strengths (+73% and 35%, respectively, in comparison with plain mortar) but also fracture energy (+80%). These results can be explained on the basis of a reduction in porosity, as evidenced by mercury intrusion porosimetry, as well as by a crack bridging mechanism and by the probable formation of nucleation sites for hydration products, as observed through scanning electron microscopy.

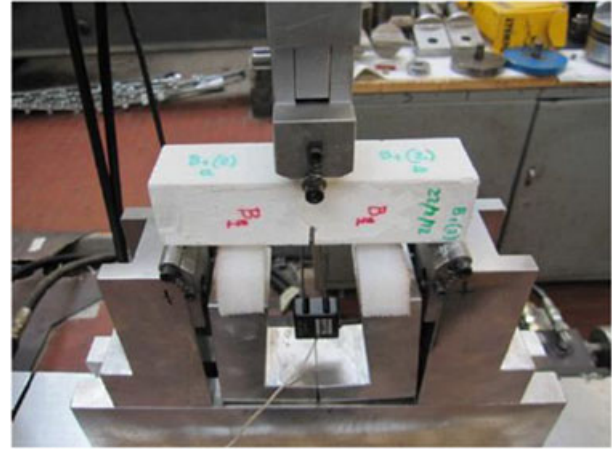
**FIGURE 1** Three-point bending (TPB) test configuration [Colour figure can be viewed at [wileyonlinelibrary.com](http://wileyonlinelibrary.com)]

The experimental tests were performed by using a 100 kN MTS servo-controlled machine and by imposing a constant increment of crack mouth opening displacement (CMOD; Figure 1). To this end, a clip-on gauge was used to control displacement during the test. The data were recorded at 10 Hz by using a specific data acquisition system. Complementary to the MTS machine data, a back-up database was recorded at 1 Hz by a CatMan system, providing a real-time graphical interface for the test operator.

However, it was not possible to use this equation for the reduction of the test data because the three-point flexural test setup configuration used for tests did not include a transducer that could measure  $\delta_0$ , as seen in Figure 1. Therefore, only load and CMOD test data were used to calculate fracture energy,  $G_F$ , by means of OriginLab software (OriginPro 8.5, OriginLab Corporation, USA).

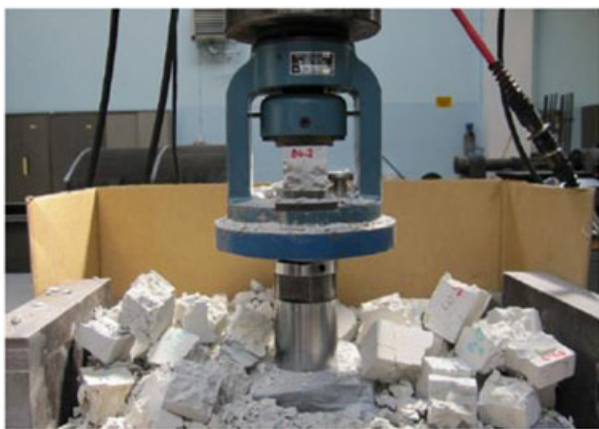
**FIGURE 2** Compressive test configuration [Colour figure can be viewed at [wileyonlinelibrary.com](http://wileyonlinelibrary.com)]

After flexural testing, portions of broken prisms were tested in compression, in accordance with ASTM C-348 compressive strength standard (Figure 2). The same MTS servohydraulic machine, with load cell capacity of 100 kN, was used.

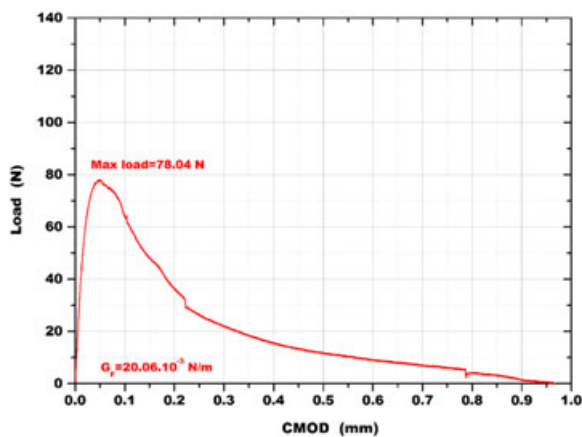
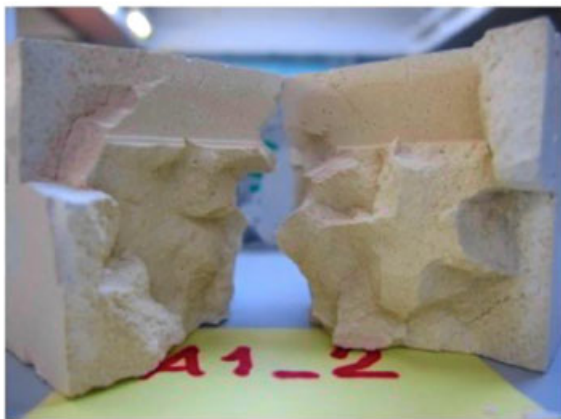
**FIGURE 3** Load vs. crack mouth opening displacement (CMOD) curve for pure Mape Antique I sample and broken prisms after flexural test (A1-2) [Colour figure can be viewed at wileyonlinelibrary.com]

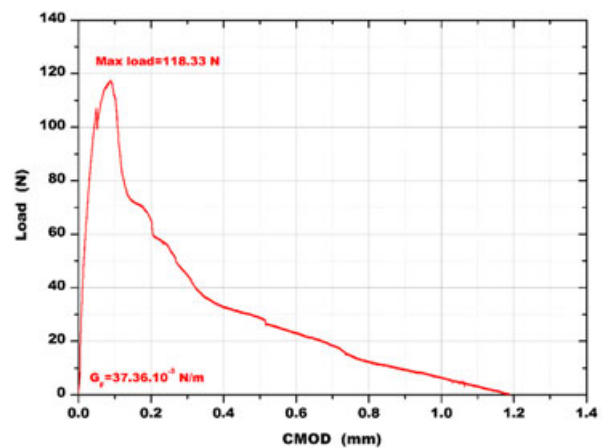
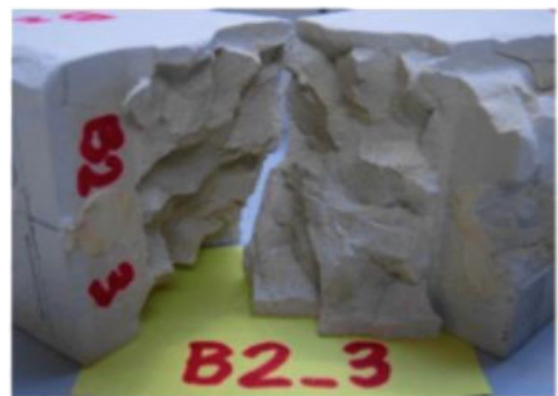
**FIGURE 4** Load vs. crack mouth opening displacement (CMOD) curve for Mape Antique I + 0.05 wt% of carbon nanotubes (CNTs) and broken prisms after flexural test (B2-3) [Colour figure can be viewed at wileyonlinelibrary.com]

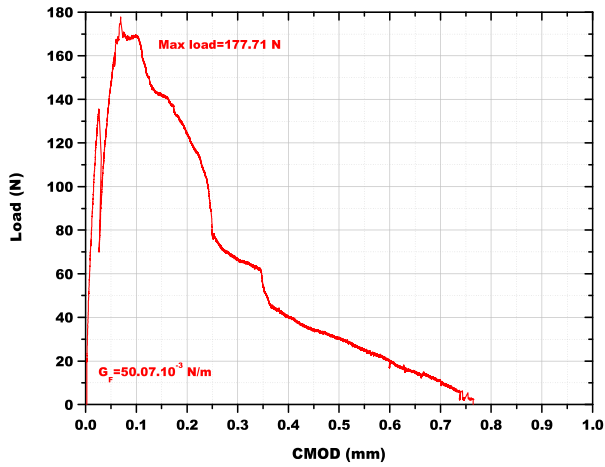
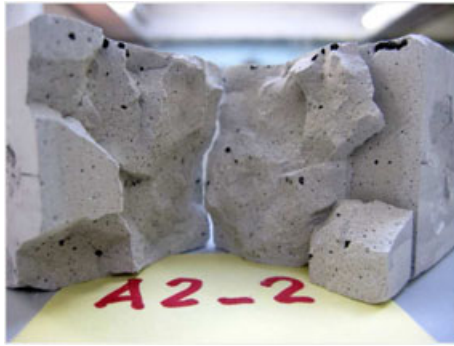
**FIGURE 5** Load vs. crack mouth opening displacement (CMOD) curve for Mape Antique I + 0.25 wt% of carbon nanotubes (CNTs) and broken prisms after flexural test (A2-2) [Colour figure can be viewed at wileyonlinelibrary.com]

Within the context of this work, the results of the tests indicate that CNT addition to the injection mortar Mapei Mape Antique I significantly increases flexural strength as well as fracture energy for CNT additions of 0.25 wt% (see Figures 6 and 7). Exceeding this amount of CNT addition entails a decrease in  $G_F$ . Similar results were already observed on cement pastes, where additions of up to 0.08 wt% CNTs greatly increased fracture energy.<sup>16</sup>

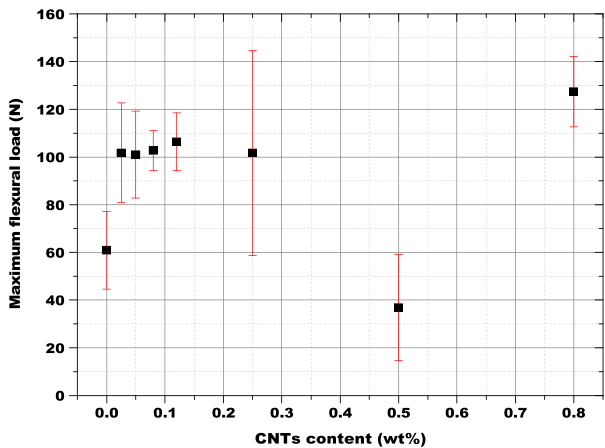
**FIGURE 6** Influence of carbon nanotube (CNT) content on flexural strength for the target grout [Colour figure can be viewed at wileyonlinelibrary.com]

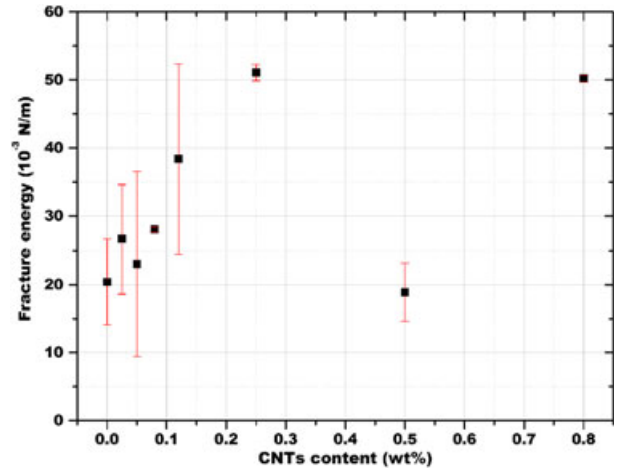
**FIGURE 7** Influence of carbon nanotube (CNT) content on average fracture energy for the target grout [Colour figure can be viewed at wileyonlinelibrary.com]

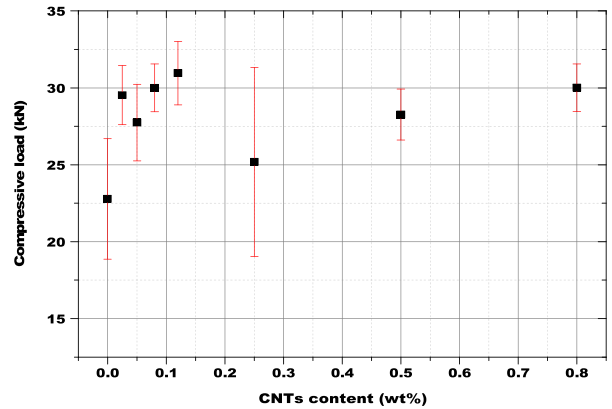
**FIGURE 8** Influence of carbon nanotube (CNT) content on compressive strength for the target grout [Colour figure can be viewed at wileyonlinelibrary.com]

Compression tests also confirmed the beneficial effect of CNT addition to the grout, ie an increase of compressive strength was observed up to 0.12 wt% addition of CNTs with respect to the pristine sample (Figure 8 and Table 5).

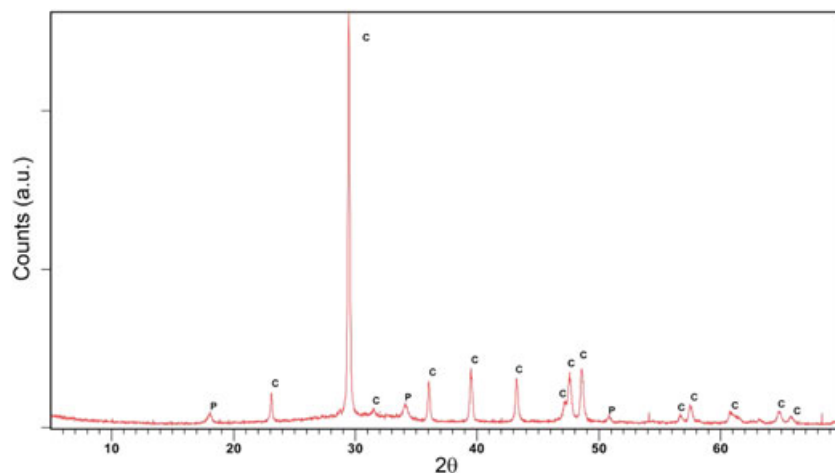
**FIGURE 9** X-ray diffraction (XRD) pattern of the hydrated pristine sample (C indicates calcite; P, portlandite) [Colour figure can be viewed at wileyonlinelibrary.com]

Calcium silicate hydrate, a reaction product of portlandite and pozzolan, is difficult to detect by X-ray analysis, due to its low degree of crystallinity. It is characterized by a wide band of peaks in the range of  $2\theta$  28 to 33°. These results are in line with producer specifications, ie it is a cement-free fillerized hydraulic binder.<sup>24</sup>

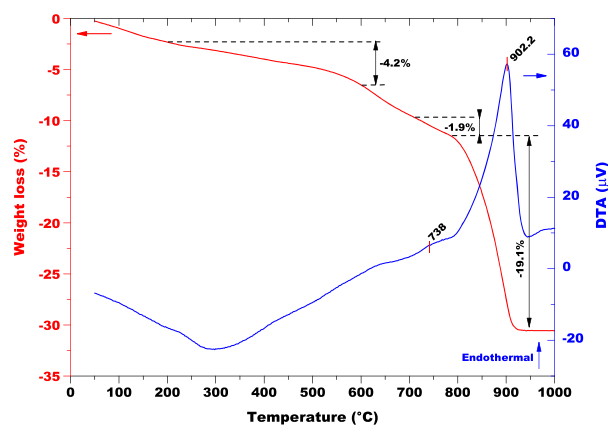
**FIGURE 10** Thermogravimetric-differential thermal analysis (TG-DTA) curve of Mape Antique I hydrated grout [Colour figure can be viewed at wileyonlinelibrary.com]

Thermogravimetric-differential thermal analysis curve (Figure 10) indicates that hydrated Mapei Mape Antique I mortar is just composed of mineral components, as no exothermic peak due to thermal degradation of any organic fraction was observed. Three main mass losses were observed between room temperature and 950°C (Figure 10), associated with 2 endothermic peaks (the first is a very weak broad peak at 738°C with a weight loss of 1.9% due to recarbonated calcite, while the second is intense at 902°C with a weight loss of 19.1% due to calcite decomposition). Usually, weight losses corresponding to temperatures around 120°C are attributed to the loss of physically adsorbed water in samples.

Weight losses in the temperature range of 120 to 200°C and 200 to 600°C correspond to the loss of bound and of chemically bound water, respectively, when there are no hydrated salts in the sample.<sup>28,29</sup>

render the loss of  $\text{CO}_2$  from recarbonated lime, not from primary calcite.<sup>28</sup> This is because recarbonated calcite decomposes at a lower temperature than it does naturally. In fact, natural calcite possesses large crystals, while when recarbonated, it is made of microcrystals. Calcite is also due to the filler used (50 wt%, as declared by the producer). There was a mass loss of 4.2% between 200° and 600°C, which is in line with observations in artificial pozzolanic mortars.<sup>30,31</sup> Finally, contrary to XRD findings, portlandite was not detected by TG-DTA, probably because of a complete reaction with pozzolan when the sample was analysed by XRD or because it was already carbonated when TG-DTA was performed.<sup>32</sup> These results confirm the specifications provided by the grout producer.<sup>24</sup>

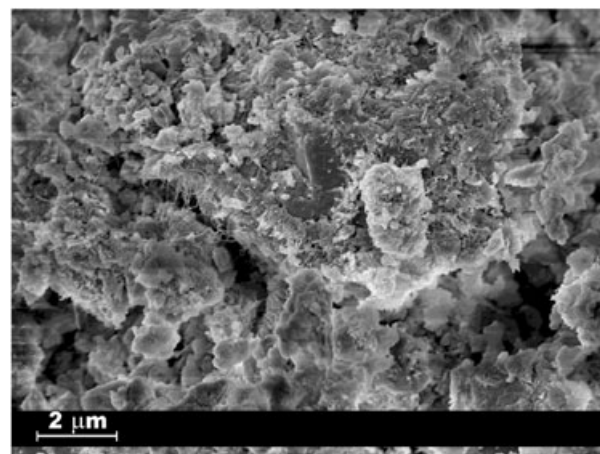
**FIGURE 11** Field emission scanning electron microscopy (FE-SEM) micrograph of carbon nanotube (CNT) pullout from the mortar matrix: sample containing 0.8 wt% CNTs

Carbon nanotube crack bridging and pullout was clearly shown by FE-SEM observations in the binder matrix (Figures 11, 12, and 13). This behavior is well known in cement pastes, where CNTs act as bridges across cracks and voids and form a network that transfers the load in tension.<sup>7,8</sup>

To sum up, grout with added CNTs led to a reduction in nanoporosity (Table 6), activated the crack bridging and pull-out mechanism (Figures 11 and 12), and acted as nucleation sites for hydration products (Figure 13). That is to say, 3 of the 4 reinforcing mechanisms observed in cementitious matrices<sup>7-17</sup> were found in a hydraulic injection grout.

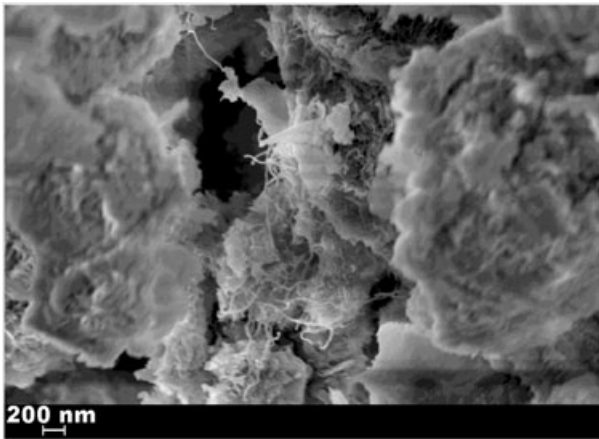
**FIGURE 12** Field emission scanning electron microscopy (FE-SEM) micrograph of carbon nanotube (CNT) pullout from the mortar matrix: sample containing 0.25 wt% CNTs

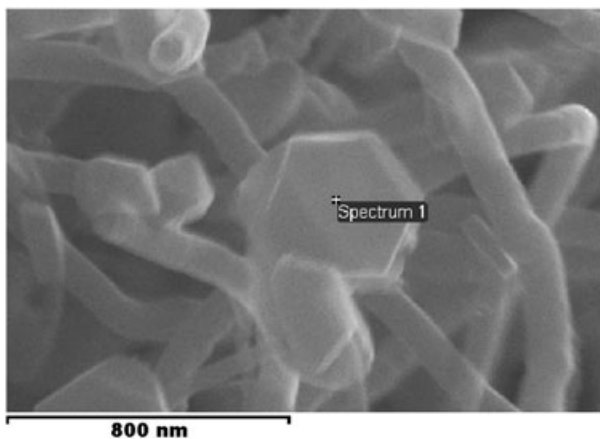
**FIGURE 13** Field emission scanning electron microscopy (FE-SEM) micrograph of carbon nanotubes (CNTs) with silicon-rich crystals

Figure 13 shows crystals bound to the CNTs. Energy-dispersive X-ray analysis (spectrum 1 in Figure 13) indicates the presence of carbon and of silicon only. The presence of nanotubes means that the carbon can be ascribed to them, while silicon is probably due to a fine grain of quartz (from sand in the grout). The important conclusion that can be drawn from these observations is that other crystals on the left of the same image are visible and are also bound to the CNTs. Therefore, as observed in cementitious materials, CNTs are probably able to chemically bind hydrated phases in a hydraulic binder.<sup>13-15</sup>
