Article

Monitor Activity for the Implementation of a Pavement—Management System at Cagliari Airport

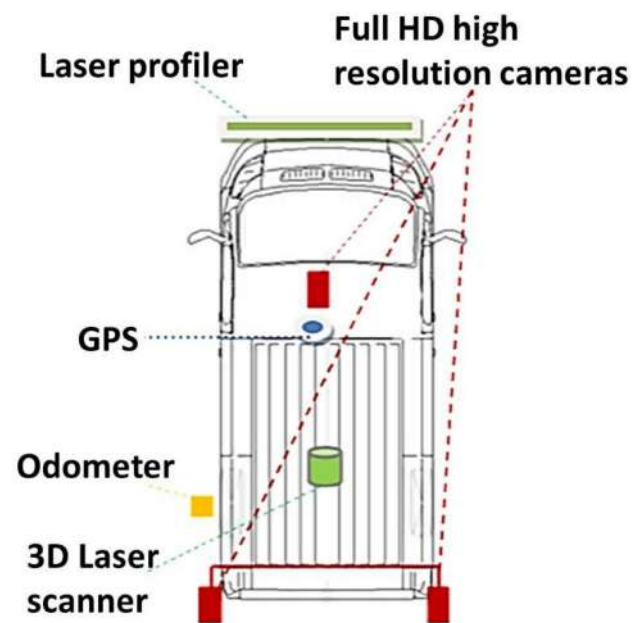
Figure 1. Top view of LSV vehicle system.

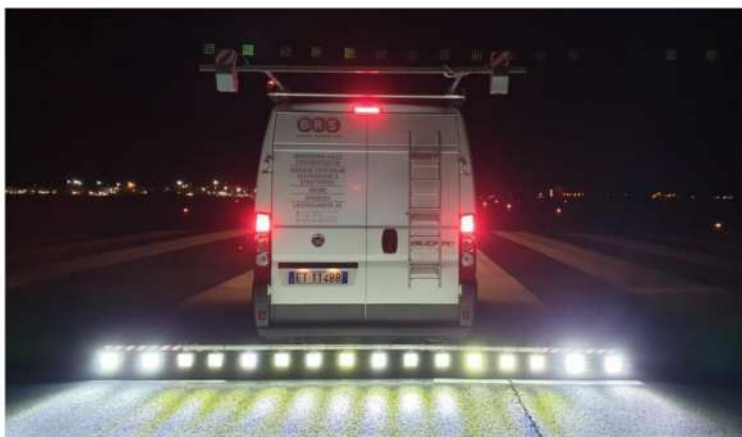
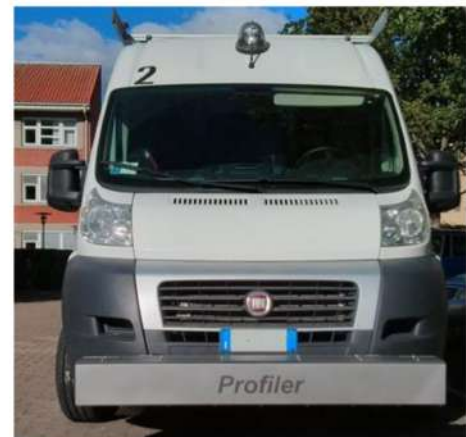
LSV (Laser Scanner and Video survey)

Laser RSP—Runway Surface Profiler

Figure 2. LSV vehicle.

2. Laser Scanner and Video survey: the high-performance surveys for assessing the deterioration condition, pavements evenness, and profiles (longitudinal and transverse) of the airport infrastructures were carried out with the LSV—Laser Scanner and Video Survey multifunctional system (Figures 1 and 2). The LSV system is equipped with full HD matrix cameras with lighting bar to ensure homogeneity of the survey conditions, allowing high productivity and stability of the acquired data both in day and night conditions. The rear chamber system consists of two sensors with nadir orientation (modifiable according to the purpose of the survey) placed on a support bar mounted at about 2.30 m from the ground, which acquires a longitudinal continuity of a band of about 4.5 m in width. To measure longitudinal and transverse evenness conditions, the LSV system is equipped with a Laser RSP (Runway Surface Profiler) profilometer bar. The bar is equipped with 16-KHz (for measuring pavement profile) and 62.5-KHz sensors for measuring pavement profile and macro texture. It is mounted integrally with the vehicle and can detect the longitudinal and transverse profile of the measurement line. The measurements made by the lasers are compensated by an inertial navigation system equipped with accelerometers and gyroscopes. The surveyed dataset is directly georeferenced by the position and orientation data of the odometer, IMU (Inertial Measurement Units), and GPS antenna, starting from the runway heads.

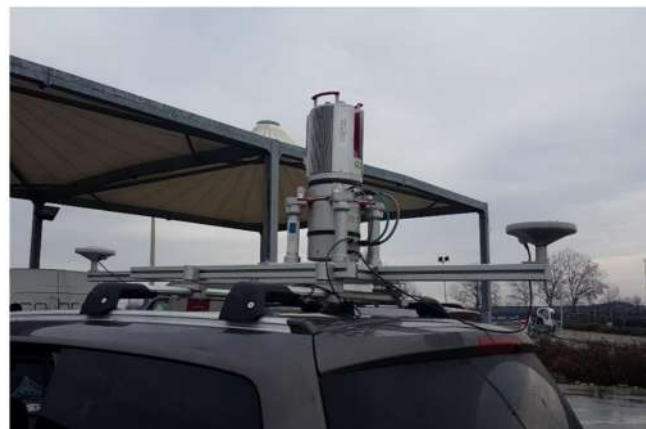
Figure 3. Riegl VZ 400i system.

3. Laser scanner Mobile “Stop and Go”: to acquire the geometric features of the pavement with greater accuracy, geo-referenced, three-dimensional point clouds are acquired with a laser scanner used in Stop and Go mode to maximize productivity and compatibly with the accuracy required. With suitable laser scanner instrumentation and the use of an inertial platform, with the aid of a suitable georeferencing technique, it is possible to obtain three-dimensional models of the state of the place with centimeter-level accuracy. The Riegl VZ 400i system installed on a road vehicle was used (Figure 3).

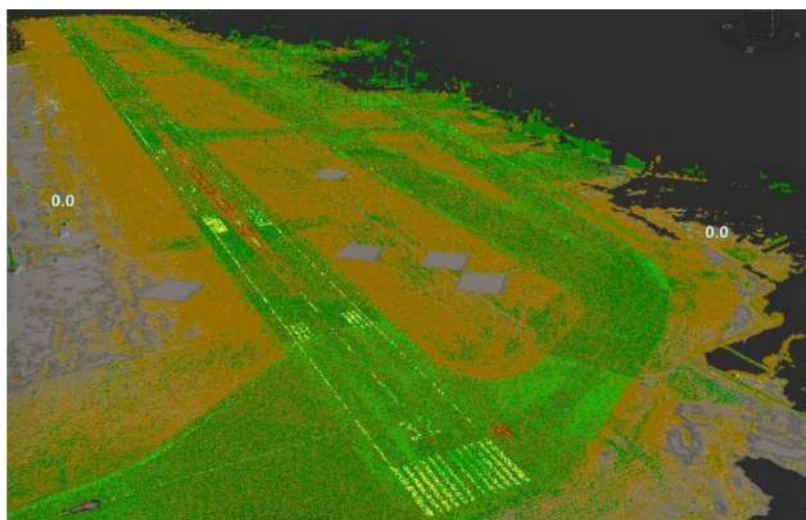
This high-precision survey method allowed the reconstruction of a three-dimensional model of the paved surfaces. An example is shown in Figure 4.

Figure 4. 3D model of the runway surface pavement.

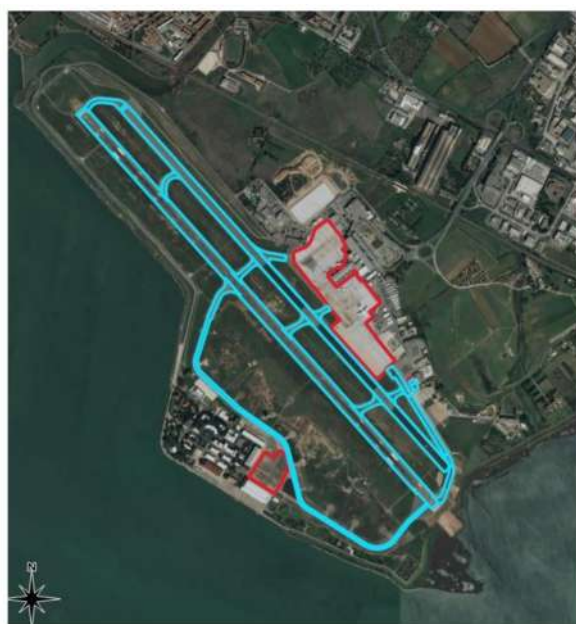
- The rigid pavement of the newly built apron and taxiway T, for a total extension of about 18.6 hectares, bordered in red in Figure 6;
- The flexible pavements of the runway and taxiways, for a total of about 35 hectares, bordered in blue in Figure 6.

Figure 6. Surveyed areas.

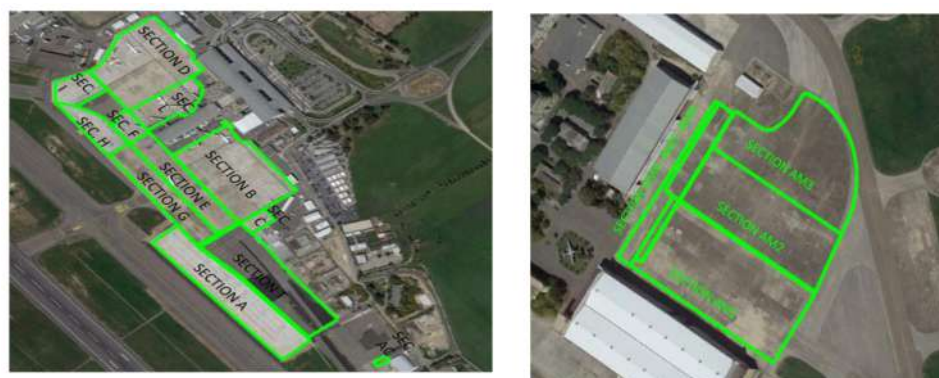
The updated area was divided into 12 sections and alphanumerically numbered, consistent with that of the previous survey. A similar organization in six sections was carried out for the new area detected in the military apron, as shown in Figure 7.

Figure 7. Rigid pavement sections in the updated area.

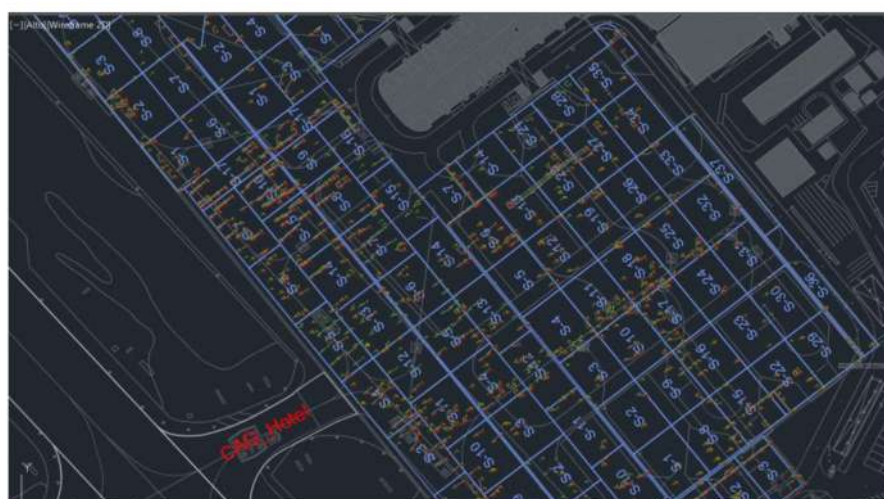
The distresses present on each slab were classified according to the international reference standards mentioned above [12], recording their types and severity. In support of the visual investigations, the cracks in the concrete pavements were located by precision GPS references, relying on previously acquired known points (2016 survey campaign and head nails). Thanks to the positional data, each single distress was associated with each slab (Figure 8) so as to be able to proceed with the calculation of the PCI for each individual sample unit (SU).

Figure 8. Georeferenced distresses on rigid pavements.

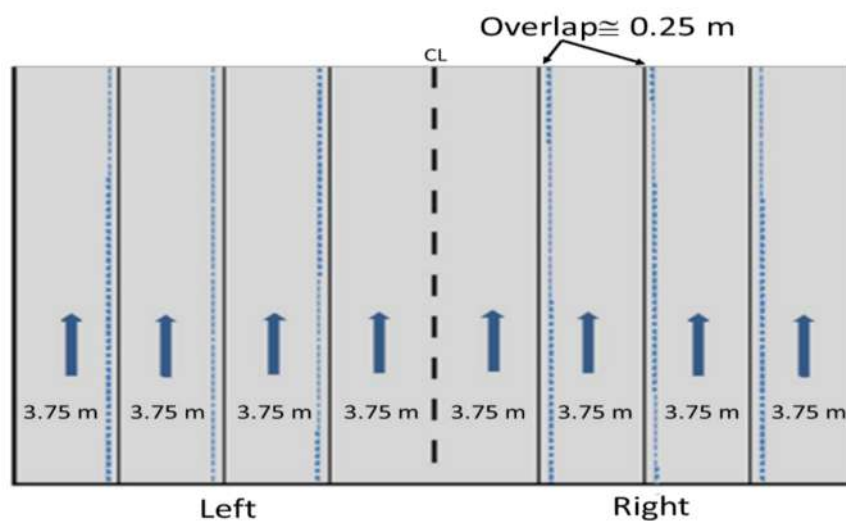
The surface distresses were acquired by means of the instrumented vehicle Laser Scanner and Video survey, previously described. The vehicle acquires, without interruption, images of the pavement for a width of about 4 m (parameter that can be modulated in the system configuration) to cover the entire width of the infrastructure through successive relief alignments, guaranteeing a good overlap between the parallel strips. The layout, shown in Figure 10, was determined to cover the entire length and width of all the analyzed infrastructures, considering for each alignment a useful band of 3.75 m and an overlap area between contiguous alignments equal to 0.25 m.

Figure 10. Survey scheme on parallel alignments.

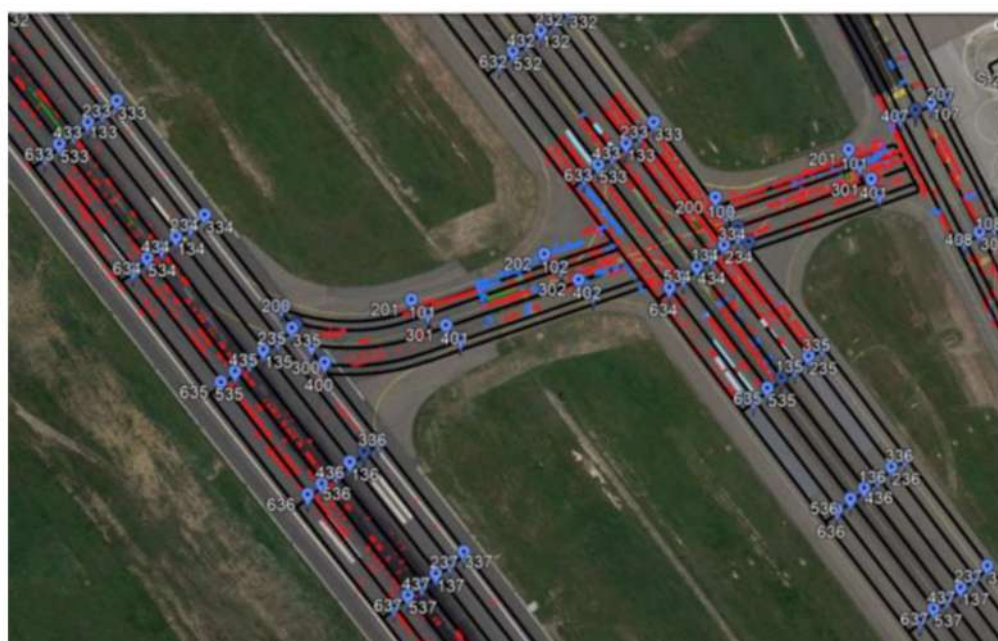
The distress computation procedure on each single SU of the network was performed in a GIS environment (QGIS), while the PCI calculation was performed using the FAA PAVEAIR application [26]. Following the methodological steps described above, it was possible to create a mapping of the deterioration present on the single sample units, as shown in Figure 12.

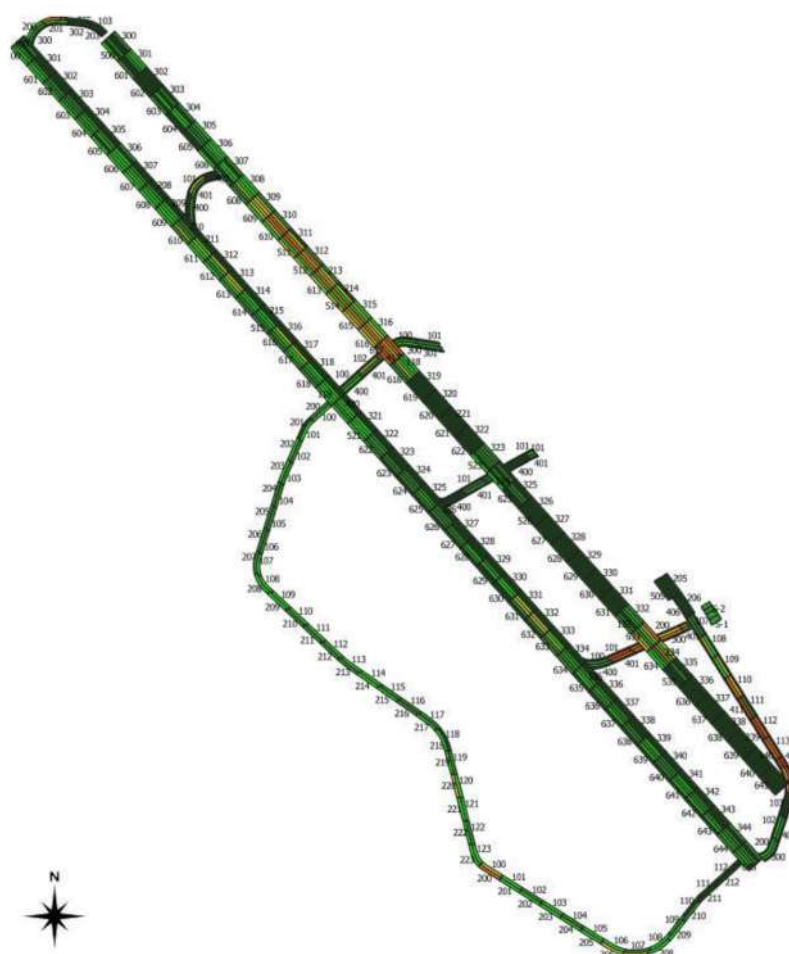
Figure 13. PCI map on flexible pavements.

The recent pavement restoration work on an extended portion of taxiway A is evidenced from the much higher PCI values as Figure 13 shows.

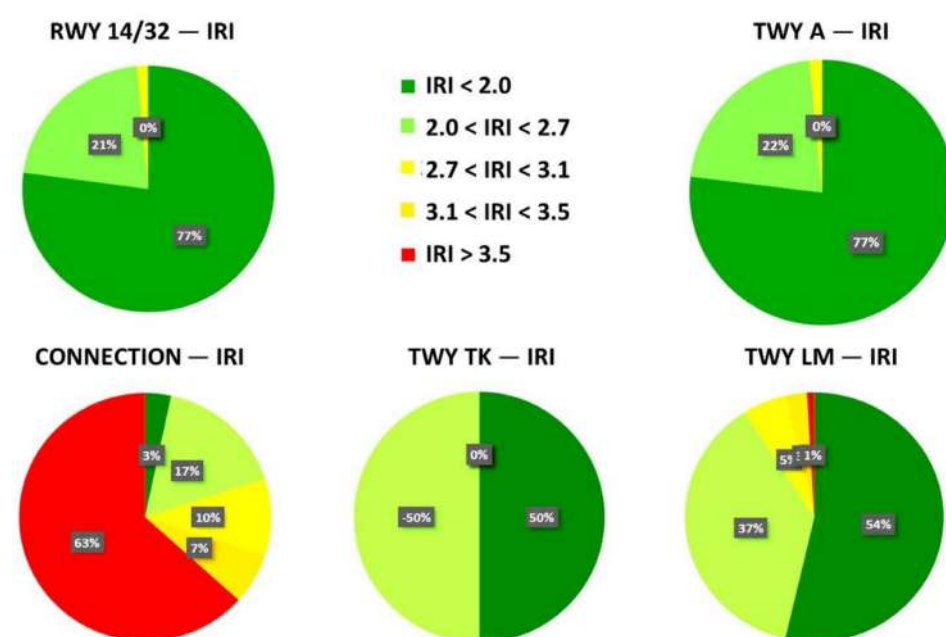
The IRI analysis highlights a satisfactory condition of evenness longitudinal extension for almost all the flexible pavements in the maneuvering area. The graphs in Figure 14 briefly represent this condition and show lower IRI values on the zones afferent to the connections between runway and taxiway A: AA, B, CG, DH, EJ, and F, where localized IRI values were found to be greater than 3.5 mm/m.

**Figure 14.** Percentage of IRI value extension on flexible pavements in airside.

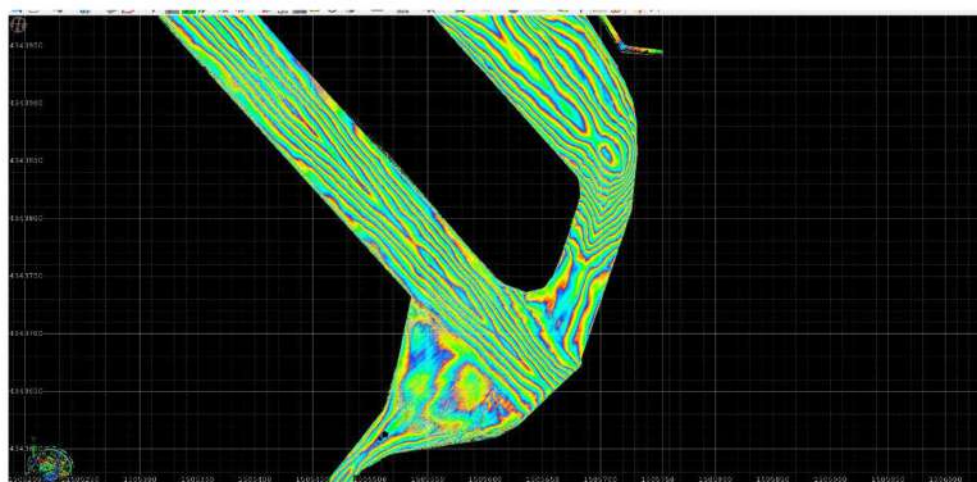
For example, Figure 16 shows the 3D model of the identification of rutting in the runway threshold 32. The different coloring indicates the different level of severity of the ruts (Table 4). From the distribution of colors in Figure 16, the symmetry of the tracks with respect to the axis is highlighted.

Figure 16. 3D model to evaluate the rutting on runway threshold 32.

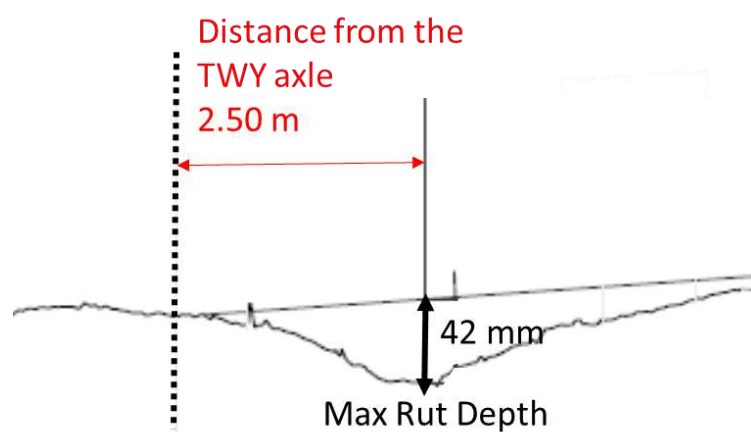
Figure 17 presents the detailed study of the rut depth in the transversal section built from the detected 3D point cloud of the pavement surface. The analysis of the transversal section allowed the determination of the maximum rut depth with millimetric precision, resulting in a high-severity level, according to the classification in Table 5.

Figure 17. Analysis of the transverse section for the rut-depth classification.

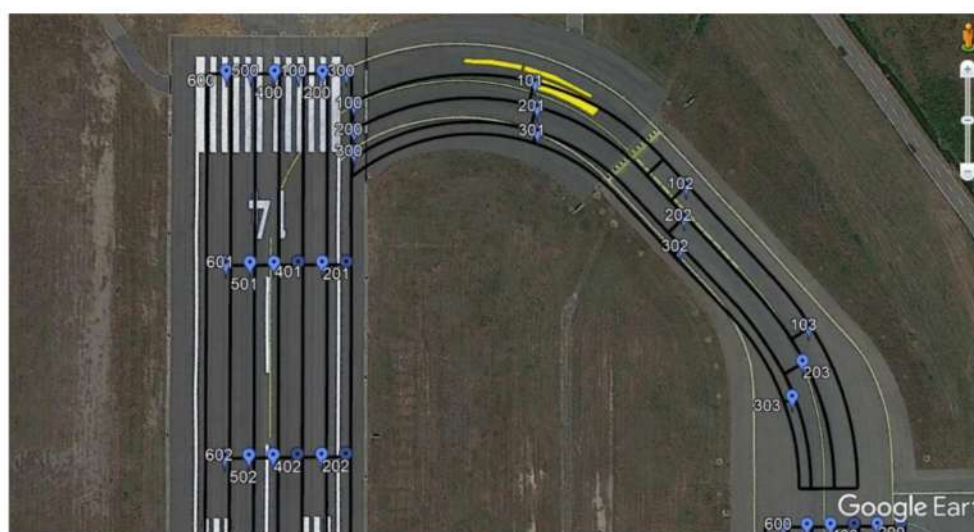
The analysis of the georeferenced 3D point cloud, acquired with a terrestrial laser scanner, highlighted the presence of two areas with ruts on taxiways AA and F, as represented in Figures 18 and 19. The severity and extension of the ruts and the correspondent sample units where they were detected are reported in Table 5.

Figure 18. Rutting on entrance taxiway in threshold 14.

The analysis of flexible pavements also reveals a downward trend compatible with the use of infrastructures: the PCI mapping confirms the good conditions on runway 14/32, shown in Figure 13; indeed, more than 80 % of samples units are between “Good” and “Excellent” condition regarding the PCI, as shown in Figure 22. The most damaged areas are concentrated on entrance taxiway AA and F (see scheme in Figure 5). This is due to many rutting phenomena already highlight in Figure 18, which play a decisive role in calculating the PCI.

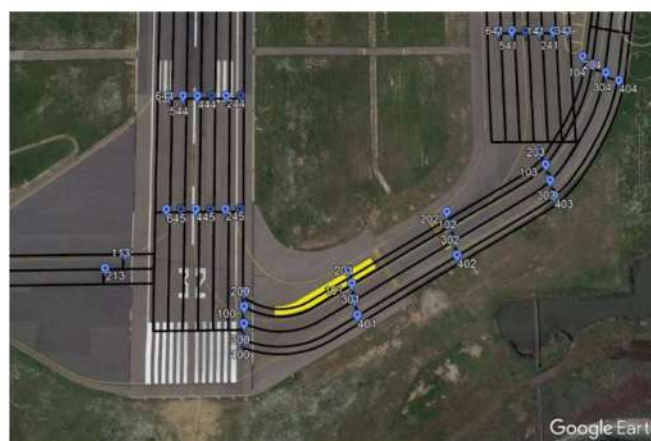
Figure 19. Rutting on entrance taxiway in threshold 32.

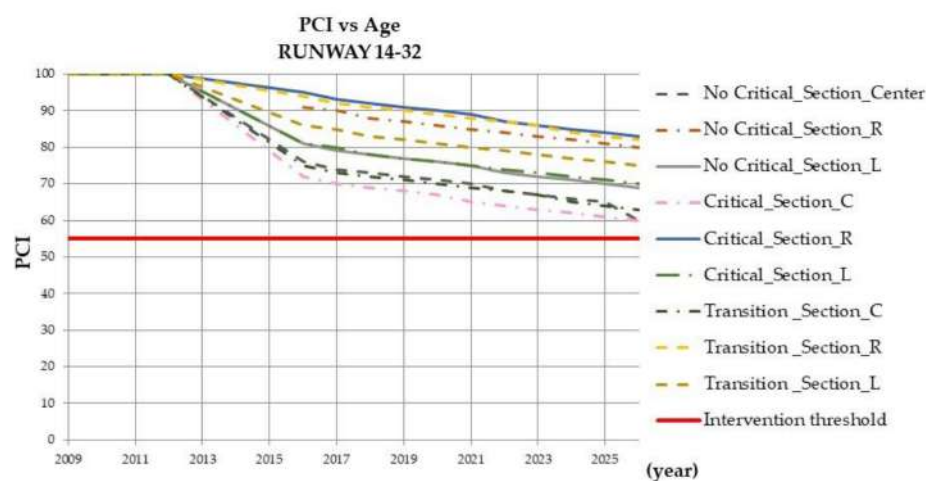
The obtained decay curves for different homogeneous sections of the runway pavements are reported on Figure 20. The prediction part of the curve highlights the need for programming a rehabilitation of the critical part of the runway pavement. The calculated PCI values of all sections were compared to the measured PCI based on the daily survey of the same segments conducted by the aerodrome operator at the beginning of the year 2021, obtaining a good correlation.

Figure 20. PCI decay curves of runway flexible pavement.

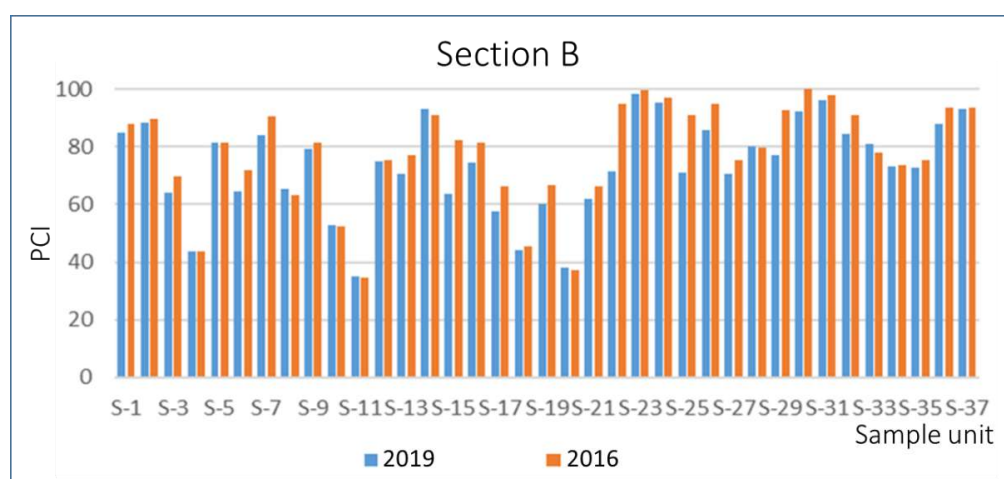
The comparison with the 2016 data suggests a trend of natural decrease in the PCI value, which is expected on average on 3–5% variation on the sample units. For example, Figure 21 shows the comparative situation of Section B, which contains most of the main apron dedicated to commercial traffic.

Figure 21. Comparison of PCI values on section B—main apron between the year 2016 and 2019.

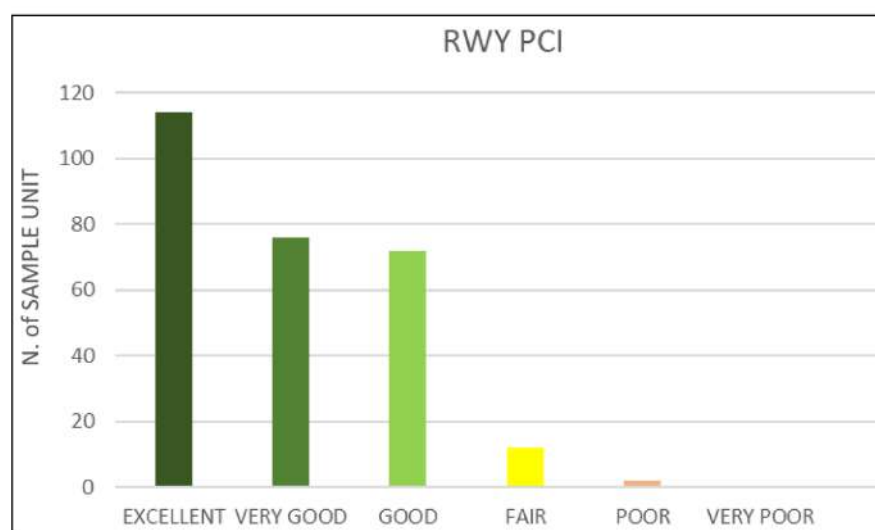
Figure 22. PCI analysis on runway.
