Geometry as Matrix of Construction of Roman Stone Bridges: The Augustus Bridge at Narni

The study of ancient Roman bridges embraces various disciplines and professions: engineers, architects, historians, archaeologists, and geologists. One of the first experiments completed by this research group was conducted on the Augustus Bridge at Narni: an integrated digital survey followed by the application of 3D digital modelling. Although only one of its four arches has been preserved, it can still be seen that the bridge was conceived on a large scale of technical complexity based on a precise knowledge that guided the choice of materials and architectonic solutions. The structure is immersed in an enchanting green landscape, which has for centuries attracted numerous scholars and artists. They have left us a precious iconographic heritage whose interpretation is still debated. As far as the geometry and proportions of the construction are concerned, to compare its present state with the original one, the structural ashlar of the bridge were modelled parametrically on the basis of transforming elementary geometric elements having adopted the Roman foot as the unit of measure.

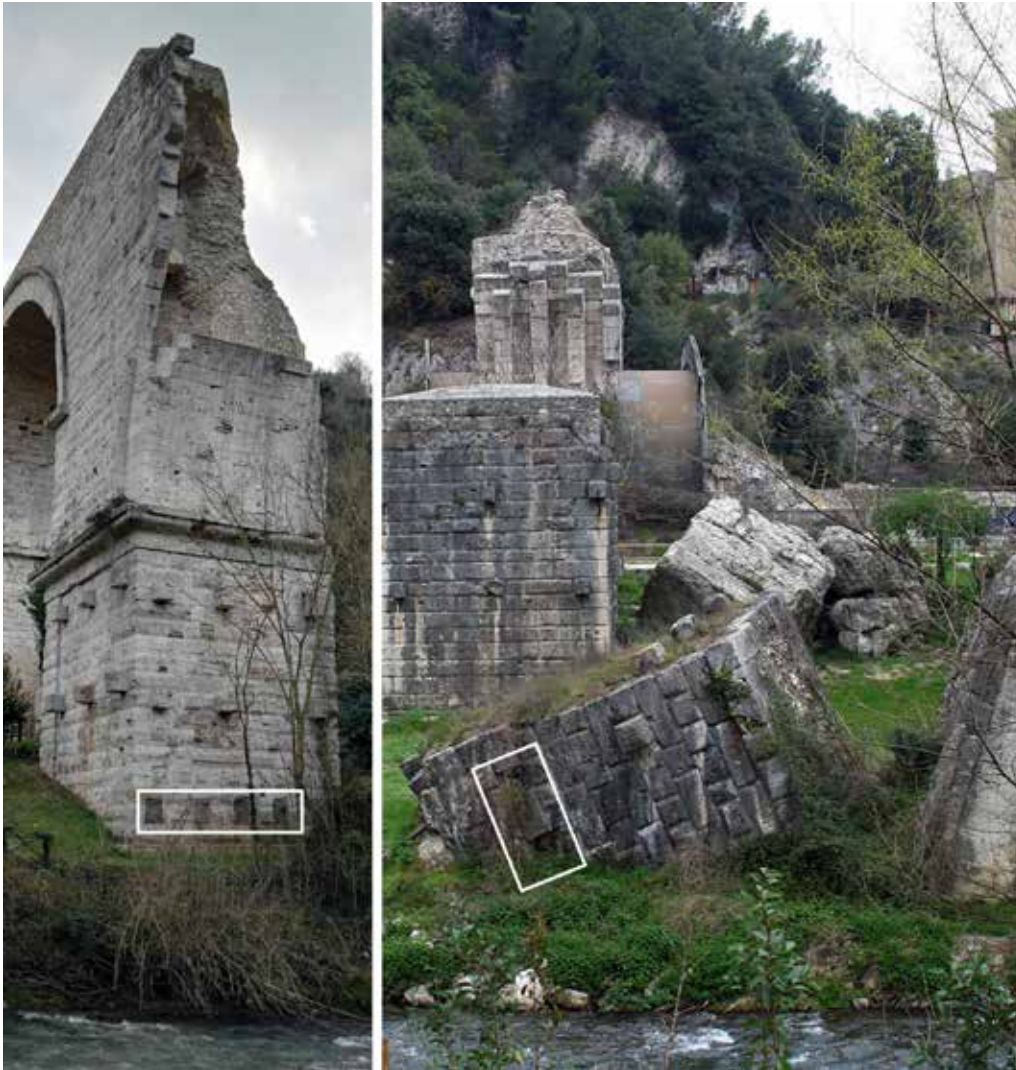
Figure 8. Holes in first and second pylon.

to the ground. In view of this evidence, the two pylons at the ends seem less different. Starting from an architectural project based on precise volumes and dimensions, the first pillar changes its volume according to the architectural logics just described, the third remains constant. The second is the pylon for which a number of disparate hypotheses were generated since it has a constant pedestal at the base which makes us think that it was precisely the basement level. Yet it has been discovered at a certain distance from the springer of the arch that is shorter than the one of the first pylon. This is precisely why so many scholars have supported the hypothesis that springers were misaligned and the arch is not a rounded one. Nevertheless, it can be maintained with high degree of certainty that the arrangement of the blocks is similar to that of the third pylon and that it was erected later on. Moreover, we know that after the bridge had collapsed in 1053, a wooden gangway was built on the stone bridge to make it crossable. Thus, a hypothesis was put forward that when the terrain subsided, the second pylon was adjusted to allow the construction of the temporary wooden bridge. The structure of the pedestal has holes aligned with those of the first pylon, used to fasten the bar of the bow

construction. This may lead to the idea that the two pylons were built in the same period, but the blocks are arranged in a completely different way (Figure 8).
