# **SOLUTION AND PRACTICE**

## CHAPTER 17

### **INNOVATIVE, MULTIDISCIPLINARY APPROACH FOR RESTORING PAINTINGS IN HYPOGEAL ENVIRONMENT: ETRUSCAN *TOMBA DEGLI SCUDI* (4TH CENTURY BC) IN TARQUINIA**

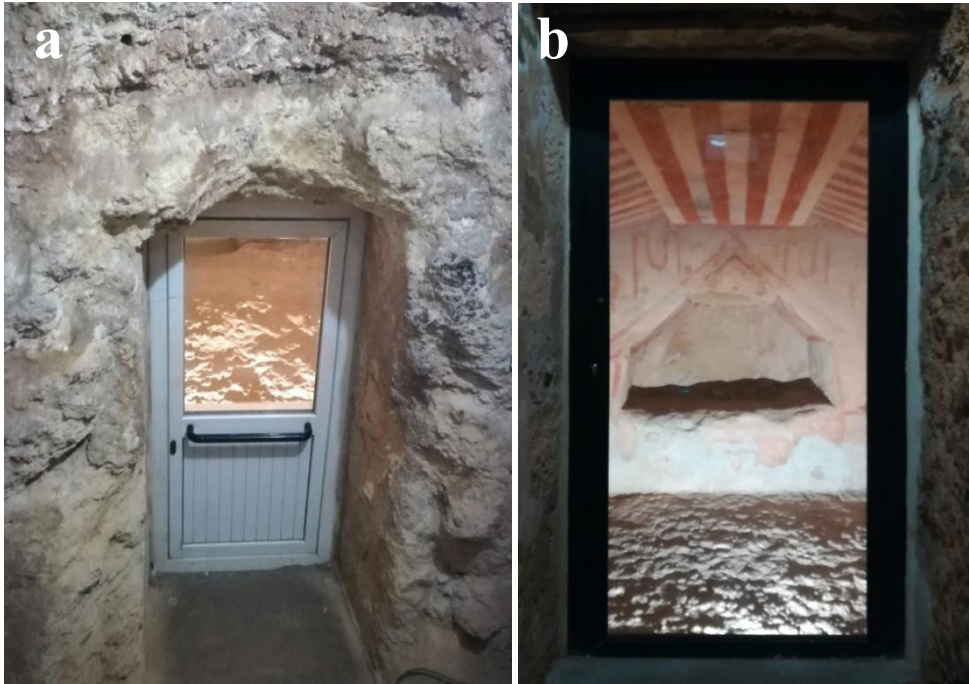
Since the late 1980s, these painted tombs have been hermetically sealed and equipped with thermally insulating portals to maintain the requisite thermohygrometric conditions crucial for their preservation (Fig. 2 a, b). Additionally, these doors feature an antifog mechanism, enabling visitors to observe the paintings unobstructed.

**Figure 2.** Examples of thermally insulating doors: earliest prototypes installed (a) most recent type (b): equipped with full glass.

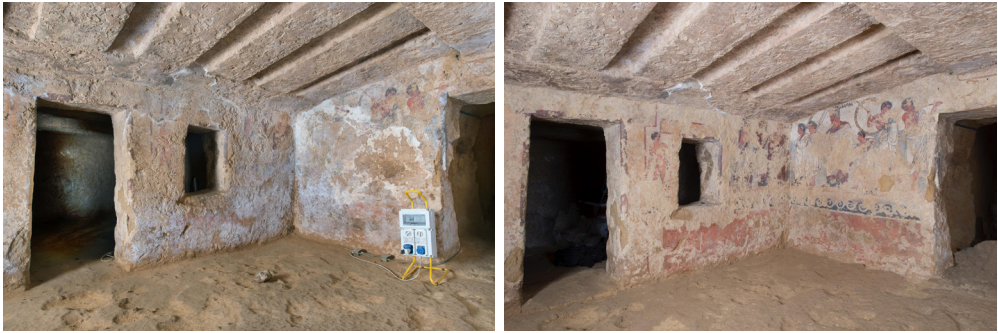
**Figure 3.** *Tomba degli Scudi*. South-east walls: before restoration (left) and after restoration (right).

The restoration endeavor was initiated in June 2016. Spearheaded by the *Soprintendenza Archeologia, Belle Arti e Paesaggio per l'Area metropolitana di Roma, la provincia di Viterbo e l'Etruria meridionale* (the Office of the Ministry of Culture in charge for the protection and management of the site before the creation of the Archaeological Park) with a valuable contribution from the FAI (*Fondo Ambiente Italiano*), promoted the restoration of the walls in the *atrium* of the tomb (Fig. 3).

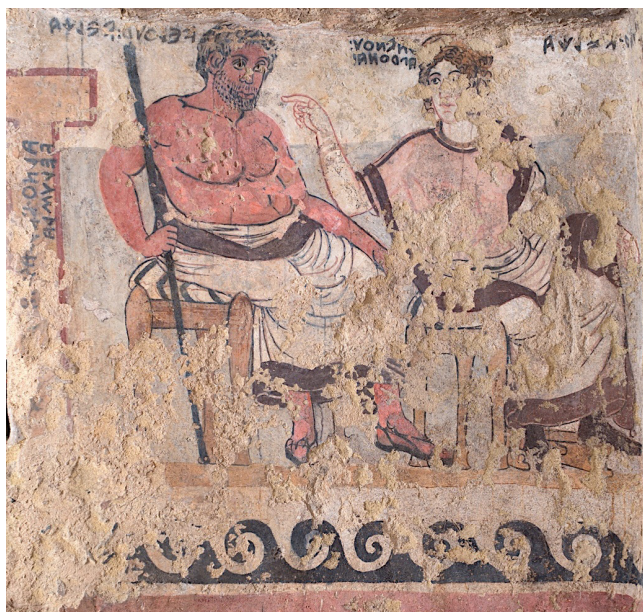
coarsely milled, pale-yellow calcarenite. Macco's prevalence in Tarquinia's tombs underscores its recognition and preference among artisans. It apparently supplanted sand, which is the byproduct of hypogeum excavation. This plaster façade received an overlay of white lime, discernible against the background of the murals and in the portrayal of female forms (Fig. 5).

**Figure 5.** Couple *Velthur Velcha* and *Ravnthu Aprtnai*, detail of the North-west wall in the *atrium*. Lime covering plaster is used as the color of background and female complexion.

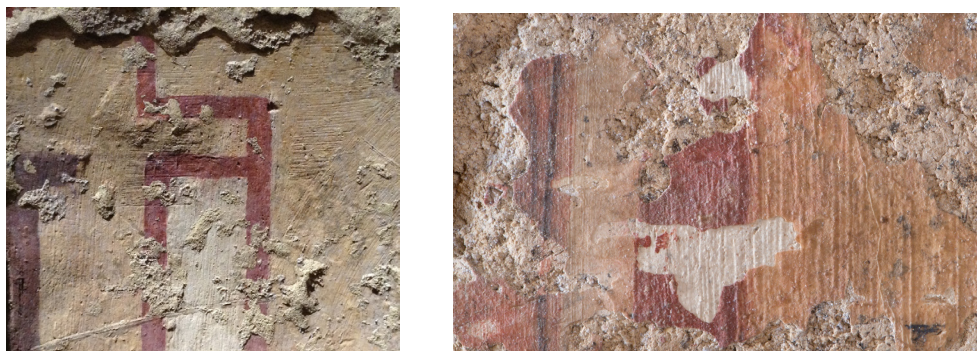
The pictorial layer is characterized by the predominant employment of a select assortment of inorganic mineral pigments, encompassing yellow and red ochre, massicot, smoke black, and lime white. From this palette, a spectrum of red, pink, and purple shades was derived (refer to Chapter 5). In certain regions, the pigment layer is denser and more robust, whereas in others, it manifests in such a fluid manner that it culminates in conspicuous, elongated drips. This disparity is primarily attributed to the frequent amalgamation of pigments with lime, especially evident in the paintings of *atrium* and more pronounced in the depiction of complexions. The integration of lime is not guided by any technical intent linked to a purposeful carbonation process; thus, it does not conform to a deliberate *pittura alla calce* technique. Instead, hydrated lime functions as a pigment additive to soften ochre hues, facilitating the generation of various pink gradations. Similarly, it contributes to crafting the light-blue backdrop behind the figures when blended with vegetable black. One can discern the pigment thickness and the *ductus* of the brush strokes, particularly in the complexions, distinguishing it from the foundational preparatory layer. Conversely, in the Burial Chamber, the pigment appears more diffuse. Examination of the cross-sectional samples (TSP-7 and TSP-2), detailed in the laboratory analysis segment of Chapter 5, highlights a clear demarcation between the paint and lime preparatory layers, demonstrating the application of the *secco* method (Fig. 9). Given the ambient conditions, a prominent re-carbonation layer overlays the paint film, ensuring the preservation of pigments that are only solubilized in water, devoid of any calcium hydroxide mixture.

**Figure 9.** Left: *Atrium*, the brushstrokes of the whitewash and the pictorial layer are well-visible under raking light. Right: detail of the same wall.

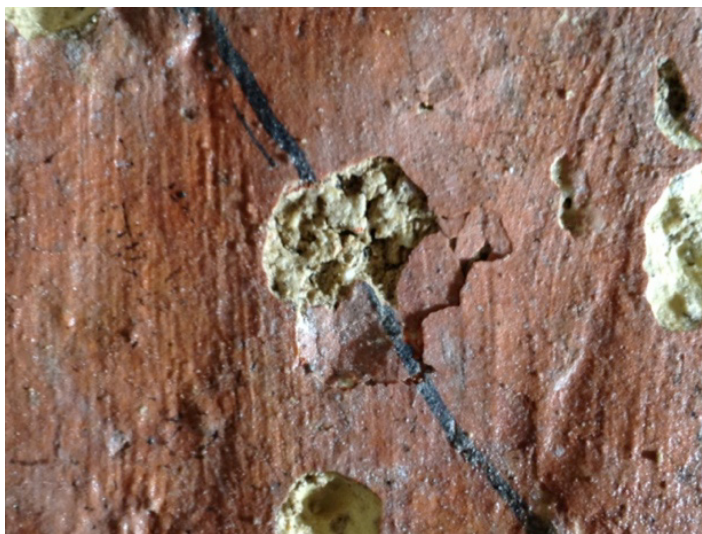
The principal contributor to plaster degradation is the infiltration of water in its liquid form within the substrate. This invasion renders the plaster more susceptible, even making it malleable. Concurrently, a sequence of physicochemical reactions associated with calcium carbonate dissolution manifests a unique degradation phenomenon. This entails a significant depletion of calcium carbonate, inducing a mechanical frailty of the plaster and subsequent cavity formation beneath the pictorial stratum (Fig. 10).

**Figure 10.** *Atrium*, voids of different sizes are present underneath the pictorial layer.

Although the outermost layers largely remain preserved, the underlying plaster exhibits voids of varying dimensions, ranging from minuscule cavities to expansive hollows, undermining its structural integrity. This condition arises from a complex interplay of chemical and physical reactions, moderated by several factors that balance calcium carbonate solubilization and re-deposition. The cyclical migration of water vapor between the internal atmosphere of the tomb and the exterior of the wall might prompt partial solubilization of calcium carbonate. Additionally, it can lead to the formation of thin calcitic layers, stemming from the evaporation of walls saturated with calcium carbonate. Another distinct, localized issue is the perilous seepage of rainwater, culminating in an accentuated dissolution of  $\text{CaCO}_3$  (Dreybrodt, 2012). In karstic contexts, the primary agents of this phenomenon are calcium carbonate ( $\text{CaCO}_3$ ), water ( $\text{H}_2\text{O}$ ), and carbon dioxide ( $\text{CO}_2$ ). The inaugural component constitutes the primary ingredient of the plaster, whereas the latter two are omnipresent, both within the rock and the ambient atmosphere:

To address the voids in the plaster, numerous tests were conducted within the hypogeum under optimal temperature and humidity conditions. These were aimed at determining the right balance of binders and aggregates to mirror the mechanical strength of the severely compromised original plaster. The composition is as follows:

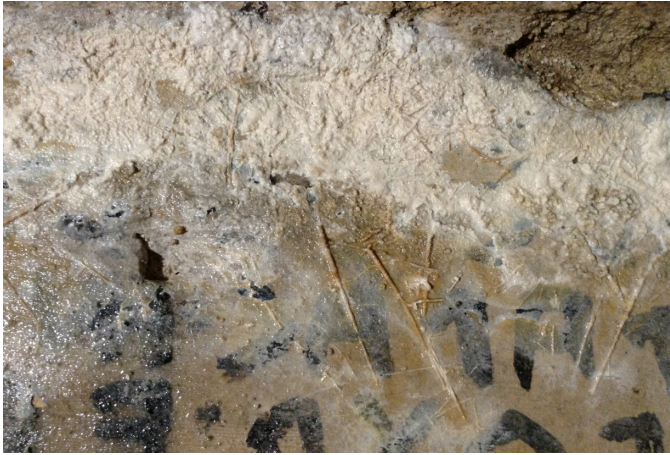
diated dissolution of calcium carbonate into bicarbonate that is soluble, and therefore, readily removed by infiltrating water, the calcium carbonate may be precipitated from the solution. Nonetheless, this precipitation process is gradual and contingent on specific environmental prerequisites (Lerman & Mackenzie, 2018). Consequently, within the tomb, the plaster acts as the nexus for this chemical dynamic, resulting in a substantial reduction of calcium carbonate within the layer structure, and consequently, the loss of extensive painting sections. Calcite deposition may materialize as either insoluble patinas or dense concretions (Fig. 11).

**Figure 11.** *Atrium*, carbonate depositions of different nature and typology are re-deposited on the pictorial layer.

The patina, characterized by its glassy and pale appearance, served a protective role for the painted layer in the *atrium*. Nevertheless, it induced a slight tonal lightening and, in certain instances, exhibited flaking that compromised part of its depth. Ultraviolet fluorescence (UVF) imaging conducted during the restoration phase indicated that these deposits aligned with regions exhibiting pronounced fluorescence (refer to Chapter 5). Although visually, these zones appeared unaffected, tactile examination revealed pronounced dampness. Hypothetically, these damp zones might harbor water enriched with  $\text{CaCO}_3$  or other compounds conducive to surface carbonate precipitation.

Given the dearth of prior restoration endeavors in the painted chambers of the tomb, the cleaning procedure was relatively straightforward. This phase primarily focused on eradicating the delicate moonmilk patina obscuring the artworks. The tasks involved addressing minor regions of carbonate concretions and clay deposits at the base of the wall, remnants of historical rainwater infiltrations. The moonmilk, being a biogenic deposit not chemically adhered to the substrate, was cleared using a simple aqueous medium. Generally, the carbonate concretions were malleable and could be mechanically removed; however, specific sections (half wall to the right of the entrance door and long inscription above *Velthur Velcha* wall) in the atrium necessitated preliminary softening using buffered ion exchange resins (anionics).

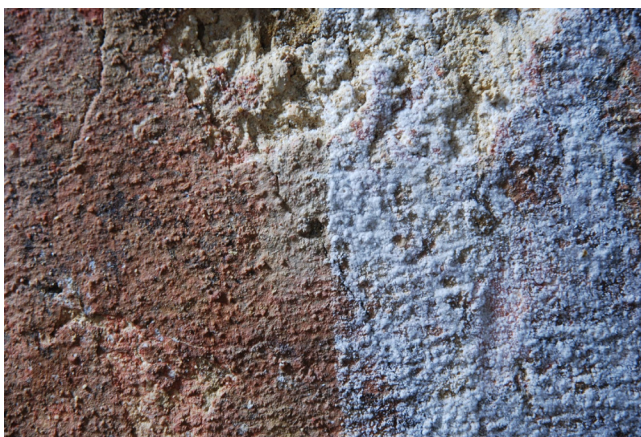
infiltrations and time-induced mechanical and abrasive wear, yielding color loss. Moreover, the tomb walls exhibited a biological patina, termed as moonmilk (refer to Chapter 4). Its whitish, powdery appearance is attributed to its composition: a delicate layer of calcium carbonate nanofibers (Fig. 12). Contrary to potential assumptions, this biogenic layer does not harm the paintings; rather, it apparently shielded them. Notably, a direct correlation emerged: a thicker moonmilk layer corresponds to greater conservation of the underlying pictorial layer (Fig. 13).

**Figure 12.** Detail of the wall where the biological white and powdery patina of moonmilk has been removed on the left side.

For eliminating moonmilk patina, a 1% benzalkonium chloride water solution was chosen. Application was done using a gentle synthetic bristle brush, with minimal agitation to the surface to lift the patina that rendered the surfaces coarse. In areas where the conservation

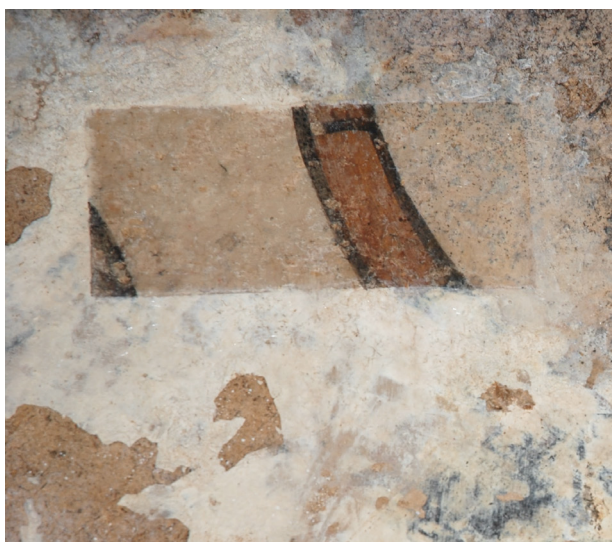
**Figure 13.** Detail of the biological patina of moonmilk, where it is thicker and harder, thereby protecting rather than damaging the murals.

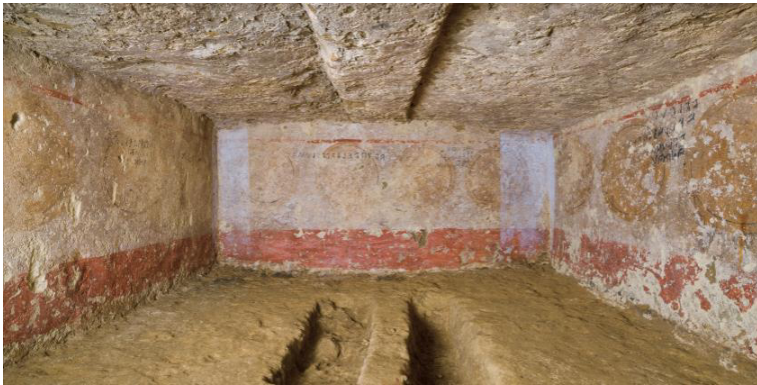
*Burial chamber*: Pre-restoration. Throughout the restoration, professionals noticed an unusual white deposition on the tomb walls and ceiling. The wall paintings were obscured by a white, feathery carbonate layer, a calcite deposit known as moonmilk (Mura et al., 2020). Commonly found in karst caves, moonmilk is composed of calcite nanofibers, each less than 1  $\mu\text{m}$  in width (Fig. 14) (Mura et al., 2021).

**Figure 14.** Burial chamber after the restoration. Two microbiological samples for each wall were studied.

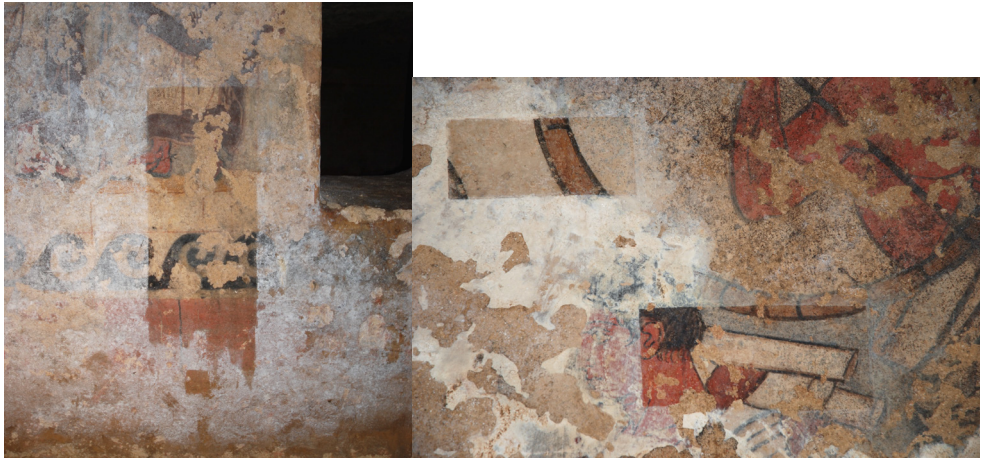
**Figure 23.** Cleaning tests with the removal of calcite depositions. (Left) north-west wall and (right) south-east wall of the tomb.

state permitted comprehensive cleaning, residual moonmilk deposits were eradicated using low-pressure nebulizers and soft sponges, methodically dissolving and blotting the sediment. Supported by the biocidal properties of benzalkonium chloride, the subtle surfactant potential of the product chemical composition aided in dispelling the patina, mitigating prolonged interaction with the fragile plaster and pictorial layer substrates (Figs. 23 and 24).

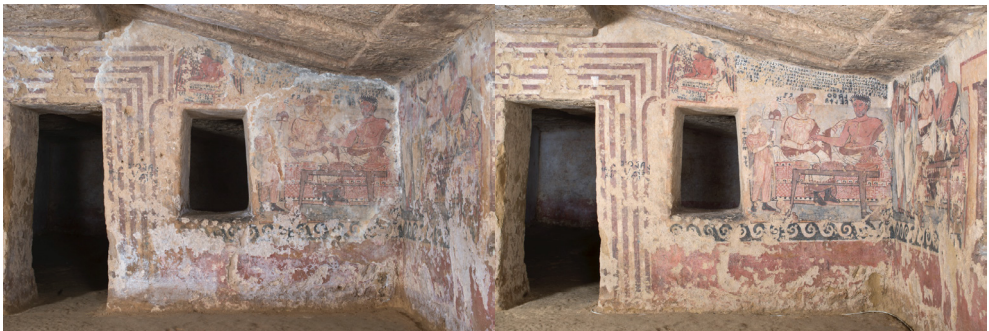
**Figure 24.** North-east walls before (below) and after restoration (above).

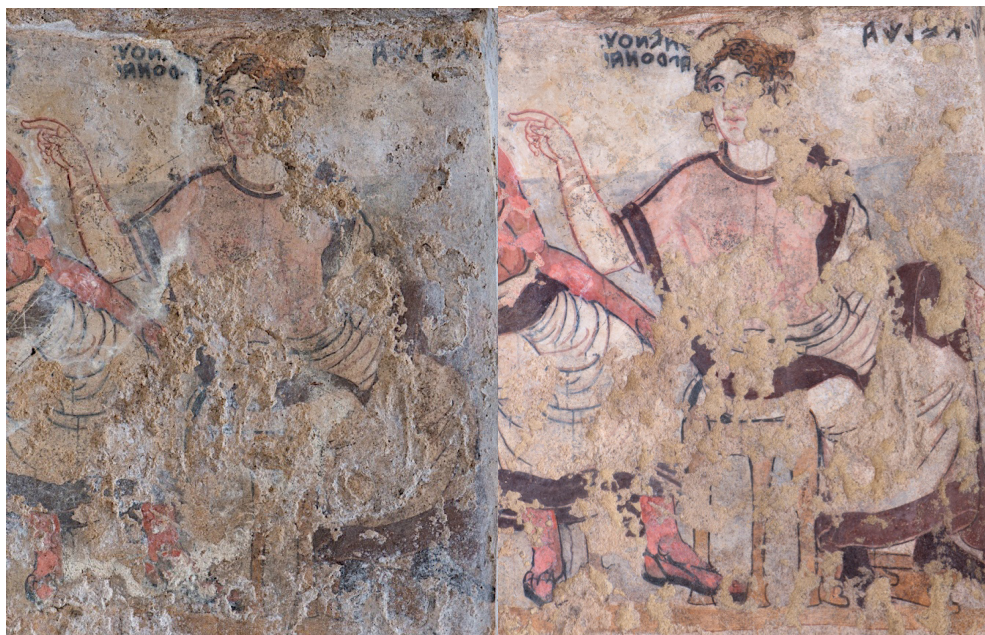
**Figure 25.** *Ravnthu Aprtnai* on the South-West wall. The deeper losses of the plaster have been partially infilled for conservation reasons and to make the image easier to read. They were then glazed with natural inorganic pigments to have a single tone of that level.

On the foundational level, which comprises the fragile sandstone support known as *sabbione*, only the edges of significant and deep gaps were stabilized, primarily for conservation reasons. These minimal infillings were crafted using yellow sand, closely resembling the original in both color and grain size, and bound with a sparse amount of a 1:6 water-diluted colloidal silica solution. This high dilution of the binder produced a mortar that was both malleable and of low mechanical strength, reflecting the properties of the original material. This level was maintained incomplete was backed by the intent to preserve the historical integrity and state of the artwork, especially considering the overall deterioration of the paintings and the specific origins of these gaps. Notably, a number of these gaps can be traced back to distinct, documented historical events. The upper plaster layer saw only selective infillings, corresponding to its original elevation (Fig. 25). Although the *sottolivello unico* technique (entailing the unification of all infilling levels of a layer—wall, *arriccio*, plaster, *intonachino*, etc.—to a singular elevation for distinction from other layers) is commonly employed for wall paintings, it was deemed unsuitable here. Such a method would have substantially altered the visual representation of the artwork conservation status. Following the infilling of the preparatory layers, an initial surface assessment facilitated decisions regarding pictorial reintegration. Primarily, the tone of minute gaps and abrasions in the paint film was subdued. The light hue of both the original and filled plaster made the gaps more prominent than the actual painted images. To prevent the lacunae from drawing undue attention, their tone was slightly reduced, referencing specific areas where the plaster naturally appeared darker. Only stable, water-diluted powder pigments were employed for pictorial touch-ups. The decision to forego water colors or other conservation-specific colors was established during the initial

2016 restorations, to exclude any organic material, such as Arabic gum, which could potentially serve as a habitat for microbial colonization. Additionally, an additional binder is not required given the porous nature of plaster.
