Article

Unveiling Vernacular Features: Interdisciplinary Knowledge for the Conservation of Villa Murat in the Sorrento Peninsula

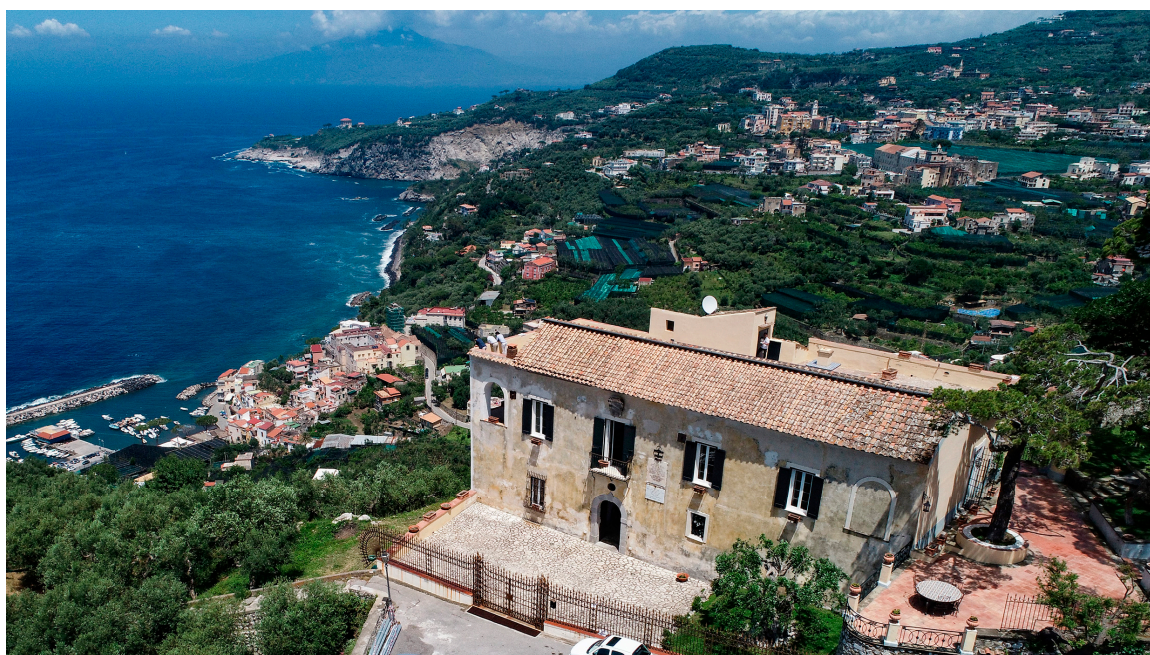
Figure 1. Villa Murat with Vesuvius in the background. Photo taken by a drone (arch. M. Facchini).

Villa Rossi, subsequently renamed Villa Murat, is situated within the Massa Lubrense municipality, at the extreme edge of the Sorrento Peninsula (Figure 1). This building has also undergone the aforementioned process of transformation. An initial nucleus, dating back to at least the 17th century, was expanded during the following century, with the addition of new volumes and the regularization of an initially spontaneous architecture. Despite such transformations, Villa Murat still retains some constructive features that are typical of vernacular architectures of the Sorrento and Amalfi coasts, such as extradosed vaults covered with a layer of beaten lapillus or loggias facing the sea. The villa intertwined major historical events at the beginning of the 19th century, having become the headquarters of king Gioacchino Murat—hence its name—during the “Capture of Capri” against the British in 1808. Since then, the villa has been preserved as a “villa of delights”, with no major alterations and as property of different owners who have succeeded each other over the past two centuries.

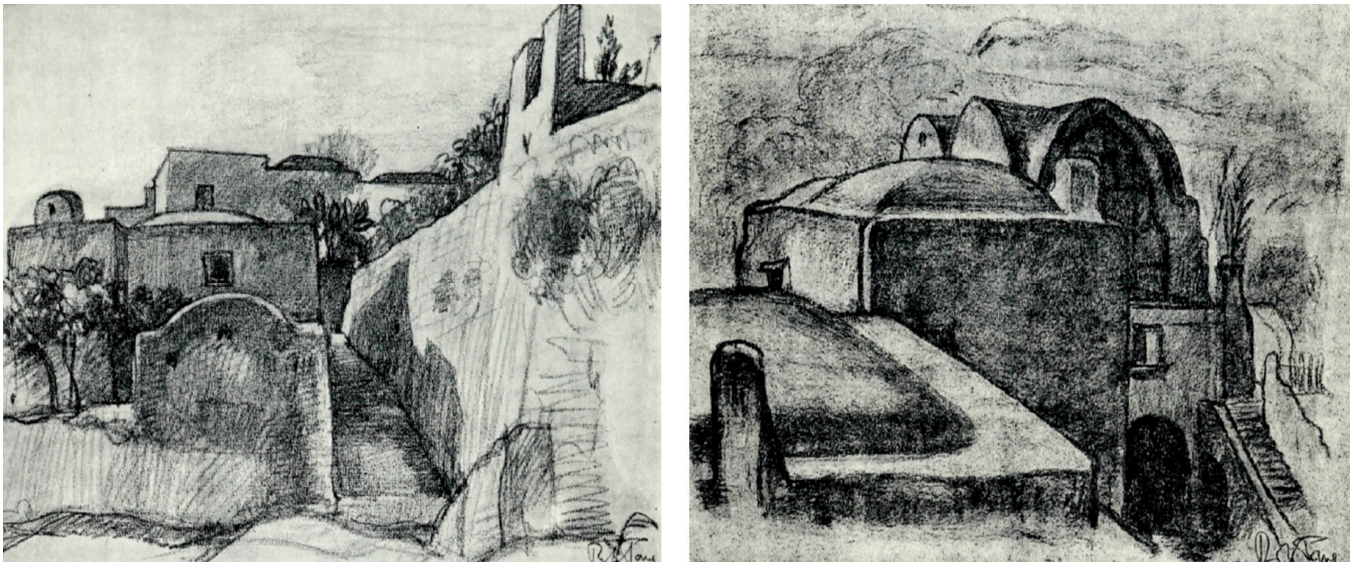
Figure 3. Rural houses in Capri. Drawings by Roberto Pane [1].

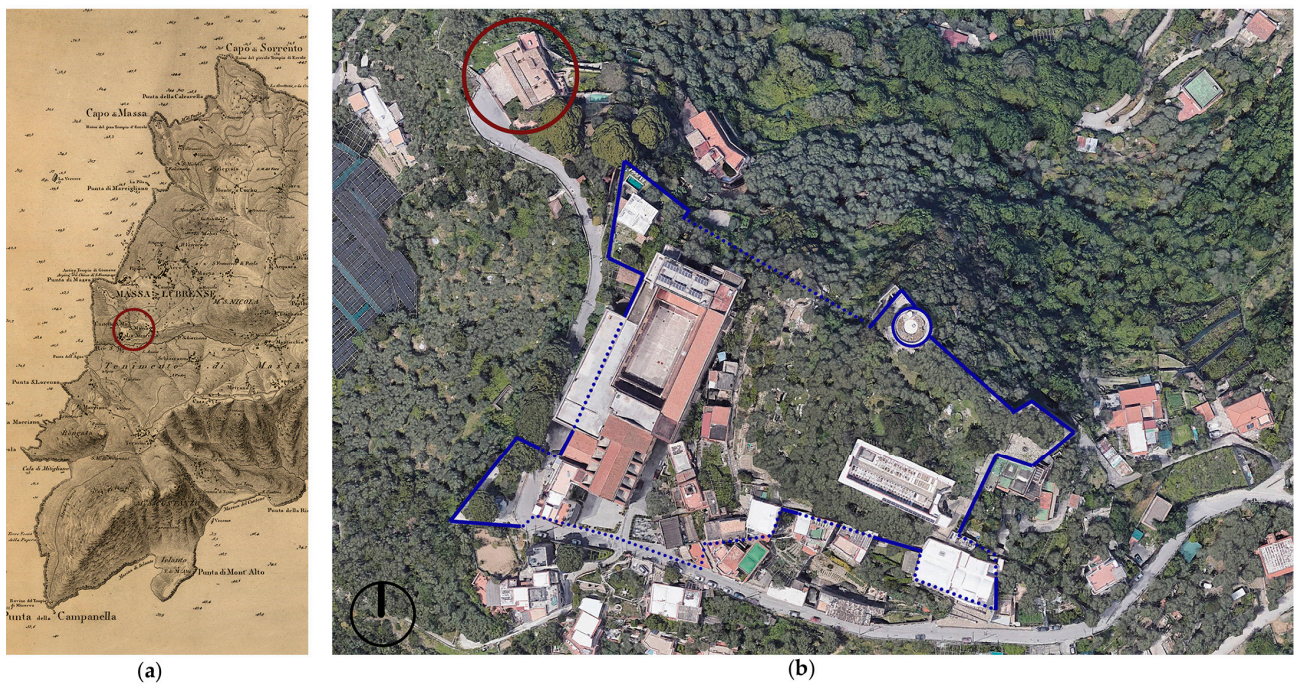
Figure 4. (a) Reale Ufficio Topografico, *Carta topografica e idrografica dei contorni di Napoli*, 1817–19. The circle indicates the Annunziata hamlet. (b) Aerial view of the Annunziata hamlet with Villa Murat. The surviving parts of the XVI century fortification are highlighted with a continuous line. The hypothetical reconstruction is indicated with a dotted line.

The municipality of Massa Lubrense is set at the extreme edge of the Sorrento peninsula and stands out for its polycentric settlement pattern. It does not have a real historical center but is made of numerous hamlets. Among them, there is Annunziata (Figure 4). This is located on a hill facing the island of Capri and was chosen as the most suitable place for the foundation of the *Civitas Massae*, a fortified citadel that has been destroyed and rebuilt several times. The fortifications that can still be seen today date back to the third *castrum*, built in the viceregal period, between the second half of the XVI century and the beginning of the XVII century, together with the coastal towers, to defend a territory that had been devastated by Saracen raids [15,16]. The first *castrum*, dating back to the Norman period, was destroyed by Charles I of Anjou around 1273. In 1389, the castle was rebuilt, then destroyed again by Ferrante d’Aragona in 1465.

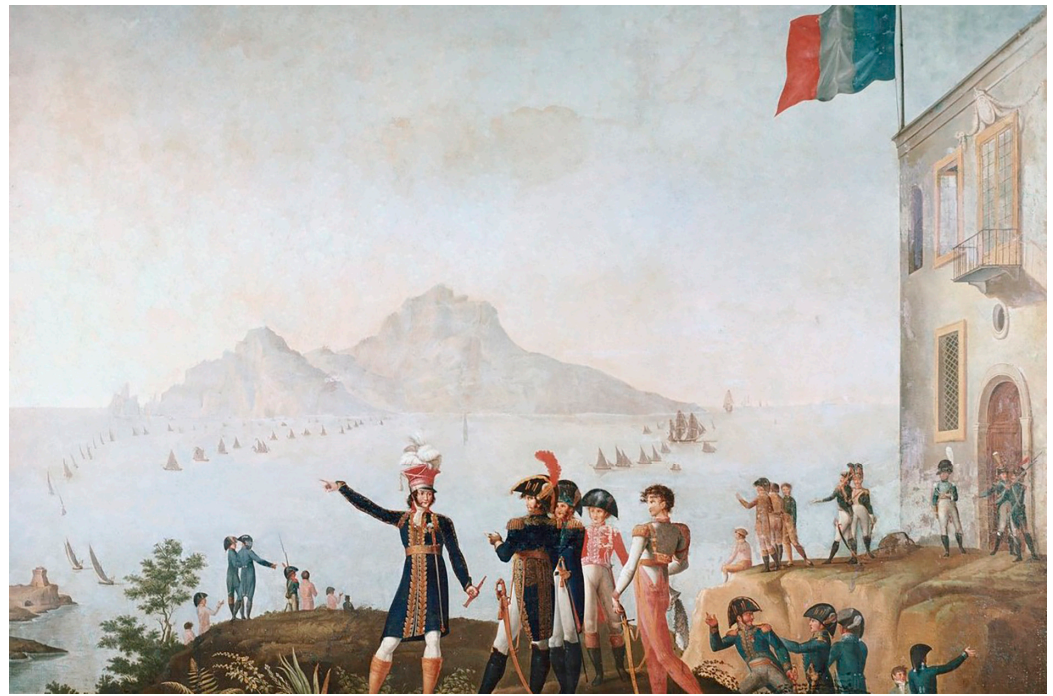
Figure 6. O. Fischetti, *Gioacchino Murat, Re di Napoli, assiste alla presa di Capri da Massa Lubrense, 1809*, Museo della Certosa di San Martino, Napoli. The main elevation of Villa Murat is accurately represented on the right.

The date of Murat’s arrival is uncertain and fluctuates between October 10th and 14th. The king did not previously know the owners of the villa, who were even absent on his arrival. He simply chose the building because it offered the best view on the battle [20] (pp. 187–188). The stalemate ended on October 15th, when French fire succeeded in opening a hole in the walls of Capri. Difficult negotiations between the British and the sovereign followed, until Murat signed the capitulation on the night of October 16–17th, at the Rossi’s villa, from then on called “Villa Murat” (Figure 6).

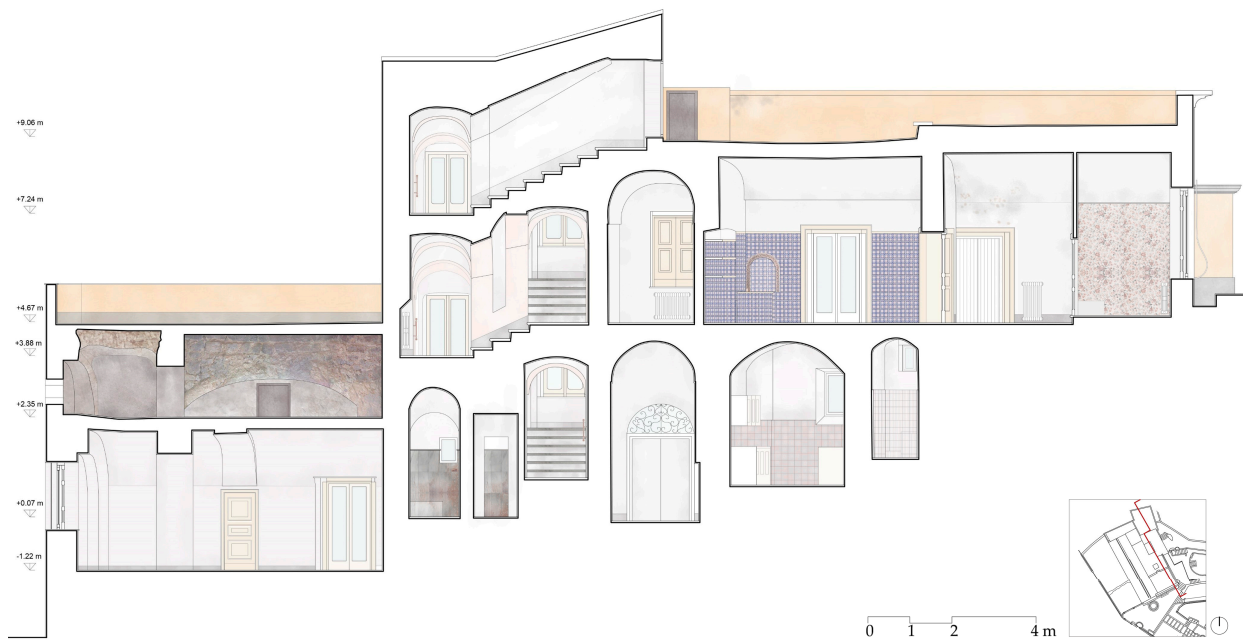
Figure 9. Longitudinal section showing the staggered floors of the building.

This configuration may evoke the site's initial agricultural use. Indeed, some spaces for agricultural functions were partially underground, as evidenced by the historical land registers, which record some *trappeti* in the property. The ground floor therefore retains a “handmade” character, comprising a number of irregular volumes. The first floor is characterized by a more regular layout, although some exceptions were necessary in order to accommodate to the preexisting structures underneath (Figure 10).

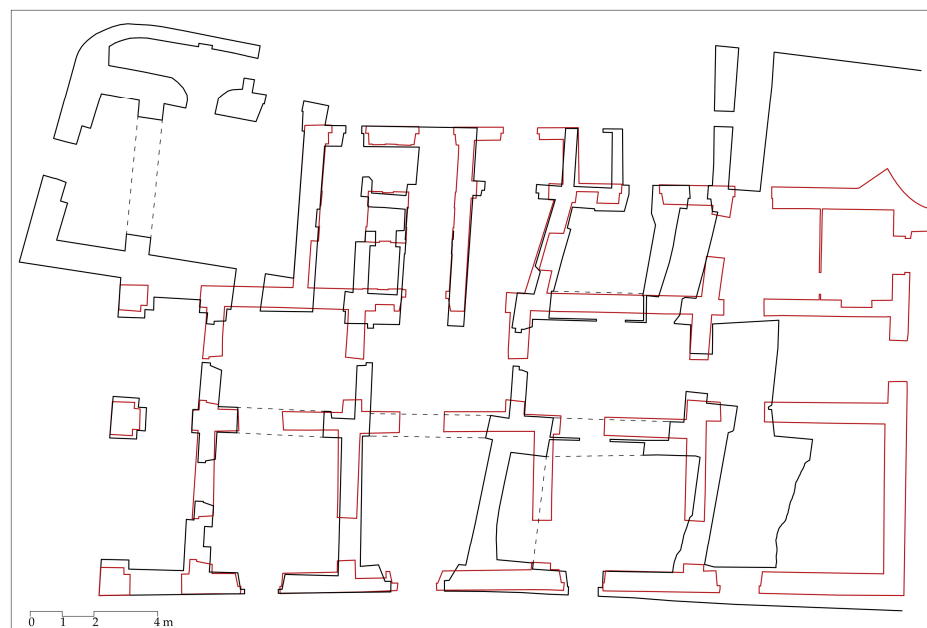
Figure 10. Overlapping of ground floor (in black) and first floor (in red) plans. The first floor is more regular, with some exceptions necessary to adapt to the lower structures.

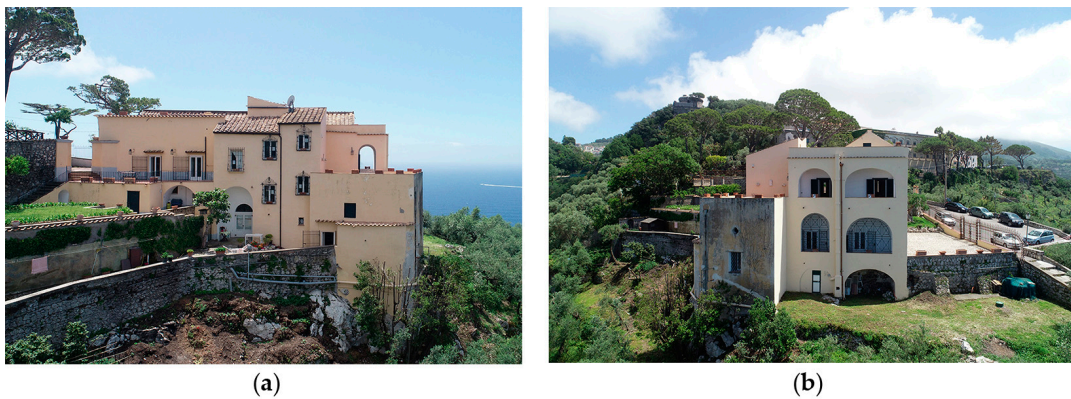
Figure 11. (a) Back elevation of the Villa. (b) North elevation with loggias and angular volume identified as pre-dating the rest of the building.

The plan follows a somewhat diffuse pattern, comprising two rows of rooms. The main ones obviously face the front elevation, the back row corresponds to antechambers, while the service rooms are at the back. The complex spatial articulation is clearly visible when observing the back elevation, which, in contrast to the more regular main one, still allows the different volumes to be distinguished (Figure 11).

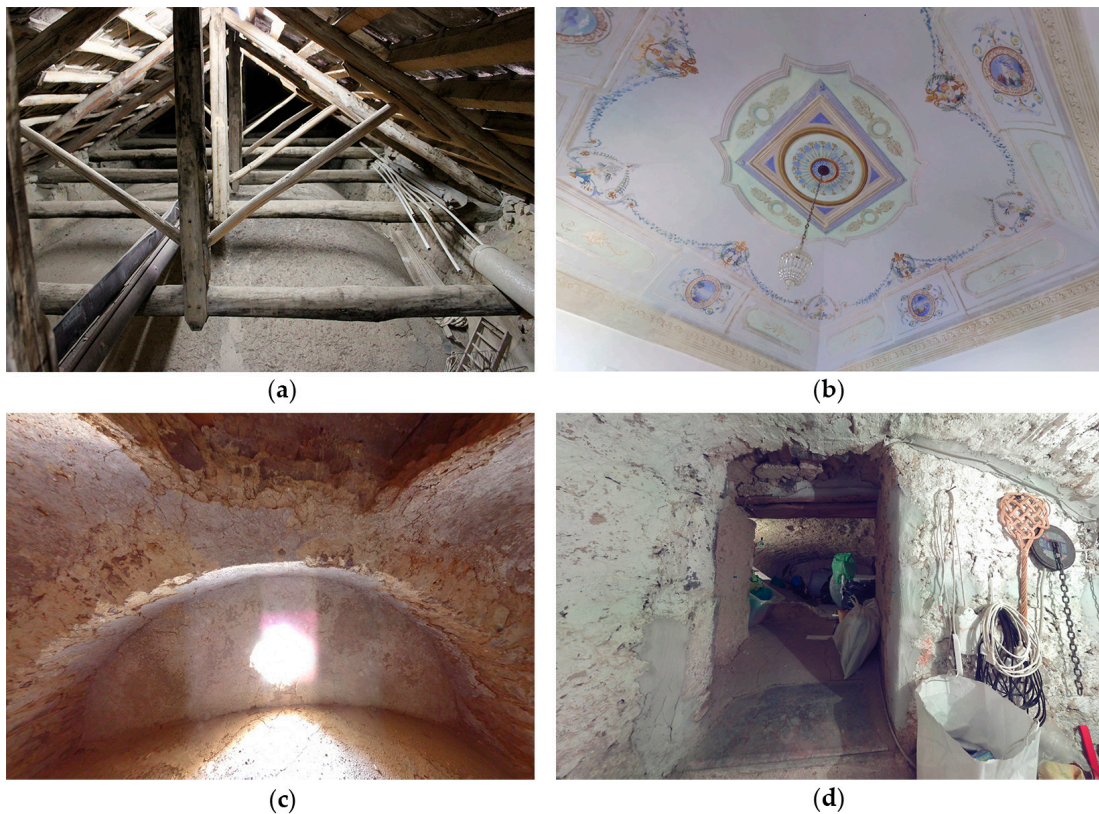
Figure 12. (a) Extrados vaults in the attic. (b) Intrados of one of the painted vaults of the first floor. (c) Extrados vaults in the mezzanine level. Here, the vault collapsed and the masonry in irregular stones of grey tuff is visible. The four-lobed window may recall a previous use of this volume, before it was incorporated into the villa. (d) Spaces partly carved into the rock on the ground floor.

As previously stated, the primary architectural feature of rural houses on the Sorrento peninsula, specifically the extrados vaults, can also be observed in Villa Murat (Figure 12a). Although hidden at first glance by a double-pitched roof with wooden trusses added at a later date, they cover the rooms on the first floor and are clearly visible in the attic, where the historical finish in beaten lapillus is preserved. The addition of a pitched roof is a recurring transformation of this type of architecture. This certainly ensures even better waterproofing and rainwater runoff. Perhaps the addition of the roof is also an aesthetic choice, aimed precisely at concealing the rural appearance of the building.

Additionally, extradosed vaults are present on the two levels of the corner volume, where, following a collapse, the masonry in irregular ashlar of so-called grey tuff can be observed (Figure 12c).

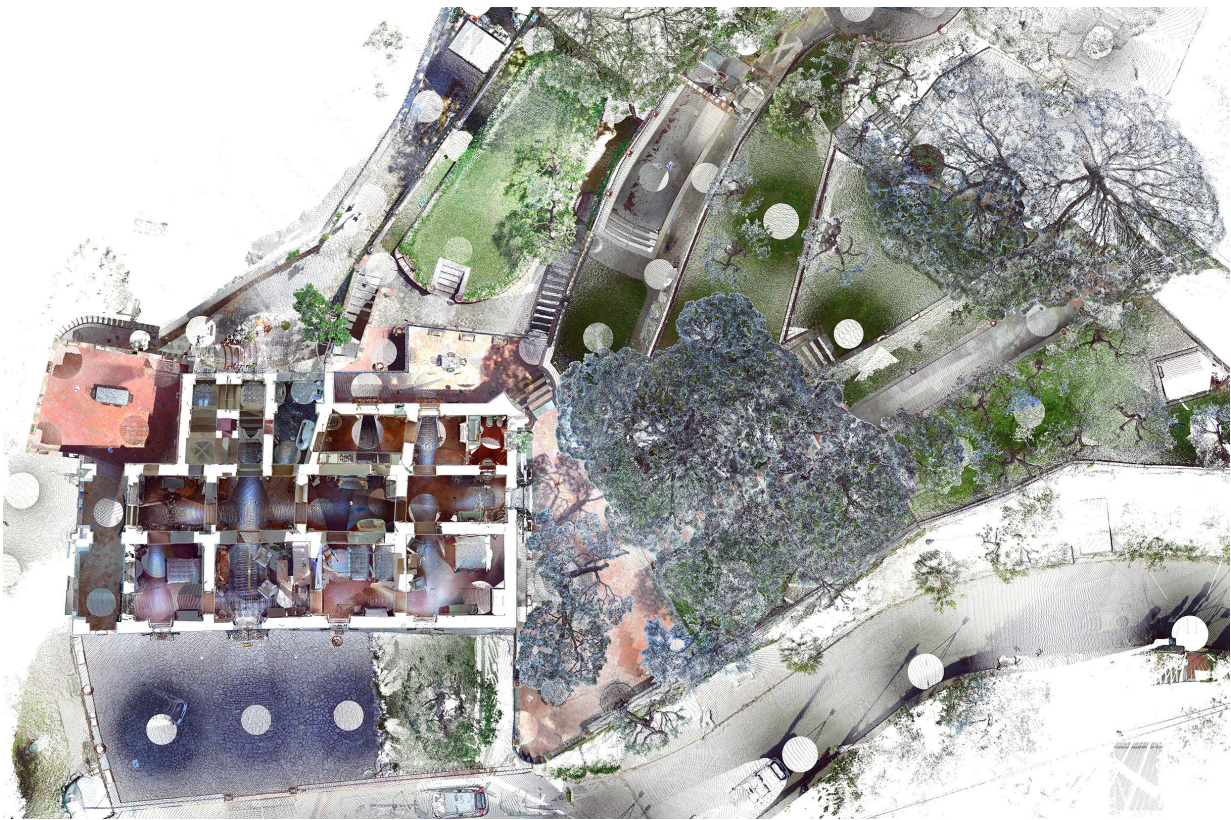
Figure 14. Plan view of the point cloud from the laser scanner survey. Station points are clearly visible.

A total of 169 scans were completed, with the selection of appropriate station points made with minimal occlusion (Figure 14). The resolution selected was 6136 mm, measured in a plane 10 m from the emitter, with 3× quality. Each scan lasted seven minutes. The acquired point clouds were recorded through collimation of the artificial targets, with a cloud-to-cloud process used for some parts that could not be directly reached. Following preprocessing, the registration phase of the individual scans started by establishing the

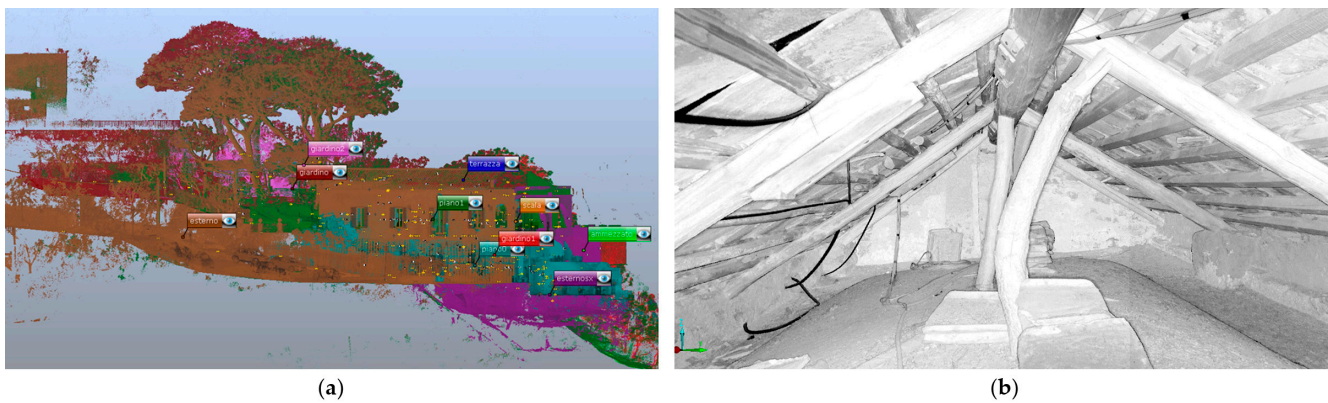
Figure 15. (a) Registration phase in FaroSCENE software. (b) Reflectance map of the scan in the attic.

The data obtained using laser scanning enabled the acquisition of metric values, the generation of orthophotos, and spherical photos of both internal and external spaces. The choice of an active sensor technology such as laser scanning made it possible to acquire data even in low-light environments such as the villa's attic, acquiring its reflectance values (Figure 15).

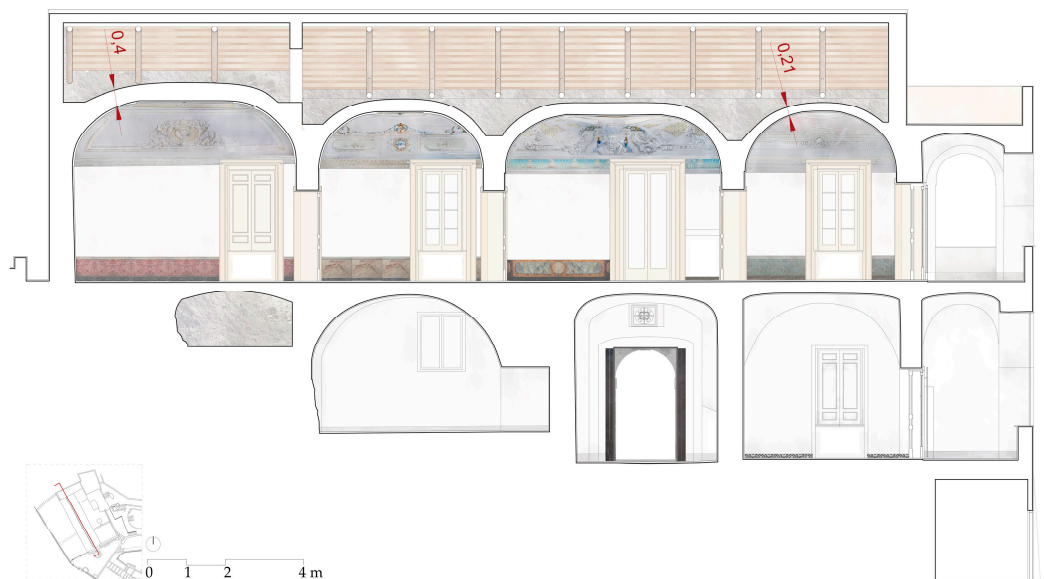
Figure 17. Longitudinal section. The differences in the thickness of the vaults are evidenced. The part of the roof on the left of the section is that with trussing structures instead of trusses.

The laser scanner survey facilitated an accurate examination of the crack pattern and precise measurement of the thicknesses of the extradosed vaults. This revealed that the vaults are of varying thicknesses, from around 20 to 40 cm (Figure 17). The vault closest to the loggias is notably thinner and exhibits the most pronounced cracks. The vault closest to the garden, on the other hand, is markedly thicker and almost free of cracks. The second floor was located in correspondence with the vault with a greater thickness. Likely, this vault was built to be more stable, precisely because it was at an intermediate level. The greater thickness, as well as the more stable position in comparison to the front facing the sea, which was more prone to subsidence, meant that no cracks were formed.

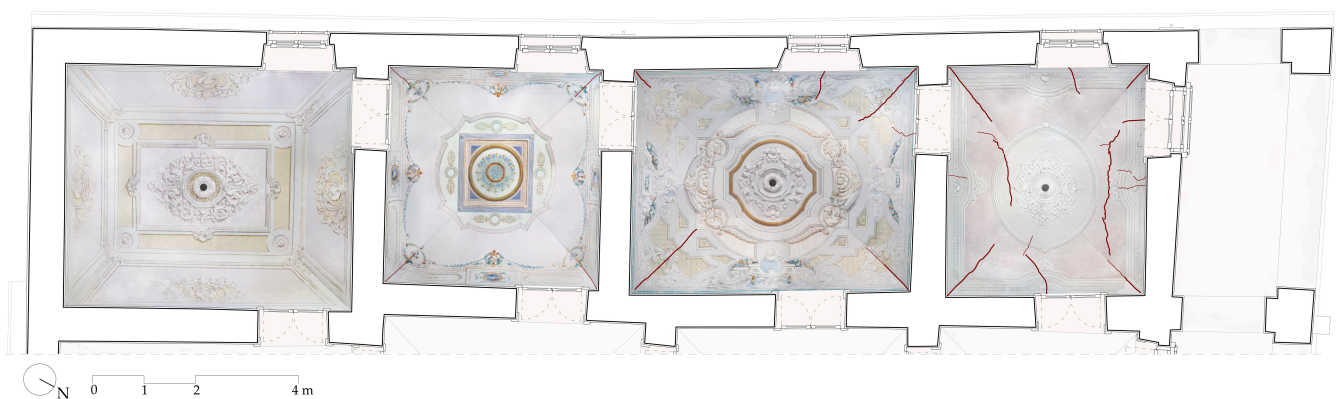
Figure 18. Crack pattern survey of the painted vaults of the first floor.

In addition to some damage over the doors caused by the inflection of wooden lintels, the cracks are consistent with well-known collapse mechanisms of vaulted structures and of cloister vaults in particular [31,32] (pp. 231–237) [33] (pp. 90–97). One of the most prevalent failure mechanisms observed in cloister vaults is the detachment of the four webs that constitute the vault, with the formation of cracks along the diagonals of the vault due to tensile stresses. In Villa Murat’s vaults, this type of crack pattern can be observed and is more pronounced, with passing cracks of major widths in the two vaults in proximity to the loggias, and especially in the nearest one. These are thinner than the others and more susceptible to potential shifts of the springs and bearing walls due to movements of the northern front with the loggias. Indeed, the presence of a long crack parallel to the lateral wall next to the loggia is indicative of a small failure of the loggia structure. These cracks had been previously repaired and had reopened, showing an ongoing mechanism (Figure 18).

In addition to verifying the efficacy of the existing ties rods in counteracting movements of the north elevation, the proposed solution entails consolidating the vaults with bands of fiber-reinforced composite material, aiming to select the most compatible matrix in accordance with the theoretical principles of conservation [34] and the need to preserve the historical finish in beaten lapillus. These bands should be placed at the extrados, along the diagonals and as annular strips, so that they can act as a hooping against the detachment of the webs [35,36].

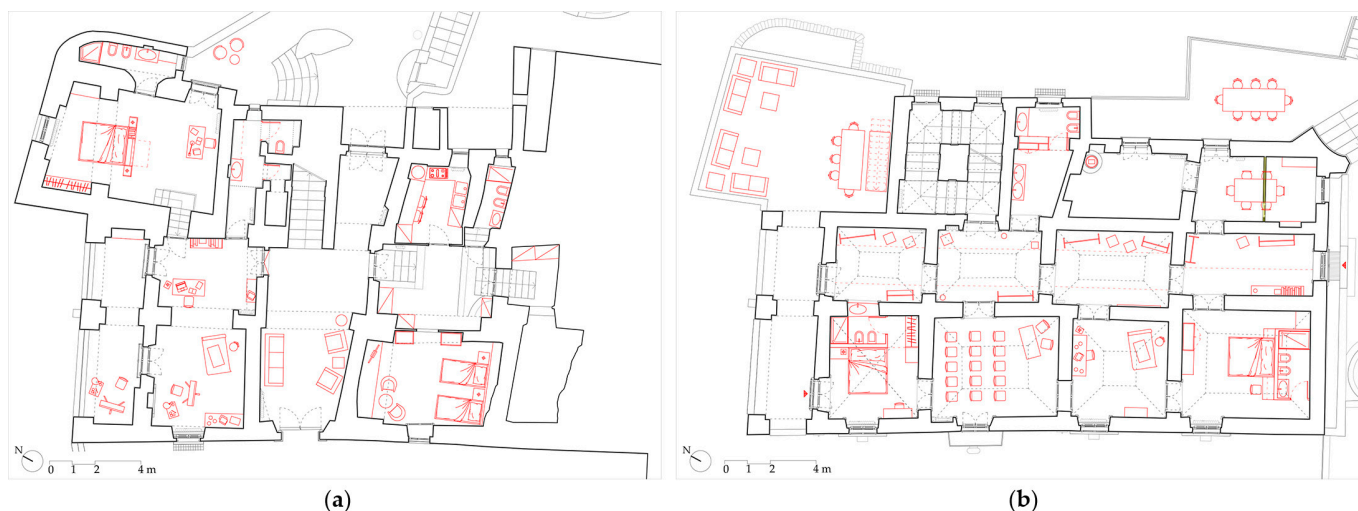
Figure 19. Villa Murat converted into Artists’ residency. (a) Ground floor plan; (b) first floor plan.

The design of the interior spaces is based on minimal intervention and flexibility, allowing the artists to organize their studios according to their preferences. The revised layout (Figure 19) allows for the simultaneous accommodation of three artists, with dedicated workspaces allocated to each. The ground floor houses service areas and a shared atelier, situated within the largest room, which is free from any decoration that could be damaged by the artists’ activities. The lower level also comprises a first room, divided into a sleeping area and workspace in the brightest part. The artists’ rooms are diversified based on the art practiced and organized through flexible furnishings and low-height service blocks to avoid obstructing the view of the painted vaults. These blocks are dry-built and therefore reversible. Two more bedrooms are on the first floor. In addition to the private rooms, the new layout for the villa includes common areas for events and moments of interaction among the guests, such as the two rooms on the main front. Moreover, the row of rooms at the back is configured to accommodate small exhibitions of the works realized in the residence. The outdoor spaces, loggias, terraces, and garden are an essential part of the new layout. The aim is to bring new life to Villa Murat and also to introduce a compatible form of tourism in the Sorrento peninsula.
