# Heritage Problems, Causes and Solutions

Calogero Bellanca and Susana Mora Alonso-Muñoyerro

## CHAPTER 7. FOUNDATIONS: CONSTRUCTIVE SYSTEMS, PROBLEMS, CAUSES AND SOLUTIONS. SOIL MOISTURE

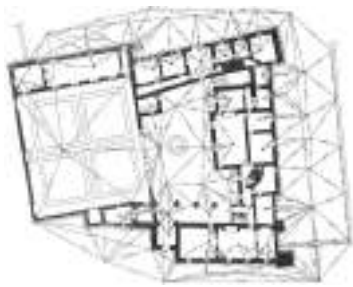
Fig. 1. Geometrical Survey.  
From F. Vella, E. Viganò,  
“Final Degree Project”,  
*Manuale del restauro  
architettonico*, Mancosu,  
Roma 2001, Section H.  
Approcci metodologici,  
rilievo geometrico, 12.

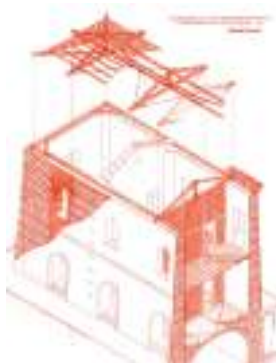
Fig. 3. Mechanical and  
Constructive Survey.  
From Carlo Blasi, *Manuale  
del restauro architettonico*,  
Mancosu, Roma 2001.

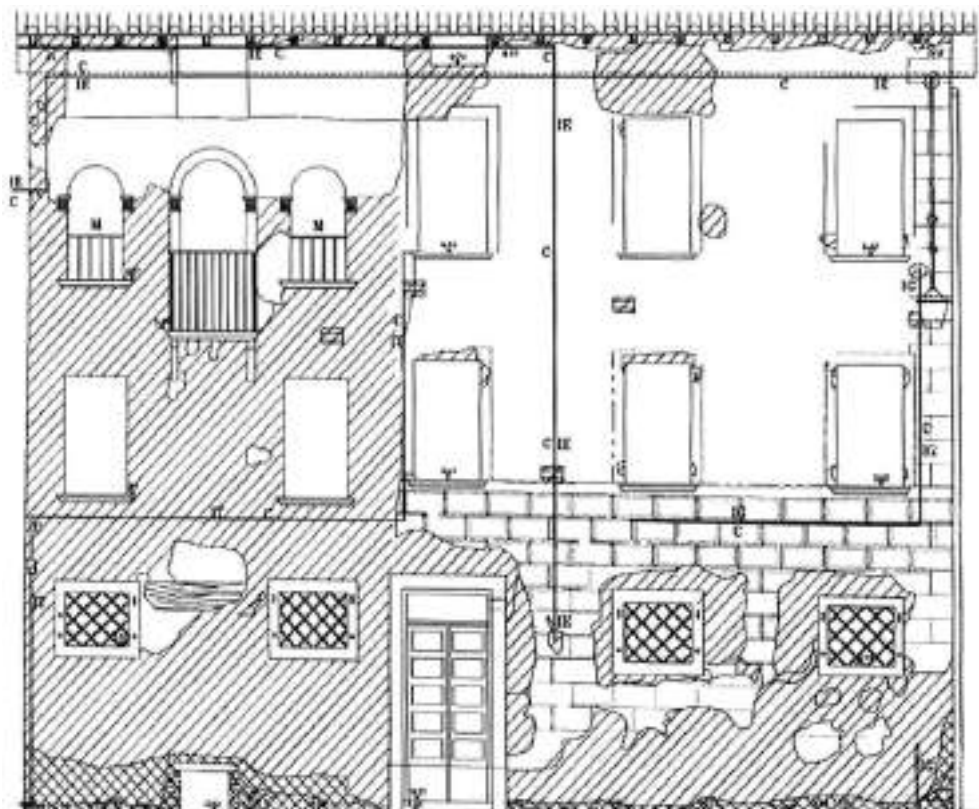
Fig. 5. Map of Damages.  
From F. Doglioni,  
*Nel restauro. Progetti  
per la architettura  
del passato*, (IUAU  
Documenti), Marsilio,  
Venezia 2008, p. 228.

Using as a basis a cartographic architectural survey on which is portrayed the perimeter of the areas subject to some typical aspects of degradation, such as surface deposit, cracking, fracturing, scaling, alveolization, black crusts, pitting, corrosion, spotting, efflorescence, detachment, etc.

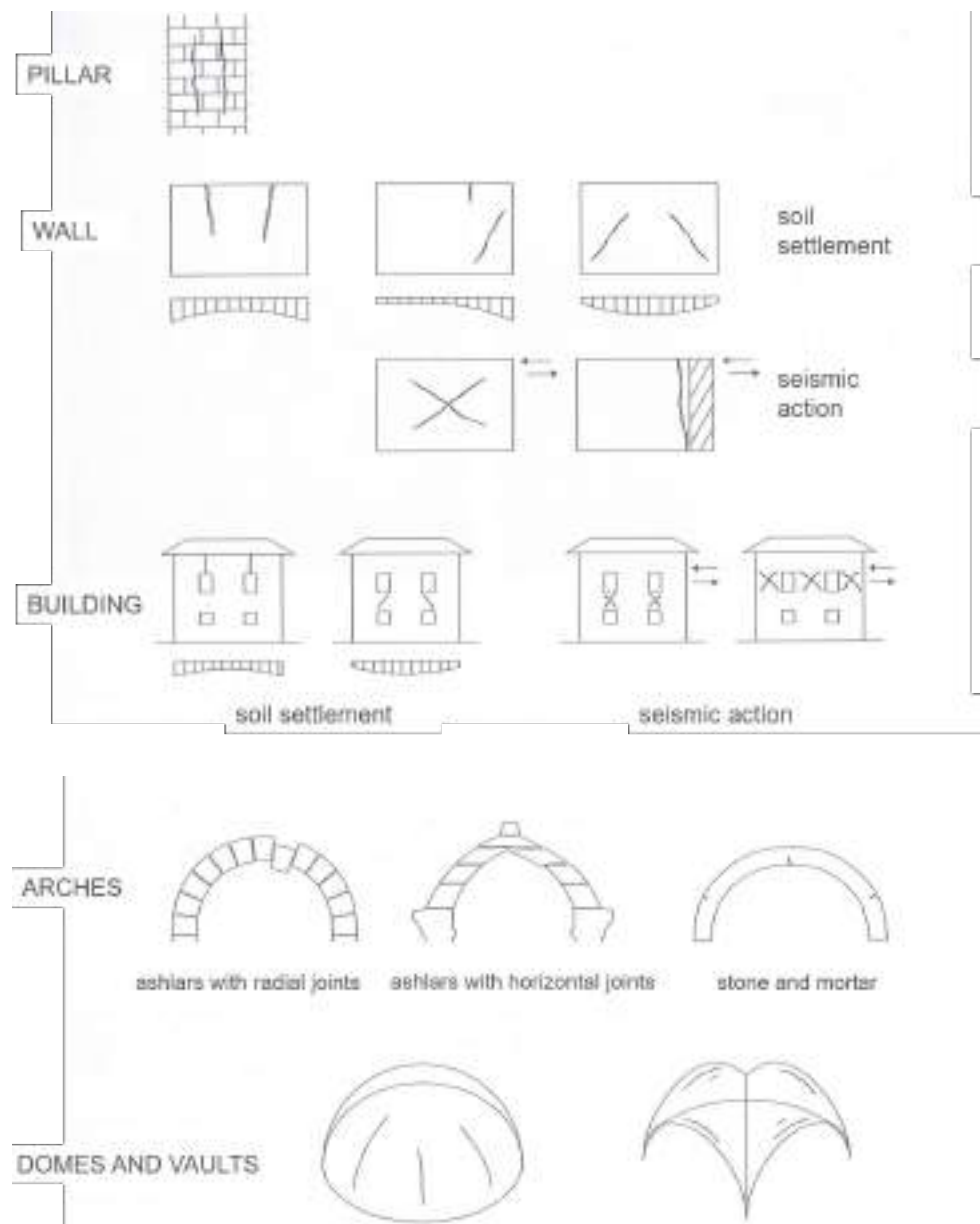
Fig. 11. From G. Croci, *Conservazione e restauro strutturale dei beni architettonici*, Utet, Torino 2001, p. 121.

- Damages and deformations in a masonry structure:

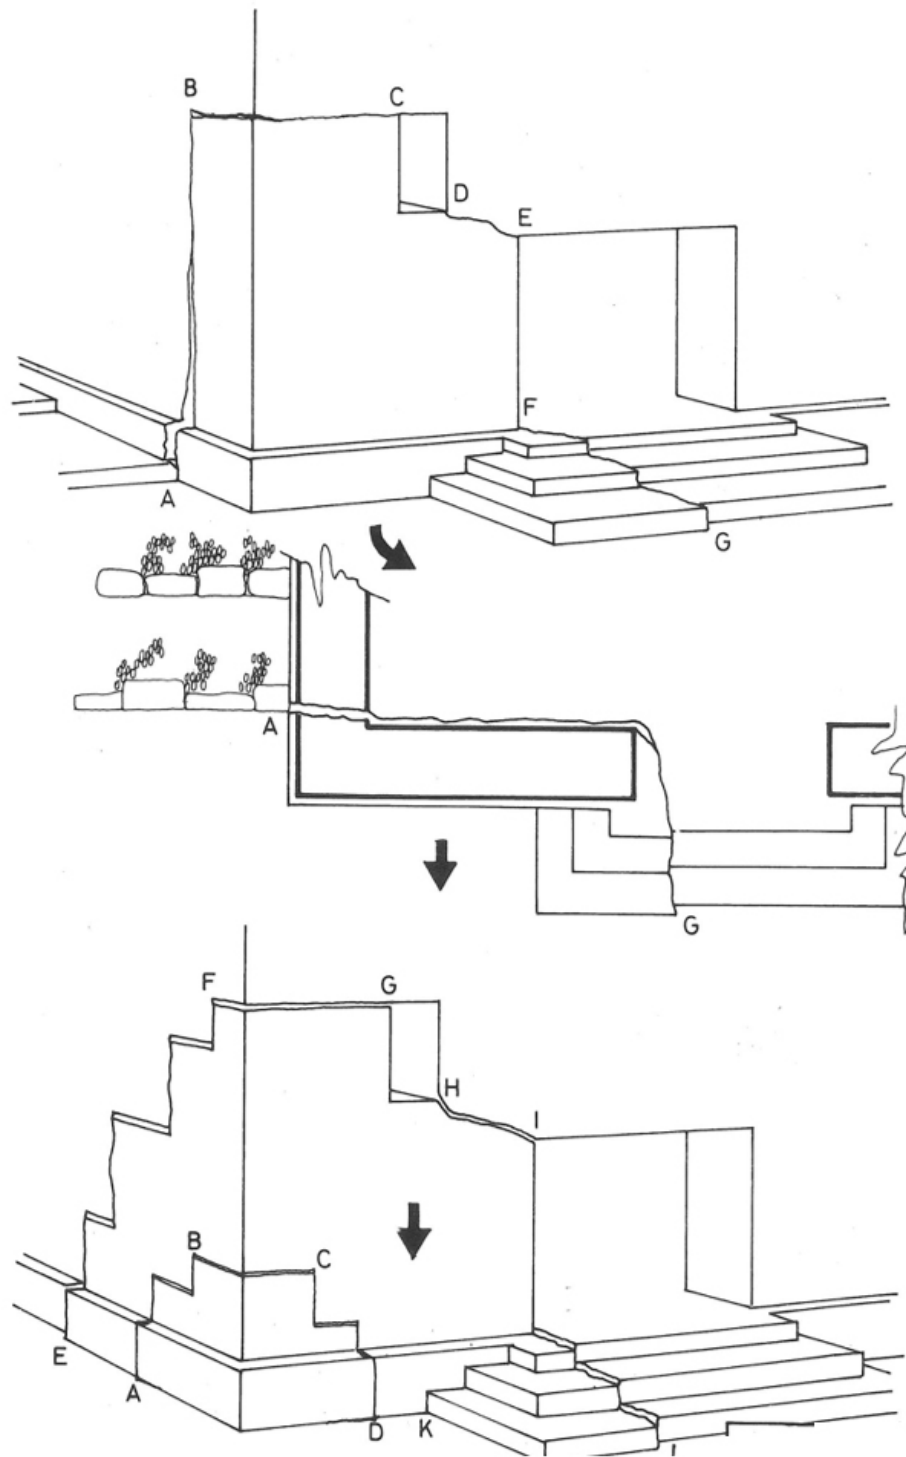
Fig. 14. From G. López Collado, *Las Ruinas en Construcciones Antiguas*, Miján, Artes, Gráficas, Ávila 1985, p. 66.

FOOTING SETTLES AND  
LEANS  
combination of movement in two  
orthogonal planes with shear and  
steps cracks

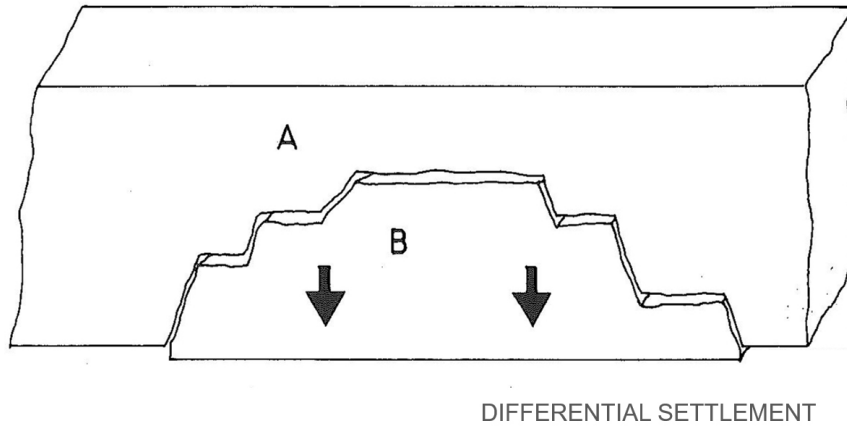
Fig. 15. From G. López Collado, *Las Ruinas en Construcciones Antiguas*, Miján, Artes, Gráficas, Ávila 1985, p. 54.

- Foundation and ground damages: Internal movements.

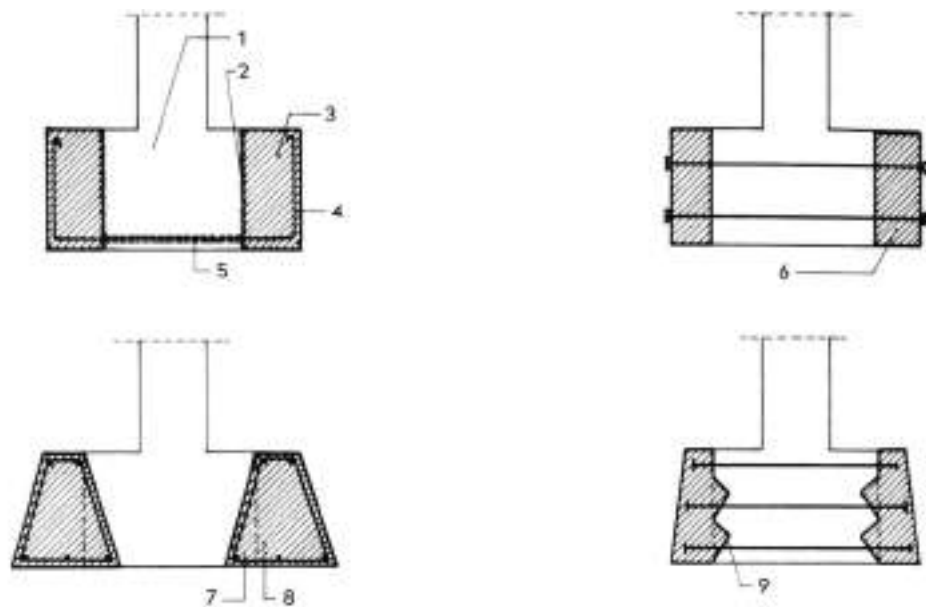
Fig. 17. From J.M. Rodríguez Ortíz, *La cimentación*, Curso COAM, Madrid 1984, p. 32.

**Wider footings solutions**

1. Original foundation
2. Grout
3. Perimeter ring or concrete tie beam
4. Anchor bar
5. Drill
6. Cable-stayed perimeter ring
7. Wedge cutout
8. Pyramidal ring
9. Toothed joint

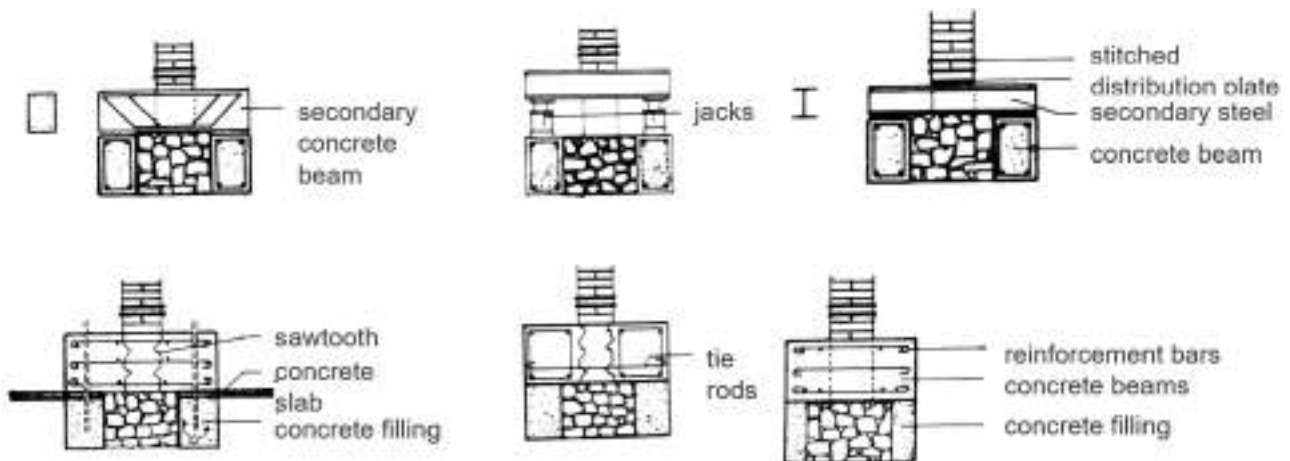
Fig. 18. From J.M. Rodríguez Ortíz, *La cimentación*, Curso COAM, Madrid 1984, p. 32.

**2. BRIDGING AND ENLARGE FOOTINGS SOLUTIONS**

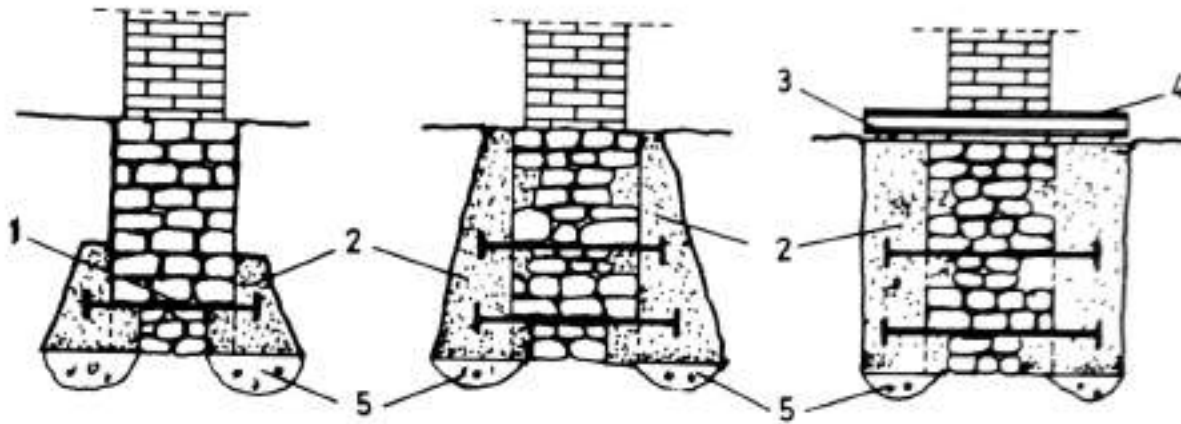
Fig. 19. From J.M. Rodríguez Ortiz, *La cimentación*, Curso COAM, Madrid 1984, p. 33.

Enlarge footings solutions with local ground improvement.

1. Tie rods; 2. Concrete; 3. Wedges; 4. Secondary beam; 5. Compacted or injected soil.

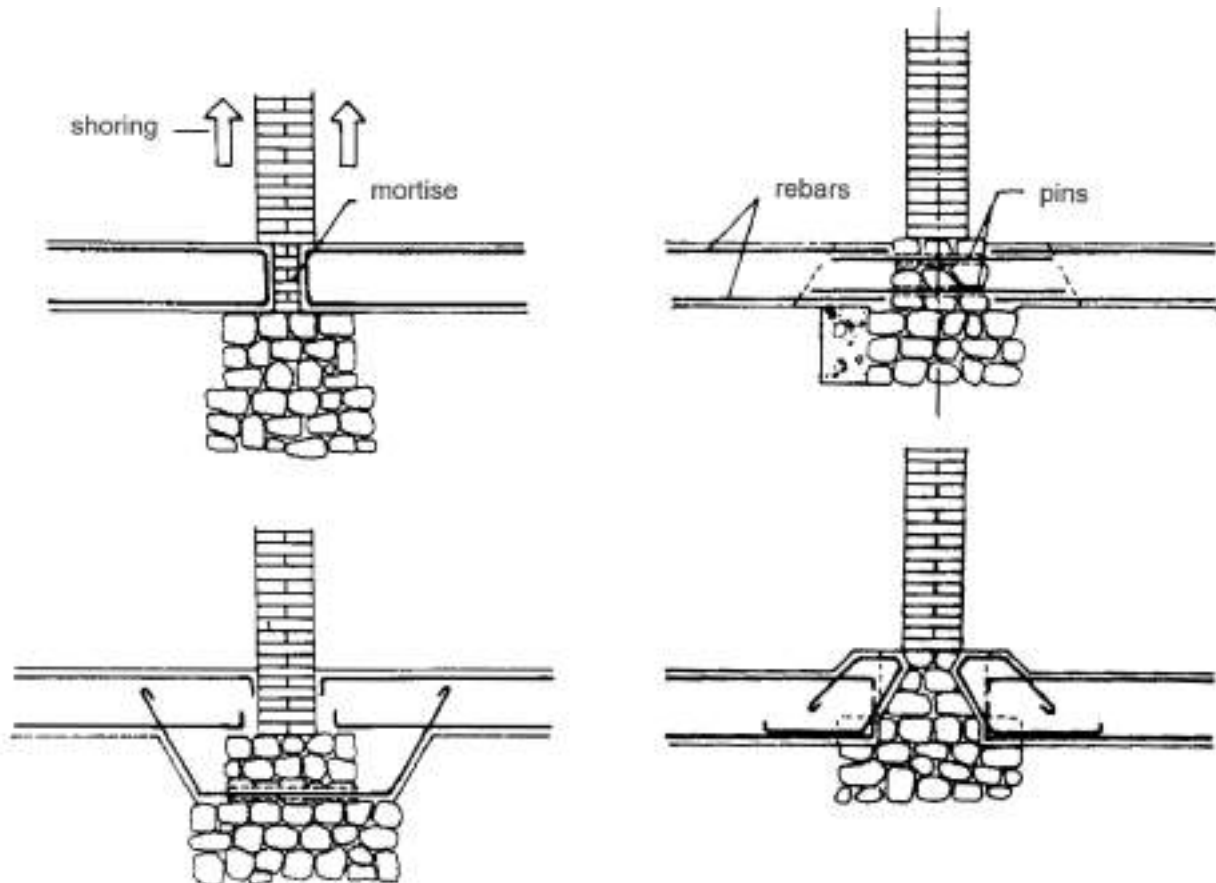
Fig. 20. From J.M. Rodríguez Ortiz, *La cimentación*, Curso COAM, Madrid 1984, p. 35.

### 3. NEW FOUNDATION PLACED OVER THE PREVIOUS

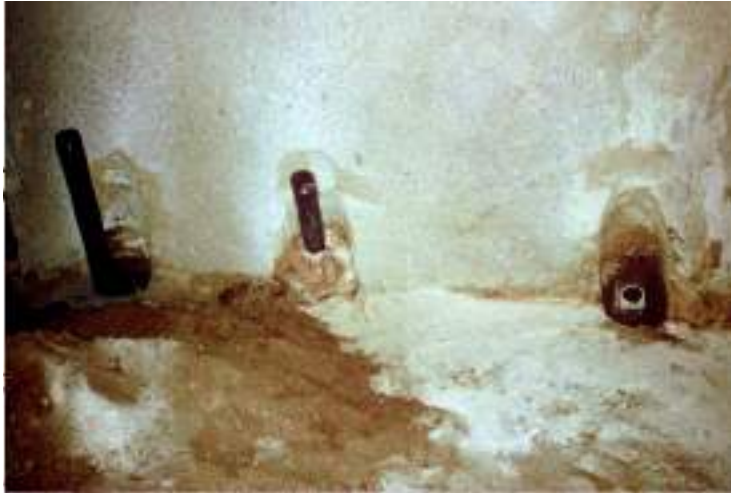
Fig. 21. Above left. San Bartolomé, Tarazona de la Mancha. Photo by Susana Mora.

- (2) Micropiles are a deep foundation element constructed using high-strength, small-diameter steel casing and/or threaded bar.

- 2) Micropiles used in the consolidation of the foundations of the church of San Bartolomé in Tarazona de la Mancha, Albacete, Spain. Project and direction of Restoration by Susana Mora, architect, for the Junta de Comunidades de Castilla La Mancha (1990-95).

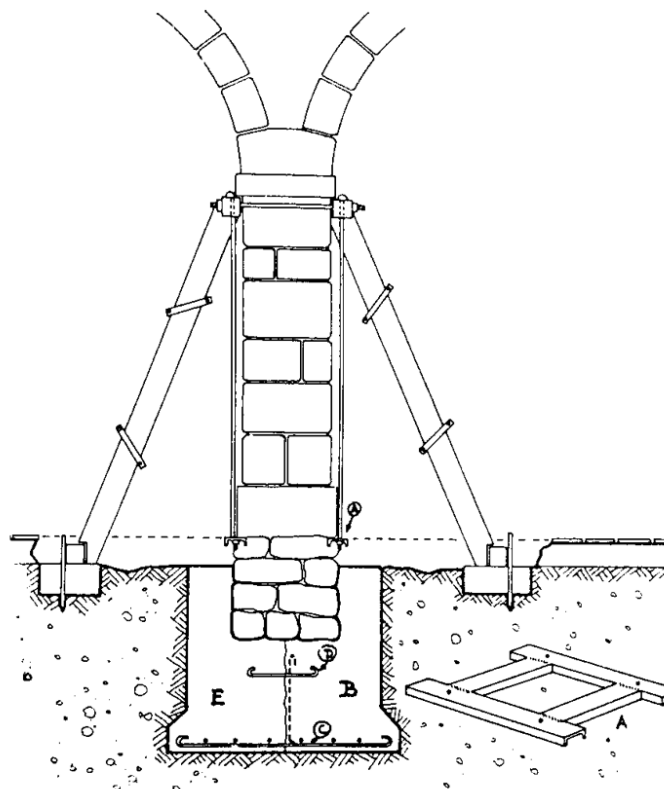
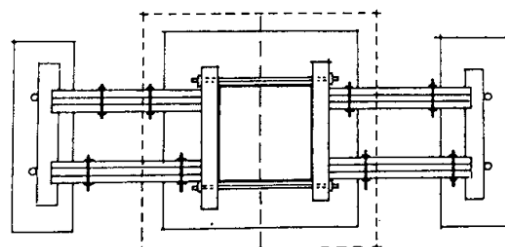
Fig. 23. From J.M. Rodríguez Ortiz, *La cimentación*, Curso COAM, Madrid 1984, p. 37.

Complete shoring of the pillar for replacement of the foundation with shoring and hanging of the pillar.

- A. Metallic frame
- B. Half the foundation trench
- C. Footing reinforcement
- D. Rebar nailed on the ground

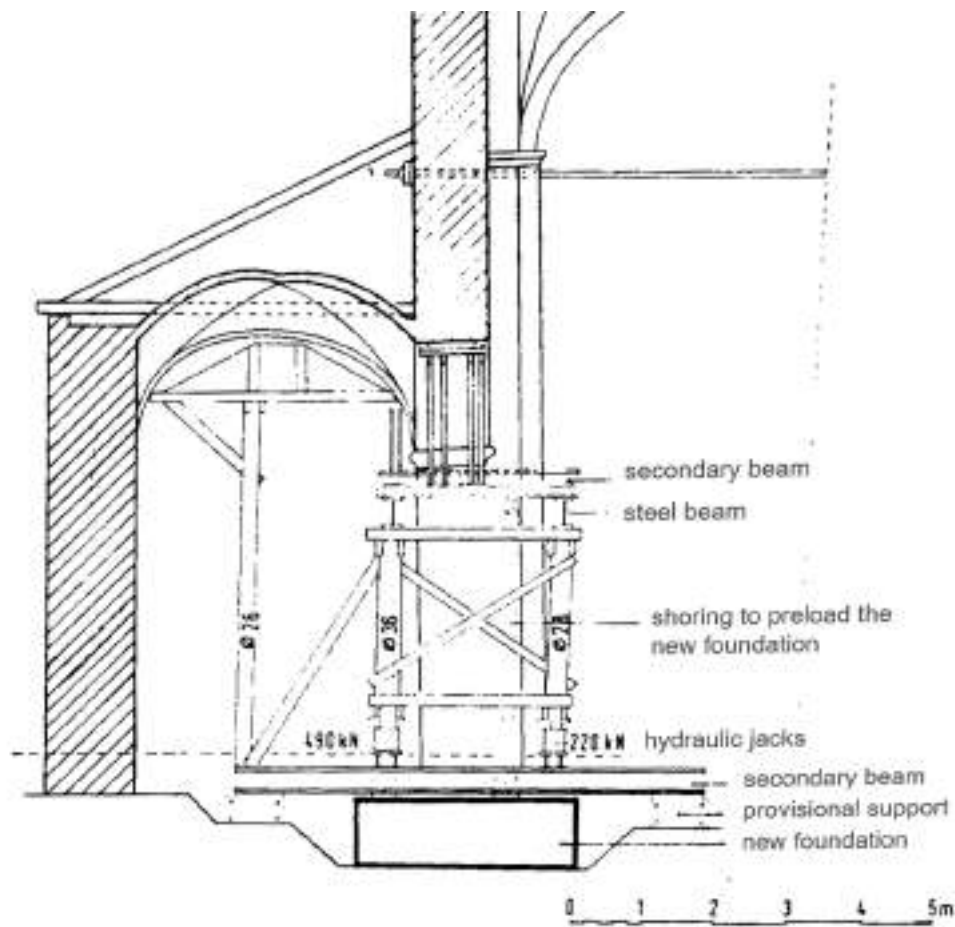
Fig. 24. From J.M. Rodríguez Ortíz, *La cimentación*, Curso COAM, Madrid 1984, p. 37.

Complete shoring of the pillar for replacement of the foundation with shoring frames on hydraulic jacks.

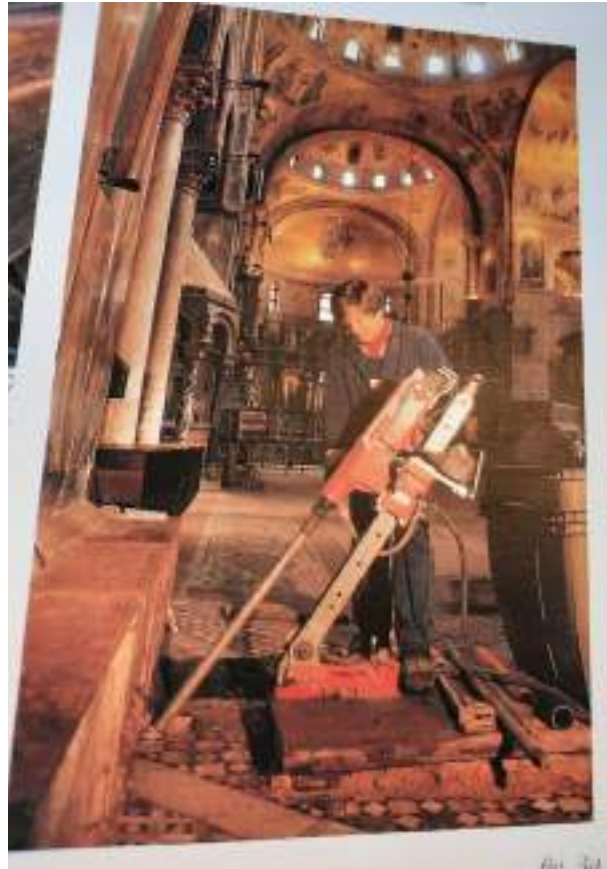
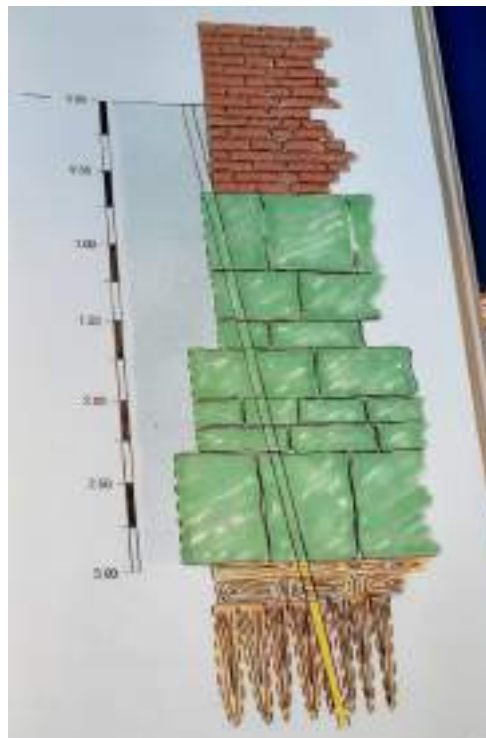
Fig. 25. Restoration of the crypt of San Marco, Venezia. From *San Marco la cripta e il restauro*, CM Vallardi & Associati, 1993, p. 83.

The objective is to improve the properties in terms of continuity and resistance. The technique consists in the injection of a liquid consistency mortar, in order to fill gaps and fissures, returning the mechanical capacity to the foundation.

- Injection control
- Grout density
- Washing inner leaf

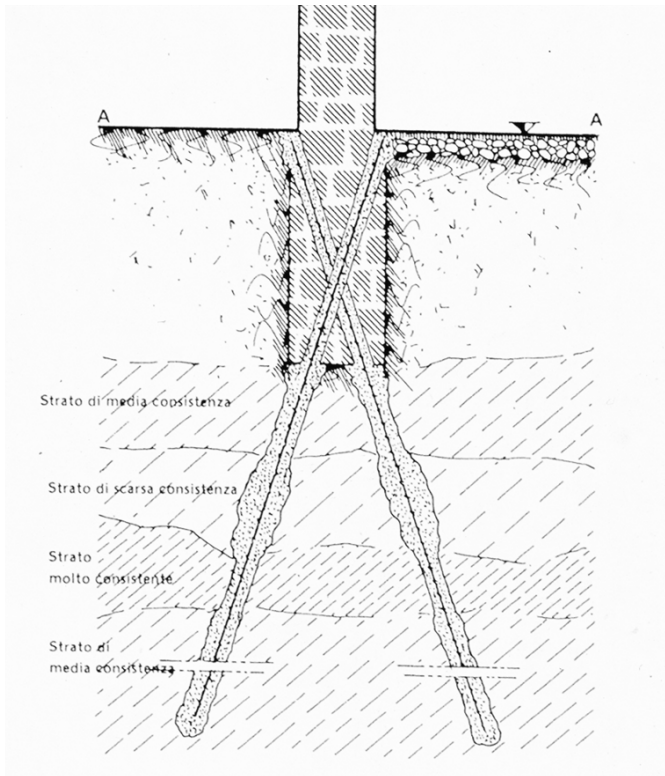
Fig. 27. From F. Lizzi, *The static restoration of monuments*, Sagep Publisher, Genova 1982, p. 29.

- Injection control
- Grout density
- Washing inner leaf

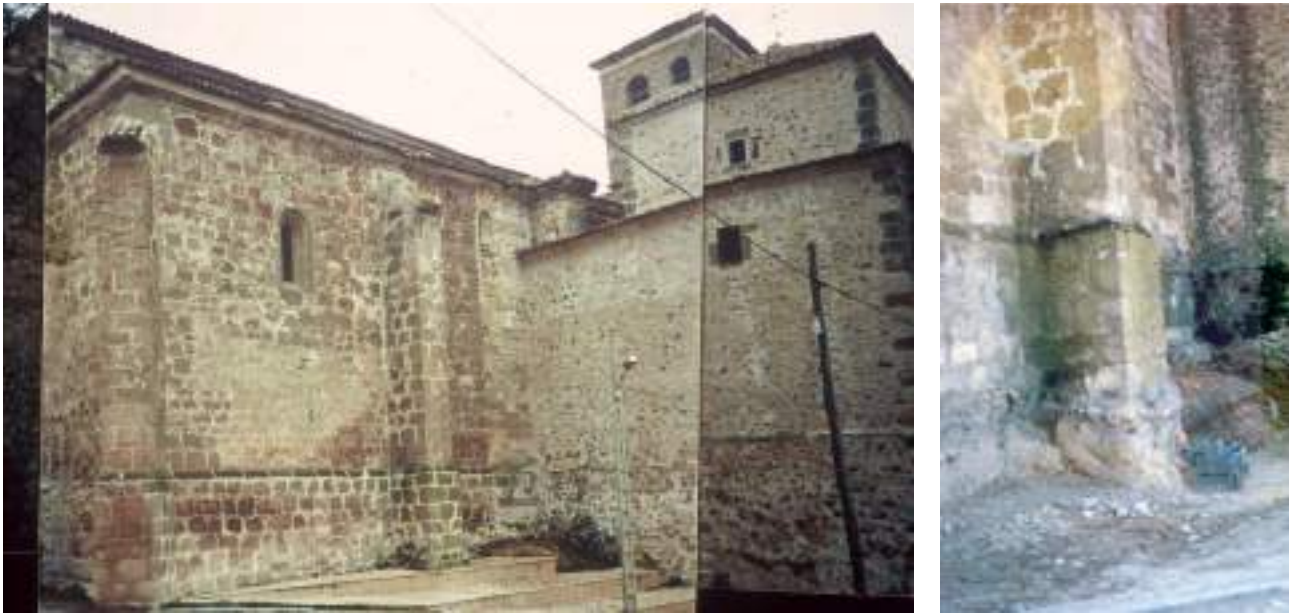
Fig. 29. Parish Church, Villalba del Rey (Cuenca). Restoration by Susana Mora. (3)

## 7. EXTERIOR REINFORCES

- 3) Exterior reinforces for the parish church of Villalba del Rey, Cuenca, Spain. Project and direction of restoration by Susana Mora, architect, (2000-) for Junta de Comunidades de Castilla La Mancha.

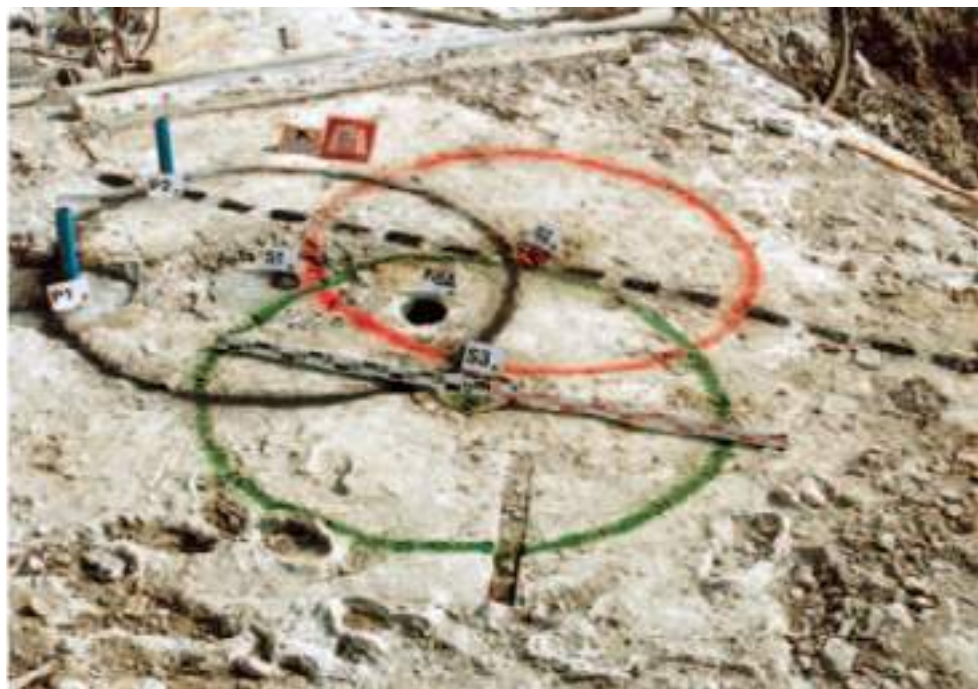
Fig. 30. Photo by F. Ripollés.

Jet grouting involves inserting a cement bond material (usually cement grout) using one or more high-speed jet pumps. The energy from the jets break up the ground and restructure it, mixing it with the injected material to produce an improved ground. Any surplus material rises to the surface as spoil return

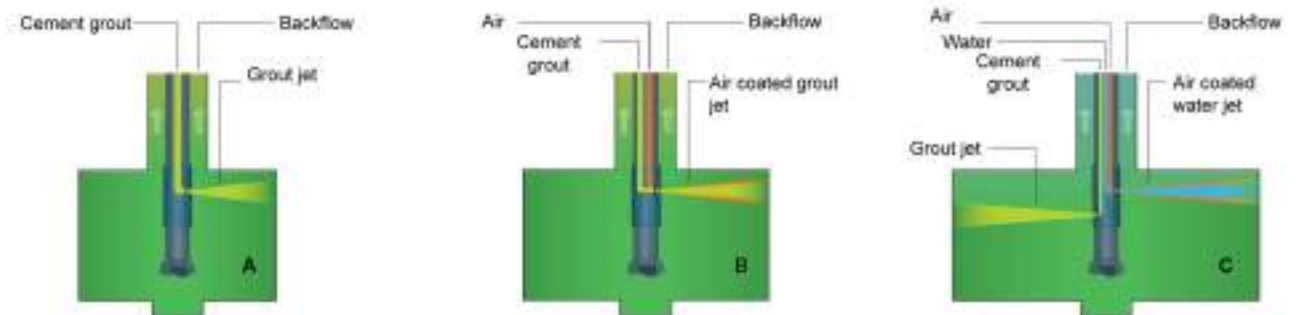
Fig. 33. Design by Fernando Ripollés.

- A. Single Fluid Jet Grouting
- B. Double Fluid Jet Grouting
- C. Triple Fluid Jet Grouting

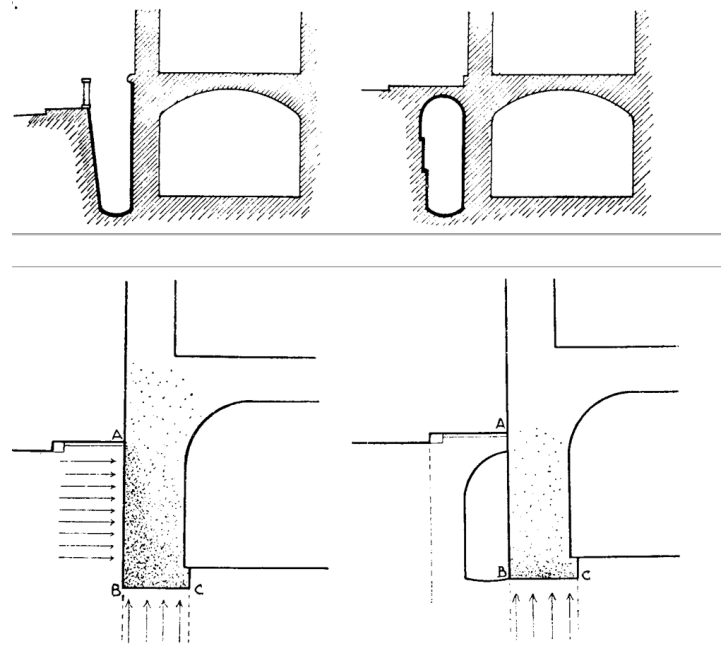
Fig. 34. From G. e I. Massari, *Risanamento igienico dei locali umidi*, Hoepli, Milano 1981, p. 111

1. VENTILATION GALLERIES

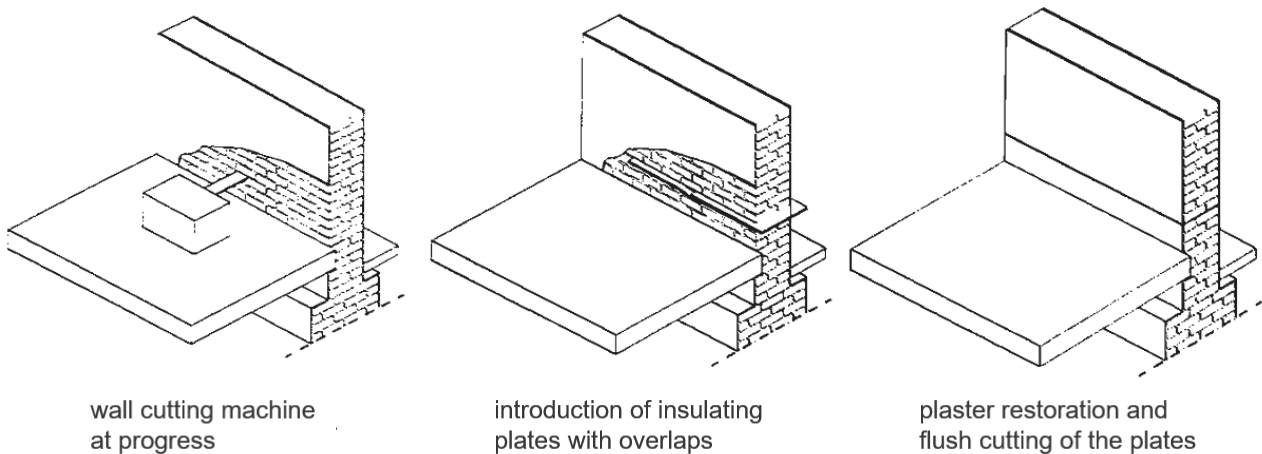
Fig. 35.

Mechanical cutting of the wall for the insertion of insulating plates

wall cutting machine at progress

introduction of insulating plates with overlaps

plaster restoration and flush cutting of the plates

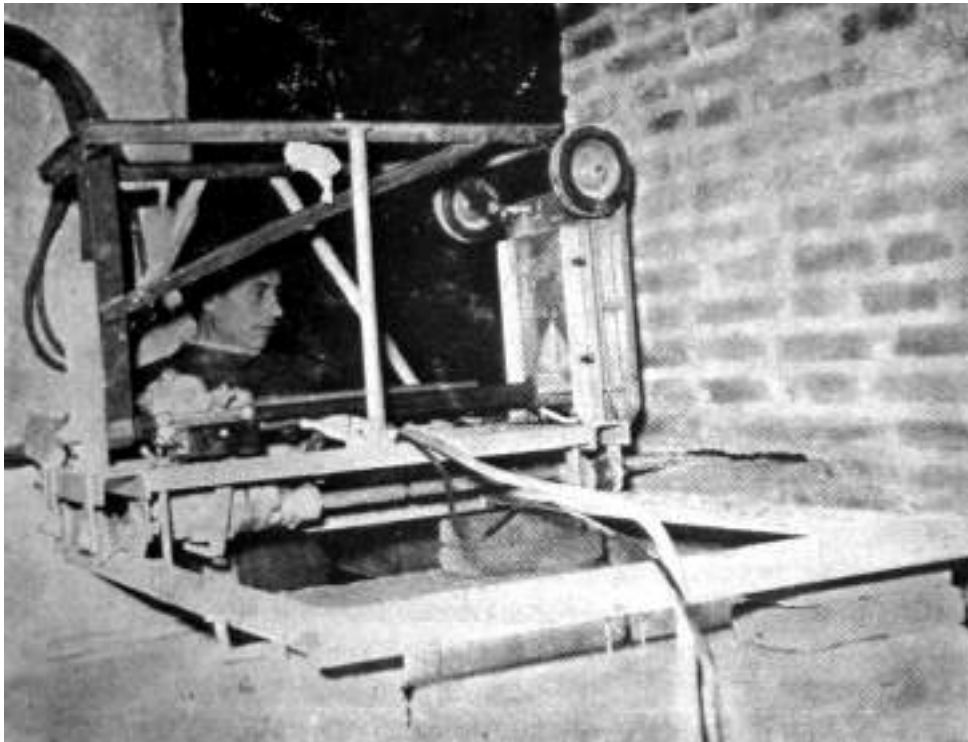
Method against the capillary rising of water: execution of a double series of partially overlapping holes for the insertion of insulating material.

Fig. 36. Core drill in operation on a brick wall. From G. e I. Massari, *Risanamento igienico dei locali umidi*, Hoepli, Milano 1981, p. 107.

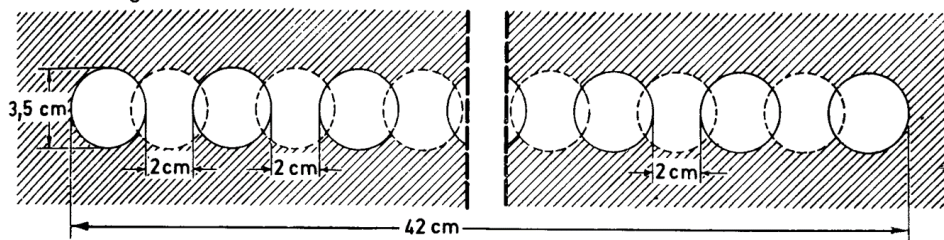
Fig. 37. Front view of the cut. From G. e I. Massari, *Risanamento igienico dei locali umidi*, Hoepli, Milano 1981, p. 107.

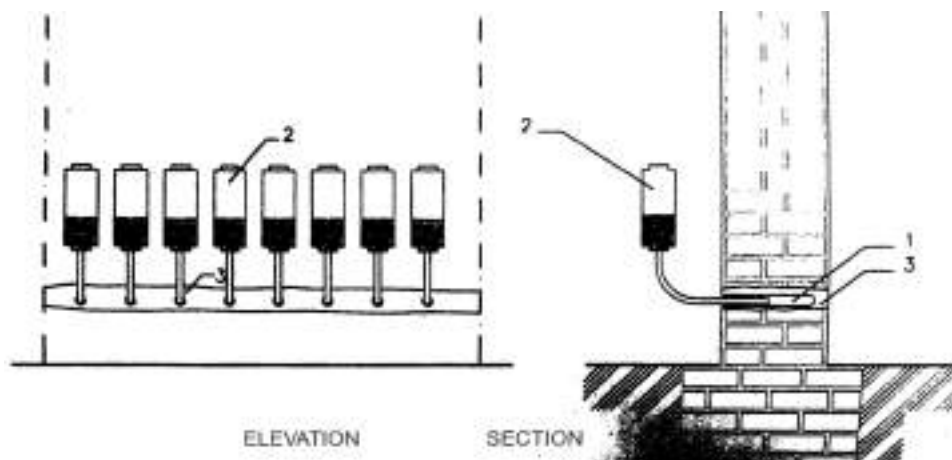
Fig. 38. From G. e I. Massari, *Risanamento igienico dei locali umidi*, Hoepli, Milano 1981, p. 107.

Horizontal barrier of slow diffusion waterproofing product

1. Hole
2. Containers of fluid resin
3. Spread of the waterproofing

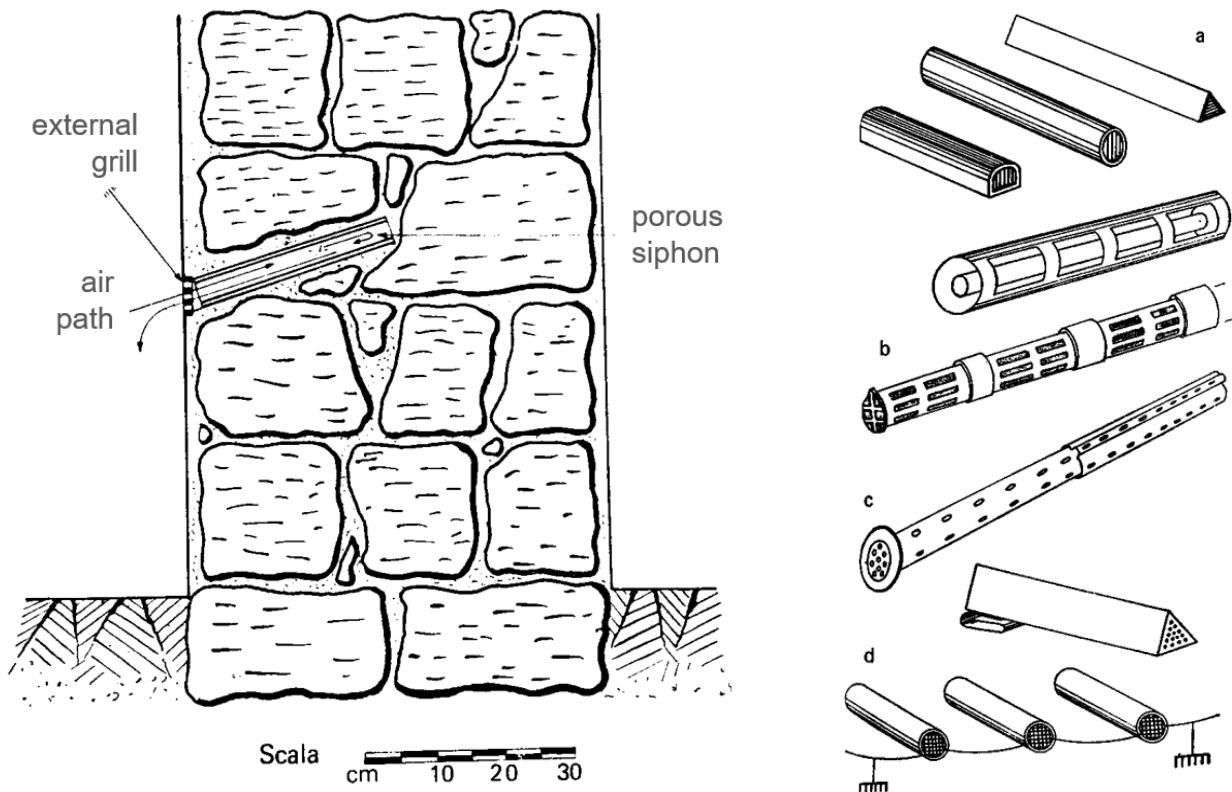
Fig. 39. Above left. From G. e I. Massari, *Risanamento igienico dei locali umidi*, Hoepli, Milano 1981, p. 113.

The atmospheric knapen siphons, placed in the walls to be treated, attract humidity and evacuate it outside by an air circuit ensuring a permanent and effective functioning.

Each siphon, in its radius of action, attracts moisture, and this, impregnating its porous wall, saturates the drier outside air that enters the siphon channel.

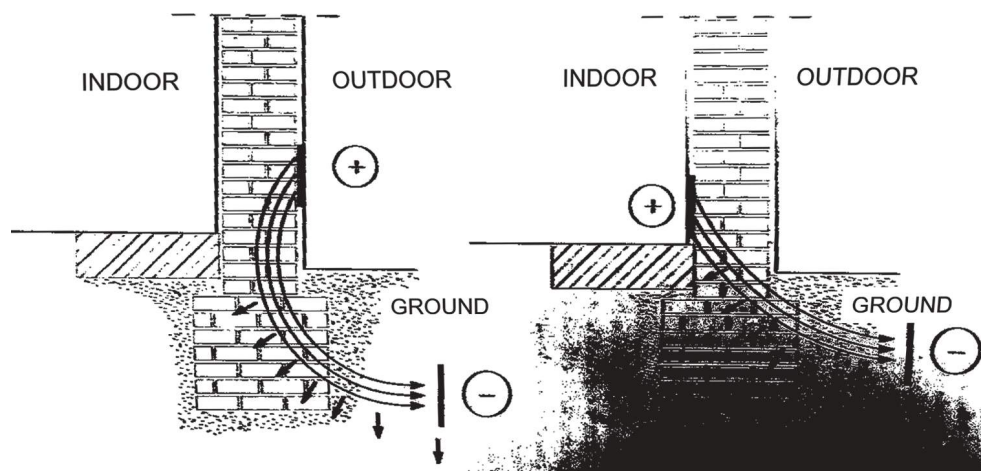
Fig. 41. From G. e I. Massari, *Risanamento igienico dei locali umidi*, Hoepli, Milano 1981, p. 119.

The device emits small pulses from electrodes inserted in the wall to the ground. In this way the polarity between the soil and the wall is inverted, causing the ionized water to descend through the wall to the ground.
