THE SCHOOL OF MATHEMATICS AT ROME'S UNIVERSITY CAMPUS

GIO PONTI, 1935

TECHNICAL ISSUES, COMFORT AND ENERGY EFFICIENCY

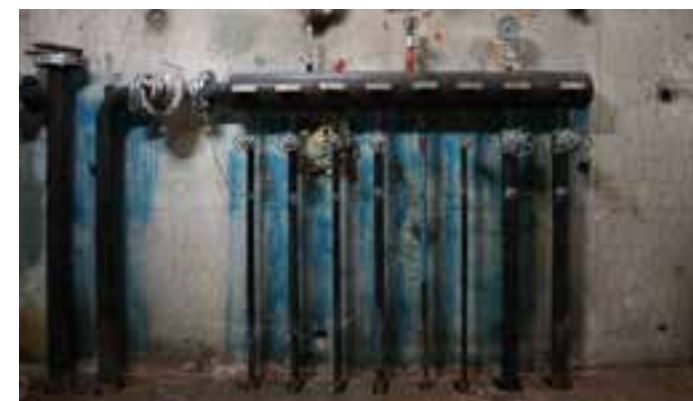
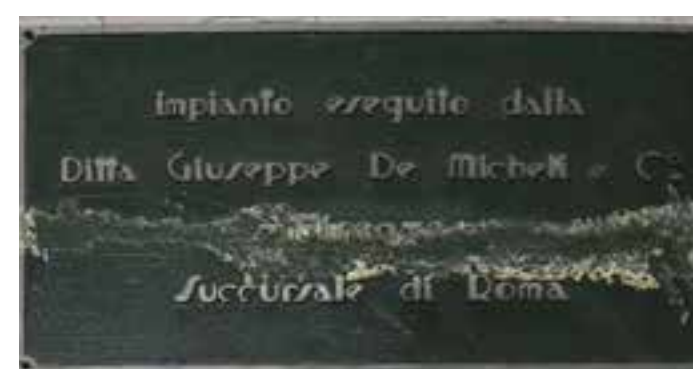
Figure 4 a/b - Original equipment and signage of the heating manifold technical room (© Salvo 2021)

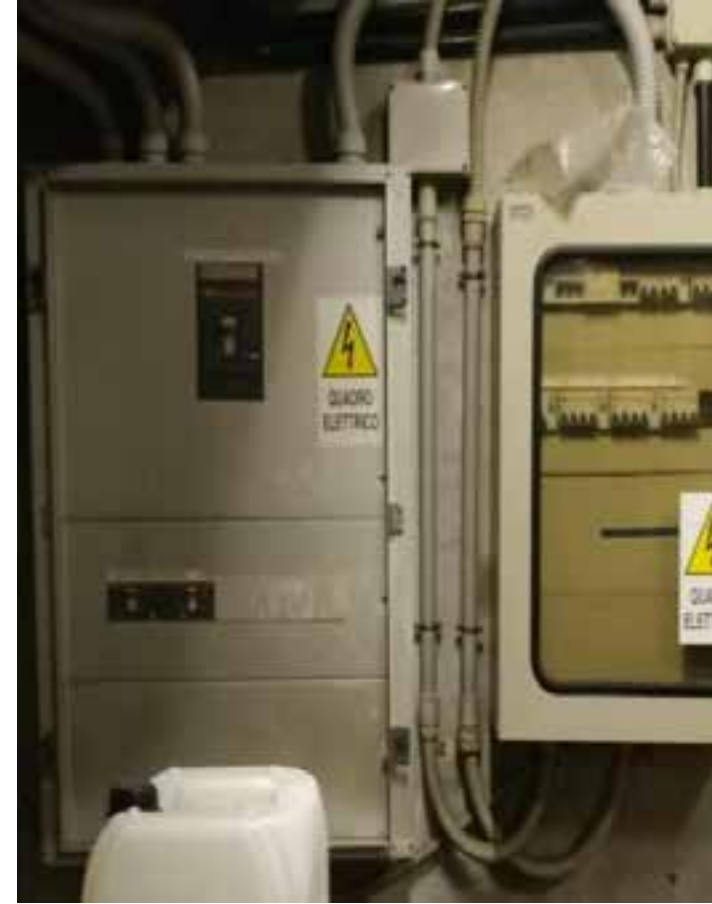
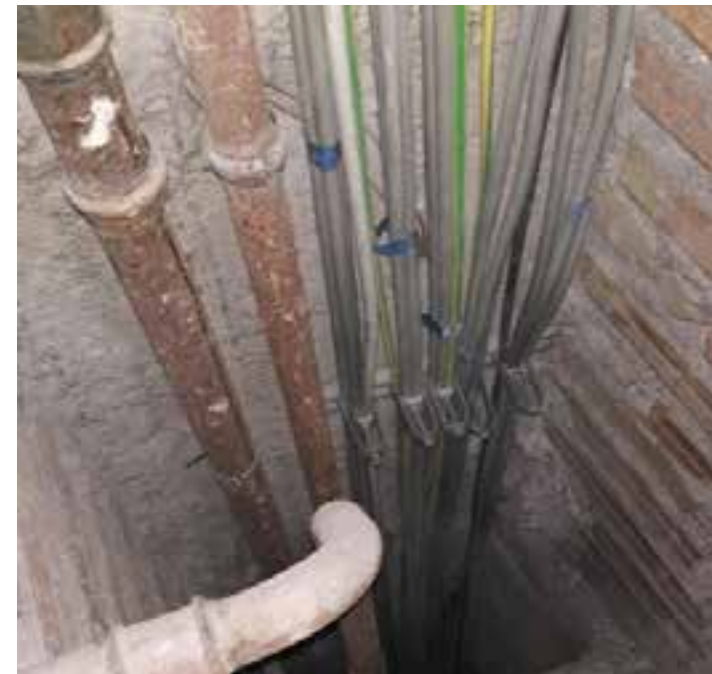
Figure 5 a/b - One of the zone switchboards and a cable duct (© Mancini 2020)

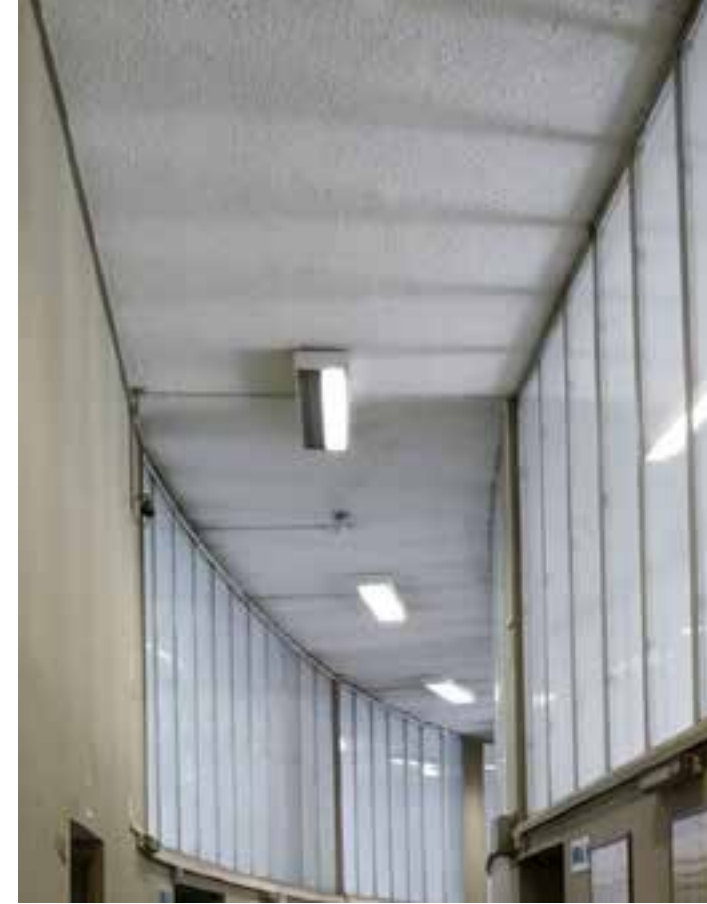
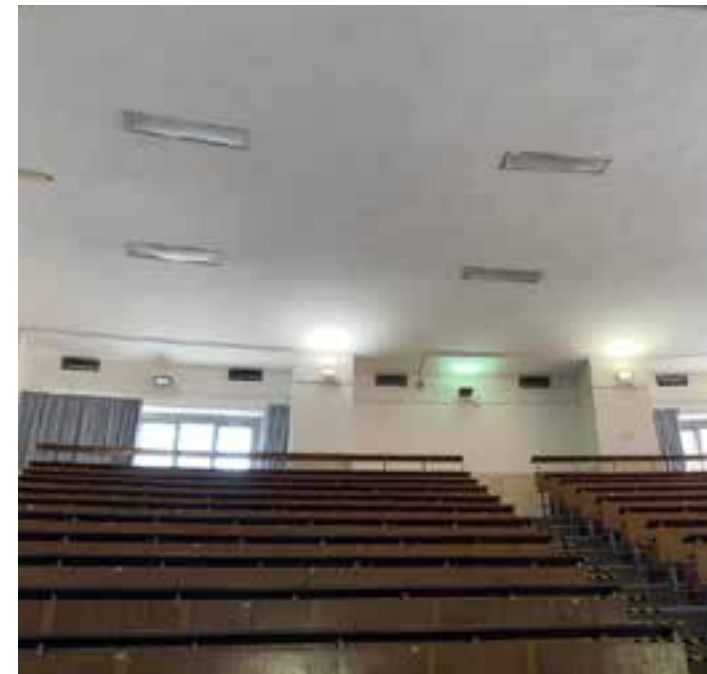
Figure 6 a/b - Original integrated ceiling lights in the tiered lecture halls and non-original ones (© Salvo 2021)

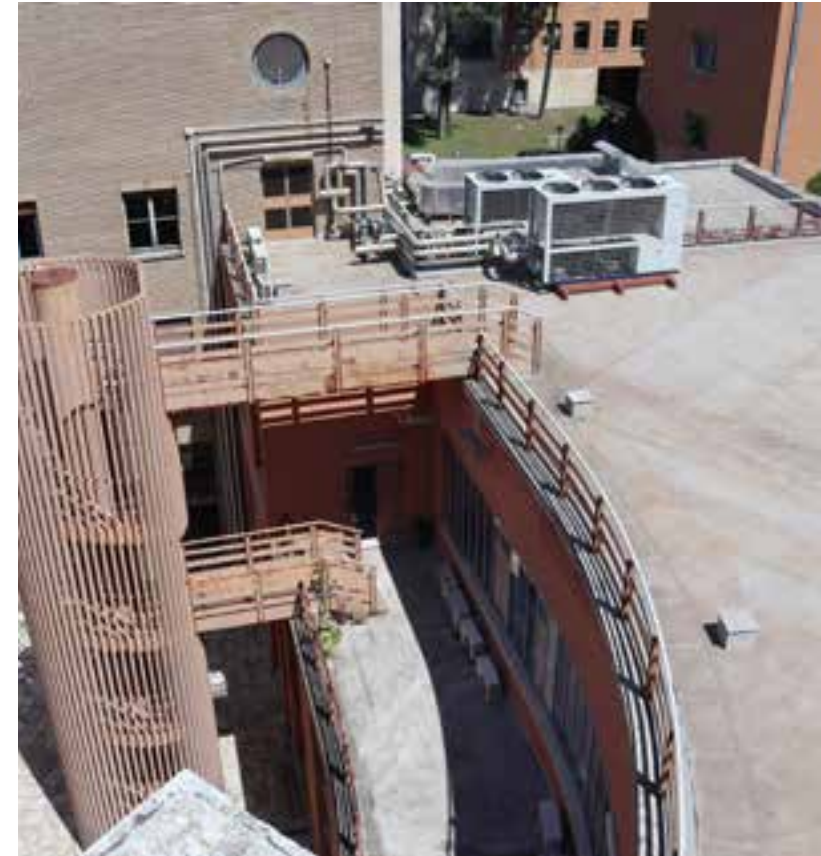
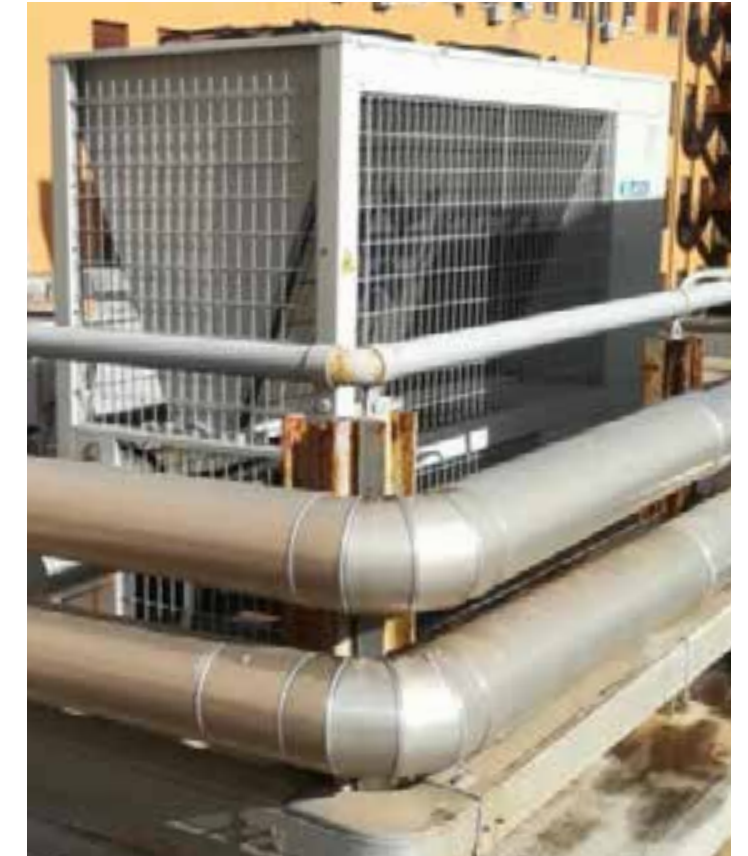
Figure 11 a/b - a) View of the refrigeration unit with Air Handling Unit dedicated to the library rooms placed on the rooftops (© Salvo 2021) and detail (b) (© Mancini 2020)

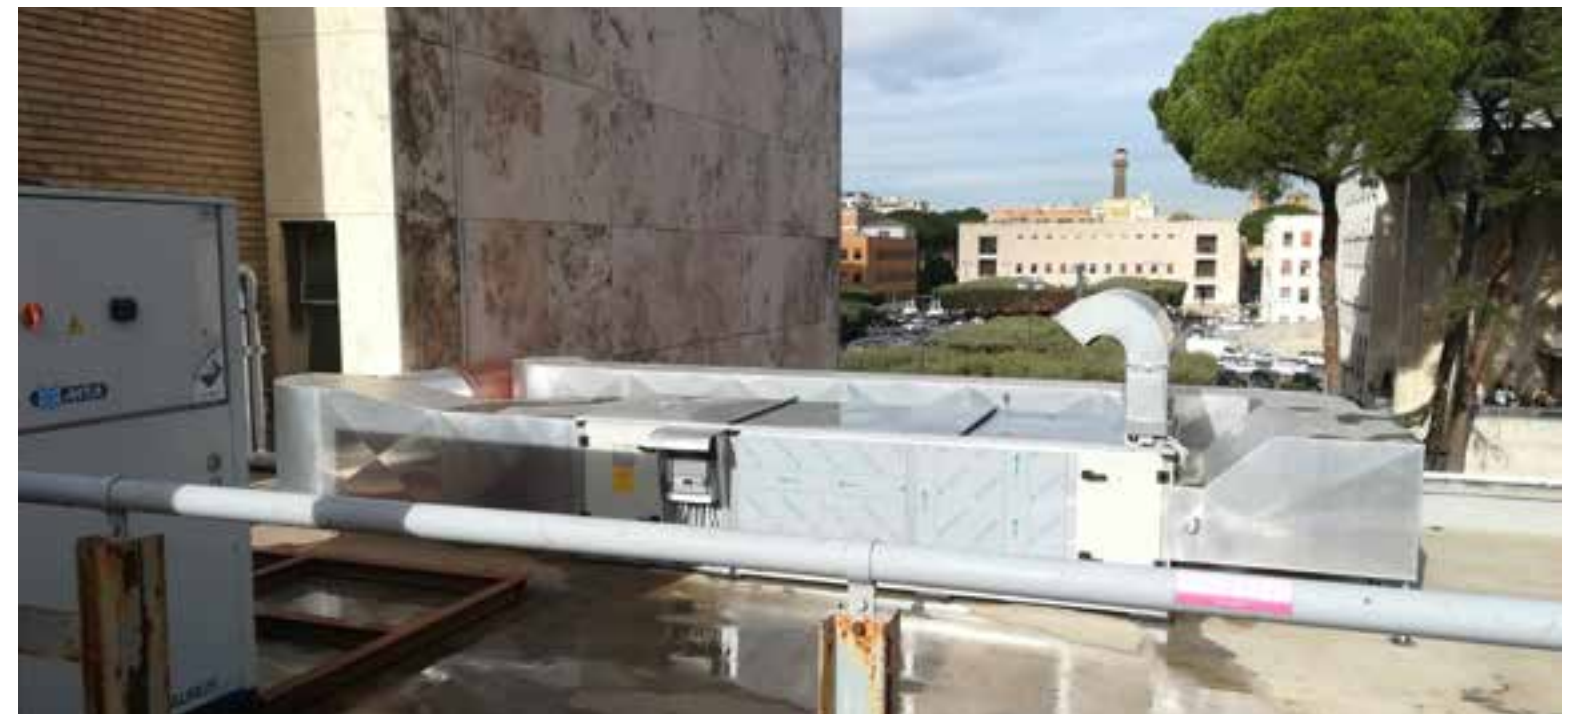
Figure 12 - Detail of the Air Handling Unit (AHU) (© Mancini 2020)

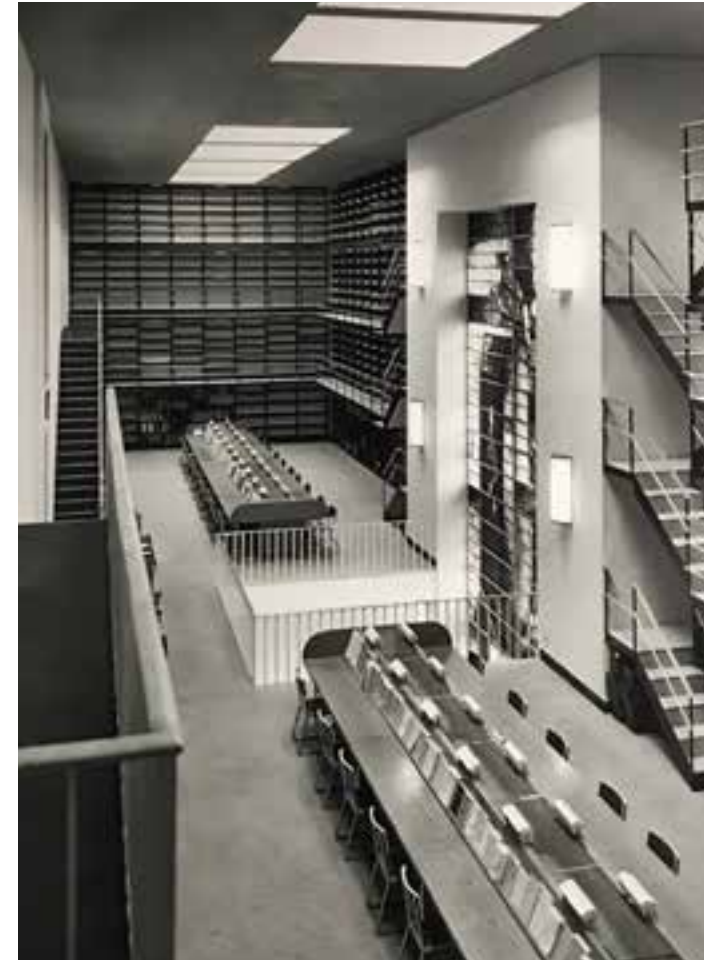
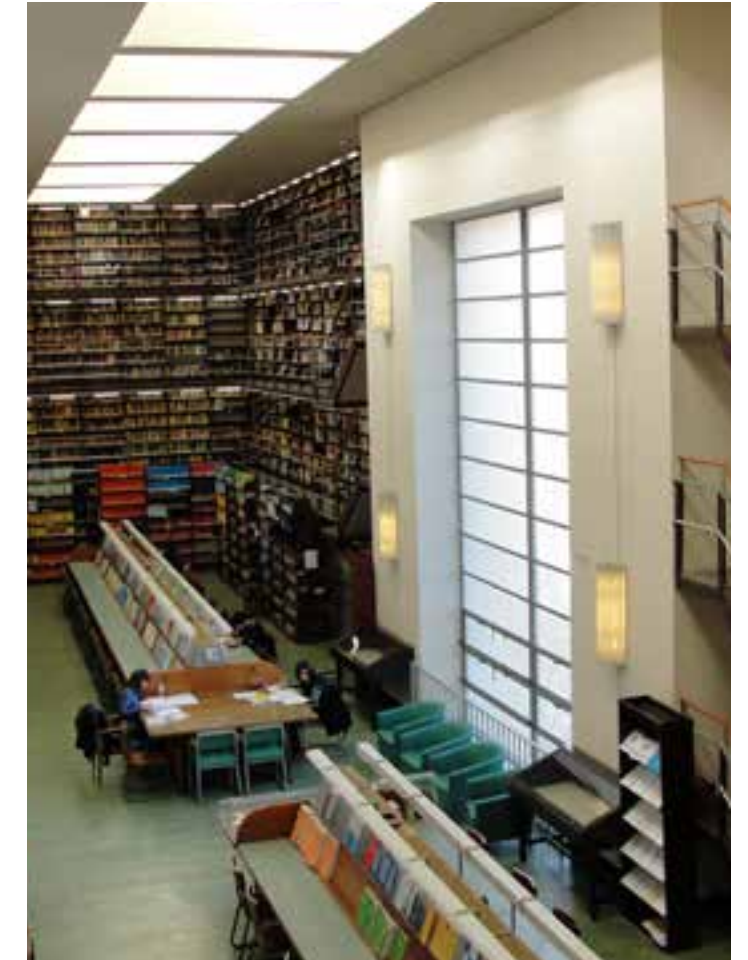
Figure 17 a/b - a) The library in 1935 (BBL_pht_30); b) the library in 2020 (© Romano 2020)

Probably, after the subdivision of the triple height, and in consequence to the locking of the windows on the skylight, radiators were replaced with fan coils in order to cool the room during the summer. This alteration may be also linked to the rise in temperatures due to the reduction in air circulation produced by the same alteration and by the closing of originally open passages with doors and partitions. However, the combination of alterations has led to a decisive worsening of the environmental comfort in the winter season, and probably to a more dangerous microclimate for the conservation of the book collection¹. More specifically, the presence of radiators and cooling systems may produce the deterioration of the book collection due to the rising of hot air currents, which are forced by the action of the fan coils and channelled through the narrow section that has been created above the study tables.

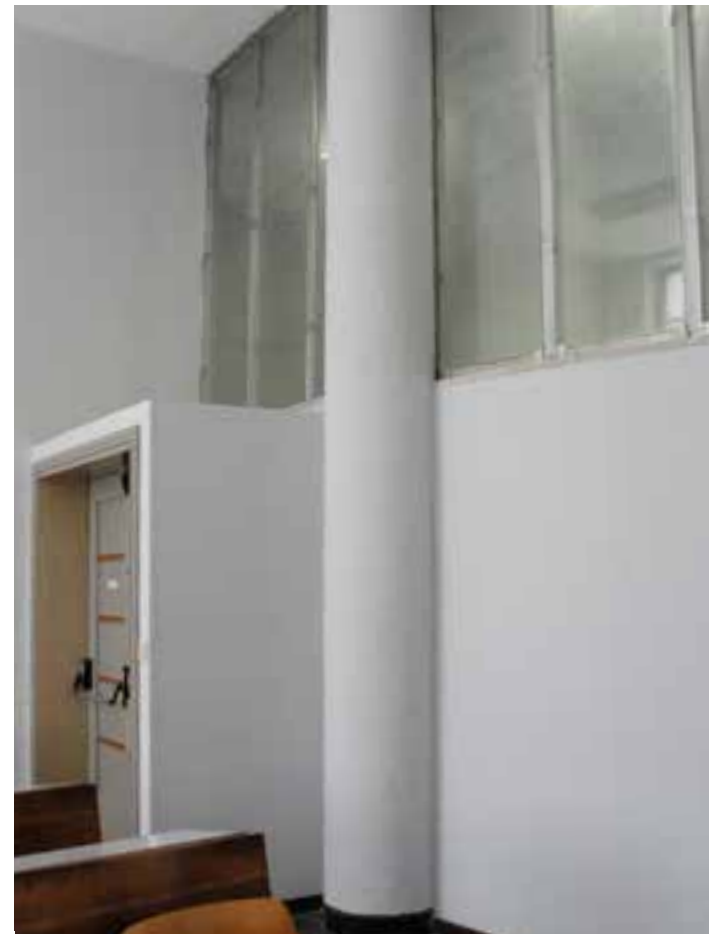
Figure 22 - One of the columns incorporated in the walls added to fragment the drawing rooms at the first level of the curved wings (© Salvo 2021)

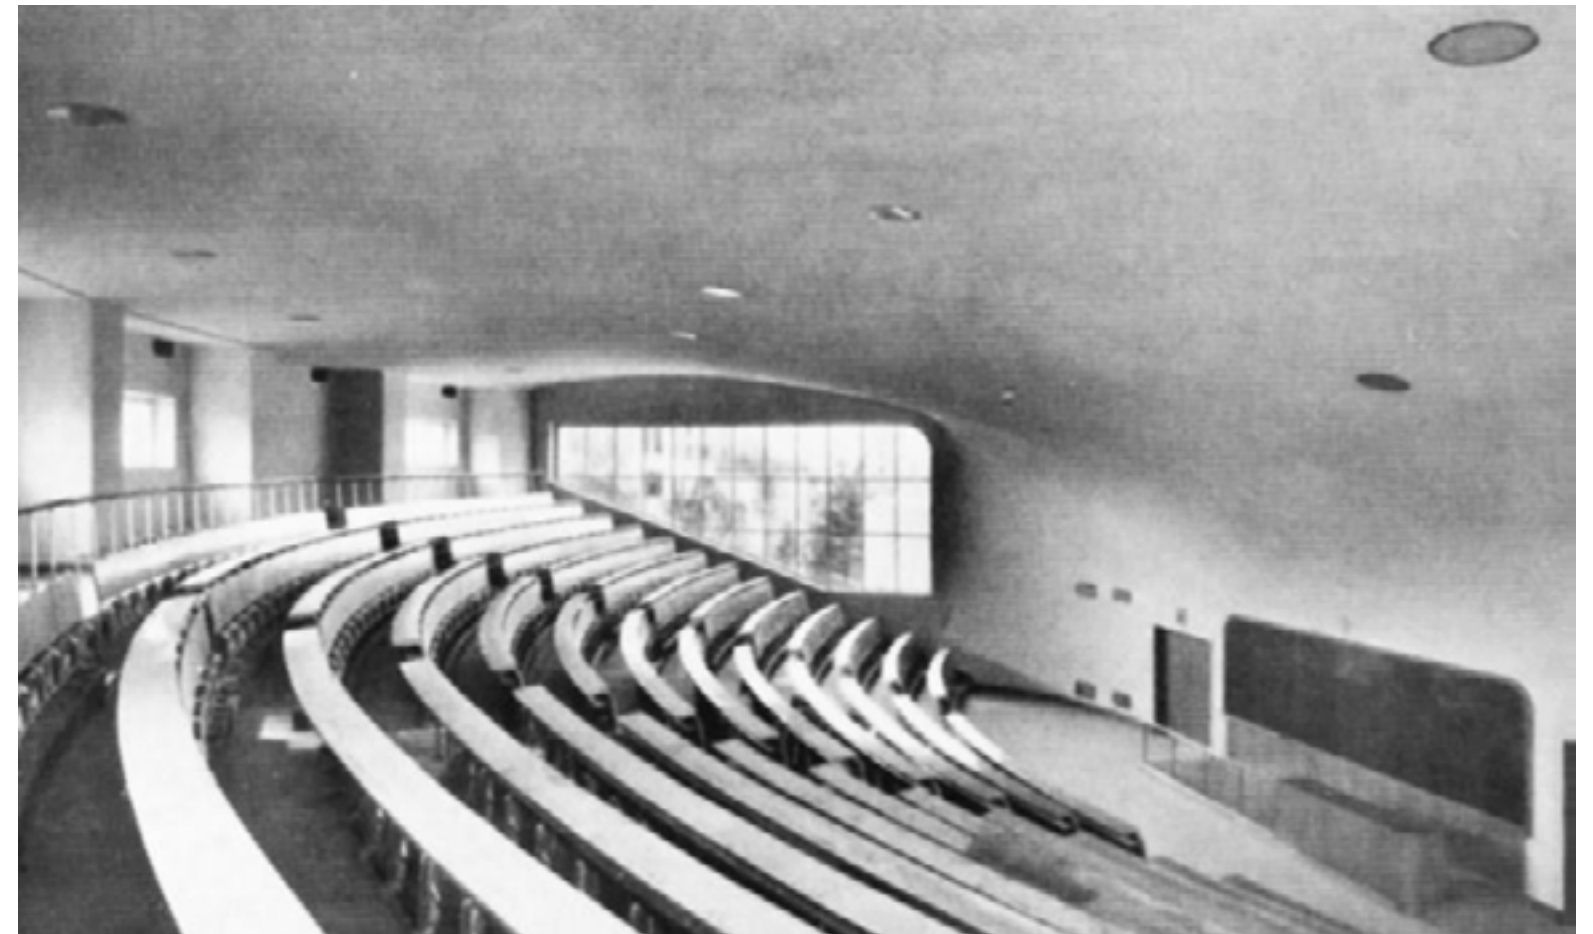
Figure 23 - The main tiered lecture hall at the third level, in the original condition (ACS_pht_18)

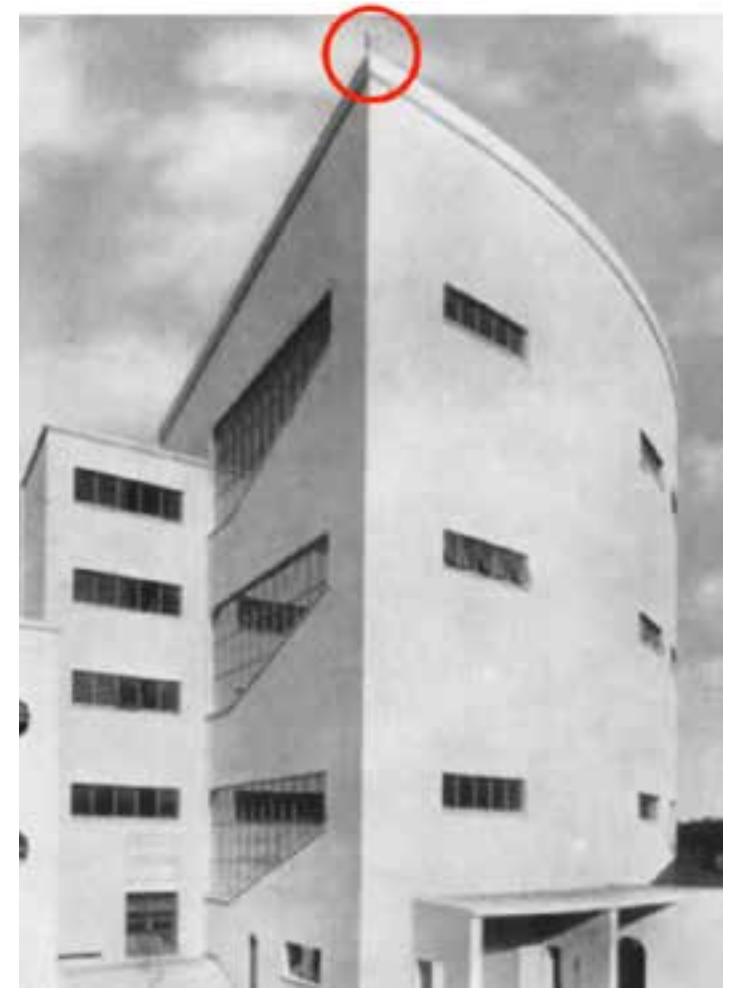
Figure 24 a/b - Diagram of hot air circulation system in the tiered lecture halls: blue arrows indicate the delivery section of air, red expulsion (© Mancini 2020), and an image of the tower of the 1930s where the chimney is still visible (ASS_pht_05)

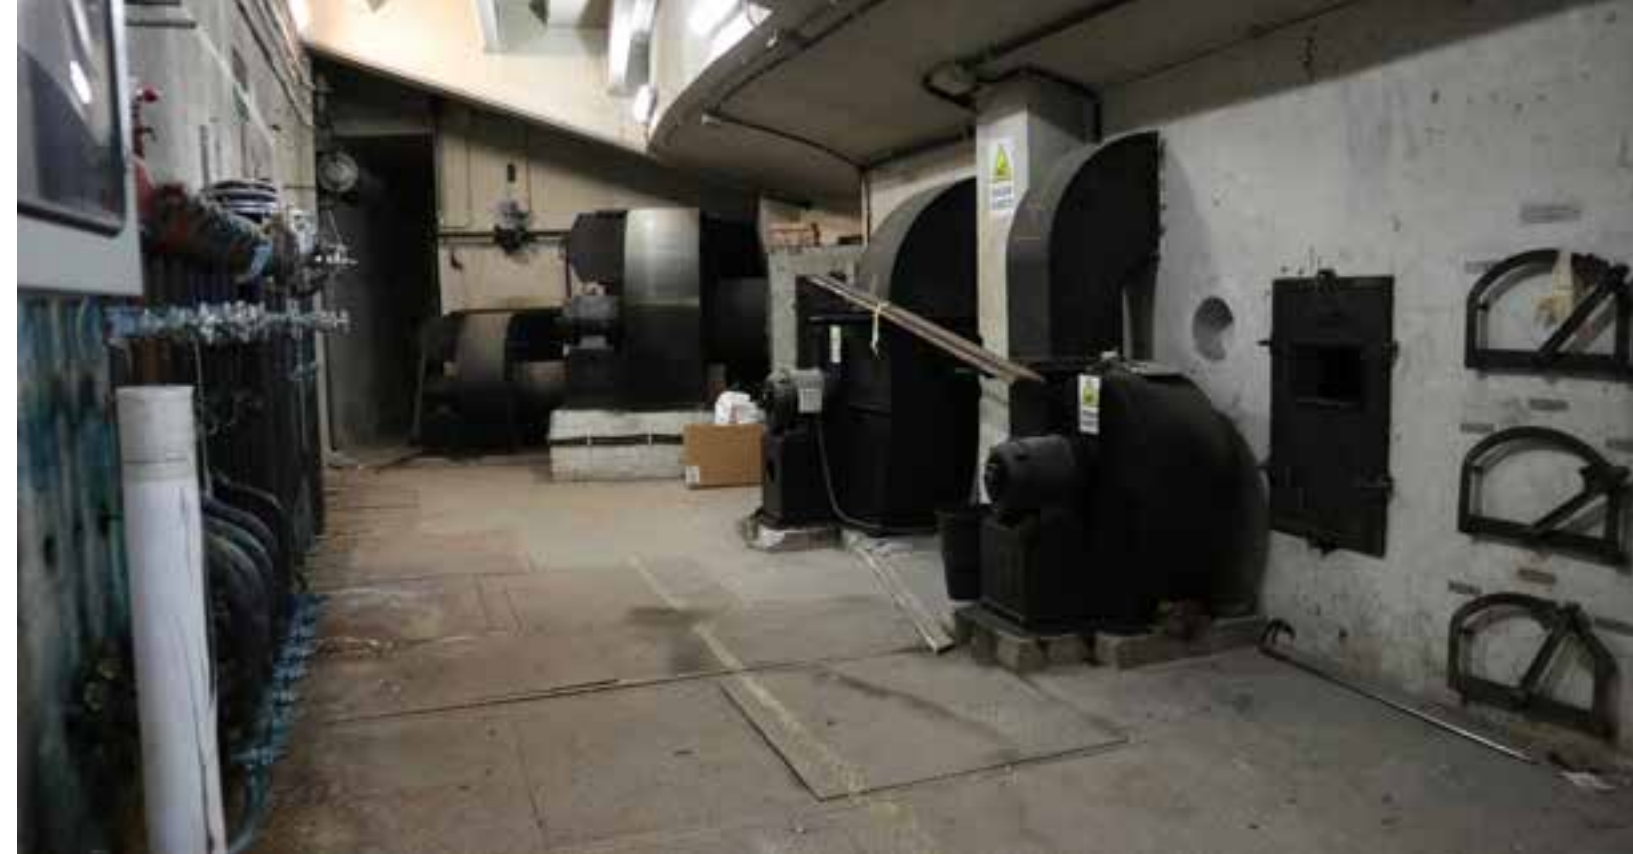
Figure 25 - Technical rooms at the foot of the Tower of classrooms where fans for delivery and expulsion of heated air are located, on the right (© Salvo 2020)

The boilers serving the heating system of these halls are located at the foot of the Tower, together with the heat transfer fluid distribution centre. The boilers are since long obsolete and no longer in use, but are still in their original position. They consist of two parallel fans for delivery and expulsion of heated air, and of dampers to regulate the air flow to the different distribution channels.

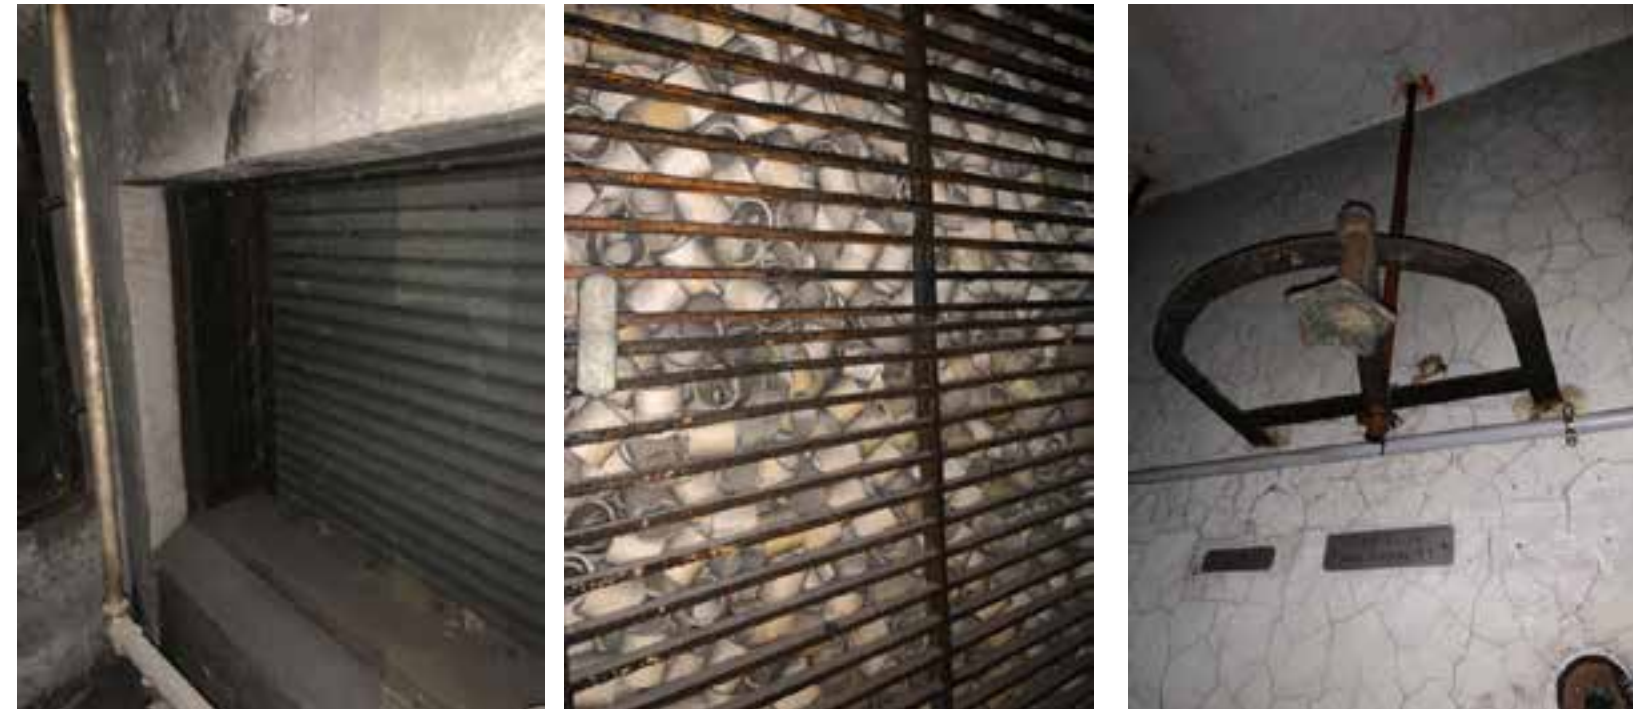
Figure 26 a/c - The delivery section of the heating system of the Tower: (a) heating coil, (b) humidification coil, (c) regulation damper (© Romano 2020)

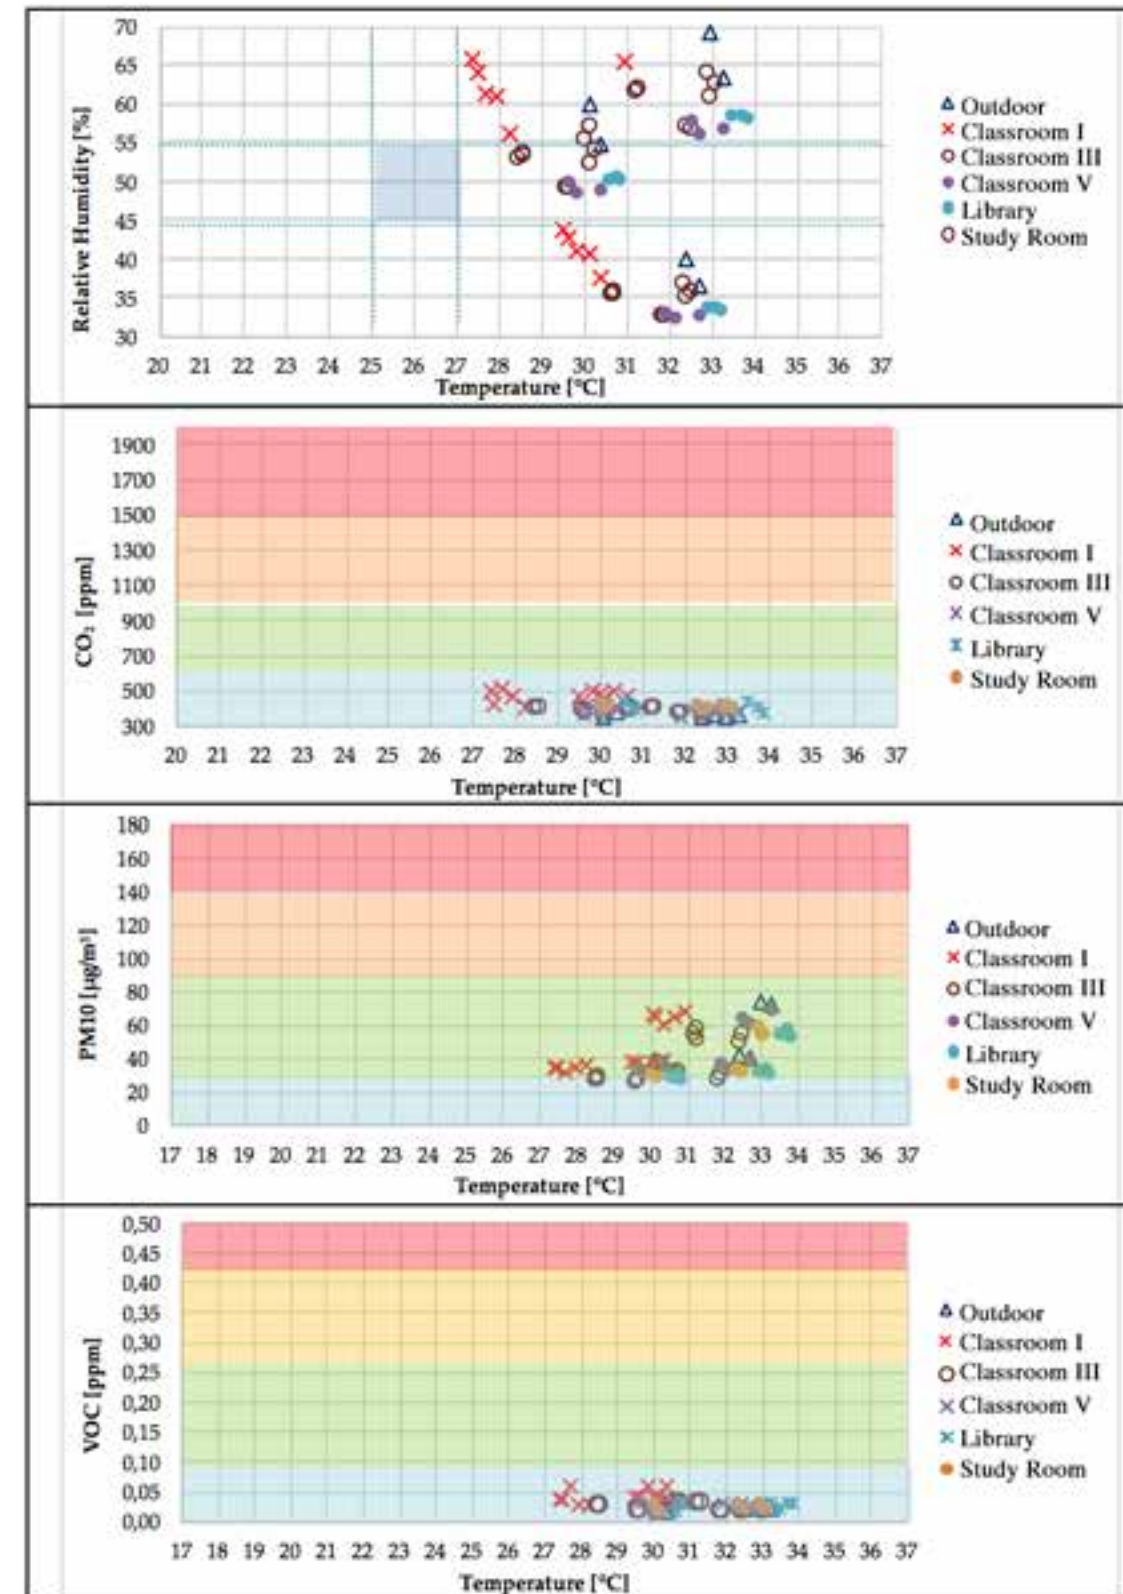
Summer monitoring campaign has taken place in presence of very few students and teachers and/or in almost empty classrooms. The cooling system was generally off. No significant difference between indoor and outdoor values has been noticed. CO₂ values, as well as VOCs measured indoor and outdoor indicate good quality levels (blue band of the graphs), while the PM₁₀ values are at predominantly of moderate quality (green band). Overall, all three pollutants detected are in acceptable quality classes, both for human health and for the proper maintenance of the book collections conserved in the library. Conditions of thermo-hygrometric comfort are instead lacking in the rooms, as expected in absence of a suitable cooling system.

Table 2 - Results of measurements in the summer season (© Mancini, Romano 2020)

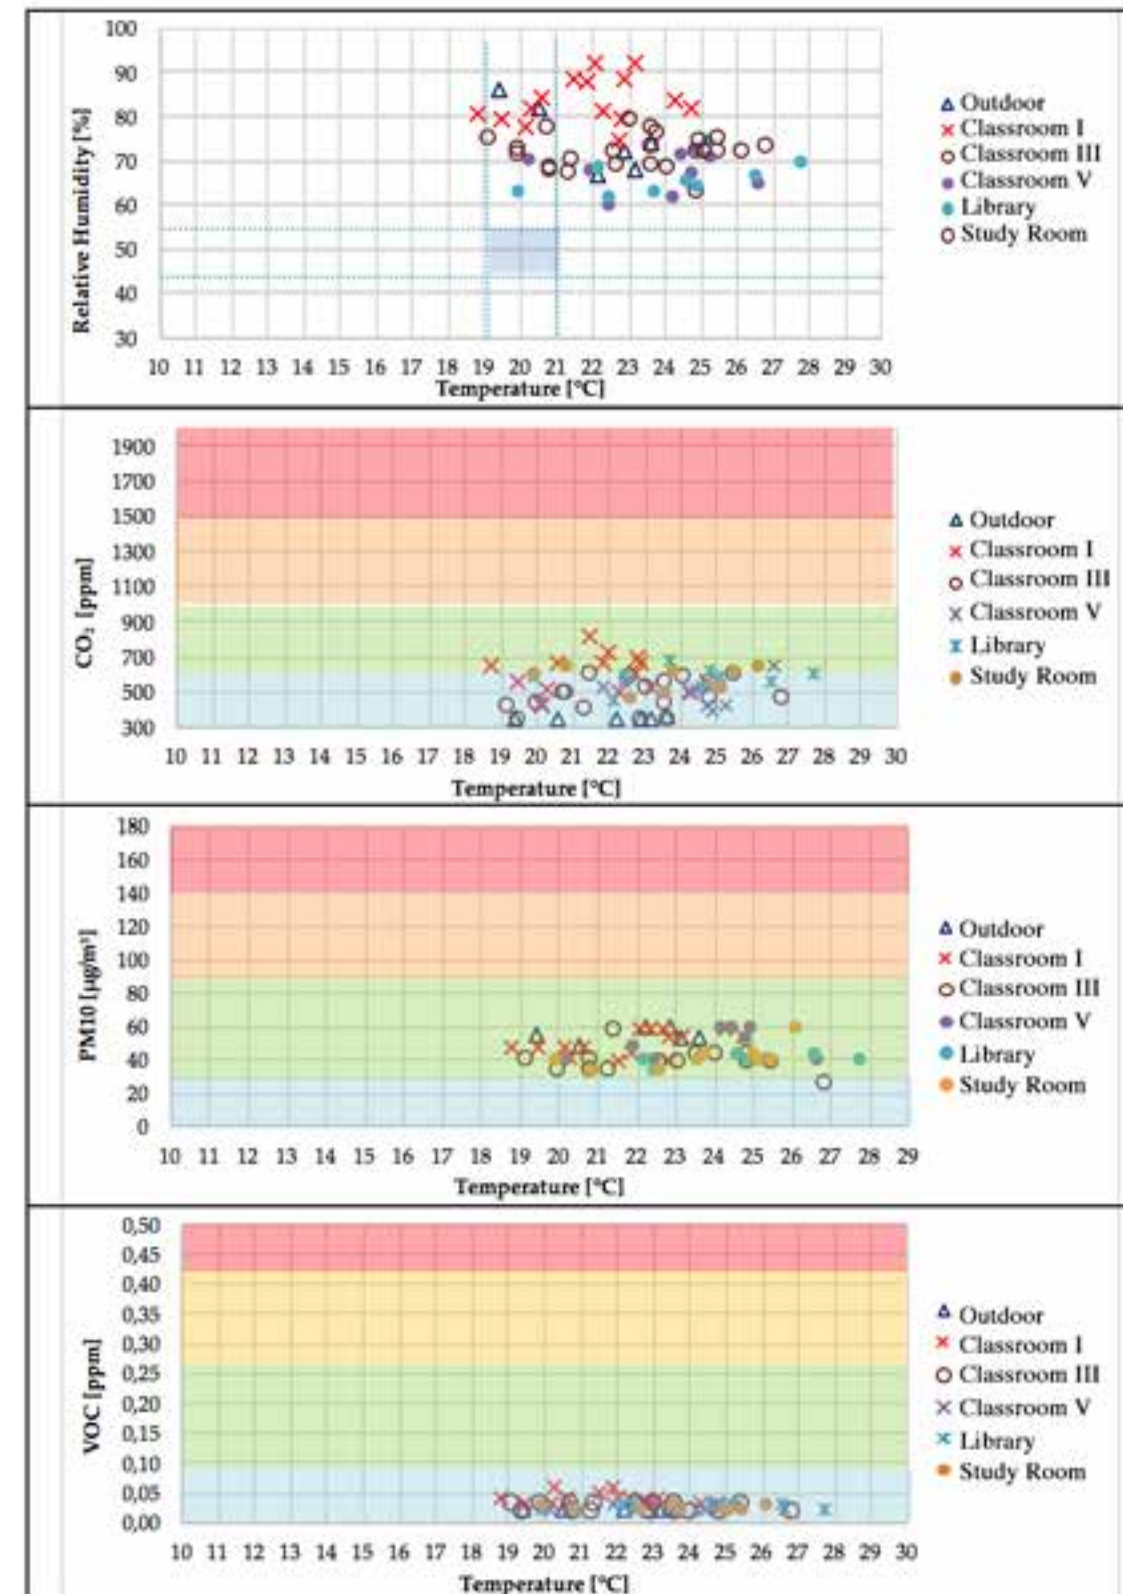
Autumn monitoring campaign has taken place as the air conditioning system was turned off and classrooms were half full, given the start of the academic year in the month of September. Also in this case, similar parameters emerged from the outdoor and indoor surveys. The CO₂ values have been found halfway between good and moderate (blue-green band), PM₁₀ values within the moderate values level (green band), while VOCs have been observed at a good level of quality (blue band). The parameters measured during the autumn season are slightly worse than in the summer, but still acceptable, and guarantee human health and the correct maintenance of the book collections. The expectations for the spring season are roughly the same, being the two seasons both of transition between summer and winter conditions.

Table 3 - Results of measurements in the autumn season
(© Mancini, Romano 2020)

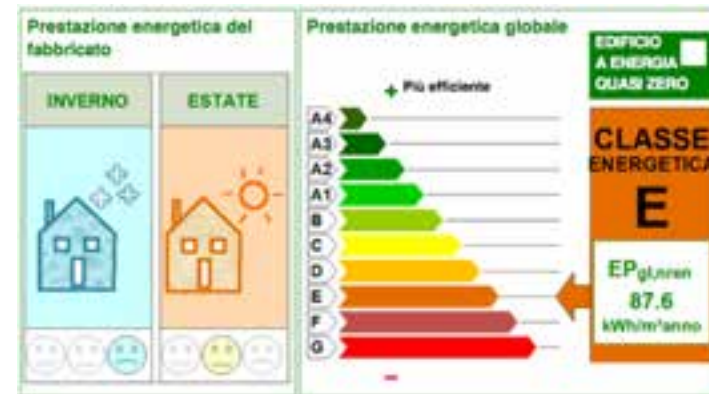
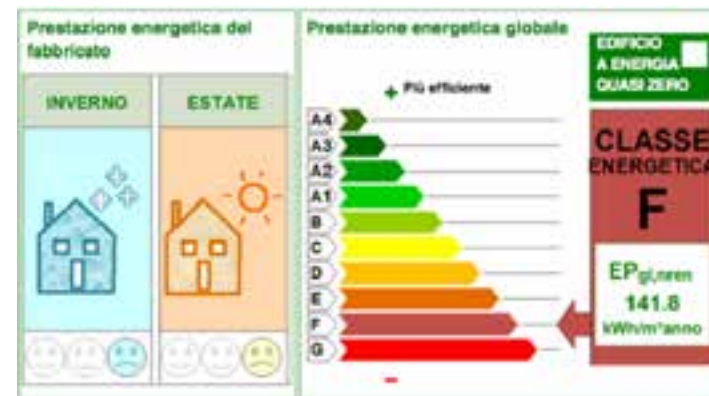
Figure 35 a/c - Energy Performance Certification of the front building, curved wings and tower of classrooms in the current condition (© Mancini, Romano, Rosso 2020)

energy performance index $EP_{gl,nren} = 123,7 \text{ kWh/m}^2$ year, thanks to which the energy class of the building has been defined as corresponding to F class. Both the winter energy performance index and the summer performance index are of low quality.
