# THE SCHOOL OF MATHEMATICS AT ROME'S UNIVERSITY CAMPUS

GIO PONTI, 1935

**CONSERVATION,  
APPRECIATION,  
ENHANCEMENT, USE**  
Simona Salvo

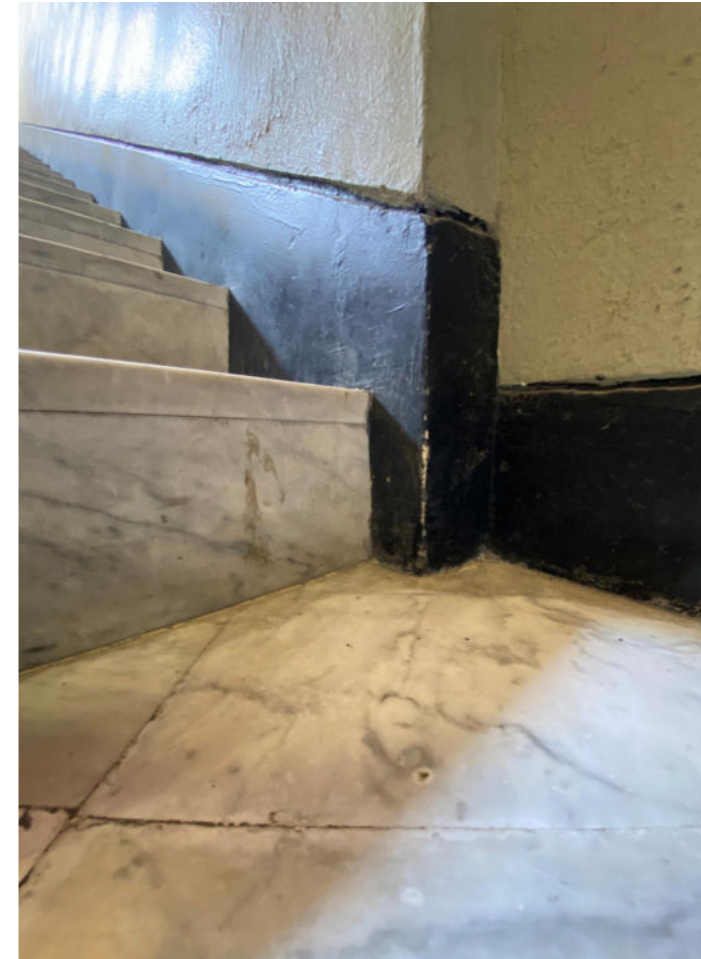
Figure 6 - A detail of the baseboard along the staircases of the classroom tower, a typical detail in the traditional construction methods used in Rome in the Thirties (© Salvo 2021)

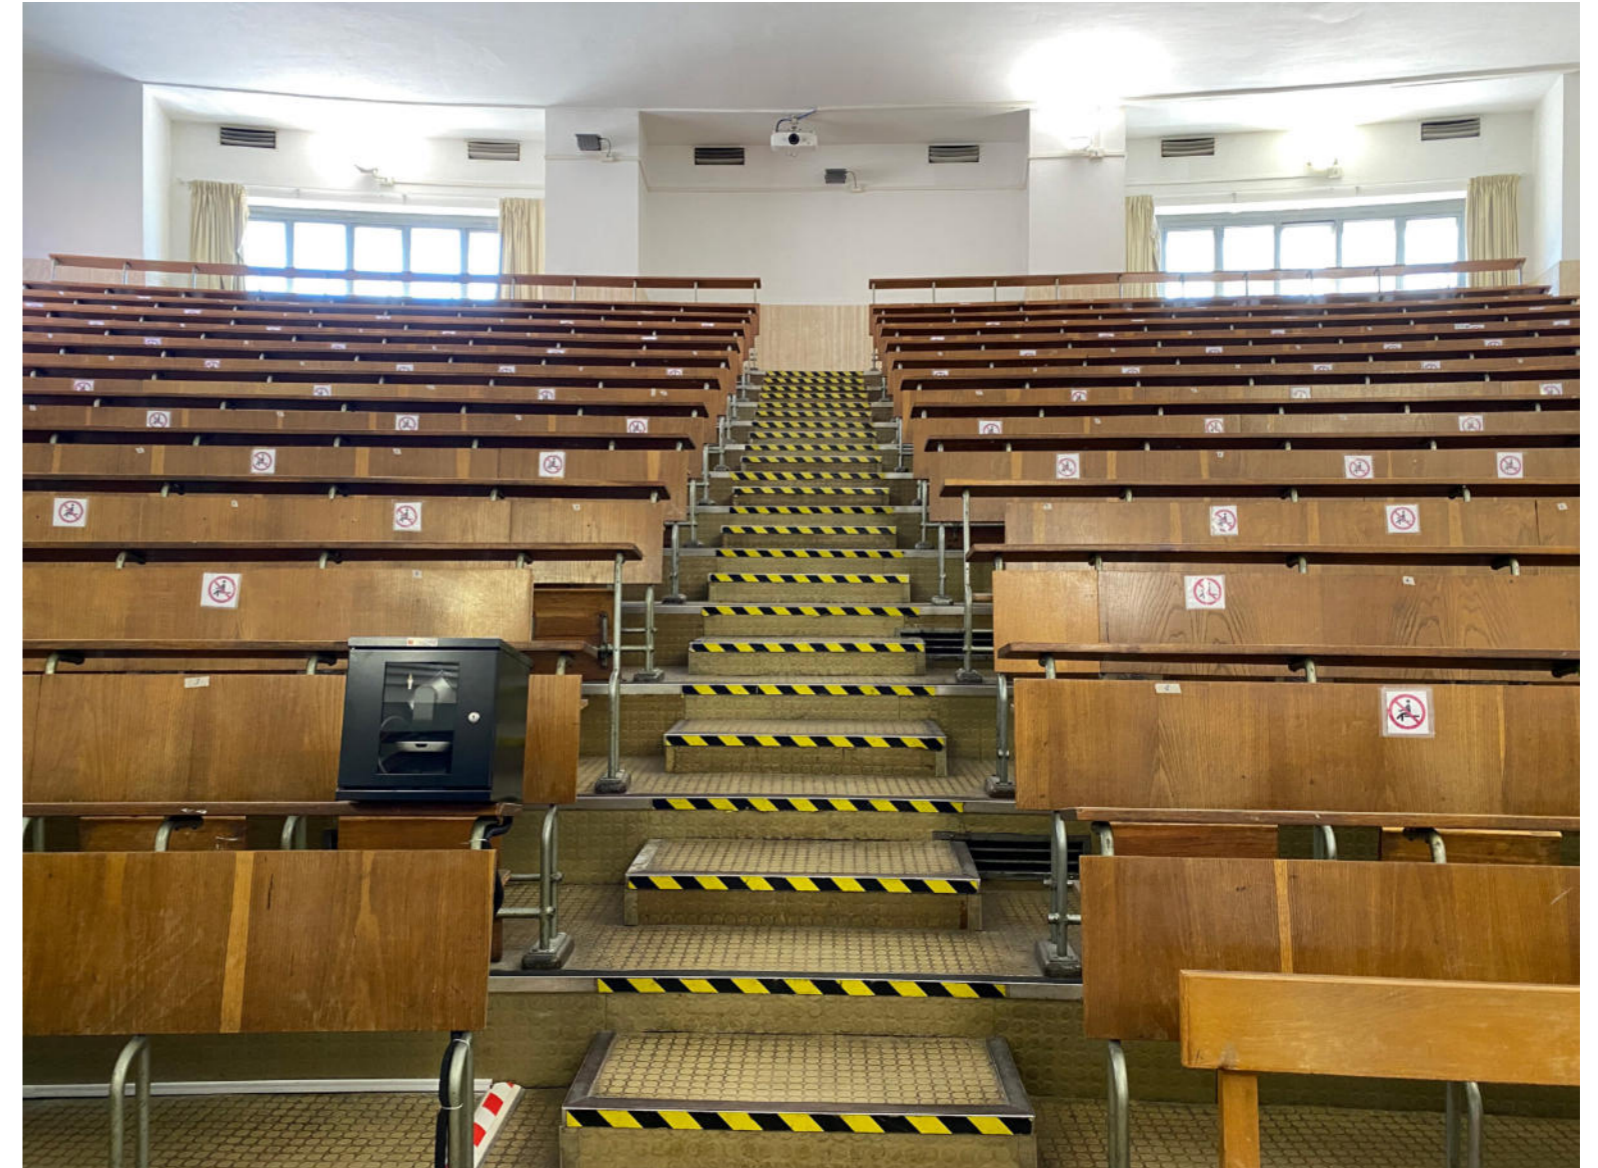
*Figure 8 - Student's desks and seats in a tiered lecture hall of the tower: alterations to, and mistreatment of the furniture is clearly visible (© Salvo 2021)*

On the contrary, it is a matter of urgency to focus on the protection of the fixed furniture- the teachers' and students' desks and seats- and save it from the continuous damage produced by the installation of any sort of equipment. A dramatic increase in this kind of damage has been produced very recently during the pandemic when these halls were equipped with IT equipment (computers, cameras, videos screens ...) in view of either remote teaching or a combination of remote and in-person teaching.

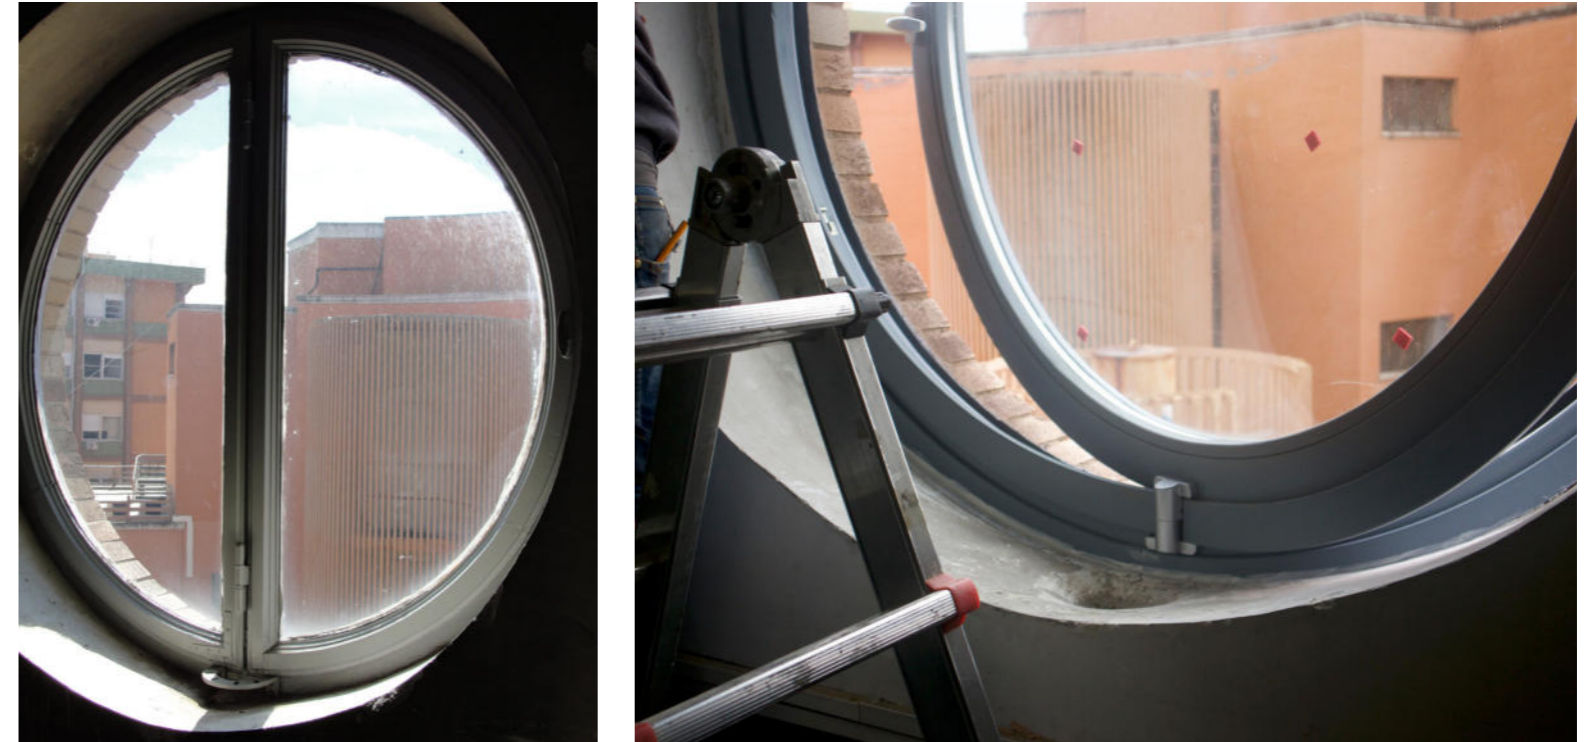
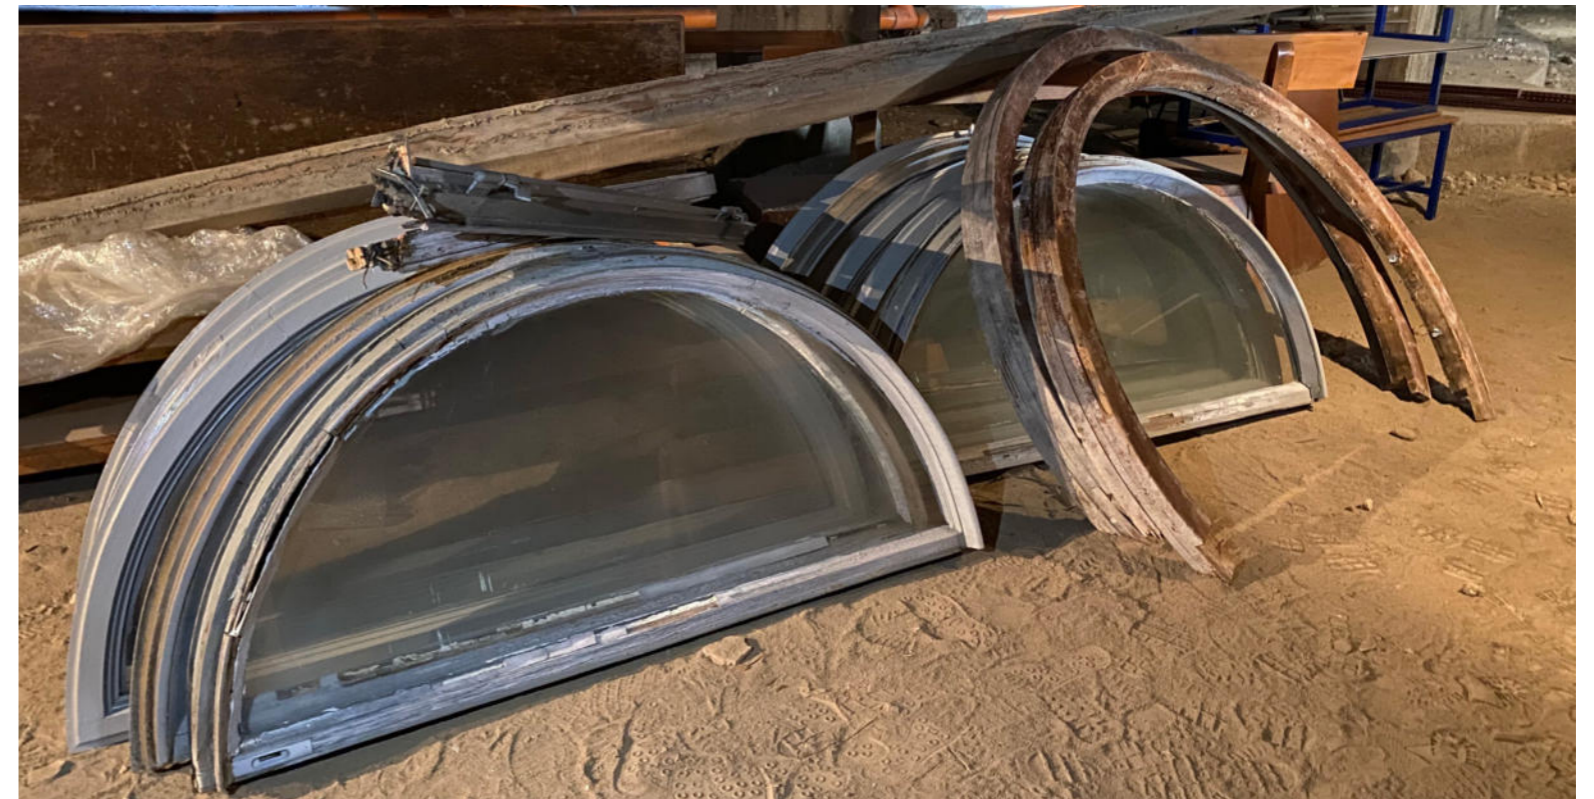
*Figure 12 a/b - The round wooden frames of the window of the book depot before (a) (© Salvo 2015) and after (b) replacement (© Salvo 2021)*

*Figure 13 - Scrapped window frames in the basement before disposal (© Salvo 2021)*

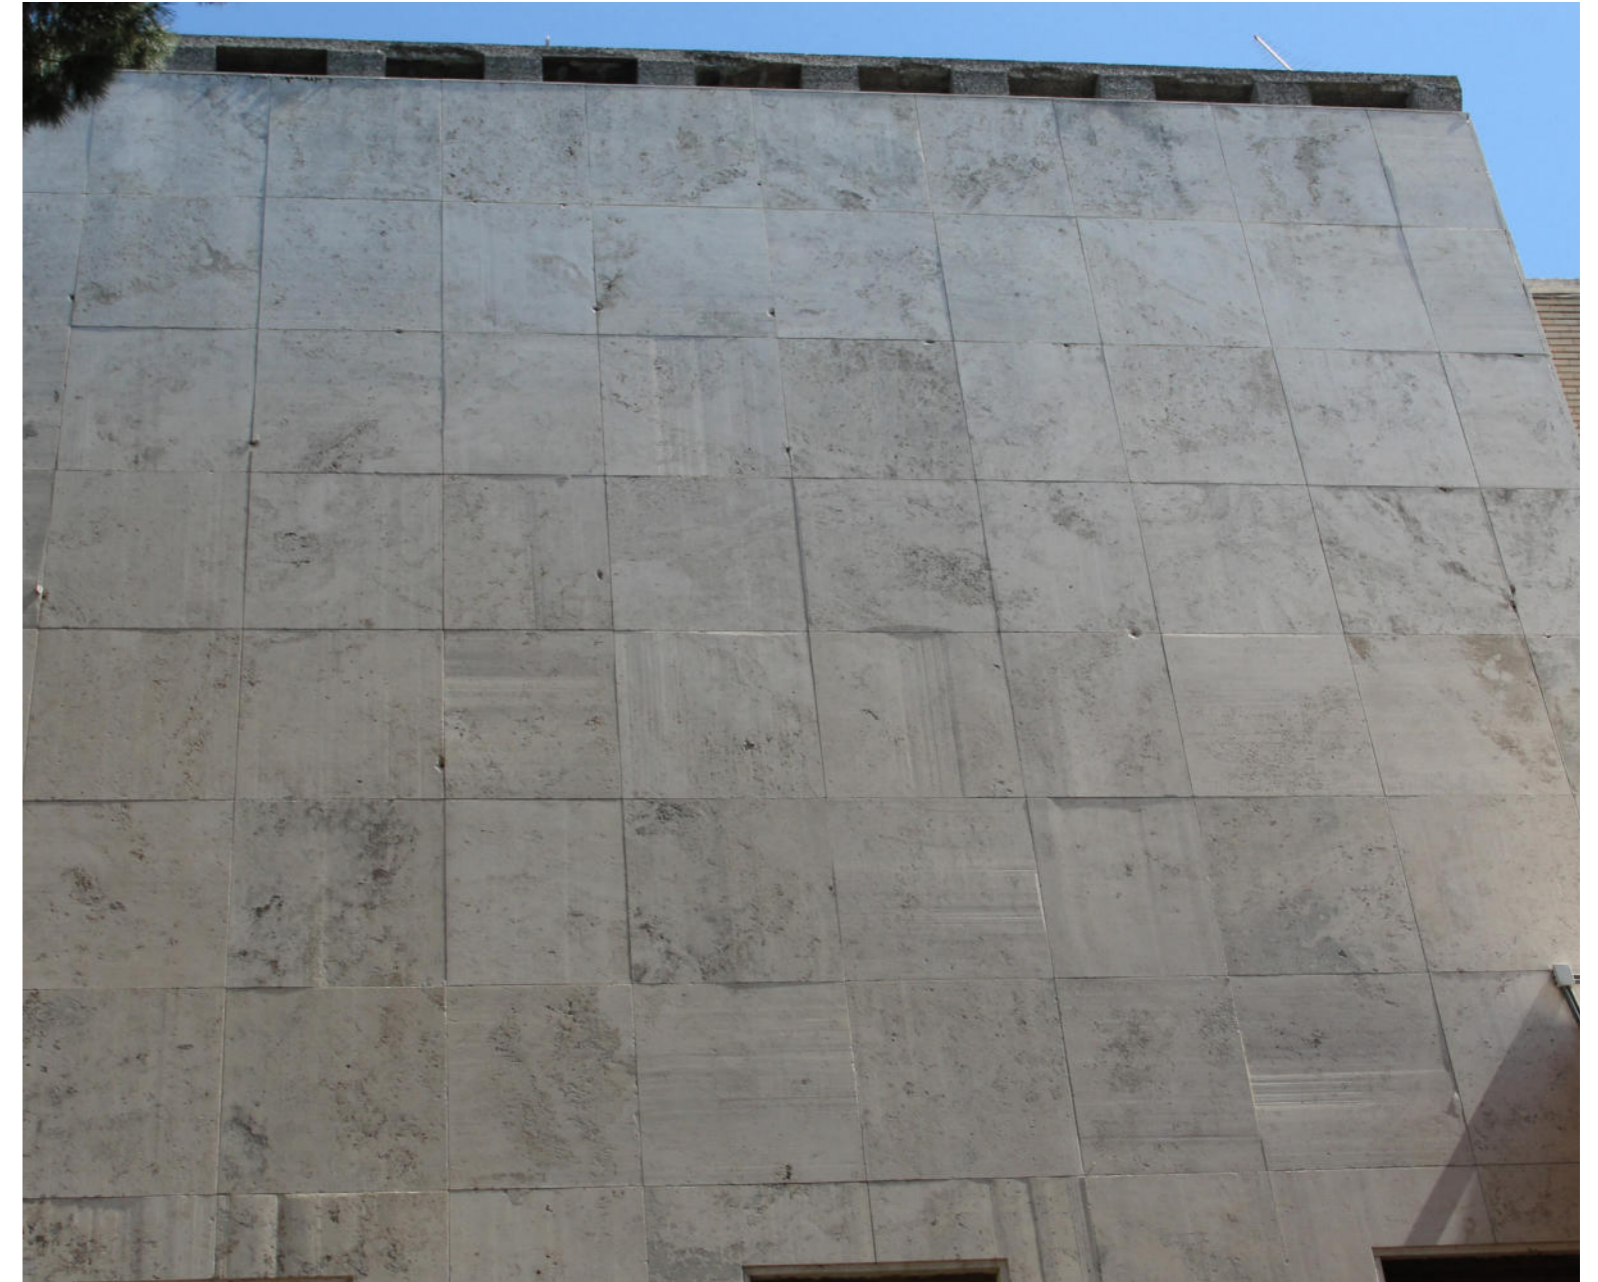
*Figure 14 - The travertine cladding on the southwest elevation photographed with sidelight in order to show the degradation of the slabs (© Salvo 2020)*

One alarming issue is the stone cladding of the main façade made up of more or less square travertine slabs. The chipped edges along the joints reveals that, without mortar joints, they do not absorb excessive thermal expansion. This suggests that the slab anchoring system is not completely secure, despite its very good resistance over the years. In addition, we cannot say that the cladding system ensures the perfect adhesion of each slab. This same situation is applicable to the Litoceramica cladding and the plastered surfaces, especially the ones facing south and southeast.

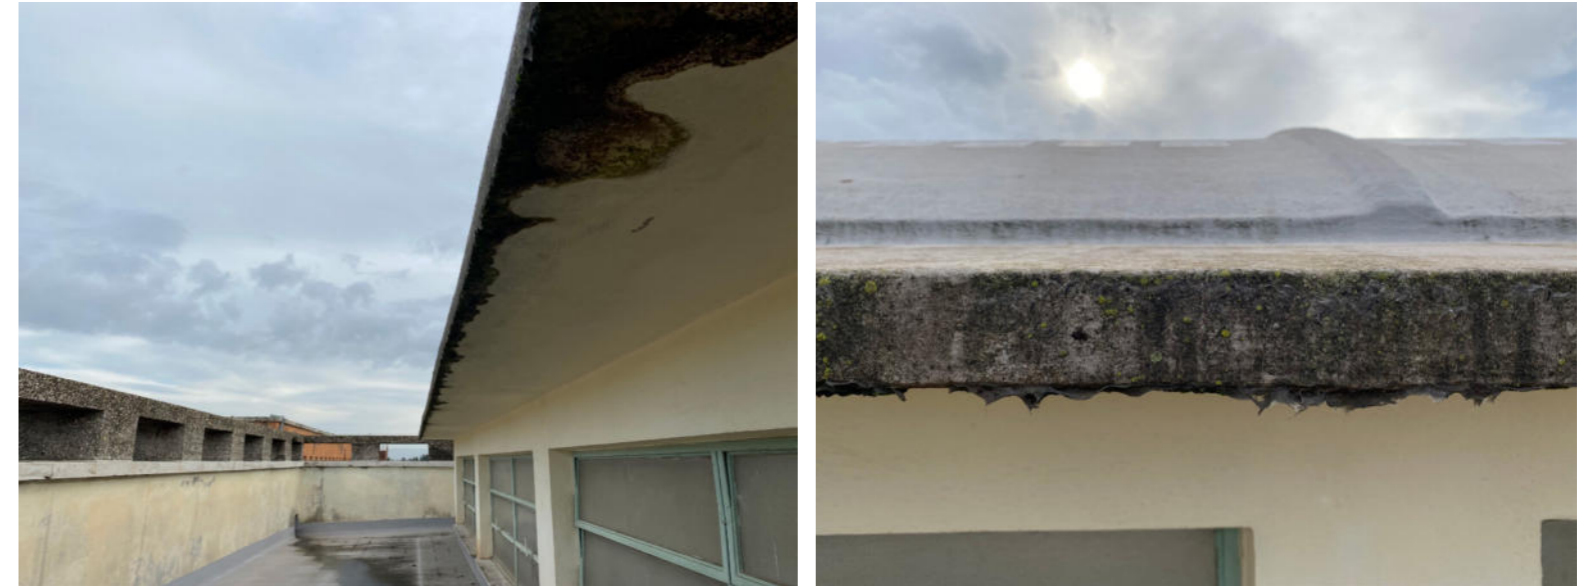
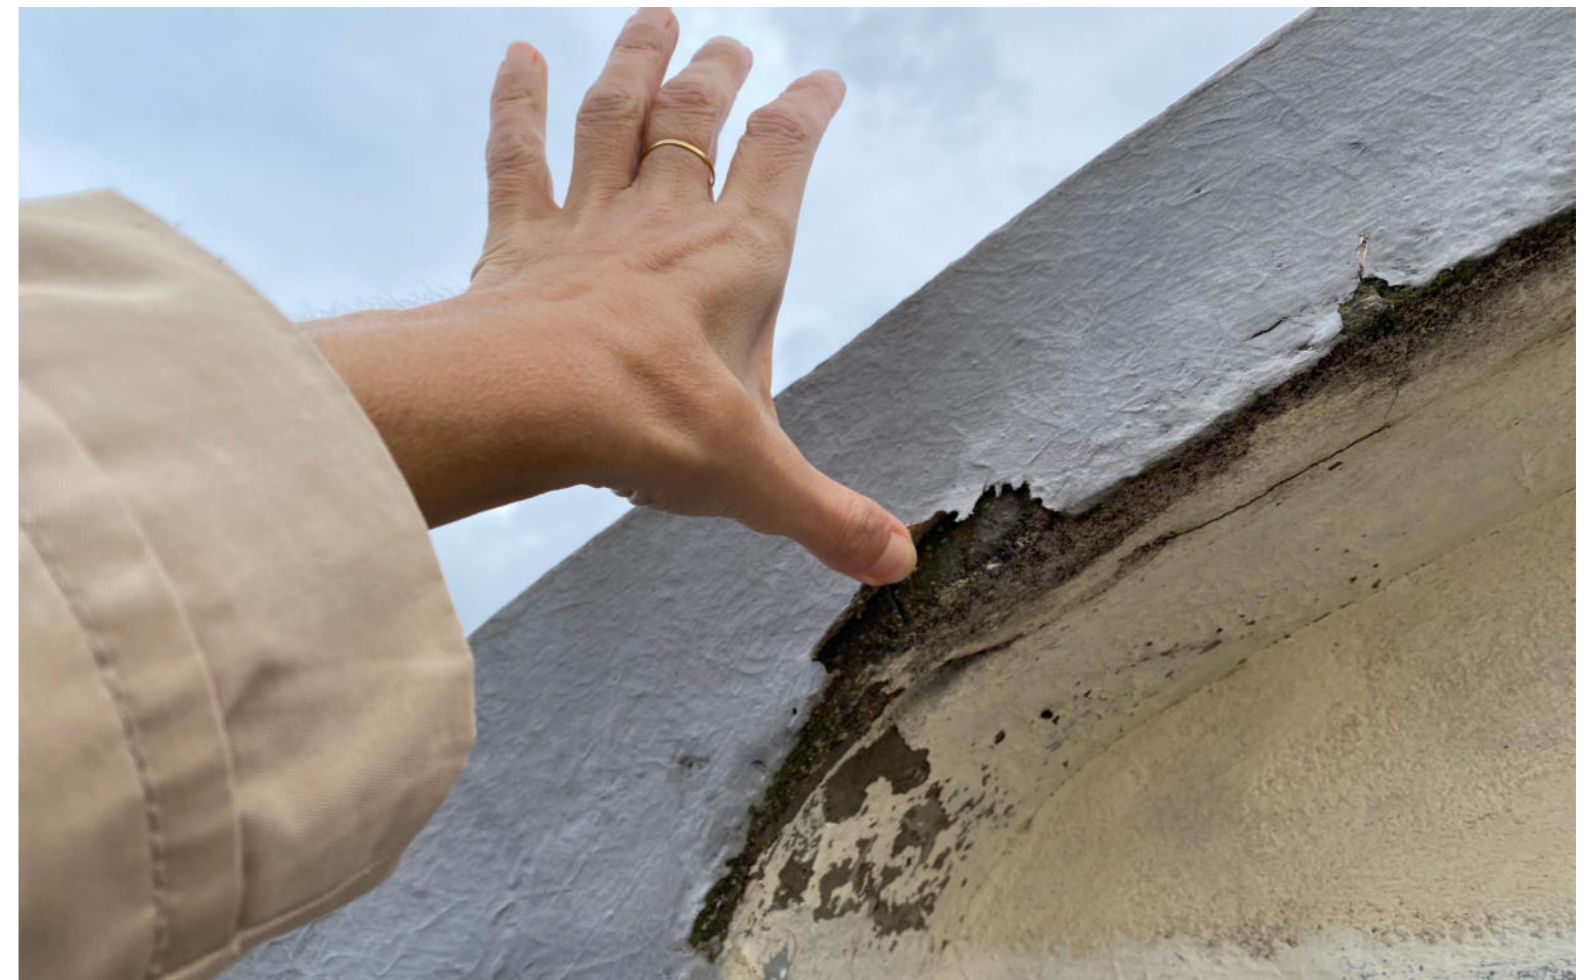
*Figure 15 a/b - The condition of the fiber-reinforced resin coating applied in 2013 on the roof and skylights of the library (© Salvo 2021)*

*Figure 16 - The layer of fiber-reinforced resin coating applied in 2013 has aged quickly and crystallized (© Salvo 2021)*

Another issue that must be given due consideration is the deterioration of the materials applied during the most recent maintenance project. The waterproofing applied using fiber-reinforced organic resins in 2013 is gradually but steadily becoming less solid. This material is generally guaranteed for no more than ten-years, in optimal conditions, which is certainly not the case here. The accelerated deterioration of this material is now alarming, especially as regards the skylight on the library roof, due to very specific conditions: the very high summer temperatures that have peaked in the last five years, combined with very strong rainfall; the application of heterogenic materials such as cement, concrete and glass; the total lack of maintenance; the combination with concomitant causes of decay, e.g., mechanical and chemical effects due to the presence of birds. All this has created an intolerable situation.

The result is very visible and consists in the plasticization and crystallization of the material, with ensuing shrinking and breaking. As a result, the protective layer is no longer seamless, allowing water percolation under its surface. We expect to very soon see the effects of this infiltration with the percolation of water through the glass blocks and the loss of glass and concrete pieces. One first urgent action consists in an accurate inspection of the situation and then the removal of this layer and the application of thin layers of either non-organic protective materials or acrylic resins, to be maintained and repeated every five years.

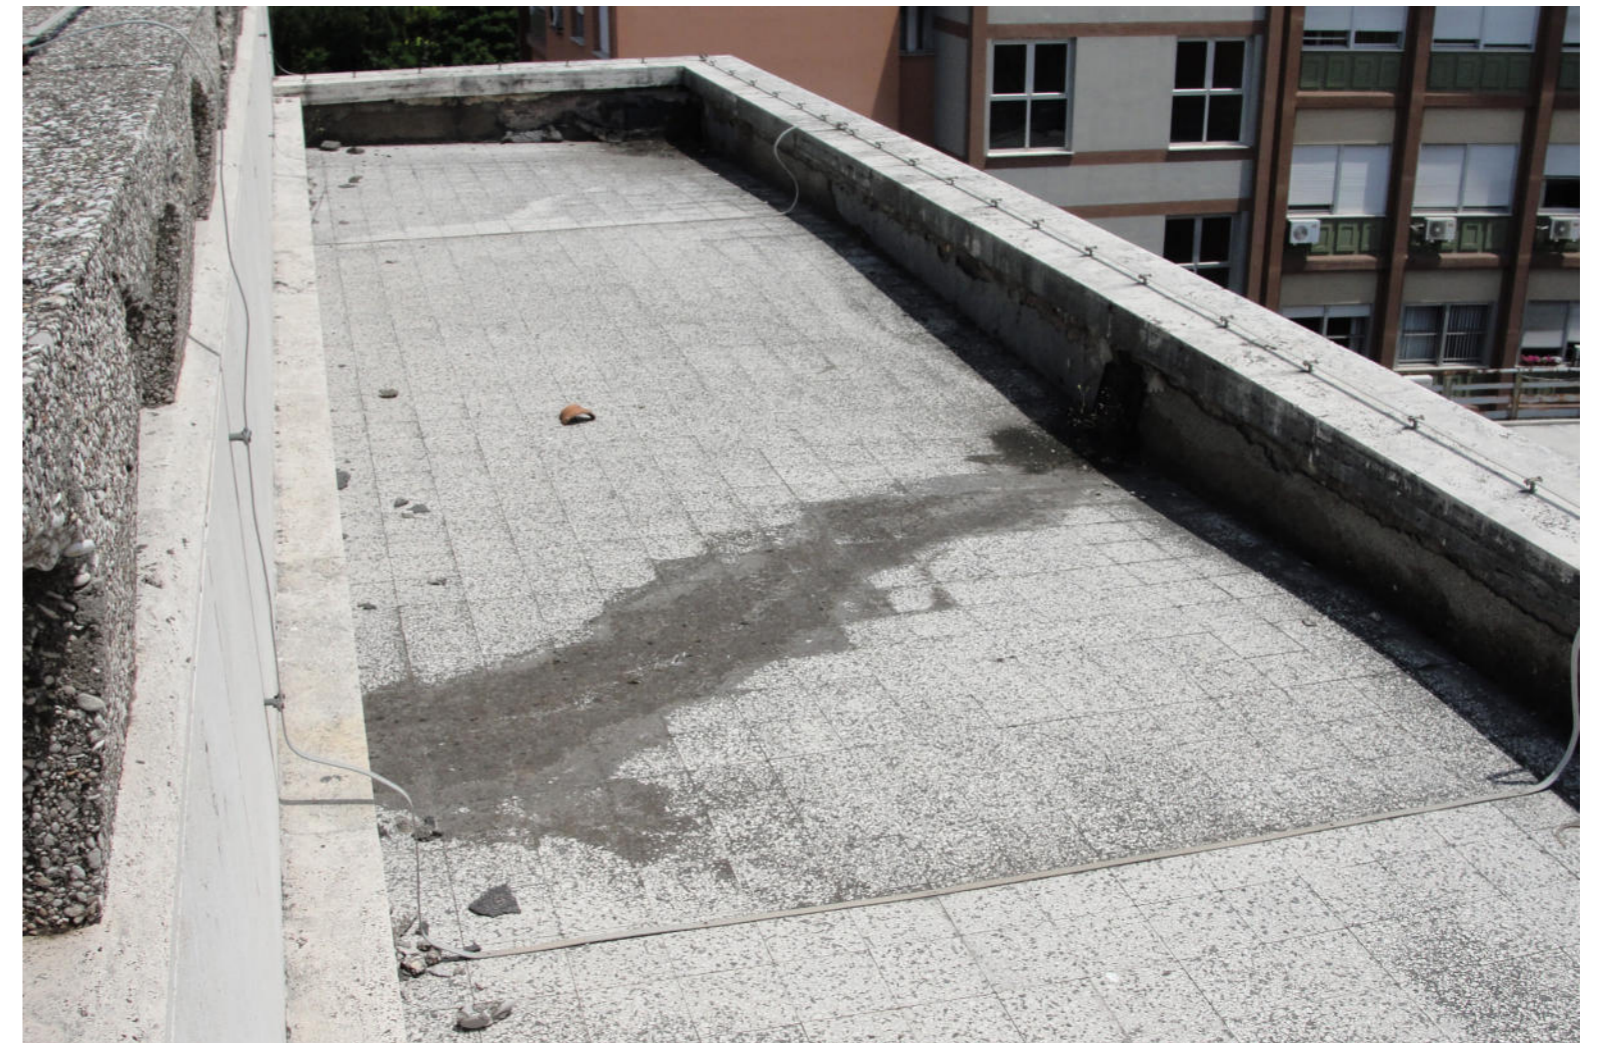
The situation of the fair-face concrete crowning frame of the front building is even more alarming. It is a very significant architectural element and a key feature in Ponti's design of the front building, as well as a beautiful artifact in terms of design, construction, materials, and technical solutions.

The surfaces and substantial parts of this element have been practically left without any protection, and certainly never maintained, so they are constantly deteriorating: the concrete cover is falling, the concrete component of the surfaces is being washed out, and crusts and deposits are forming. The entire element is thus left to be consumed and decay; the deterioration is more severe on the sides facing south and southeast, subject to stronger thermal cycles. Most of the pieces have fallen onto the terraces and not on the street because the position of the cornice on the southern side of the building is just above a lower terrace, so it is here that the pieces have fallen rather than on the courtyard. This should not reassure us regarding the evolution of the degradation process of all the surfaces that will speed up in the years to come. In short, we foresee that the degradation of the crowning frame will represent a safety hazard for the community and a conservation problem for the building. For this reason the issue should be urgently addressed.

*Figure 17 - Fragments of the concrete crowning frame that have fallen on the roof of the library depot (© Salvo 2011)*

Apart from urgent conservation and protection measures for specific endangered parts and elements such as the concrete crowning frame, one priority of the conservation management plan should be preliminary operations regarding 'preventive restoration'. The idea is to plan indirect but effective actions to revive the community's interest and awareness towards this heritage: an initial, important project could be to re-propose the reenactment of Ponti's stained glass window (already displayed in 2017) based on the data and information collected during this research. Today this operation would be scientifically correct, but also groundbreaking, visible, and communicative, with long-lasting benefits that would 'surf the long wave' of Ponti's revival.

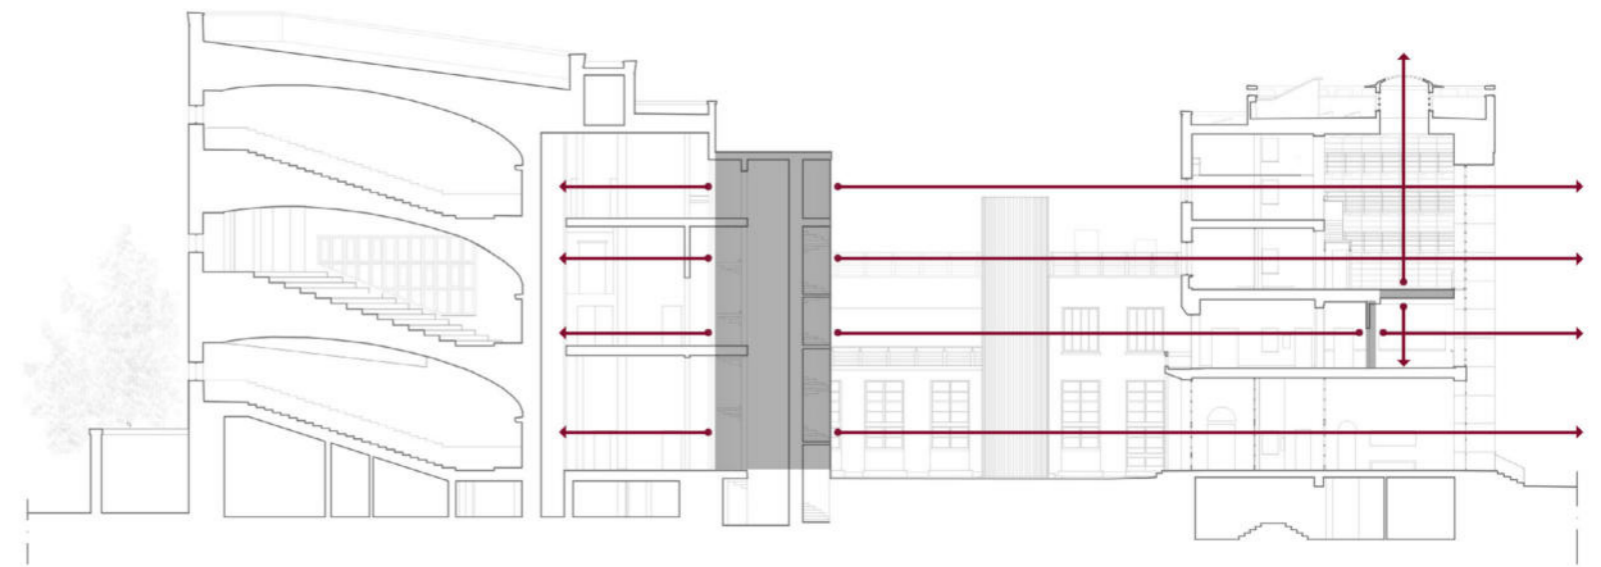
However, the courtyard plays a crucial role in the architectural layout, now compromised by the fire escape stairs. Their insertion has impaired the perception of the visual axes of the spatial sequence crossing from one side to the other of the building and establishing an ideal 'optical telescope'. In addition, it has materially damaged the paving, the elevation, and the window frames, in particular the huge central window to which the metal stairs are attached. Notwithstanding the many attempts to find a document about their installation, none were found regarding the process used to install them.

Figure 21 a/b - The visual axes crossing through the building (© Salvo 2021)

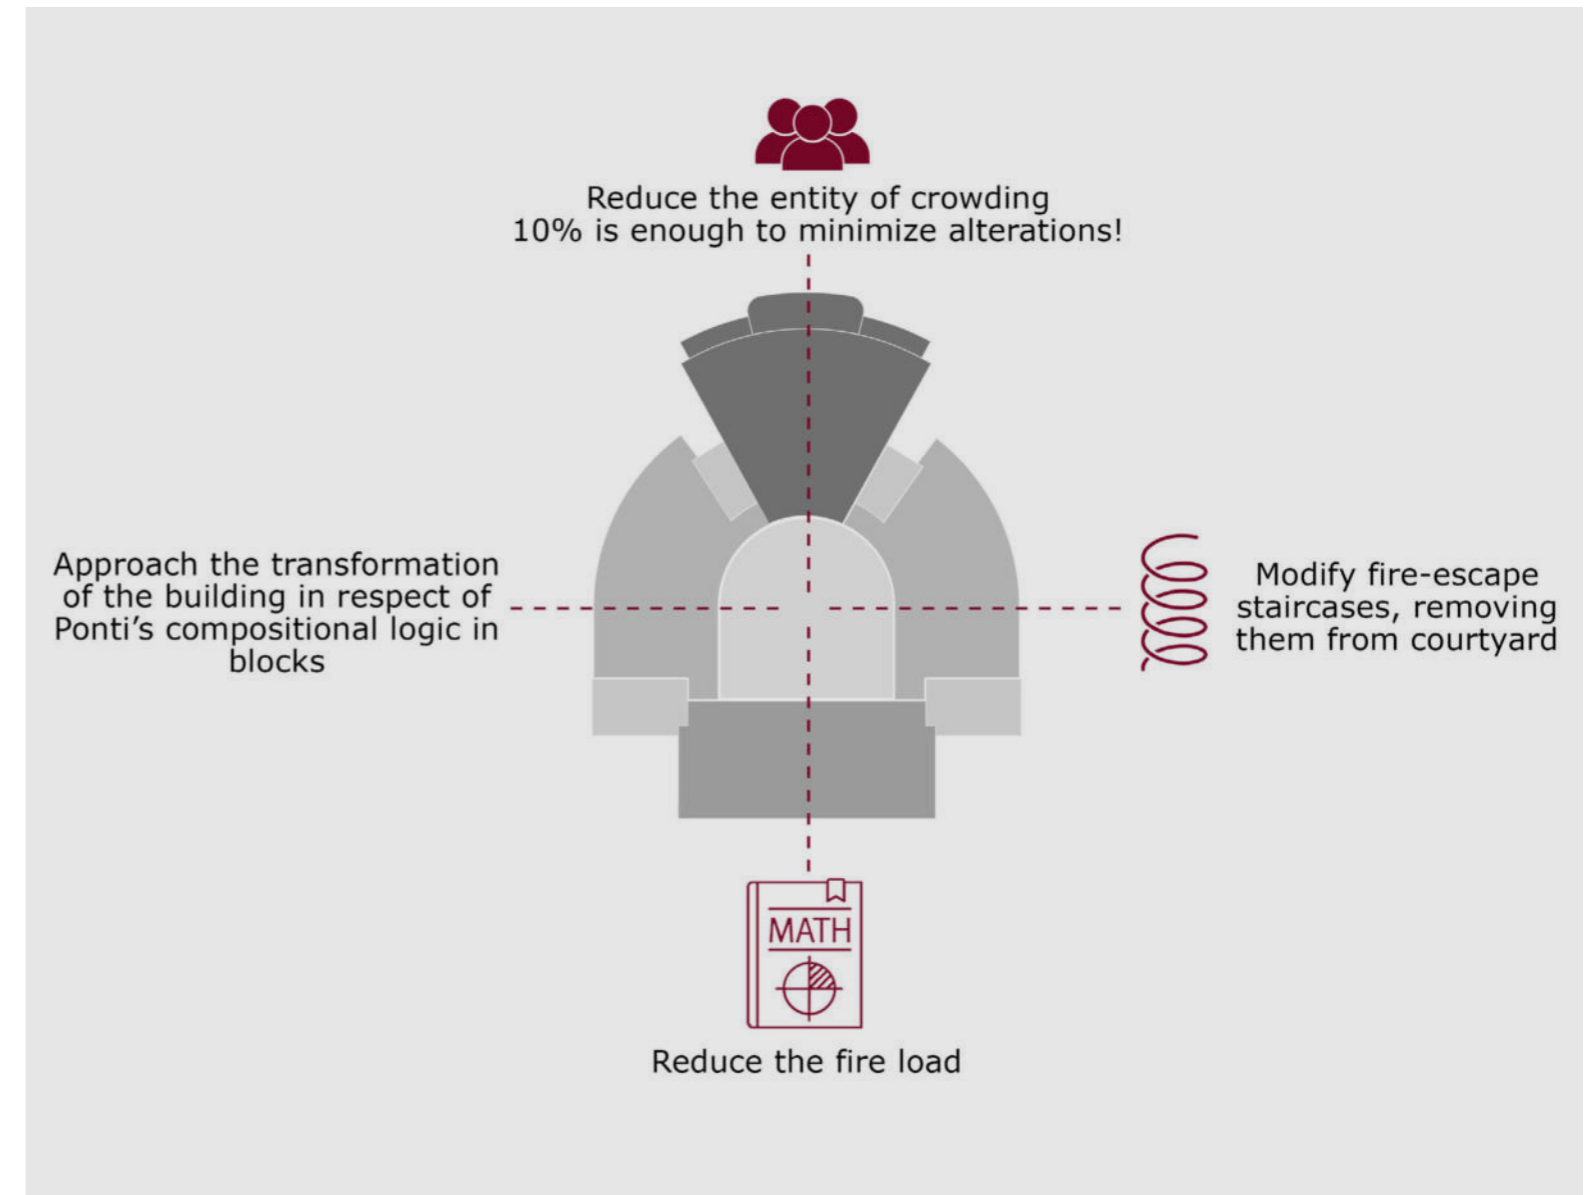
Figure 24 - Manyfold strategy to approach fire safety planning (© Salvo 2021)

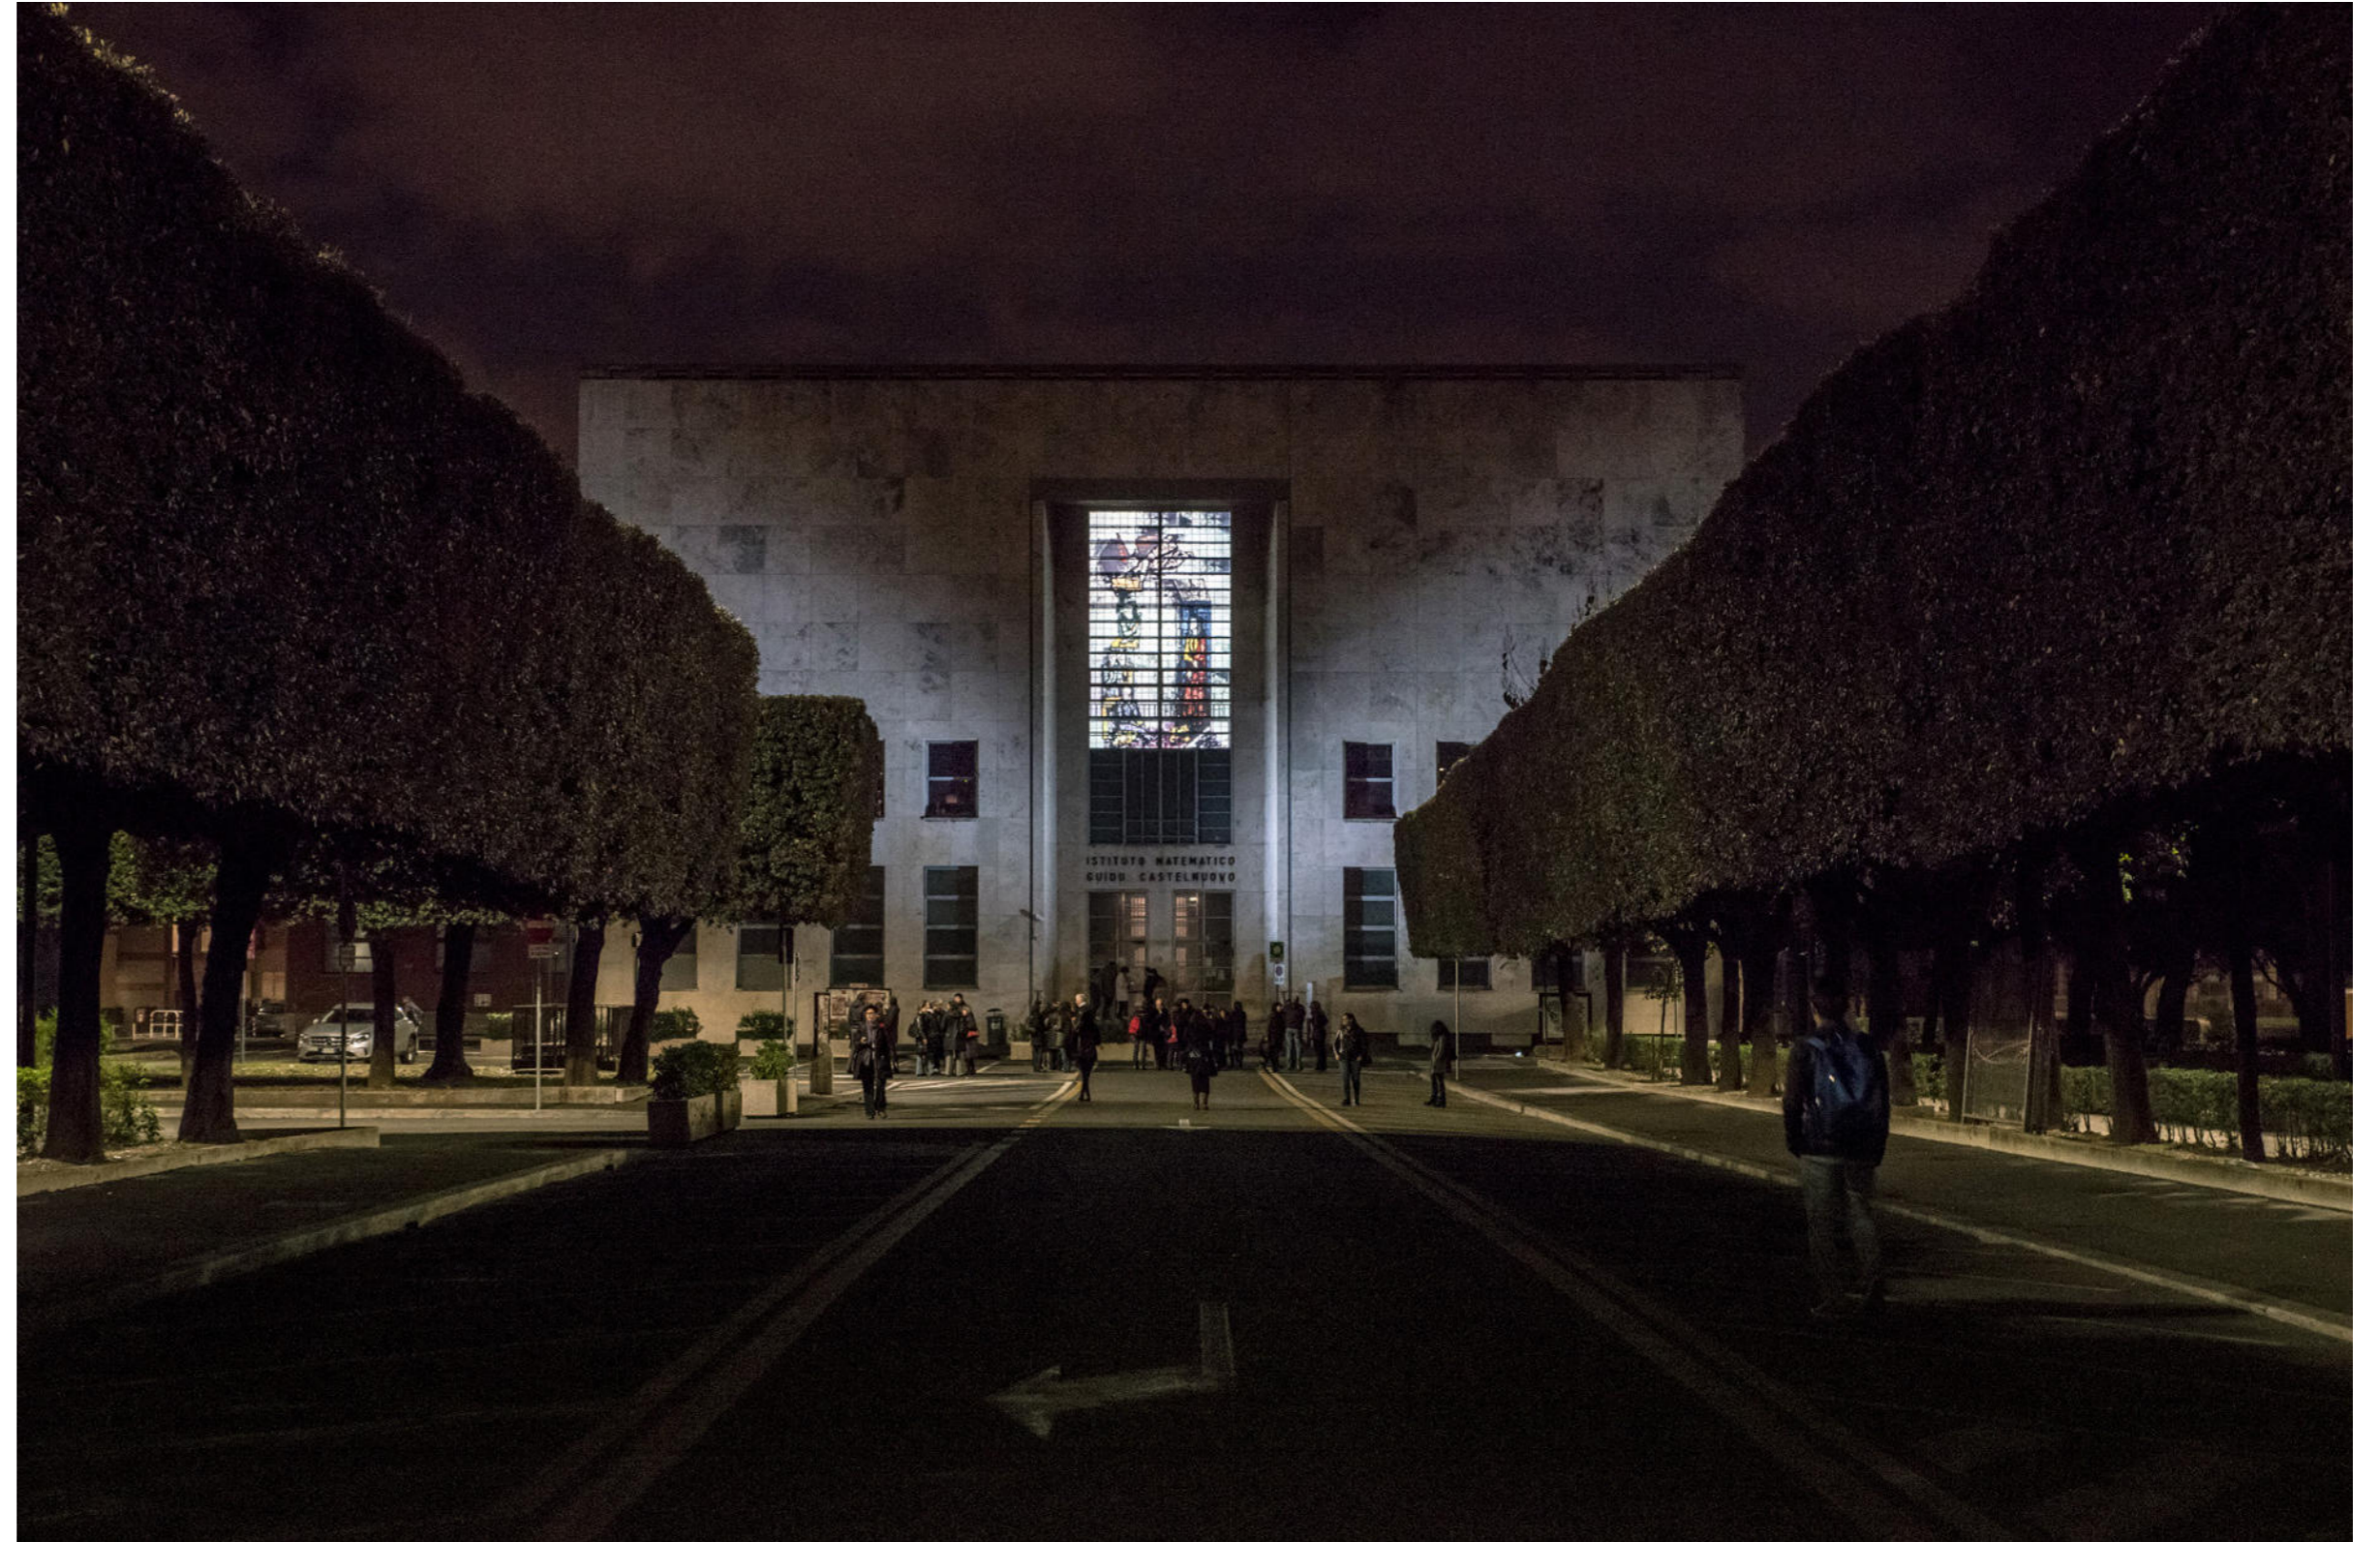
*Figure 30 - The main facade of the School of Mathematics at end of the lighting performance that re-enacted the stained-glass window designed by Ponti, on the night of November 24, 2017 (© Lanzetta 2017)*

Finally, the big window in the middle, once occupied by the stained glass window designed by Ponti, deserves a special mention. The destruction of this work of art, designed and built in 1935, should be considered a true 'loss', as it is impossible to recover other than through virtual reconstruction with the support of AR digital technologies, as in the case of the 2017 projection. This experience could be repeated, considering the amount of scientific data acquired during this research, and become a permanent fixture. An open competition call for ideas to compensate the loss, with new translucent colored glass for the big window, would highlight this matter both nationally and internationally.

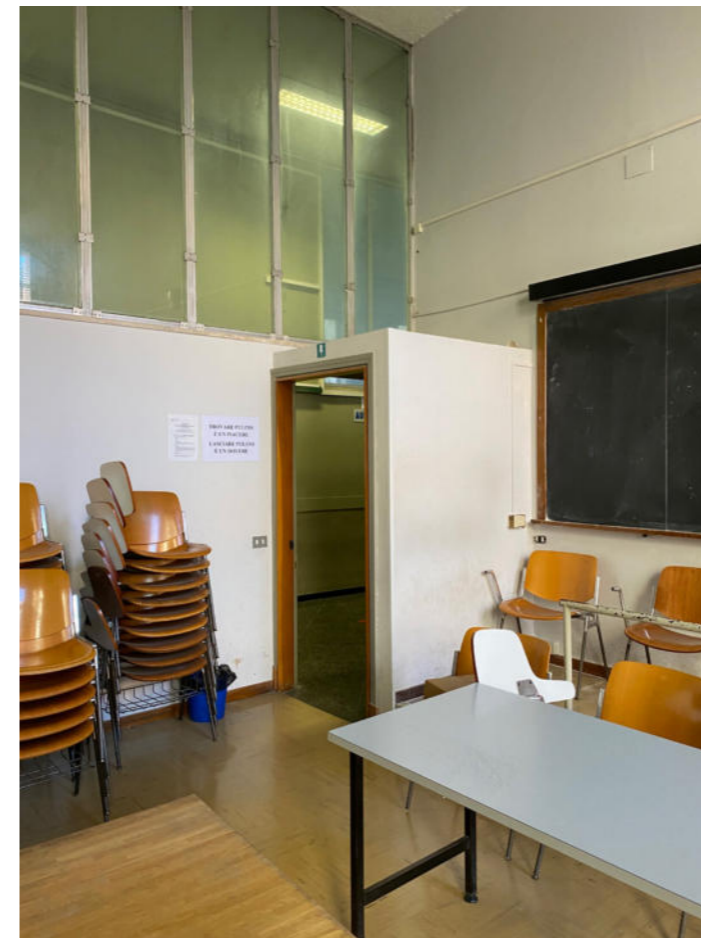
*Figure 31 - One of the classrooms created by dividing the drawing rooms in the curved wings (© Salvo 2021)*

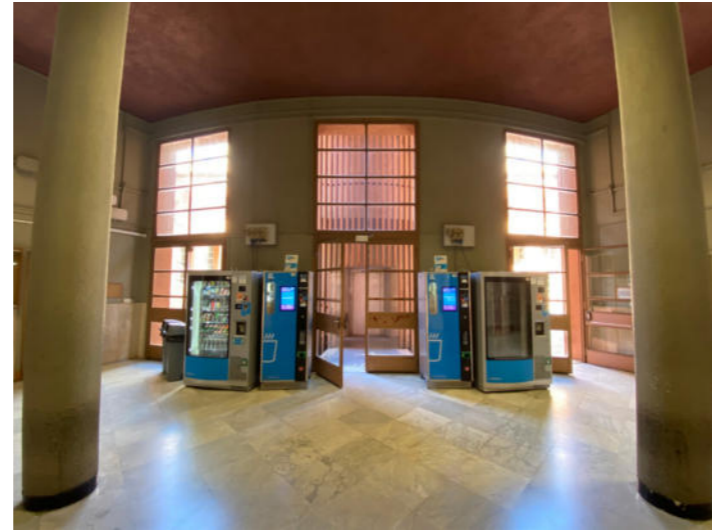
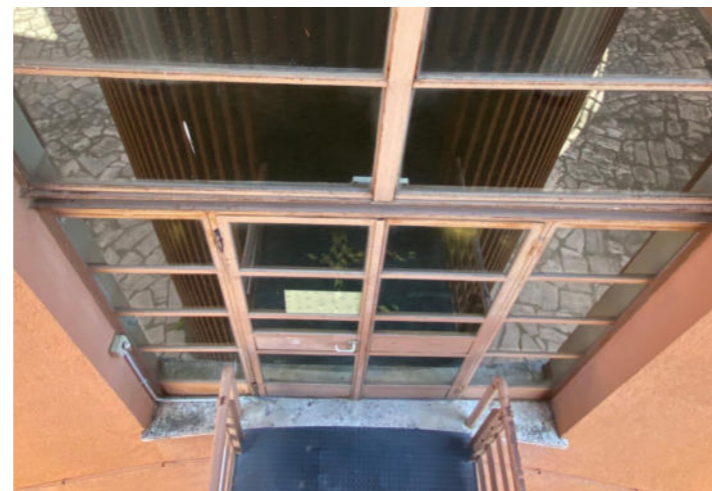
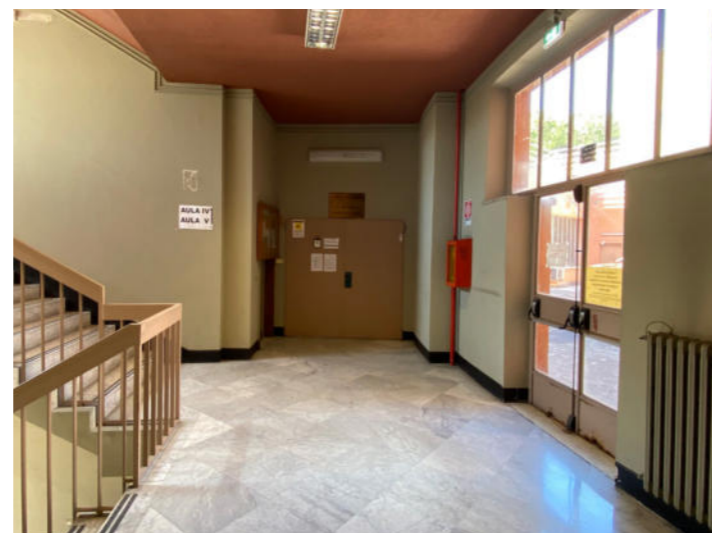
Figure 32 - The lobbies of the classroom tower towards the courtyard, on the ground floor (© Salvo 2021)

Figure 33 - The big vertical window providing light to the lobbies on the three floors of the classroom tower; top-down view (© Salvo 2021)

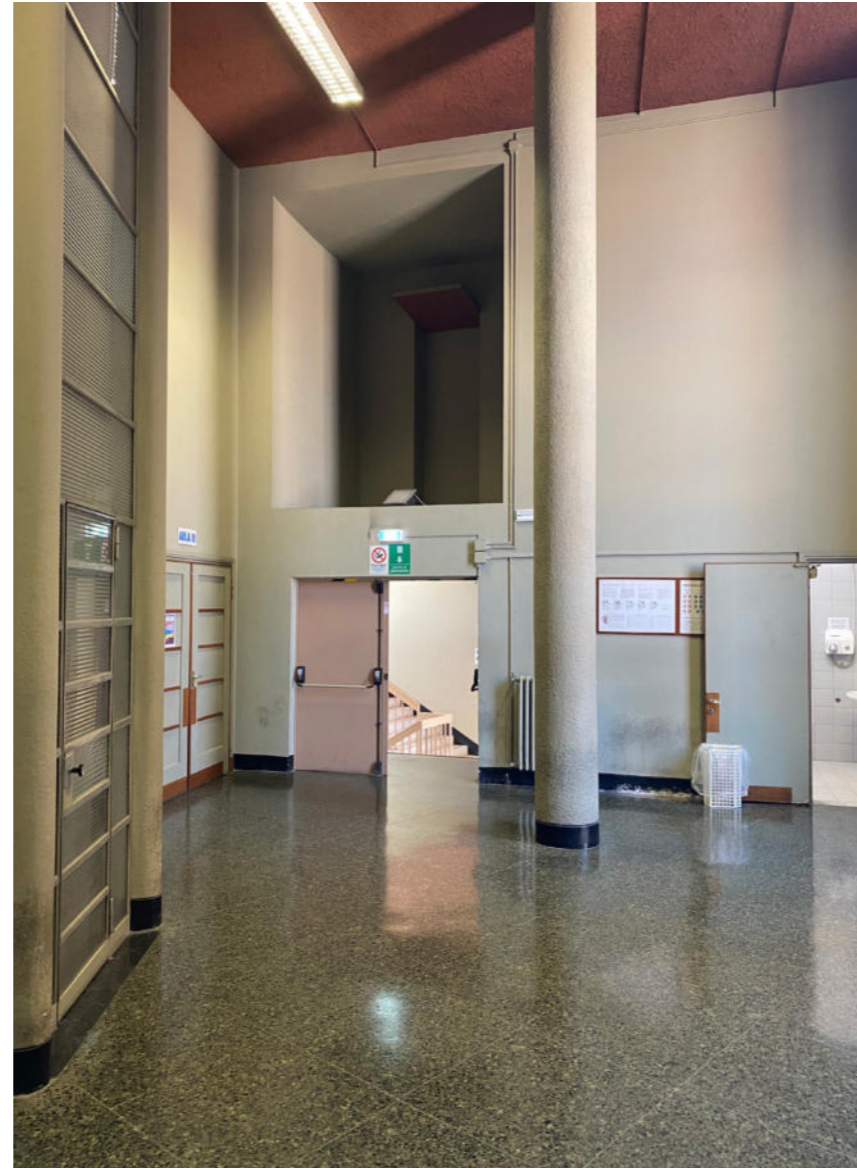
*Figure 35 - The hall of the classroom tower on the first floor; note the niche over the door leading to the staircase, closed by a wall and a fire door (© Salvo 2021)*
