Heritage Problems, Causes and Solutions

Calogero Bellanca and Susana Mora Alonso-Muñoyerro

CHAPTER 10. FLOORS: CONSTRUCTIVE SYSTEMS, PROBLEMS, CAUSES AND SOLUTIONS

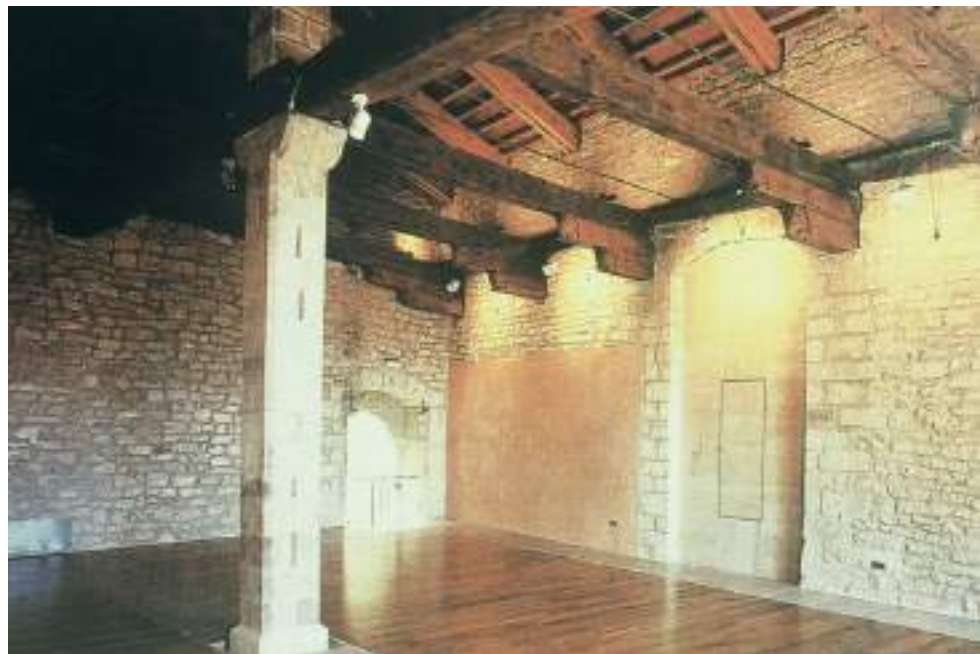
SHORTEN DISTANCE FROM A BEAM

Fig. 12. Almudín, Valencia.
Photo by Susana Mora,
2010.

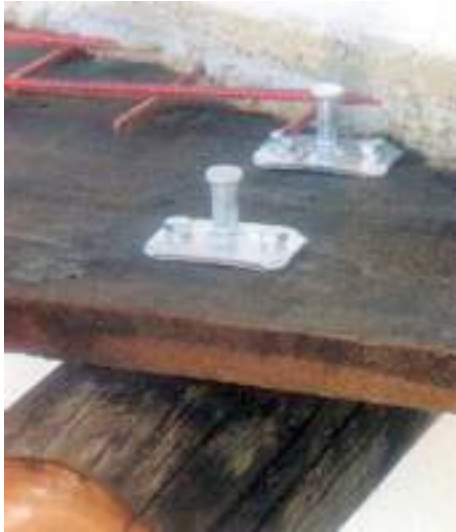
The use of connectors can allow for a significant reduction of the beam whilst ensuring the same load-bearing capacity.

- Wooden Beams.

Fig. 13. Tecnaria, Bassano del Grappa, Italy.

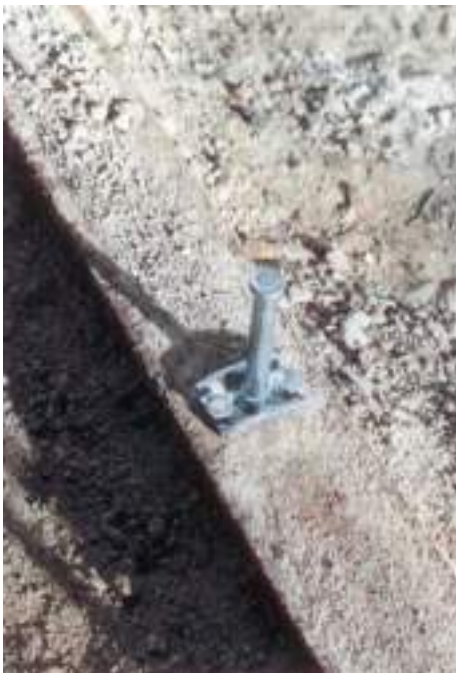
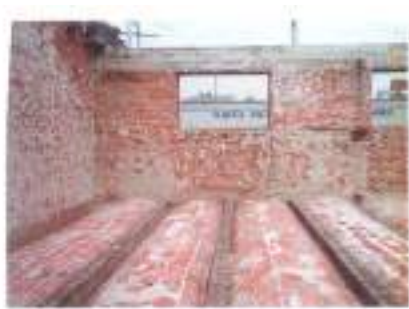
- Steel Beams.

Fig. 14. Tecnaria, Bassano del Grappa, Italy.

Fig. 15. Tecnaria, Bassano del Grappa, Italy.

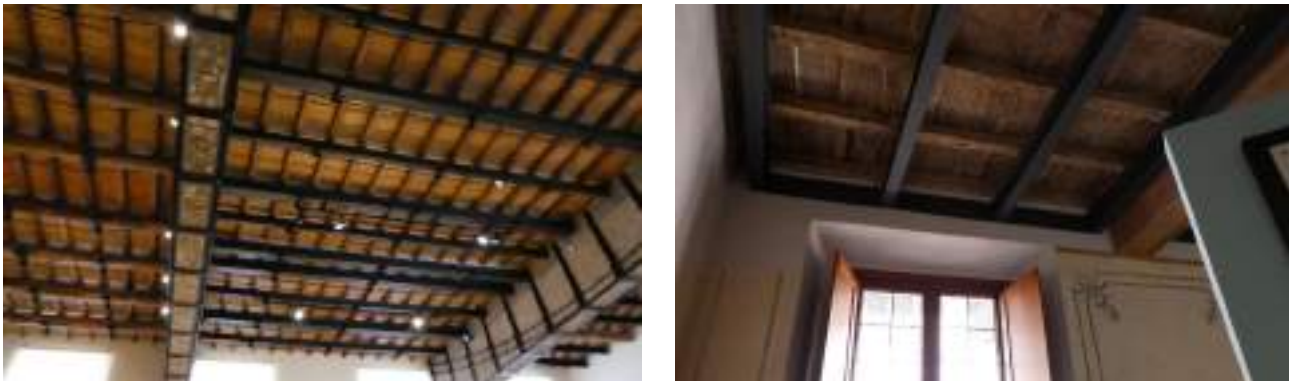
- Reinforcement. Steel Auxiliary Structure. Axial effort increased.

Fig. 17. Palazzo Altemps, Roma. Photo by Calogero Bellanca, 2020.

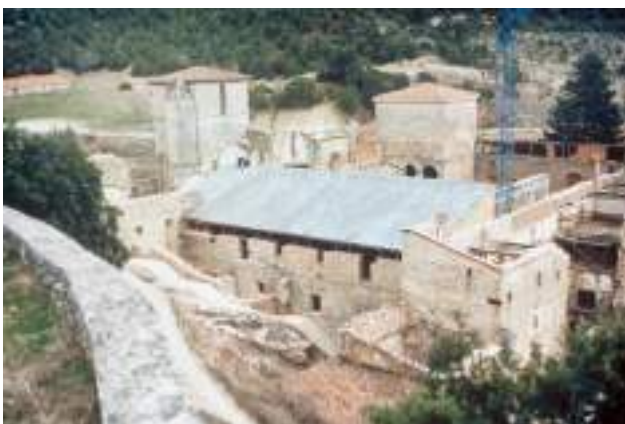
Anchoring of the floor to the masonry consolidation.

Fig. 19. Refectory and new roof of San Pedro de Arlanza, Hortigüela, Burgos. Salvador Pérez Arroyo and Susana Mora. Photo by Susana Mora, 2012.

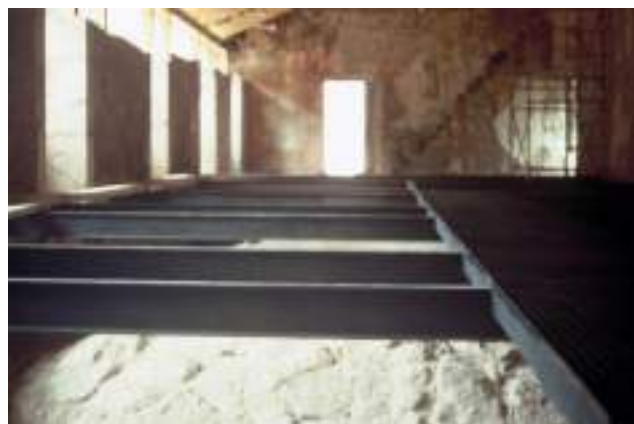
Fig. 20. New beams anchors in the vaults of the Refectory, San Pedro de Arlanza, Salvador Pérez Arroyo and Susana Mora. Photo by Susana Mora, Burgos, 2012.
