Assessment of shear strength of existing prestressed concrete bridge beams: Full-scale tests and numerical simulations

Prof. Eng. A. Lupoi
Sapienza University of Rome

Eng. A. Ficociello
Studio Speri Società di Ingegneria S. r. l.

Eng. M. Malavisi
Movyon

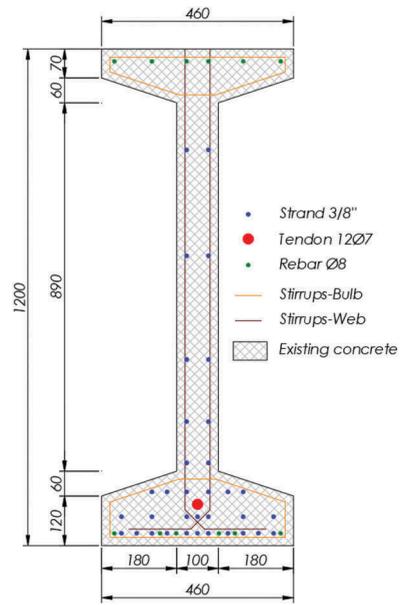
Figure 2. Geometry and reinforcement of the beam (mid-span section).

The three specimens consist in a precast double “T” girders (type TAS 120/46), with an height of 1200mm and a width of 460mm. The beams, with a span length of $L=24.30$ m, are prestressed using 34Ø3/8” pre-tensioned strands (52mm² cross-section) and one 12Ø7 mm post-tensioned tendon (462mm² cross-section). The longitudinal rebar consists of 6Ø8 located at both top and bottom girder flanges; Table 1 shows the amount of transversal reinforcement in the beam, assuming as abscissa $x=0$ mm the section of extremity of the beam.

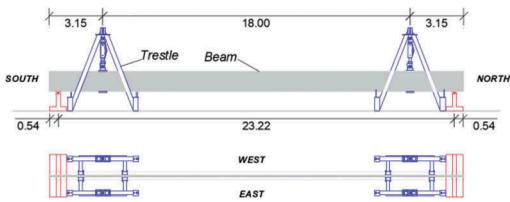
Figure 3. Test setup.

To study the behavior of the beams, four-point load tests and dynamic characterization tests were performed. In order to ensure a simple support static scheme, the beam was placed on cylindrical joints positioned at about 0.54 m from the end of the beam, with girders spanning over a length of 23.22 m. The trestles were positioned to apply punctual loads at about 3.15 m from both ends of the beam as shown in Figure 3.

Thirty-two linear displacement transducers were placed on the beam to evaluate girder displacements and rotations. A particular scrutiny was put on transducers located on the web at a section in between the bearings and load application points to obtain local deformations due to shear forces. At each load step (beginning of test and downstream of each cyclic load), a sequence of mechanical impact was performed on each specimen in order to identify its dynamic response in the Y and Z directions.

Three accelerometers and three geophones were installed on the specimen, paired and arranged at $1/4$, $1/2$, and $3/4$ of the girder span, respectively.

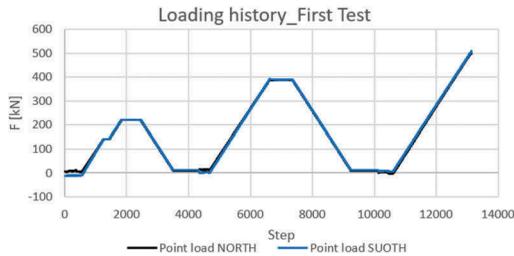
Figure 4. Loading history-First Test.

Cyclic load tests were performed with progressive increase of the load after each cycle until the failure of the specimen. All the tests were run under force control, imposing on the two actuators the achievement of the target force value in a determined time, depending on the adopted speed, 1 or 2 kN/s. Figures 4-5-6 shows the loading history associated to the three tests performed.

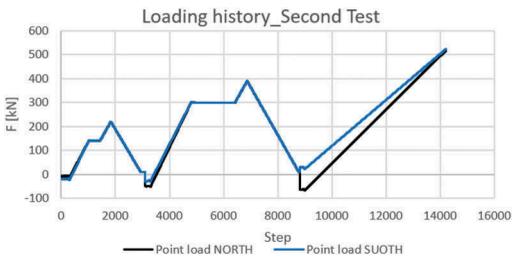
Figure 5. Loading history-Second Test.

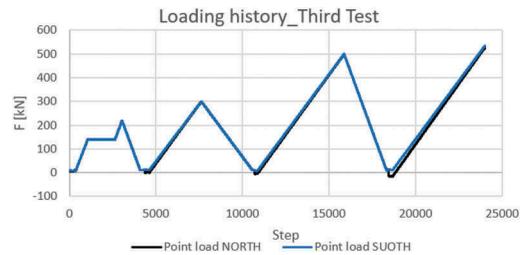
Figure 6. Loading history-Third Test.

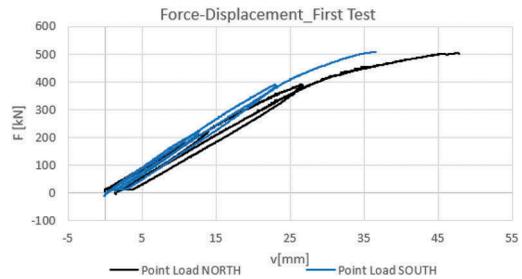
Figure 7. Force-Displacement at point load-First Test.

deformations). Figures 7-8-9 shows the force-displacement diagrams at point load.

The failure occurred from the north side of the beam. For all three tests, the experimental curves associated with the NORTH actuator show larger displacements due to greater deformability of the NORTH support system.

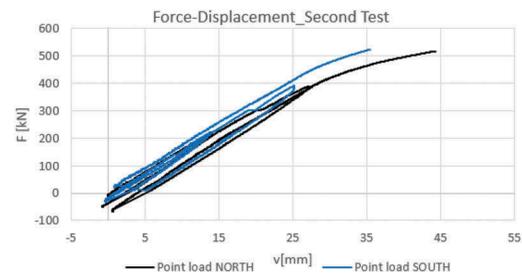
Figure 8. Force-Displacement at point load -Second Test.

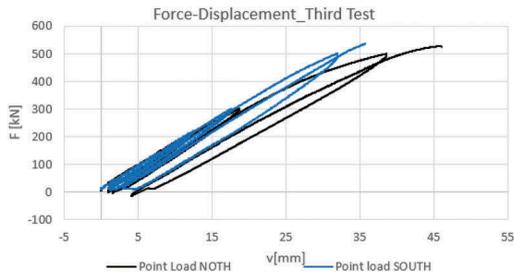
Figure 9. Force-Displacement at point load -Third Test.

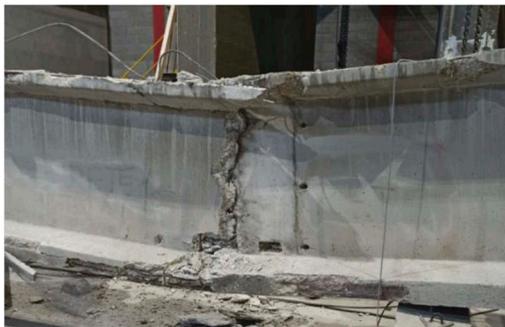
Figure 10. Beam failure-First Test.

During the first load test, the beam broke at the main beam-cross beam intersection, a vulnerable section due to the absence of a portion of the upper flange and the through holes in the web. Given the first test outcomes, the upper flange was reinforced in order to restore the section for the subsequent load tests. During the second and third tests, the failure of the

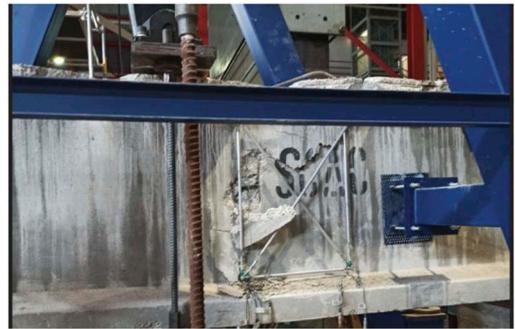
Figure 11. Beam failure-Second Test.

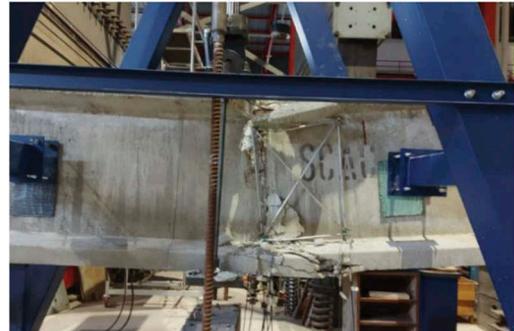
Figure 12. Beam failure-Third Test.

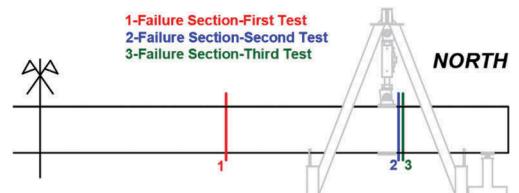
Figure 13. Failure section.

beam occurred, as expected, in a zone between the support and the point of application of the force (Figure 13). Once the principal tensile stress in the web was exceeded, the initiation and propagation of the first shear cracks occurred immediately after, so the failure of the compressed portion of the top flange occurred: this type of failure has been identified as *shear-compression failure*.

The collapse of the beam could also be attributable to the failure of the section by bending with crush of the compression zone; in fact, without the collaborating slab, high compressive stresses are generated on the upper bulb of the beam (*flexural-compression failure*).

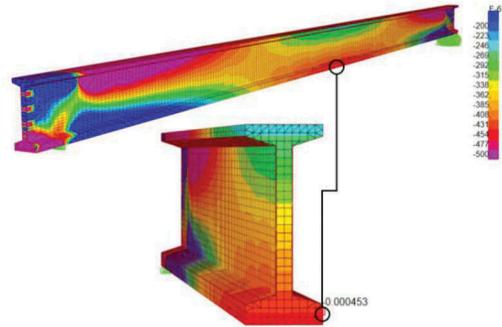
Figure 15. Deformation state of the beam subjected to self-weight and prestressing action.

The model realized with *brick* elements, where the beam is only subjected to the self-weight and the action of the prestressing system, has allowed to determine the initial deformation state of the beam. The strain recorded in the middle section at the side face of the lower bulb is 453µε (Figure 15); this value is close to the one obtained from tension release tests, varying between 406-436µε.

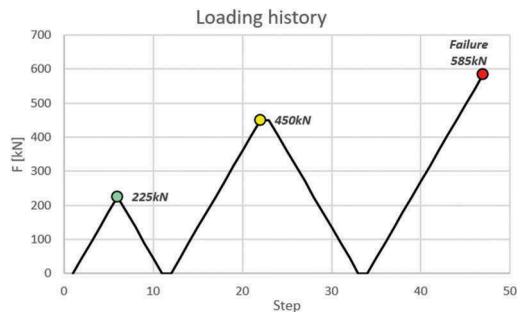
Figure 16. Loading history.

Non-linear analysis allowed to simulate accurately the behavior of the beam till its failure. For the numerical simulation, a load history with cyclic load in force control was considered, similarly to loading cycles applied experimentally; in particular, the first load cycle aims at reaching the decompression of the beam by reaching a load of 225kN, while the second load cycle involves reaching a load of 450kN, with exceeding the principal tensile stress on the web and starting the excursion in the plastic field. The load history used for the numerical simulation is shown in Figure 16.

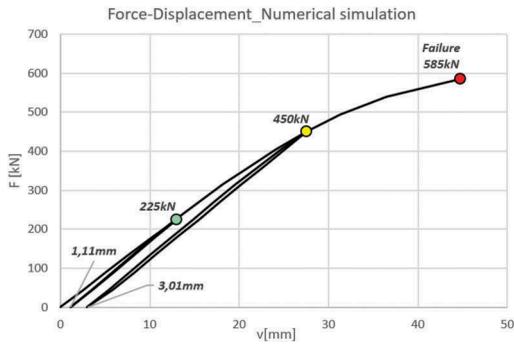
Figure 17. Force-displacement curve-numerical simulation.

Figure 17 Shows the Force-Displacement curve (read at the actuator) of the beam under the action of the load history previously illustrated.

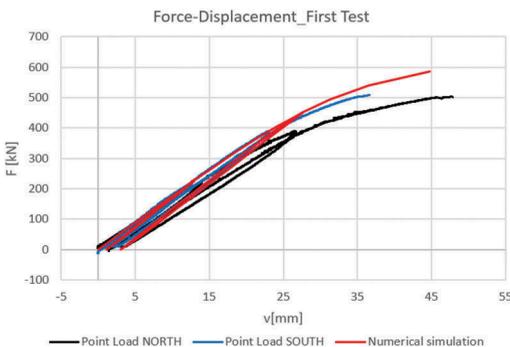
Figure 18. Comparison between numerical simulation curve and experimental curve-First Test.

Figures 18-19-20 provide the comparison between the force-displacement curve obtained from numerical simulations and the experimental tests.

As shown in Figures 18-19-20, the force-displacement curve obtained from non-linear analysis is close to the experimental response recorded at the SOUTH actuator; in the case of First Test, there is a greater discordance with the plastic field

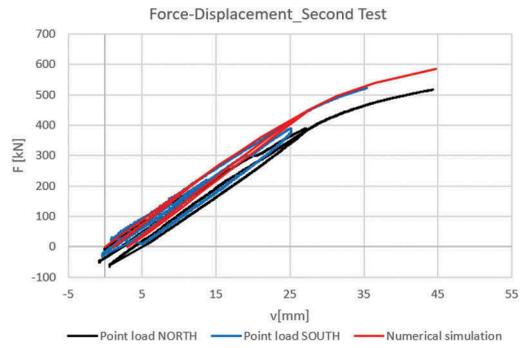
Figure 19. Comparison between numerical simulation curve and experimental curve-Second Test.

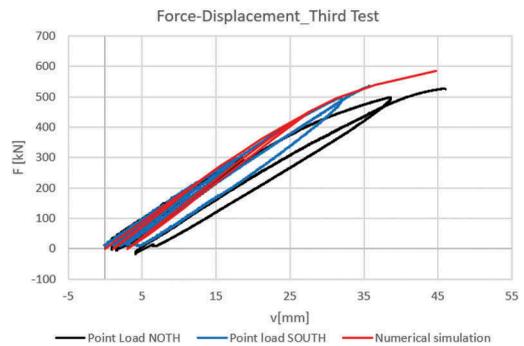
Figure 20. Comparison between numerical simulation curve and experimental curve-Third Test.

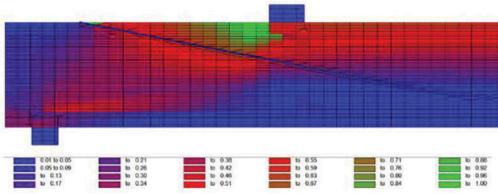
Figure 22. Ratio between compressive stress and compressive strength σ_c/f_c .

Figures 22-23-24 show compressive stress to compressive strength ratio σ_c/f_c , stress in stirrups σ_s , and crack inclination θ at failure, respectively.

Peak force is reached when the compressive stress close to the point of application of the force in the upper bulb reaches concrete compressive strength (area highlighted in green with $\sigma_c/f_c=1$ in Figure 22). This type of failure is anticipated by the activation of a shear resistant mechanism; before failure, in fact, the yield strength of stirrups is reached that consequently triggers a truss mechanism with an average inclination of the struts $\theta=29^\circ$ (from the experimental results θ ranges between 25° and 28°).

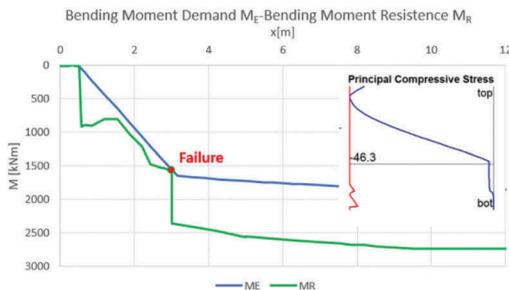
Figure 25. Comparison between bending moment demand ME and bending moment resistance.

Figure 26 Shows the global response of the beam with a comparison between the bending moment

demand M_E and bending moment resistance M_R . For the section failure is also reported the diagram of the principal compression stress in which it shows the achievement of compressive strength $f_{cm}=46,3\text{MPa}$.
