Digital transformation in the visual inspection of heritage railways tunnels: Technology, artificial intelligence and methodology

ETS Srl, Geology and Hydraulics Department

Sapienza, University of Rome, Department of Civil, Building and Environmental

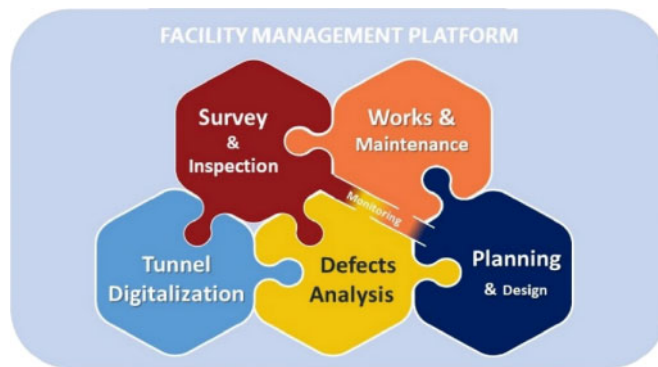
Figure 2. Puzzle chart of the workflow (Foria et al. 2021).

The complete procedure can be defined through the following milestones (Figure 2):

- *Survey & Inspection (S&I)* with multi-dimensional mobile mapping systems to have internal geometry (laser scanner), thicknesses (GPRs), and condition of the structure (thermal and linear cameras, visual inspections, and measures). In the approach, the S&I phase can be repeated to update the data through different time steps, with this instrumentation it is possible to carry out surveys and inspections with non-destructive investigations, preserving the integrity of heritage tunnels;

- *Digitalization (DI)* of the geometric survey to obtain a 3D CAD model or IFC model;
- *Defect Analysis (DA)* from HD linear photo to map and digitalize the defects in a CAD environment. The defects are statistically elaborated and combined to obtain easy and user-friendly indexes;

- *Planning & Design (P&D)*: the digital twin and the defects detection are combined in a Common Data Environment (CDE);
- *Work & Maintenance (W&M)*: the maintenance and construction works are performed according to the indication of the P&D phase. The completed works are ready for a new S&I phase to determine the new condition of the structure;

- *Monitoring (MO)* is fundamental to have continuous data input through different phases, allowing a dynamic database and assessment of the structures.

- *Facility Management Platform*: an environment in which it is possible to have a complete view of the conditions of the infrastructure (e.g., geometry, geomorphological context, and risk and hazard indices, etc.). Each index value falls within specific ranges which, (e.g., with a value from 1 to 4), indicate the health of the infrastructure. The index value is not defined a priori but varies according to the aspects considered, in fact, it is possible to deconstruct it to adapt the assessment to different situations and to make it more usable by different users. Moreover, it is possible to view monitoring alerts that show the exceeding of critical thresholds.

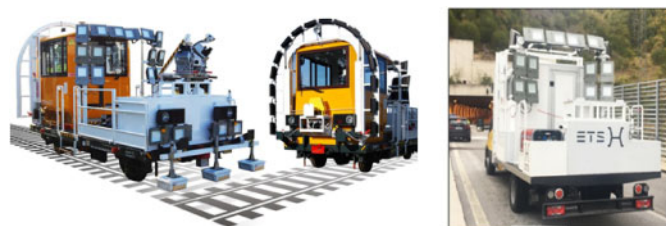
Figure 3. ARCHITA: RAIL (on the left) and ROAD (on the right) configuration (Foria et al. 2019).

In the case of ETS srl, the system developed is ARCHITA, a multi-dimensional mobile mapping system consisting of linked and integrated equipment (Foria et al. 2019). It carries out the survey activity with an average speed of 15-30 km/h, minimizing the impact on existing lines with shortstop of the traffic and without disconnection of the electrical tension (for railway). The system can work in two different configurations (Figure 3): RAIL and ROAD.

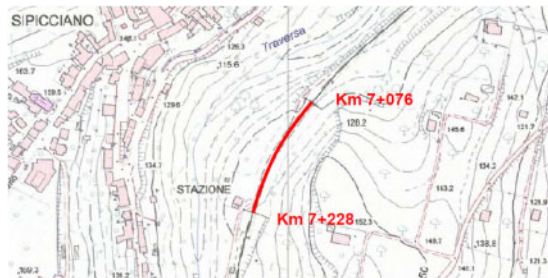
Figure 9. Galleria Sipicciano I – Regional Technical Cartography (CTR).

The Galleria Sipicciano I is located between ch. 7+076 and ch. 7+228 of the Attigliano – Viterbo railway line within the municipal area of Graffignano (VT) (Figures 9 and 10) (Foria et al. 2020).

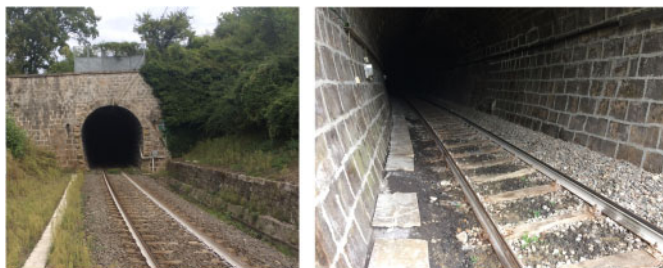
Figure 10. Galleria Sipicciano I: Photo of tunnel entrance ch. 7+228 (on the left) and photo inside the tunnel (on the right).

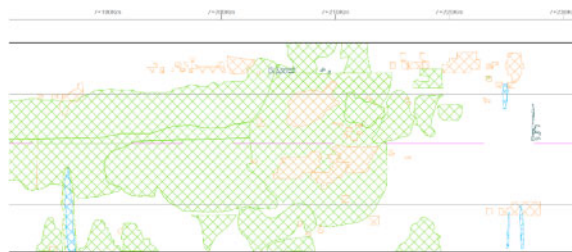
Figure 14. Defects map in CAD environment (Sector 1).

These indices were then used in the SMCA analysis (3.5) for the evaluation of the priority index. In Figures 13 and 14, the results of Manual Digitalization on Galleria Sipicciano I are shown.

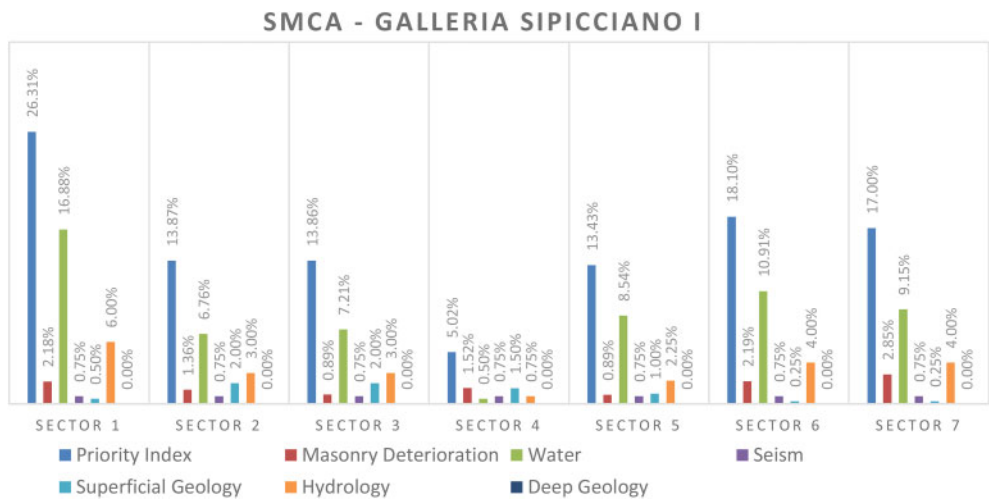
Figure 18. Priority Index.

For Galleria Sipicciano I, six categories were considered: Deterioration of the masonry, Water defects, Seismicity, Hydrology, Superficial Geology, Deep Geology. To have comparable analysis, it was decided to maintain the same sectors used for defect analysis. The results obtained for each sector are shown in Figure 18.

The results obtained highlight what was shown in defect analysis. The priority index indicates a high component linked to the presence of water and hydrology, especially in the sections of the tunnel entrance.

In conclusion, the priority of intervention on this tunnel, barring hydraulic problems near portals and center of the tunnel, is low and the actions to be carried out must be precise and will mainly concern water disposal.
