# Managing sidewalk pavement maintenance: A case study to increase pedestrian safety

*Maria Vittoria Corazza\**, Paola Di Mascio, Laura Moretti

Department of Civil, Building and Environmental Engineering, Sapienza University of Rome, Rome, Italy

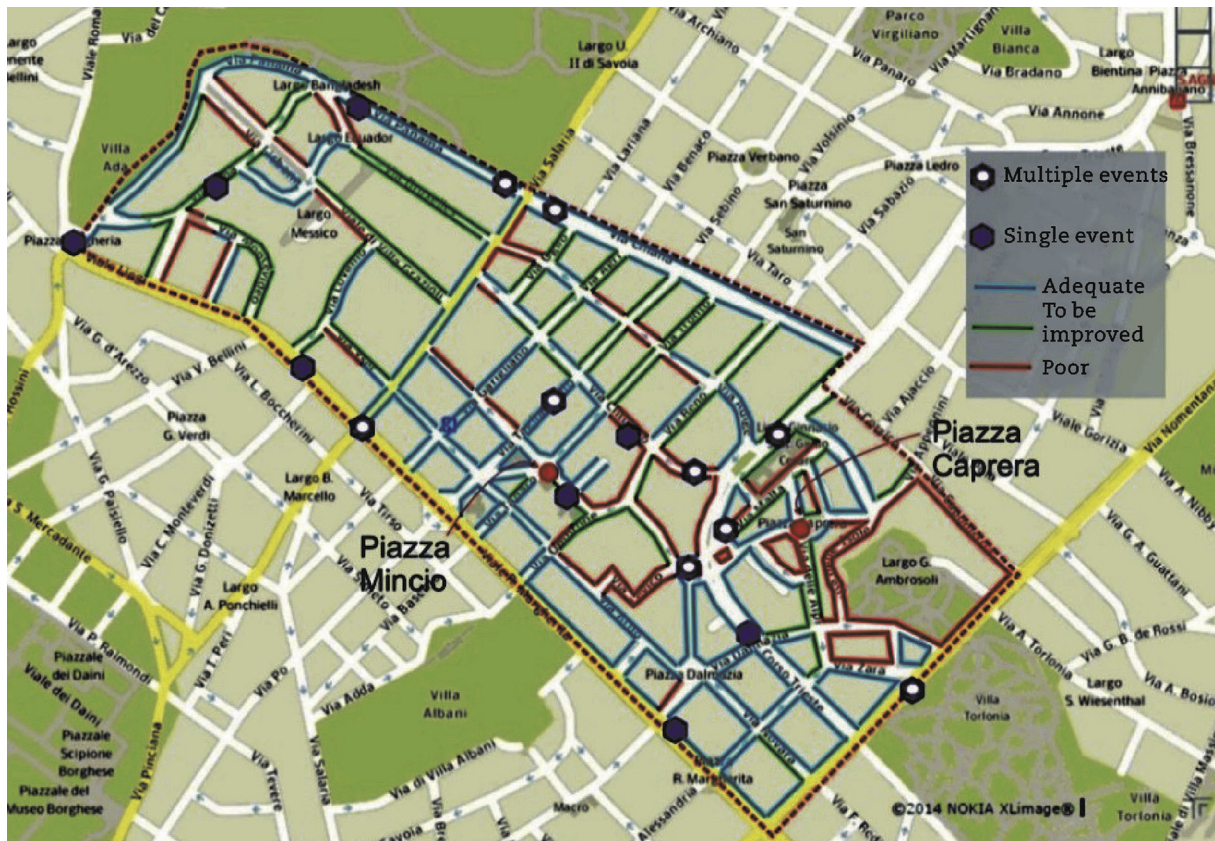
Fig. 4 – Trieste Test Field.

At the end of this process one area resulted more appropriate than the others due to the additional higher recurrence of accidents involving pedestrians (Fig. 4). In this 5500 m<sup>2</sup> area virtually corresponding to the yellow-highlighted one in Fig. 2, called the Trieste Test Field (TTF), the whole pedestrian pavement network was analysed, excluding the private access areas with interrupted sidewalks (for example driveways) as further described.
