Crack formation and damage evolution during consolidation in TBM driven tunnel linings in fine-grained soils

The paper deals with the numerical modelling of crack formation in segmental tunnel linings. A series of numerical analyses was conducted using the finite difference code FLAC2D. The primary aims of the analyses were to back-analyse the damage pattern observed in a TBM driven hydraulic tunnel excavated in clayey soils and to evaluate the safety level of the excavation assessing the stress and strain state of the lining.

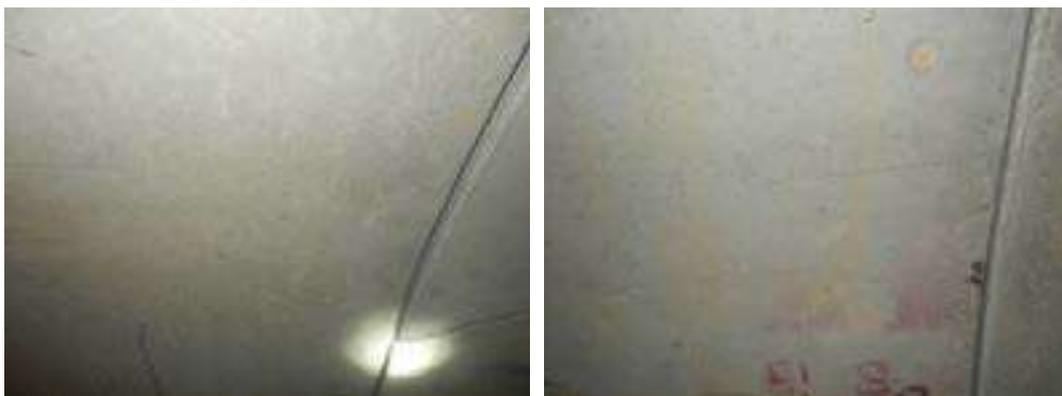
Under low cover depths, the construction proceeded normally and no problems were detected. As the cover depth increased towards its maximum value, a stretch of about 40 meters of the tunnel, near the excavation face, developed significant damage: sub-horizontal cracks were found at the intrados of the lining, roughly at the sides of the tunnel wall (see Figure 1), while at the crown some portion of concrete were detached, as showed in Figure 2. The workers reported hearing noises and noticing appreciable displacements of the lining segments in the damaged area. Through the erector pin holes, it was found a centimetric residual gap between the crown of the tunnel and the surrounding soil; at the springline and below, the soil was adherent to the lining.

Figure 1. Sub-horizontal cracks at the sides of the tunnel. Misaligned segments.

The depicted damage pattern was associated to a strongly asymmetrical closure of the surrounding soil onto the lining. In ordinary excavation condition, the ground closure onto the lining is practically symmetrical; in fact, even though the convergences are slightly different along the tunnel wall (the only exception being an isotropic geostatic stress state of the surrounding soil), the automated tail void grouting “fixes” the position of the surrounding soil before it experiences significant deformations. This ensures a globally compressive state of the lining and low variability of the normal forces along the wall.

The reported damaged was induced by the combined effect of two causes: a) the anisotropy of the geostatic stress state ($K_0 = 0.6$), which, in cases of large deformations as the ones allowed by design in the problem at hand, induces a strongly plastic behaviour near the springlines and, consequently, higher convergences on the horizontal diameter than on the vertical one; b) the downward movement of the lining, which was not co-axial to the excavation profile because of i) the lack of proper application of the hydraulic jacks’ thrust on the lining segments during every phase of the construction and ii) the absence, or at least the significant delay, of the tail void grouting.

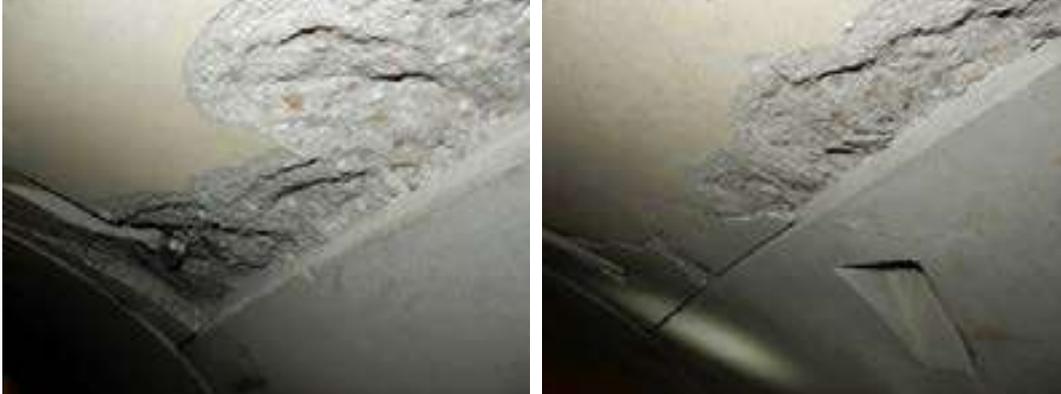
Figure 2. Concrete detachments in the upper part of the lining ring.
