SAPIENZA
UNIVERSITÀ DI ROMA

XXXI Ciclo Dottorato in Restauro dell'Architettura

**A STUDY ON THE ARCHITECTURAL FEATURES OF HOUSES
CONSTRUCTED FROM XVII TO XIX CENTURY IN THE CITY OF
MASHHAD**

Dottoranda: Rana Daneshvar Salehi

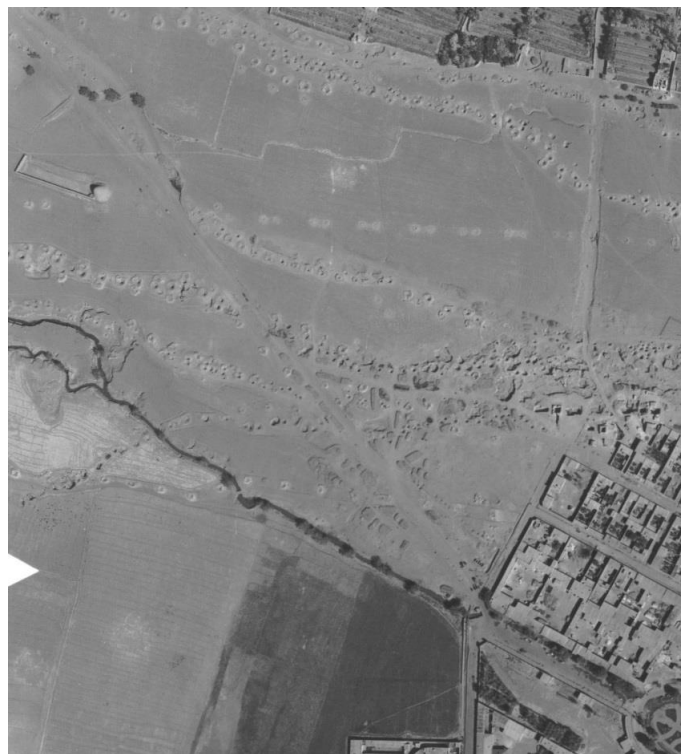
Figure 1.4 The presence of old *qanat* shafts outside northern Mashhad near the gateway and city's defensive wall, aerial photo (1956). (Archive of North-Eastern Cartographic Center)

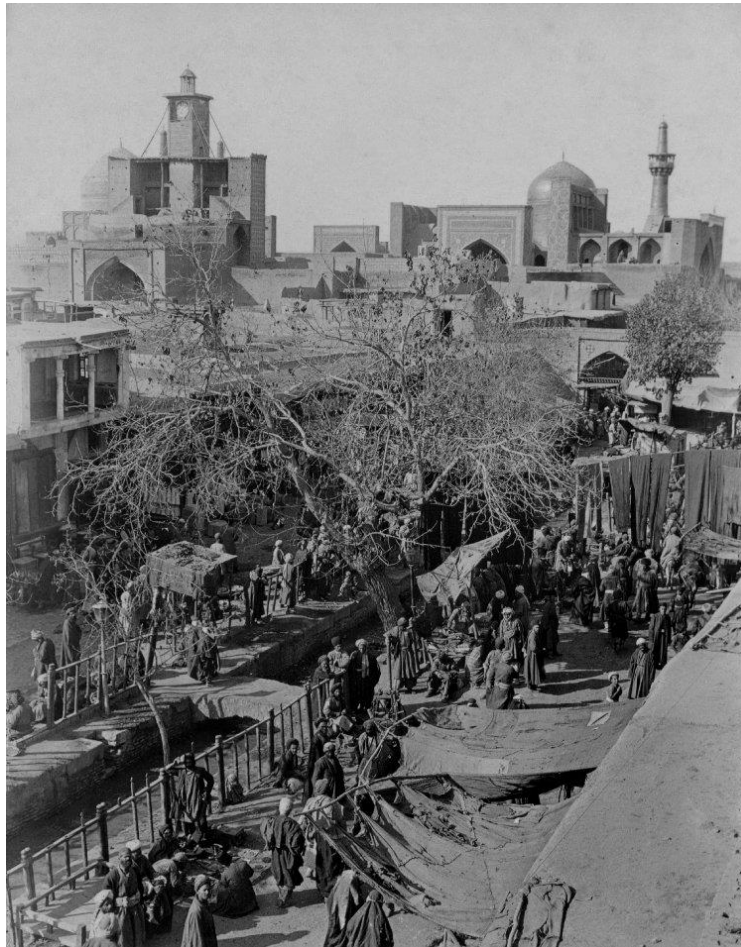
Figure 1.17 Paein khiyaban or Lower Avenue and its central canal, in the 19th century. (http://www.britishmuseum.org/research/collectiononline/collection_object_details; accessed date: November 3, 2016)

In the core of khiyaban, there was a stone canal, nine feet wide and 5 feet deep, in which the water was coming from the ceshme-ye gilās. The construction of this canal played a considerable role in the growth of the population of Mashhad, and inhabitants used it for drinking, washing and religious ablutions, although it would be dirty and marshy after entering the town.³⁸

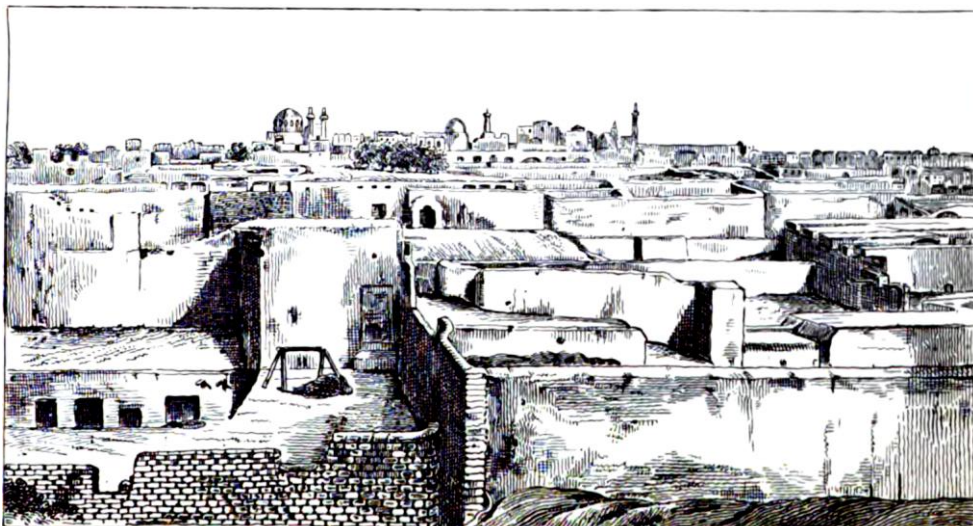
Figure 1.31 MacGregor’s illustration representing a uniform level of mud house-tops and Imam Reza’s shrine at the background. (MacGregor 1879, 283)

In his opinion, apart from the golden dome, minarets of the shrine and Goharshad Mosque, Mashhad had no other significant buildings, and the whole town presents a consistent level of mud house-tops with a few *badgirs* (windcatchers).⁶¹

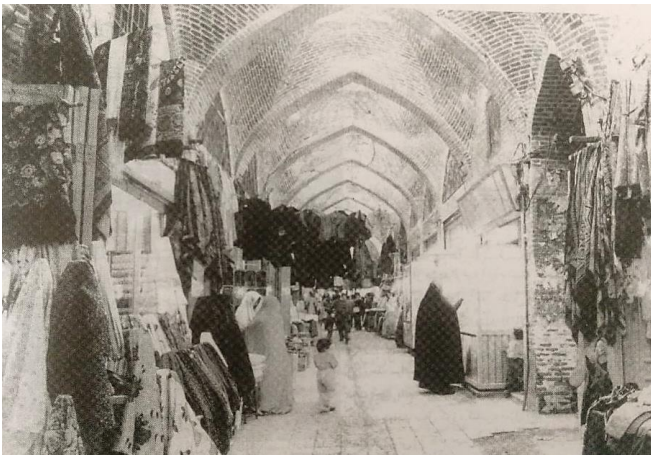
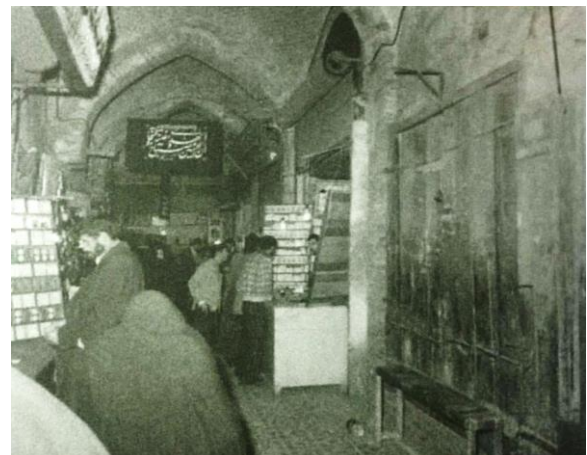
Figure 1.33 The main Ancient Bazaar (Rezvani 2005, 246). **Figure 1.34** Vazir Nezam bazaar constructed in bala khiyaban, which was later destroyed by the start of the shrine development plan in 1975. (<http://mashhadenc.ir/>; accessed date: May 19, 2018)

Like his grandfather, Naser al-Din Shah (1848-1896 AD) paid attention to the religious buildings, he traveled to Mashhad twice. On his journeys, he ordered to complete a new court at Imam Reza’s shrine and replacement of the wooden roof of the grand bazaar with durable brick-arched ceiling and, as well as making a domed ceiling for roofing another bazaar, near the grand one. In fact, the alleys of different bazaars were lit and ventilated by large holes placed at intervals in the brickwork of the vaulting.⁶²

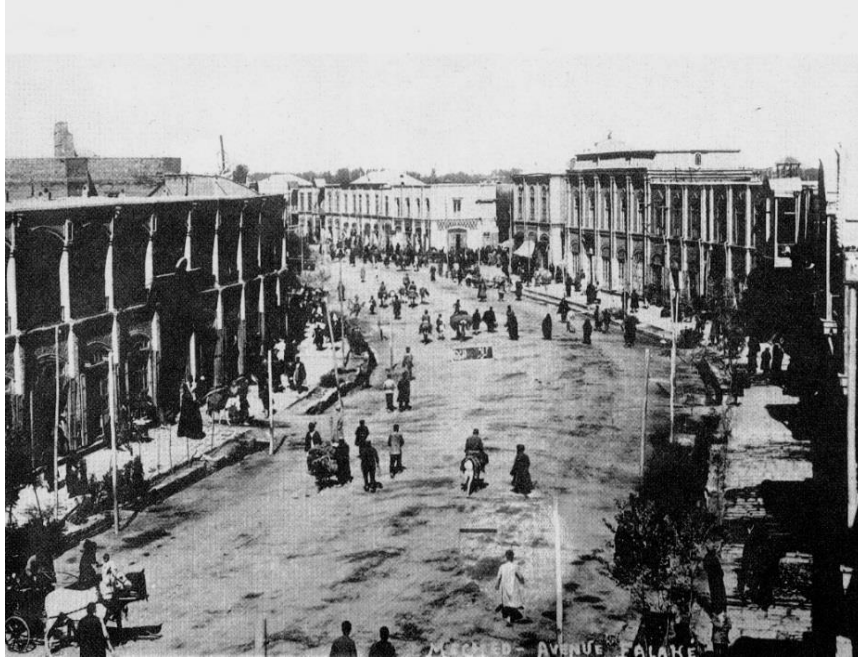
Figure 1.41 (1939) *Falake hazrat*. The image presents the replacement of introversion architecture by extraversion one and the transformation of dome-adobe ceiling into the pitch-roof. (<http://meshad.mihanblog.com/>; accessed date: May 10, 2018)

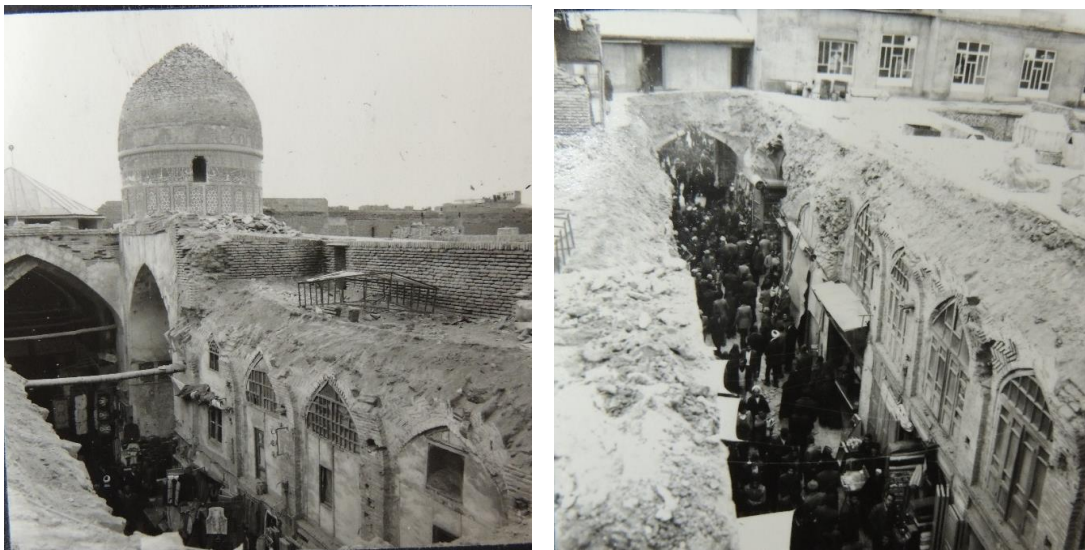
Figure 1.47 (1956) The semi-ruined ceiling of the Ancient Bazaar near Dodar Madrasa dome. **Figure 1.48** (1956) A piece of western half of Grand Bazaar. (KH-CHHTO archive)

Another route, named Khosravi No, was created along Khosravi St. which was built under Reza Khan era. This newly constructed street led to the breakdown of the city's bazaar for the third time. The Ancient Bazaar has been before divided twice; under Safavid and Pahlavi I. A part of this bazaar was demolished again and placed on the two sides of the Khosravi No St. A large portion of the residential buildings was also destroyed, and even the lands of mansions were divided into two parts in such a way that their garden was placed on either side of the street. For this reason, in order to recompense for this destruction, small bazaars were made, including the Haj Aghajan bazaar in the vicinity of Rezvan Garden and the Sarab bazaar in Sarab district.⁸¹

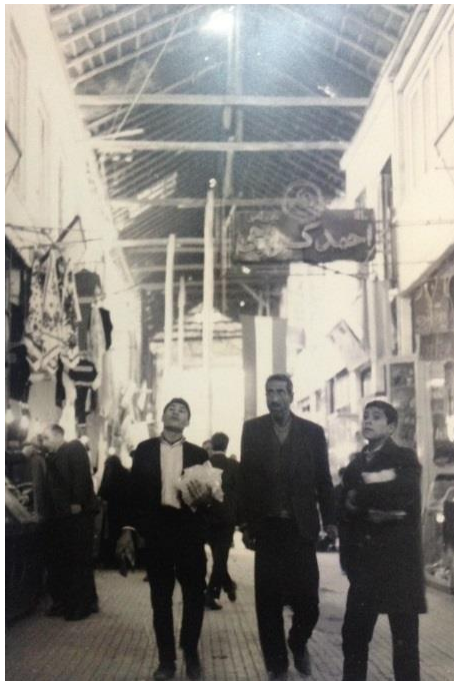
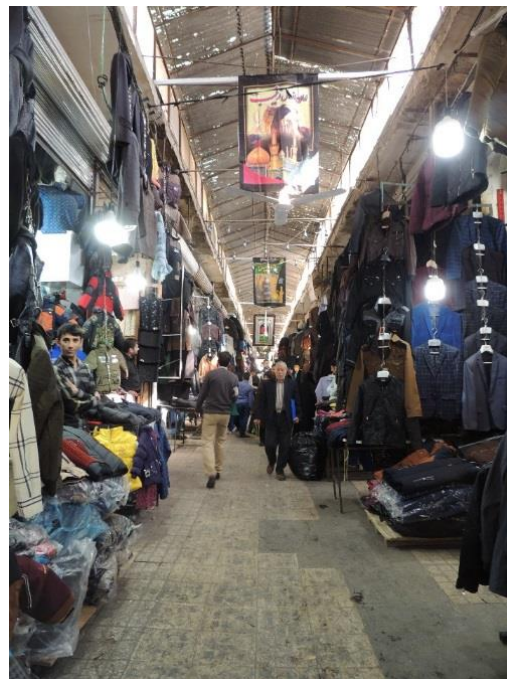
Figure 1.55 (1970s) The initial structure of Hazrati Bazaar. (Morasa 2015) **Figure 1.56** (2017) The current state of Hazrati Bazaar.

Since the merchants lost their property in this plan, Valiyan built Reza bazaar adjacent to the passage of Eidgah, which is perpendicular to the Tehran Ave., in 1976.⁸⁴ Also, the Hazrati Bazaar, which is now in the vicinity of Abbas Quli Khan’s Madrasa, moved from the Ancient Bazaar to the current place in 1976 due to its destruction in the development plan of the square.⁸⁵

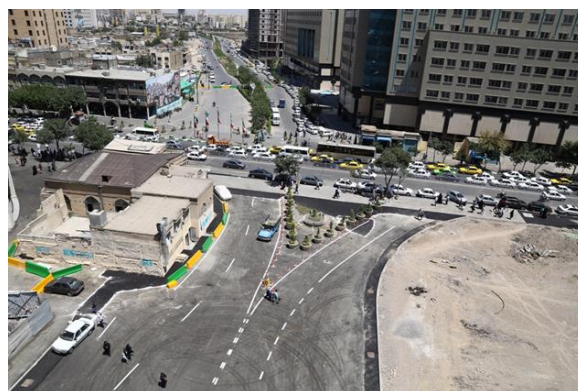
Figure 1.59 Razavi Sharestan, section (IV). (<http://www.samen.mashhad.ir>; accessed date: October 05, 2017)

The Samen municipality defines replacement of the historic district with a recent and new one as the primary purpose of the project to provide an exceptional urban aspect to the city and consequently create a contemporary space for pilgrimage. For this end, the traditional narrow lanes that were all connected to the holy region were destroyed along with their historic houses and public monuments which acted as the primary and essential components in the concept of an Islamic city. Studying all four maps guides us to identify about the semi-circular highway; *Razavi Sharestan* as a connecting path between the four sections.

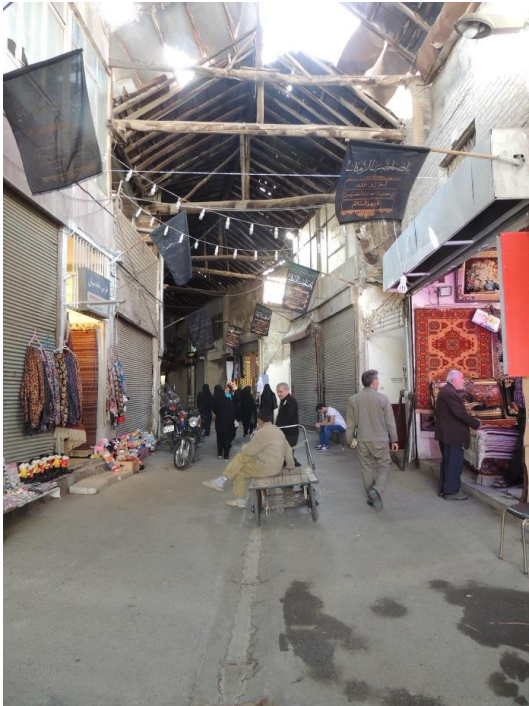
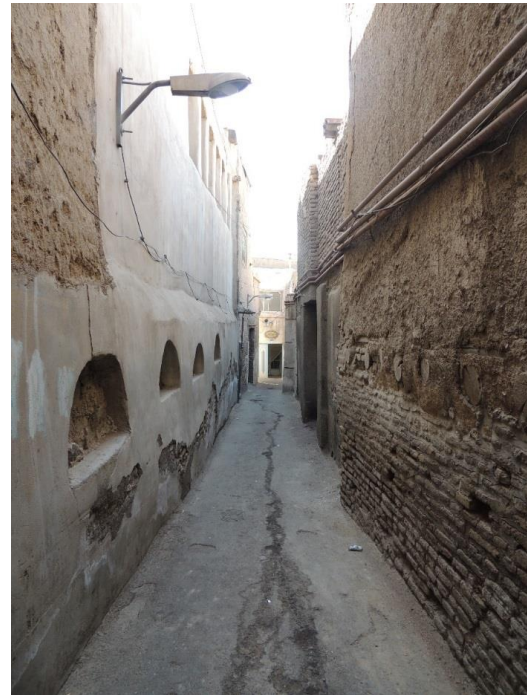
Through the making of this disadvantageous element, a significant portion of the residential neighborhoods, that also included caravanserais, bazaars, hammams, alleys and stores, became demolished, even those that had been registered as national cultural heritage.

Figure 1.61 The only part left from the Ancient Bazaar, now known and called as the Carpet Bazaar, starting from Khosravi No St. and ending near the Shah Mosque-Hammam. **Figure 1.62** A traditional narrow alley survived from recent demolitions in Lower avenue (Paein khiyaban).

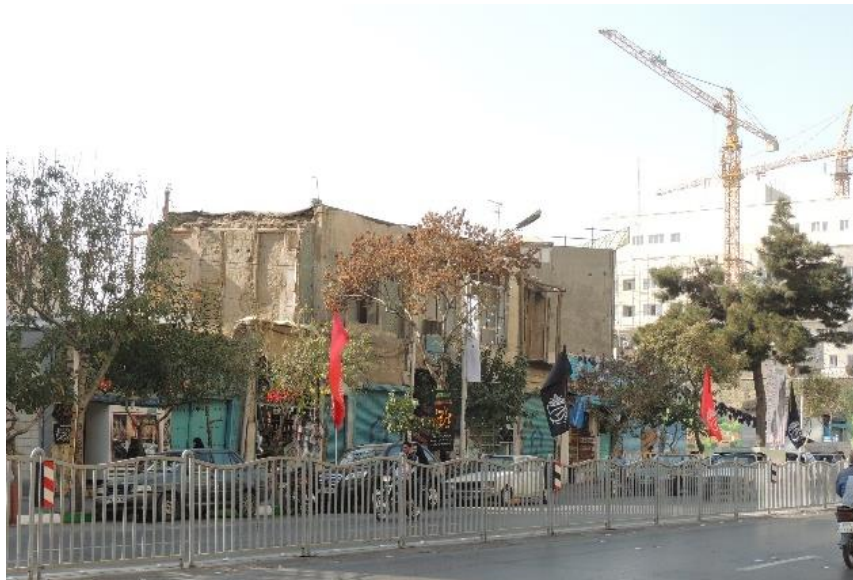
All destructions have led to the erection of modern malls, hotels, parking and apartments that give an unpleasant appearance to the historic center. For example, Fig.1.64 illustrates an apparent disharmony between recent constructions and historical ones. It clearly presents the expansion of the sidewalk and creation of heterogeneous buildings in the historic district that has now lost its identity due to the new master plan of Mashhad.

Figure 1.64 The location of Haj Ahmadian Yazdi Serai in *Paein Khiyaban (Lower Avenue)* close to Zamen commercial-residential complex.

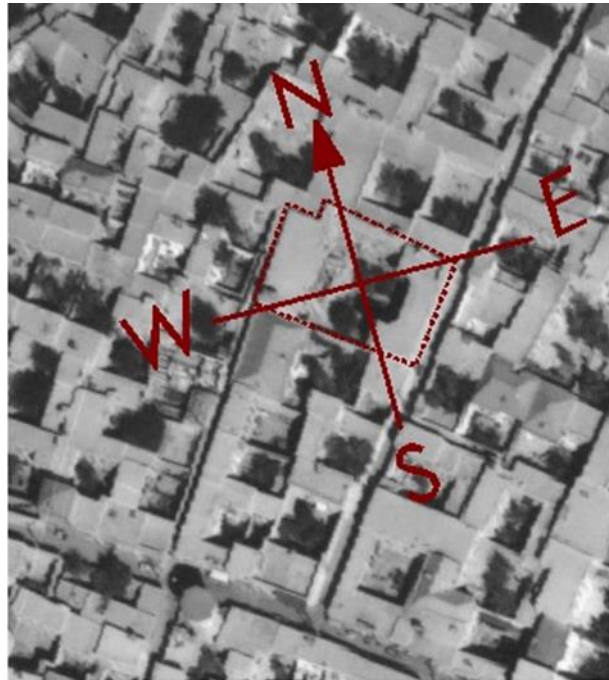
The Darugheh house is inspired by Russian architecture and according to some historians it was erected by Russian builders. The monument was a private house, where also used as a reception place which follows Isfahani orientation North-West/South-East.

Figure 2.4 (1975) Darugheh's house orientation; *roun-e-Isfahani*, aerial photo.

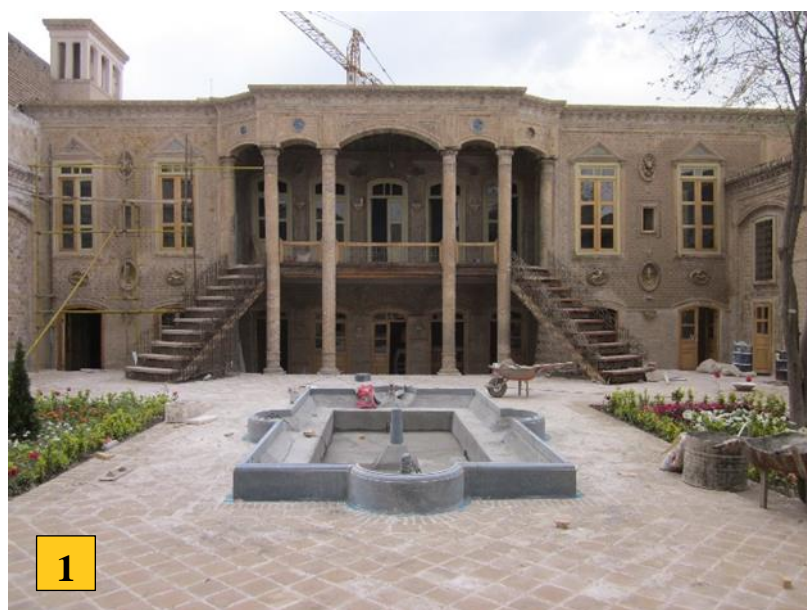
Figure 2.6 The façade of the north western living quarter.

Panjdari, the central reception area with five openings on the first floor where the mural paintings attract everyone’s attention were considered as the guest and also dining room. In the opposite facade, the ground level on the southeastern side consists of a vestibule entrance, cooking room and a *seh-dari* and its adjoining room. The existence of fireplaces and wall heater on the first story of this section confirms the identification of this floor as winter zone. Service area on the northeastern side of the courtyard encompassed storerooms, bath, and a passageway to the roof remained separated from householders comfort. Thus, there are architectural structures exposed to natural phenomena to harness energy and offer a decent home temperature without any cost to manage.¹⁰¹

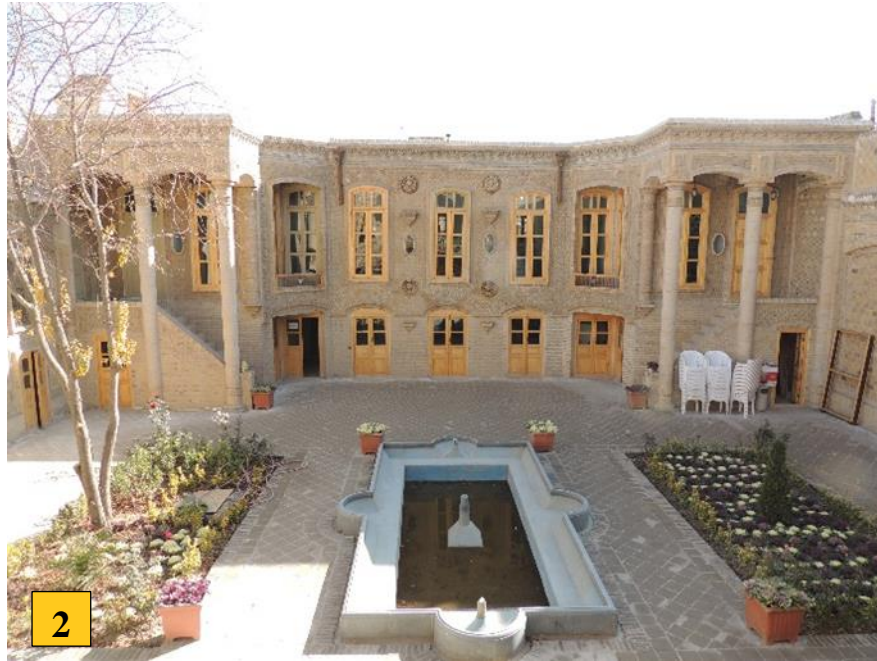
Figure 2.7 The façade of the south eastern living quarter.

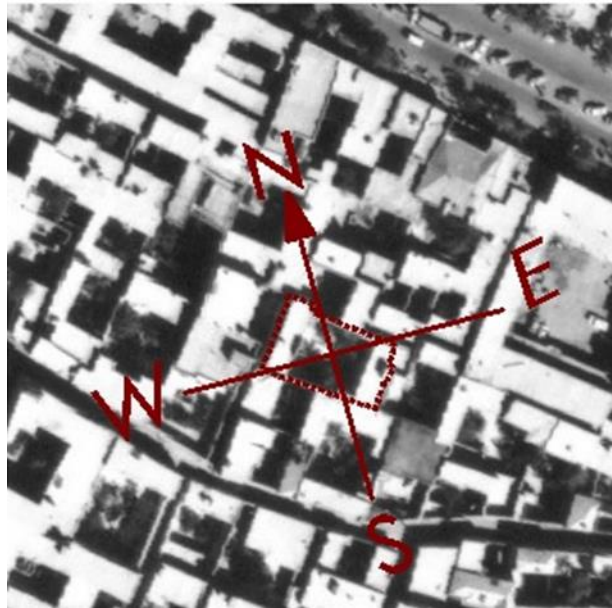
Figure 2.11 (1975) The Isfahani orientation (North-West/South-East) in Amiri House.

The entrance in Amiri's house is centered on the southeastern ground level and made of a *hashti*, an octagonal space. It is opened on the four axes and lined on both sides with flanking side chambers such as a service room and *hoz-khaneh*. *Hashti* can be considered as the versatile architectural unit which gives access to the courtyard, *hoz-khaneh* and also the guest zone.

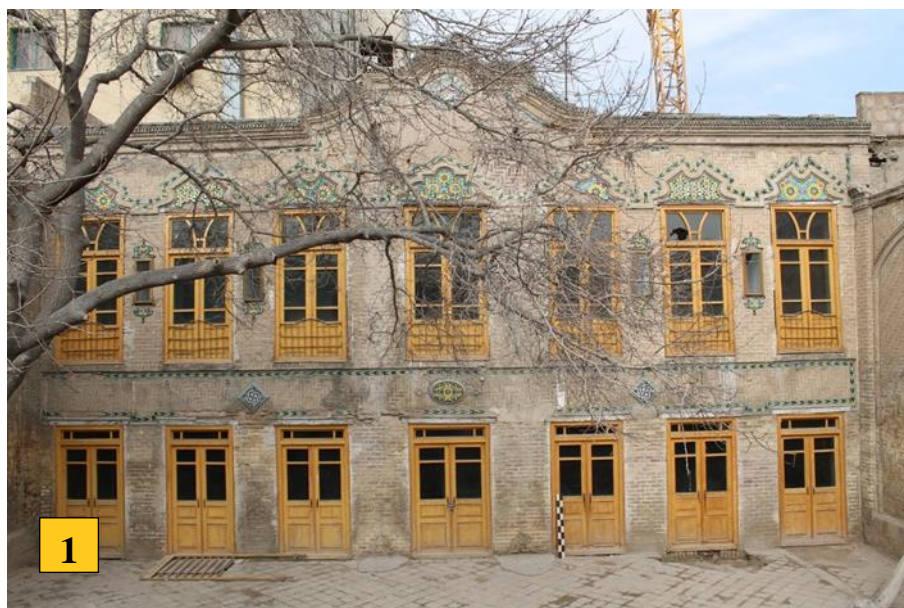
The façade of the northwestern building mass presents a *taj*, a broken skyline element with a crown shape at center. In addition, to supply the ambient light in the dark of nights, there were some places considered for lanterns or lamps on the internal and exterior faces.

Figure 2.13 The latest building mass of house where was serving as the family zone. (Govahi, 2014)

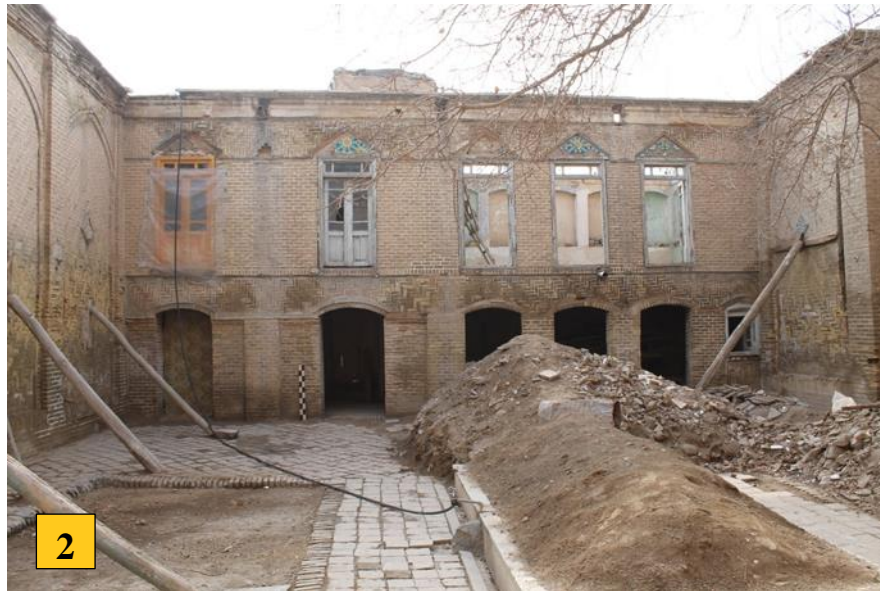
biruni, unlike *andaruni*, does not present itself as an elegant structure. The guest zone is interrupted by a square guest bedroom and reception hall on the first floor. This structure perhaps was built before the northwestern quarter according to the renovation of the facade.¹⁰³ In addition, *biruni* is directed into the Holy Shrine. Based on a religious belief, the first structure of a building should be erected towards the shrine.¹⁰⁴

Figure 2.14 The earliest building mass of house where was serving as the guest zone. (Govahi, 2014)

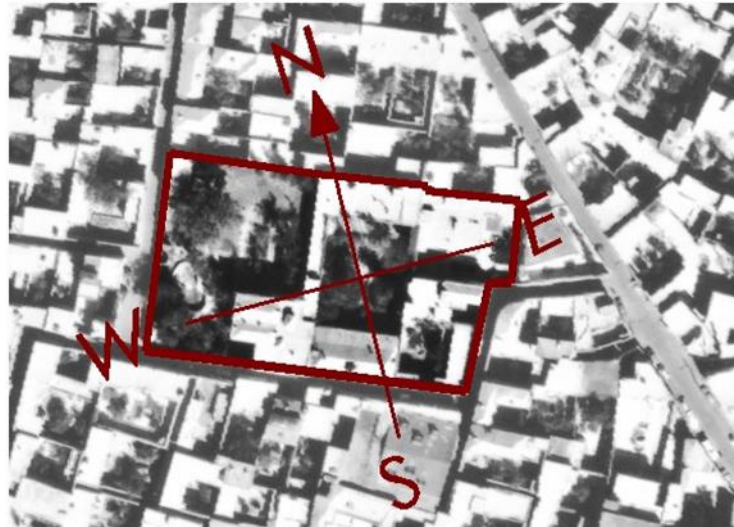
Kuzeh-Kan'ani's house located in Chaharbagh neighborhood and construction of this building belongs to Pahlavi I era (1925-1941). Kuzeh-Kan'ani's house is aligned on the *qibla* (the direction of the Kaaba in Mecca) that is the *rasteh orientation* North-East/South-West with four yards.

Figure 2.15 (1975) Kuzeh-Kan'ani's house is followed the *rasteh orientation* North-East/South-West.

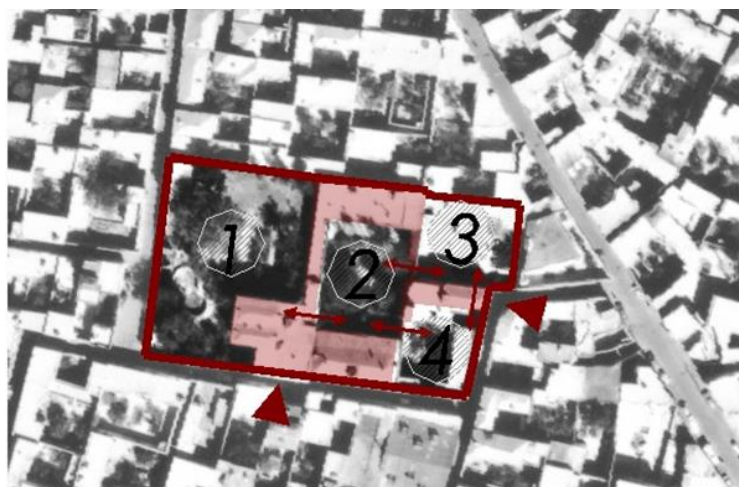
It was one of the few houses in Mashhad which had more than one courtyard. Each court is connected to the adjacent area, which is accessible through the openings on its walls. Access to the householder's area and garden would be gained through an indoor entrance of massive brick columns and semi-columns centered on the south external facade. The family living quarter is divided into two sections associated with a central yard; the southwestern building mass with an *iwan*, and a three-story building on the northeast. In spite of the many differences that can be seen in facades, both divisions on an immoderate frontage and a more moderate one perform a precise symmetry and harmony.

Figure 2.16 (1975) Distribution of courtyards on Kuzeh-Kan'ani House.

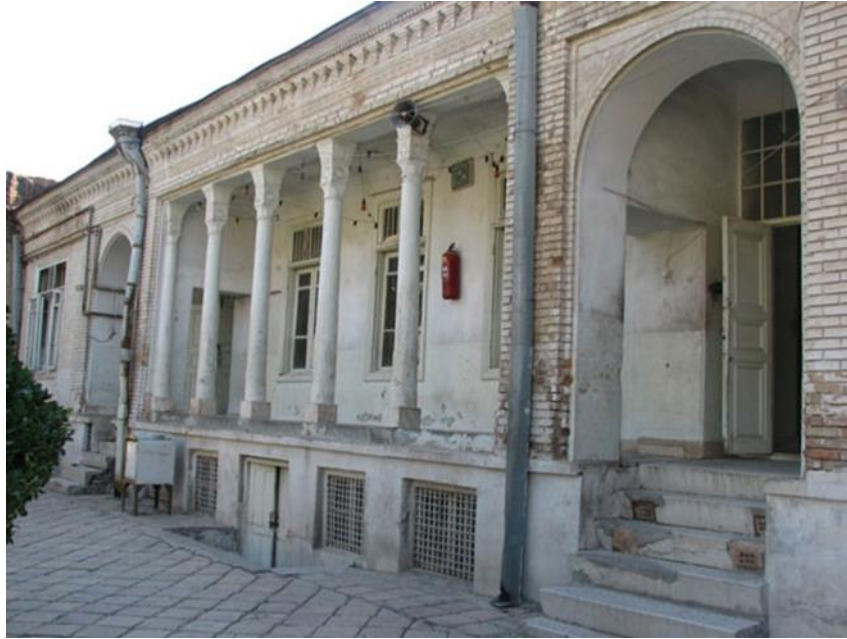
Figure 2.17 Family living quarter; the southwestern building mass with an *iwān*. (Source: <https://memari98.com>; accessed date: January 18, 2018)

A coal heater sitting on the left in the living room of three openings was utilized to increase the room temperature in winter. In the underground of southwestern section, in addition to the openings, the small lattice rectangular windows are vertically inserted to enter the daylight.

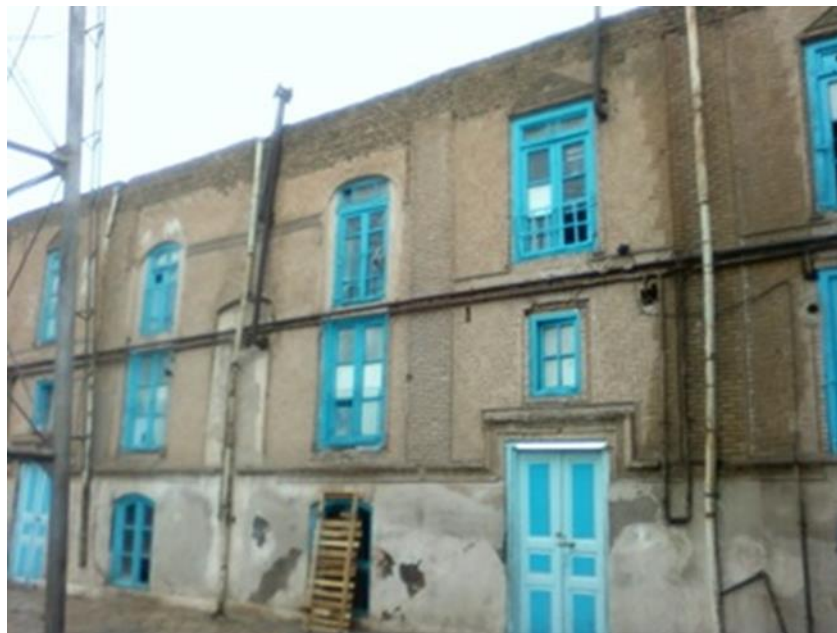
Figure 2.18 Family living quarter; the three-story building mass. (Source: <https://memari98.com>; accessed date: January 18, 2018)

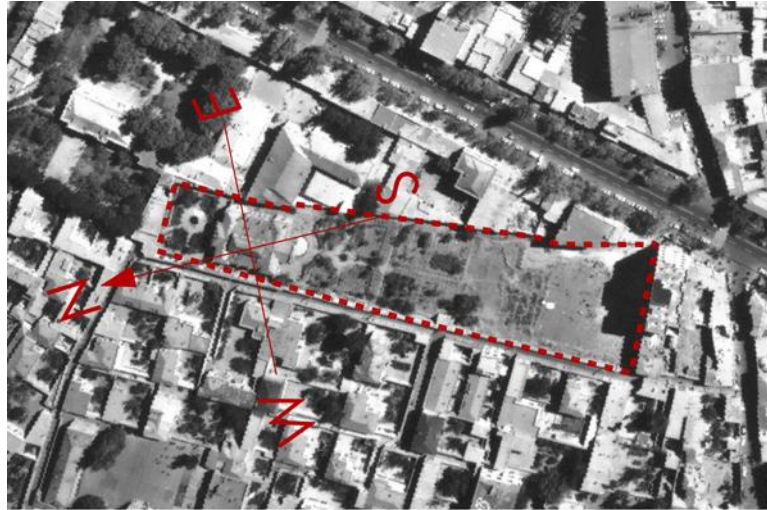
Figure 2.19 (1975) The aerial photo depicts the location of a building mass at the core of the first half of the garden. It also presents the destruction of the second part which has made to construct a madrasa.

The garden of the house was considerably enormous before it was divided due to the construction of Shah Reza street in 1939.¹⁰⁹ It has further been distributed into two halves in the 70s in order to construct a madrasa in the bottom half. Afterwards, a mosque was built next to the madrasa that caused the total demolition of the house.

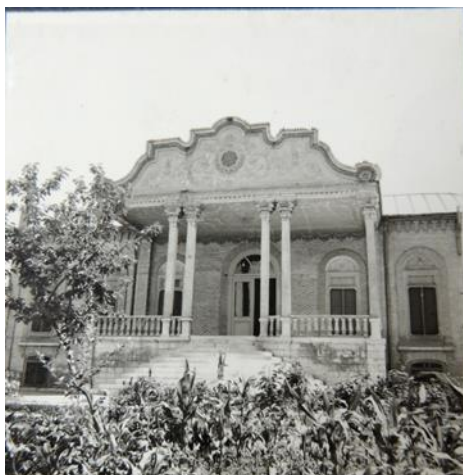
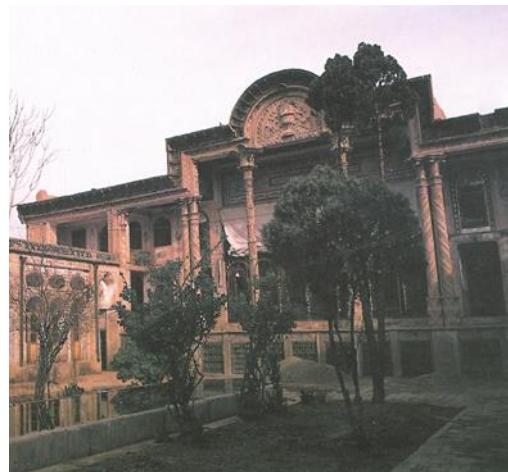
Figure 2.20 (1973) Nasirzadeh Mansion, the southwestern facade; The principal internal entrance with an *iwan* and *taj* (broken skyline element). (KH-CHHTO archive) **Figure 2.21** A'lam's House (Isfahan), the northern building mass that composed of an *iwan* and ornamental *taj*. (Haji-Qassemi 1998, p. 65)

In Nasirzadeh Mansion, *iwān* had six external piers to support the rectangular ceiling along with a broken skyline element shown in a crown shape, *tāj*. Characteristics outlined above plus *iwān* direction to the Kaaba indicated its function as an entrance lobby for both householders and guests. Another important feature in Nasirzadeh's house is the secondary internal entrance derived from a simple *iwān*, laid out in the opposite of the main entry, which is probably made for servants to maintain complete privacy at home. All the faces were formed from high oblong openings framed by semicircular arches.

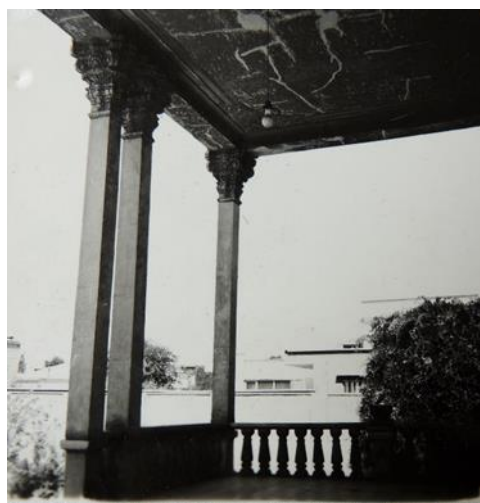
Figure 2.22 (1973) Nasirzadeh Mansion, the structure of *iwan* in the southwestern facade. (KH-CHHTO archive) **Figure 2.23** A'lam's House (Isfahan), the *iwan* from inside in northern building mass. (Haji-Qassemi 1998, p. 69)

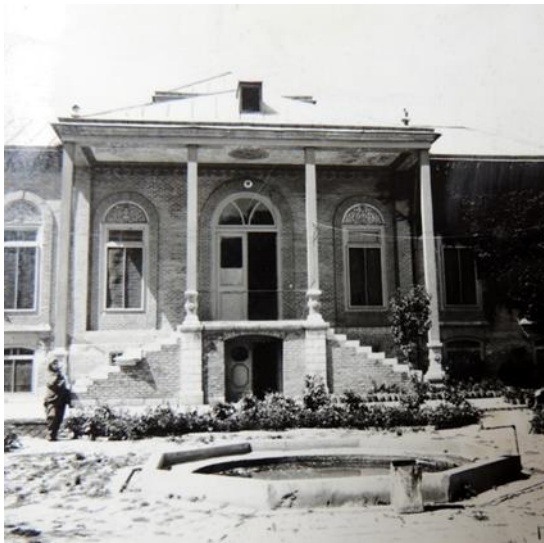
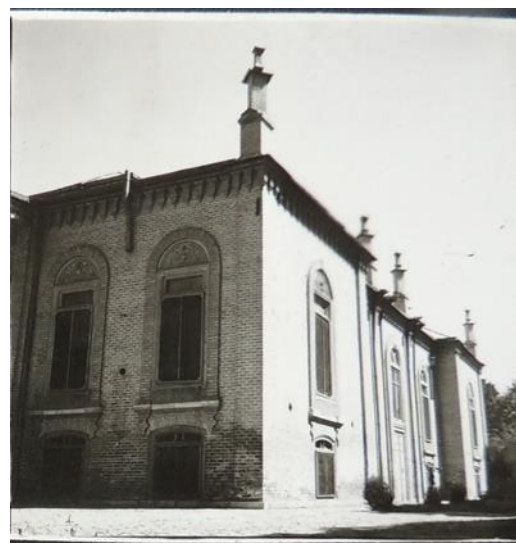
Figure 2.24 (1973) The secondary internal entrance that was reserved for servants. **Figure 2.25** (1973) The southeastern façade of Nasirzadeh House. (KH-CHHTO archive)

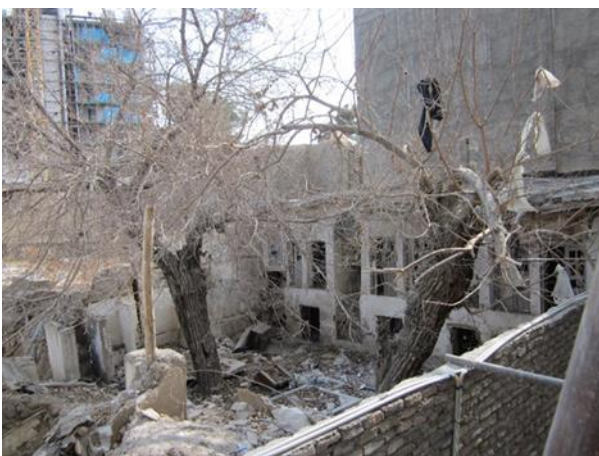
The two-story southwestern building mass of the house was the destination for seasonal immigration of the inhabitants during summer months where there was less exposure to the sun and hot desert winds blowing from the south. According to the architectural survey and study of proportion, the traditional scheme of the summer quarter has been made from the principal spaces associated with a secondary area. Indeed, each floor included an entrance and the living rooms which were in some way connected to a storage. In ornamental terms, the façade performs a regular rhythm and harmony by repeating the rectangular apertures on the first floor which are framed with a frontal arch in semi-circular, sharp or denticulate forms.

Figure 2.30 The presence of courtyard and southwestern building mass in Nili House, drawings highlight the first distribution of spaces; living and secondary zone in which storages are highlighted with yellow.

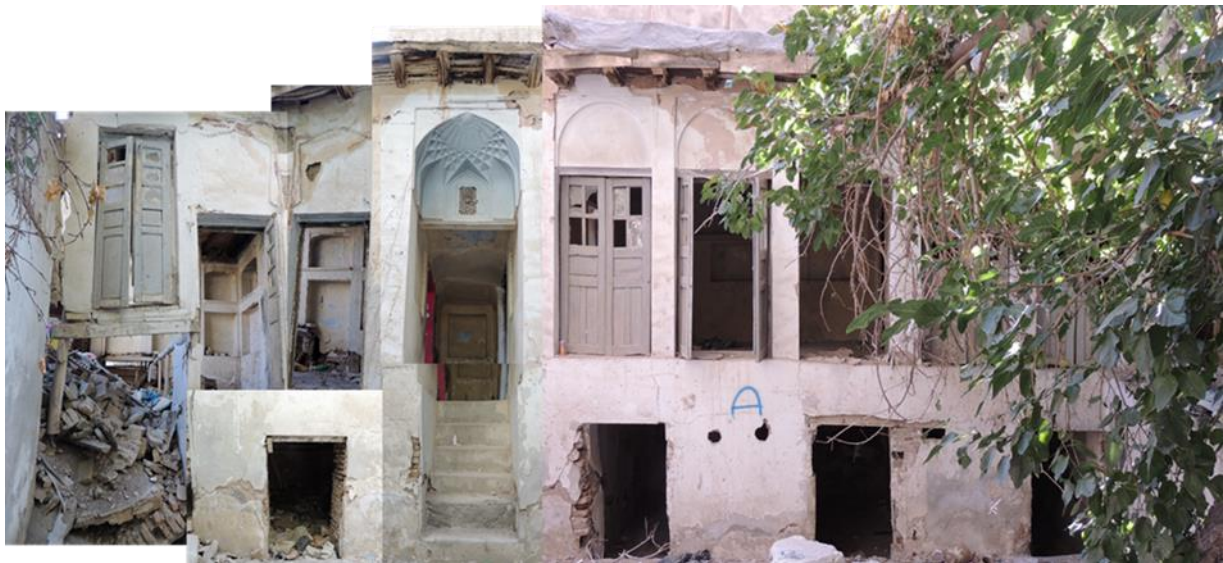
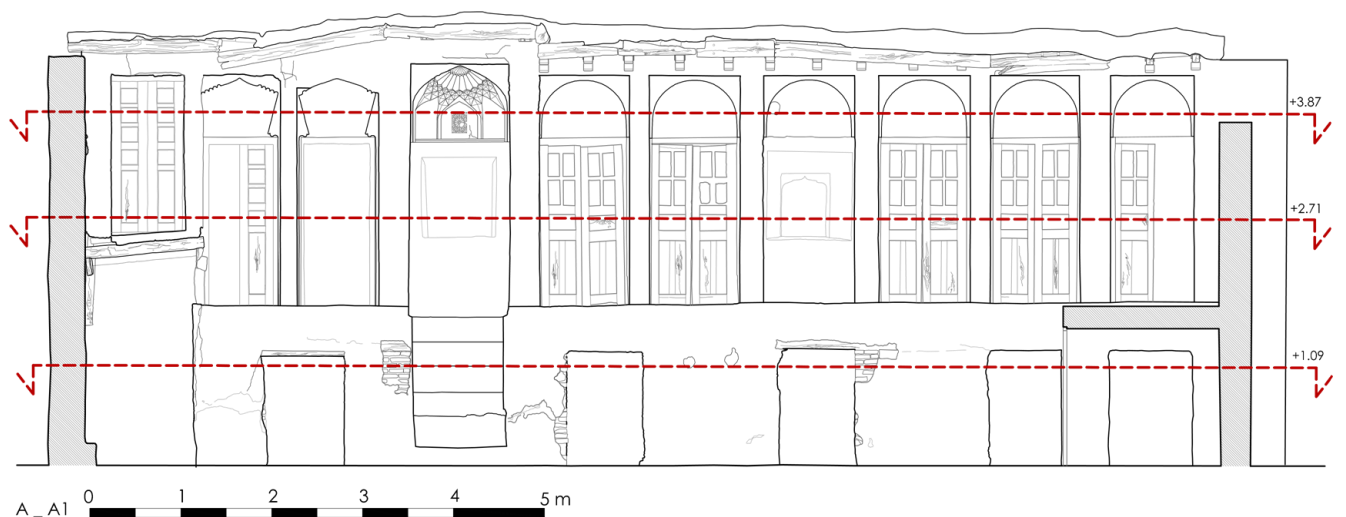
In Nili's house, the central chamber of the ground floor in summer quarter was serving as sleeping zone and the first and last rooms were the appropriate areas for food storages to keep them naturally fresh. In addition to conserving foods, in these zones barrels of water have been maintained as well. In the past, the passage from an enclosed zone to another one was continuously repeated without any interruption.

Figure 2.31 The two-story southwestern building mass, summer quarter façade.

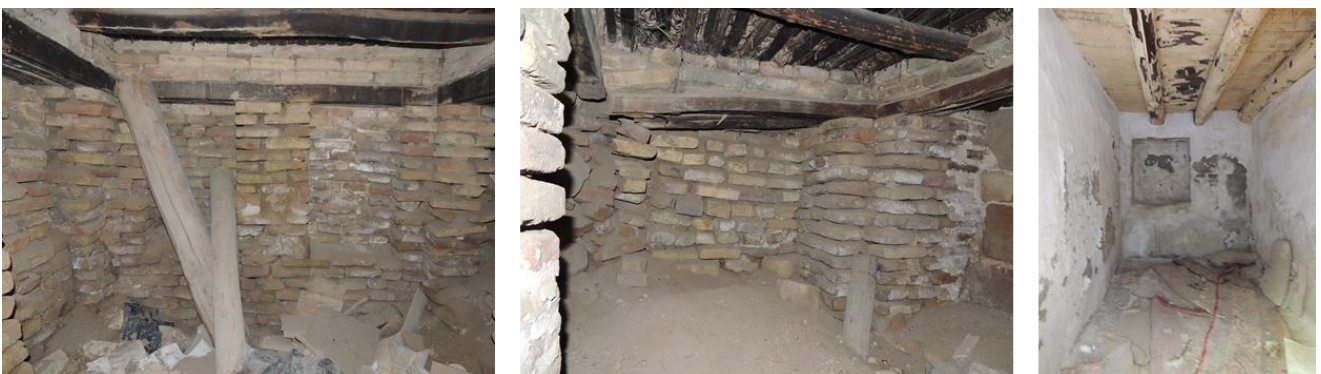
Figure 2.33 Summer quarter, the rooms on the ground floor.

On the ground story of the summer quarter, there is a cross-shaped area was allocated to *hoz-khaneh*, a pool room. According to the householder's statement, this room has been used as a place to take siestas during summer days. The pool had been employed as an architectural and aesthetical component in collaboration with natural elements namely water and wind to manage their energies and form a sustainable architecture. It generally provides a high amount of humidity and relaxed atmosphere and its water is also used for washing and ablution. The connection between *hoz-khaneh* and courtyard was possible through five openings placed on the southwestern wall. Moreover, this room is directly linked to the entrance corridor that ties inside with outside.

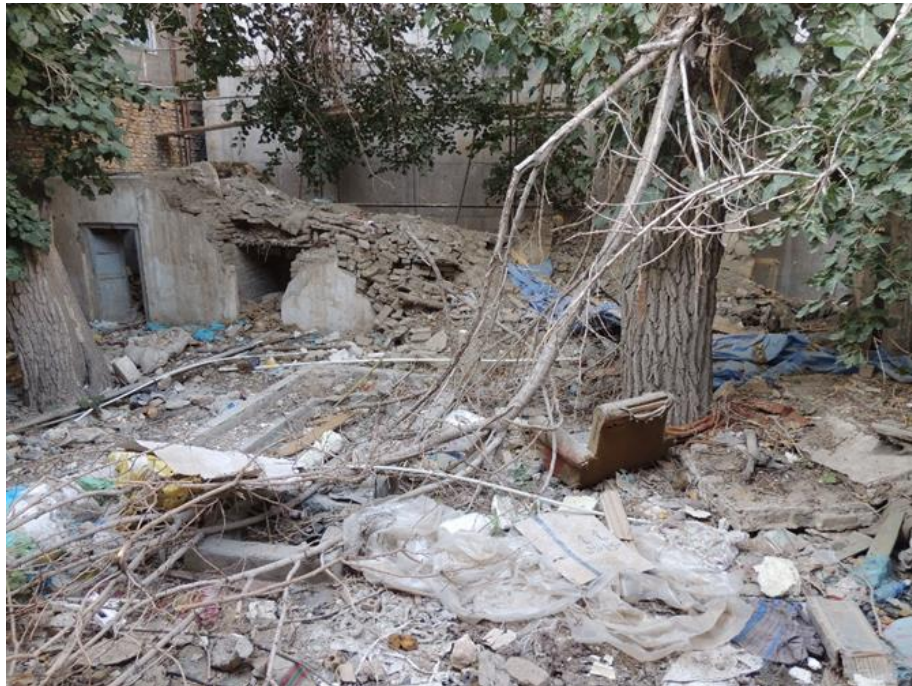
The ruined building mass on the north-eastern side of the court is a relatively recent structure which was built during Pahlavi I era (1925-1979) on the foundation of a previous construction. This portion is identified as the winter quarter of the house because of its location contrary to the direction of cool winds coming from the north and northeast. Undoubtedly, its typology and structural area were not so far from those of summer quarters. It seems that in winter quarter, three spaces that are reserved for cooking, living and storages located and interconnected from inside.

Figure 2.34 The ruined building mass on the north-eastern side of the court (winter quarter).

At first glance, it appears that the house had almost lost its authentic identity completely. In fact, those changes and renovations performed by homeowners had caused damage to various parts of the building, particularly the northeast quarter, the eastern wall and the entrance passageway. The entrance corridor is currently filled and closed by the collapse of the eastern boundary wall through a gradual process of human activities and environmental impacts.

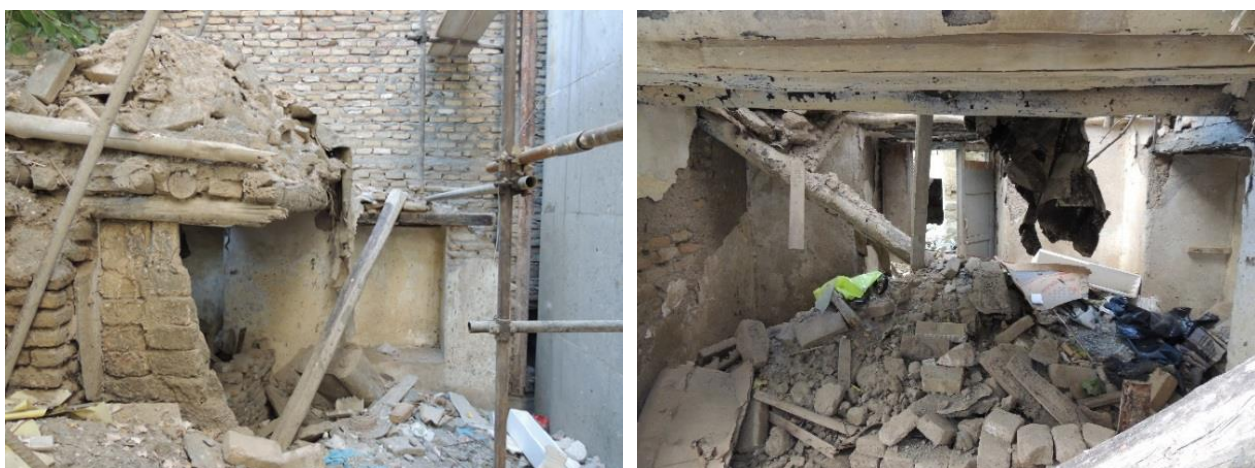
Figure 2.35 The ruins of cooking room in northeastern mass.

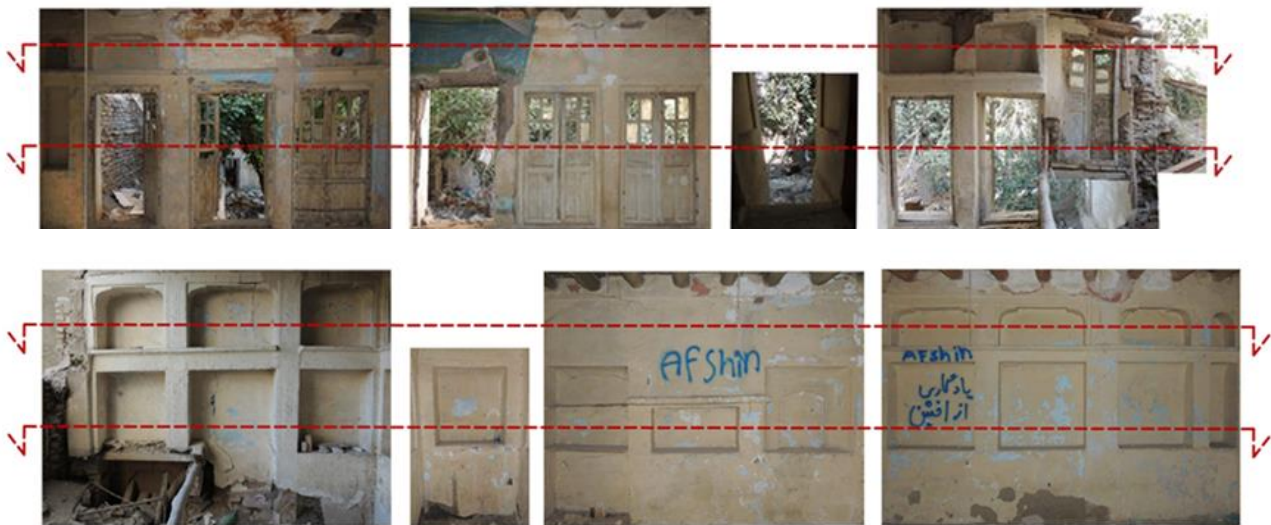
Figure 2.39 The internal façades of the summer quarter which performs a regular symmetry.

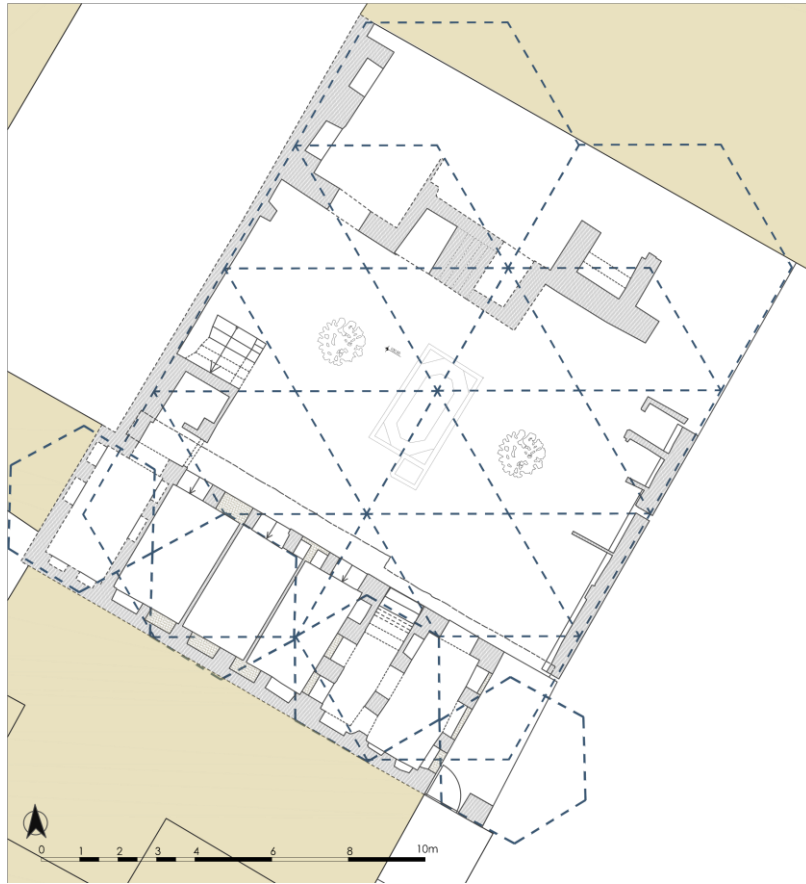
The guest room total area is approximately 17.15 m², half of the living chamber by considering the thickness of the walls. It is interesting to note that through Iranian Golden Rectangle, the architect has managed to divide the land in a balanced way and then distribute the spaces in a regular mode. Although, in internal zones, the proportion of Golden Rectangle does not conform to the plan, it is sufficiently close to it.

Figure 2.41 The analyzing the Nili House proportion through bringing the regular hexagon to the layouts of buildings, Iranian Golden Rectangle system.

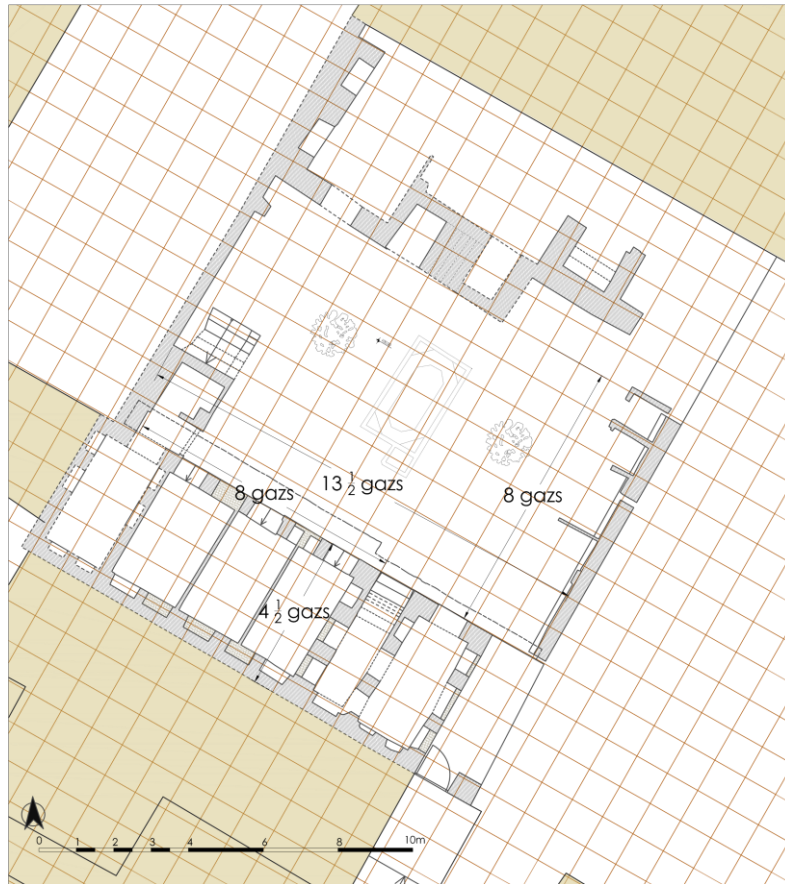
The placement of traditional modules made of *gereh* (6.66 cm) on layouts of Nili House specifies that the builder considered *gereh* as the basis unit to divide the land in a balanced way and distribute the spaces in a proportionate system. Although, it seems that the proportion of rooms is closer to the minor module than the large one.

Figure 2.42 The placement of minor module (*minor gaz*) made of 14 *gerehs* on the ground and first floors.

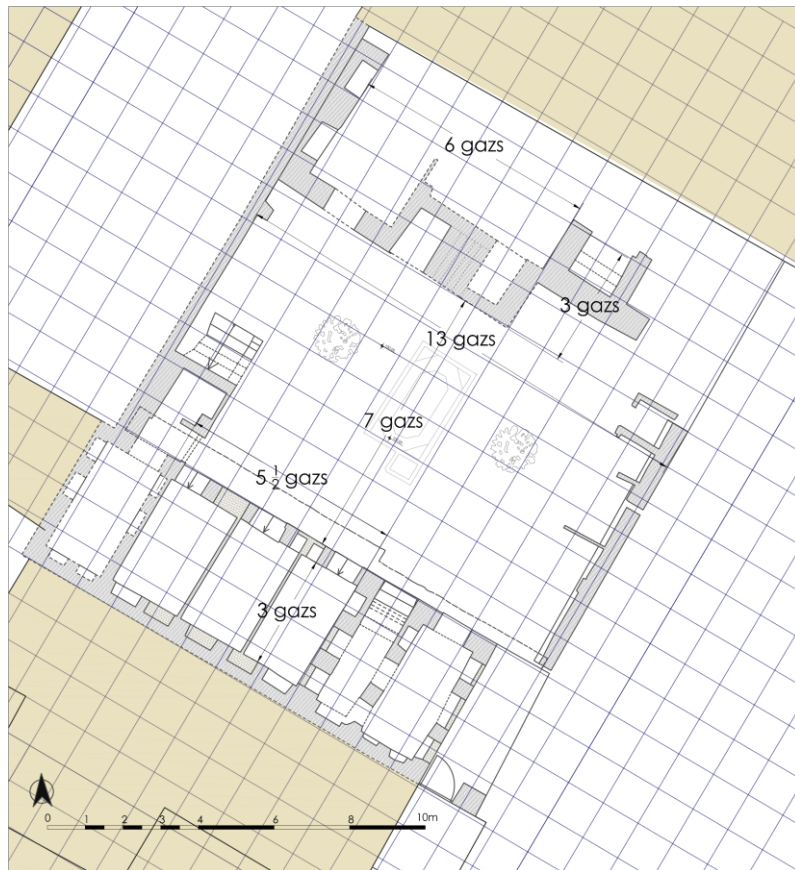
Figure 2.43 The placement of large module (*large gaz*) made of 16 *gerehs* on the ground and first floors.
