SAPIENZA
UNIVERSITÀ DI ROMA

XXXI Ciclo Dottorato in Restauro dell'Architettura

**A STUDY ON THE ARCHITECTURAL FEATURES OF HOUSES
CONSTRUCTED FROM XVII TO XIX CENTURY IN THE CITY OF
MASHHAD**

Dottoranda: Rana Daneshvar Salehi

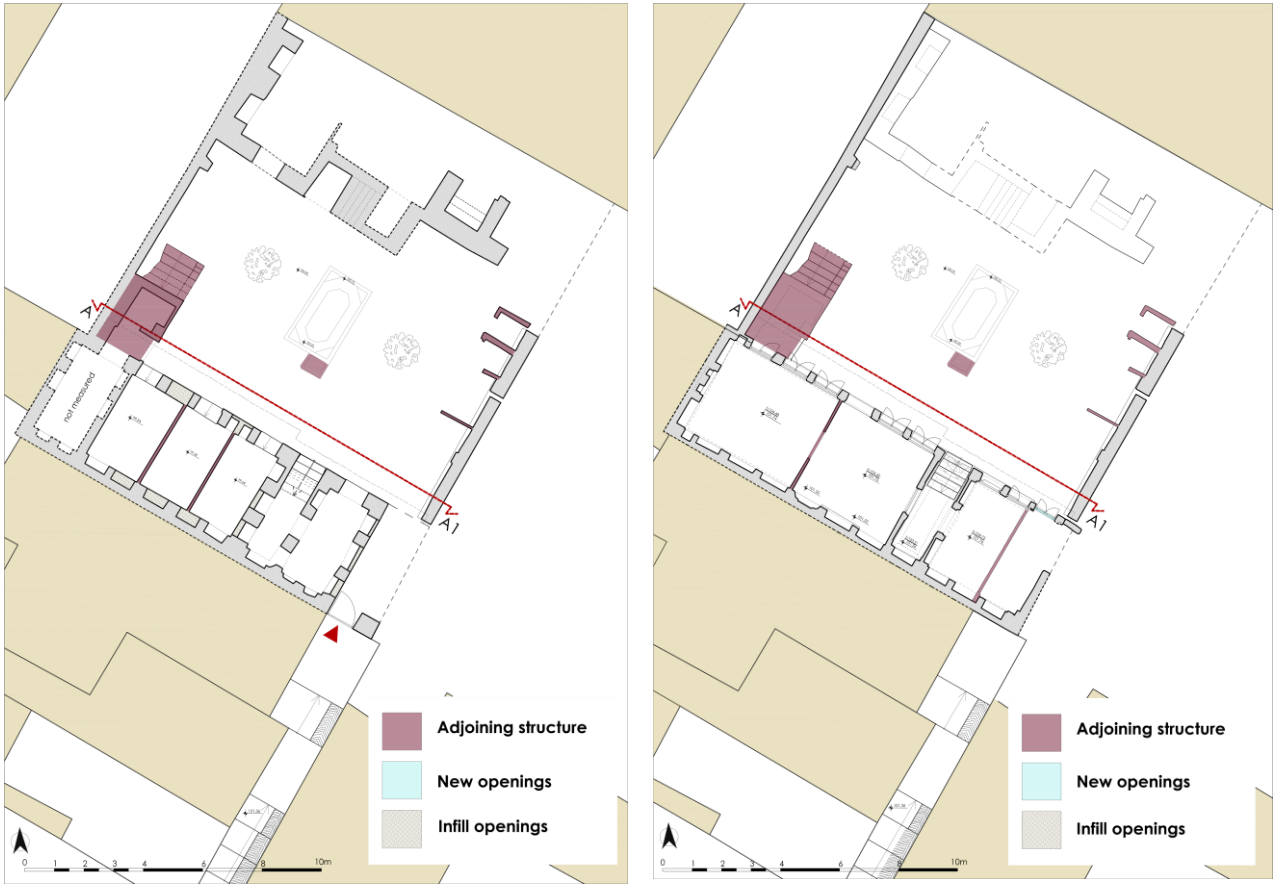
Figure 2.44 The current plans show the transformation and changes made in courtyard and indoor spaces.

At first glance, it appears that the house had almost lost its authentic identity completely. In fact, those changes and renovations performed by homeowners had caused damage to various parts of the building, particularly the northeast quarter, the eastern wall and the entrance passageway. The entrance corridor is currently filled and closed by the collapse of the eastern boundary wall through a gradual process of human activities and environmental impacts.

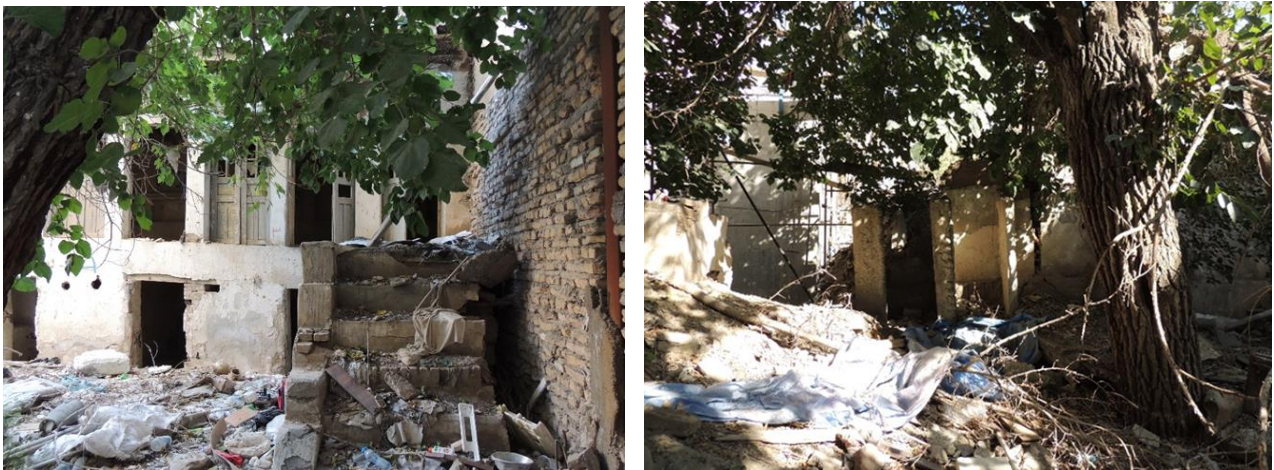
Figure 2.45 Construction of staircase in the courtyard in order to create separated entry into the western rooms on the first floor, southwestern mass. **Figure 2.46** The new walls built on the eastern side of courtyard to make new spaces like bathroom.

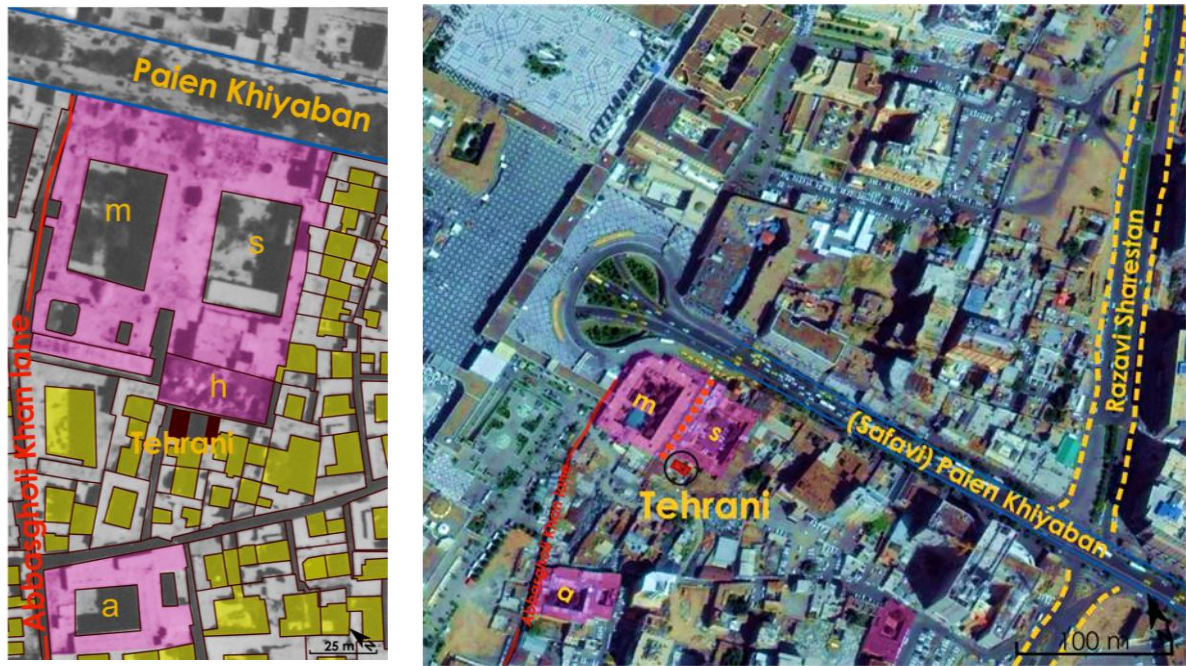
Figure 2.47 (1956) The figure presents the location of Tehrani House near to public monuments as Abbasgholi Khan monuments; m) madrasa, s) serai, h) hammam and a) Aziz al-ahof Serai and highlights the courtyards of traditional houses. **Figure 2.48** (2018) The image depicts changing of historical context, construction of Hazrati Bazaar between serai and madrase and demolishing of hammam and dwellings. (<https://www.google.com/earth/>, accessed date; July 31, 2018)

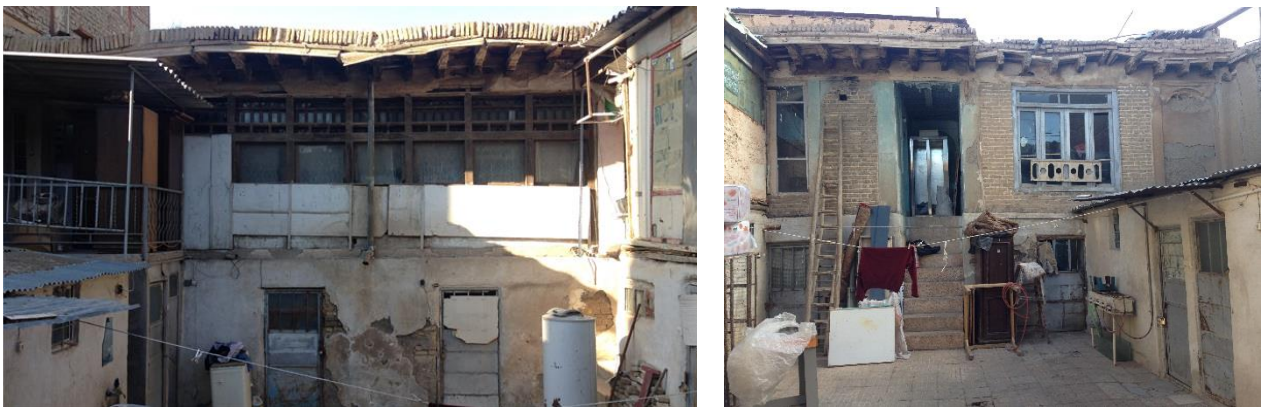
Figure 2.49 The current state of the summer quarter façade, northwestern mass. **Figure 2.50** The winter quarter façade, southeastern building mass.

The winter section is laid on the opposite side of the summer one, currently having a facade far from the usual harmony and symmetry. This building mass is much less extensive in comparison with the summer part and consists of two identical rooms on each floor plus a central staircase. This living quarter can be considered as a secondary area used only in the cold seasons based on its land percentage occupation and the simplicity of the rooms.

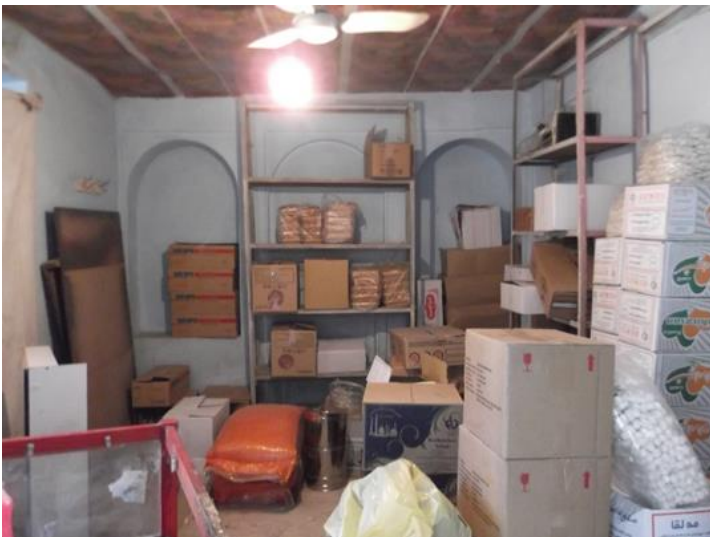
Figure 2.55 The living room in winter quarter currently used as warehouse. **Figure 2.56** The central decorative fireplace located in sleeping room, winter quarter.

Apart from closure of some lateral niches, the winter quarter inside has not undergone other alternations; however, the ground floor rooms may be recognized as the most damaged part of the southeastern building mass due to being changed into warehouses. Except for the oven chimney on

the roof, no other trace presents earlier identity of the western room as the cooking area. The central openings within rooms and outer apertures are walled, and currently each room includes only one opening instead of three.

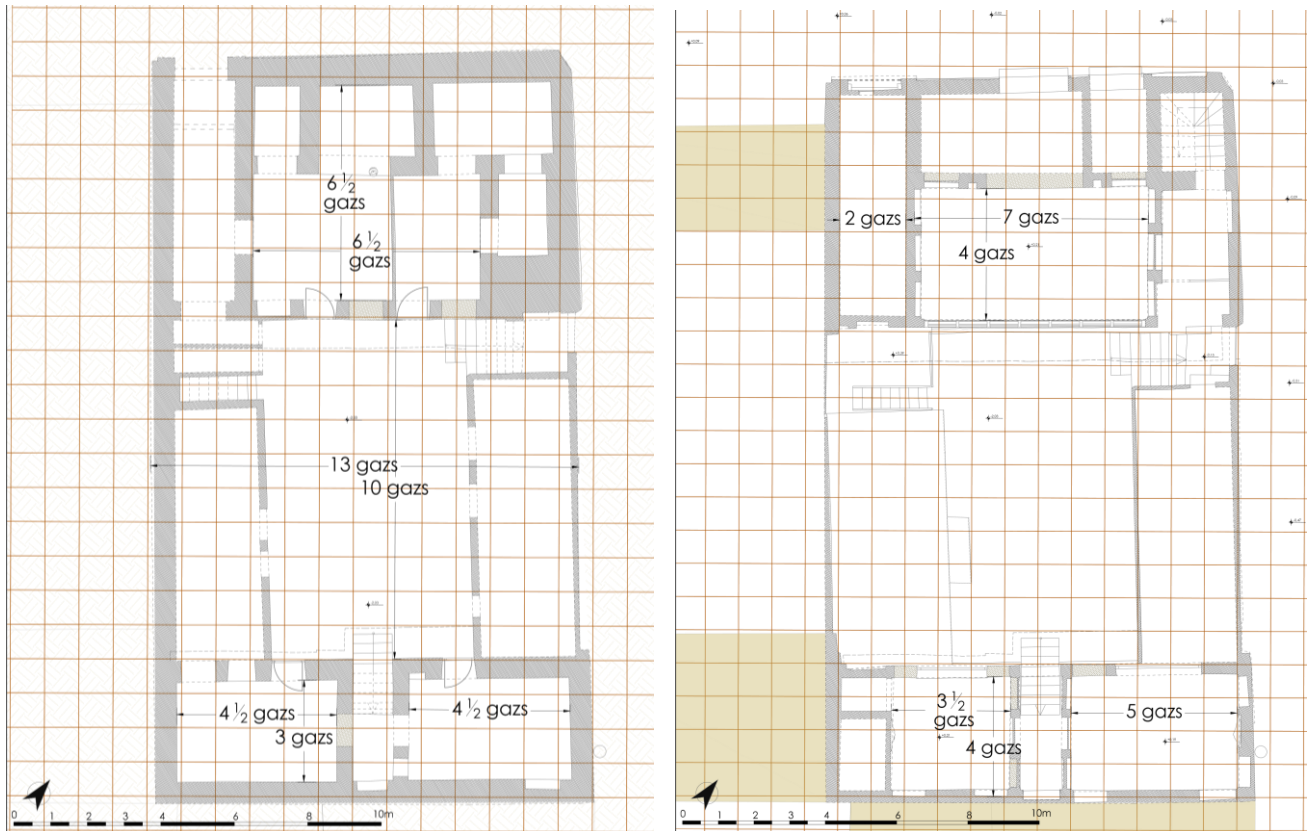
Figure 2.60 The placement of minor module (14 *gerehs*) on the ground and first floors.

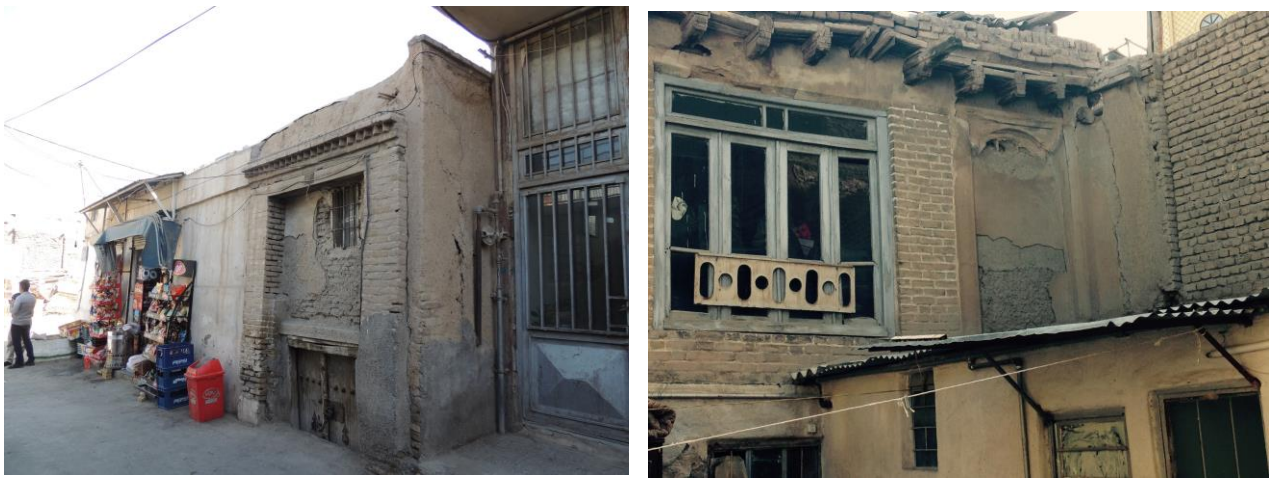
The winter façade presents an inadequate and inharmonic appearance. The combination of the remaining arches and rectangular windows on the façade is far from the usual harmony and symmetry considered in Islamic-Iranian architecture. Hence, the use of inappropriate long windows and implementation of the thickest bricks to fill the former apertures cannot correspond to the principles of a traditional uniform architecture.¹²³

Figure 2.62 The location of stores at the upper part of hall where was *shahneshin* area. **Figure 2.63** The present illustration shows the boundary between the original-earlier appearance of winter façade and the new one.

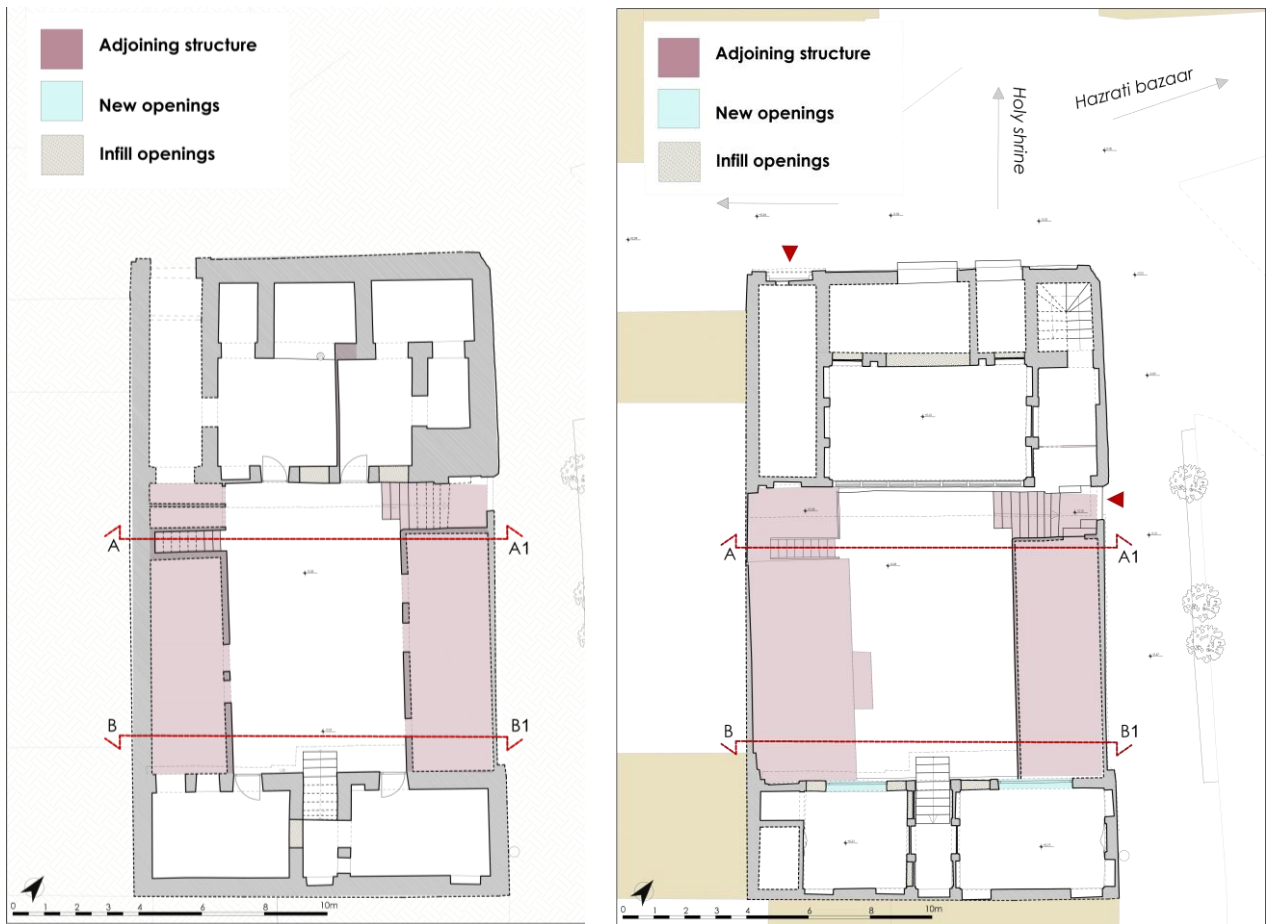
Figure 2.64 The current plans show the transformation and changes made in courtyard and indoor spaces.

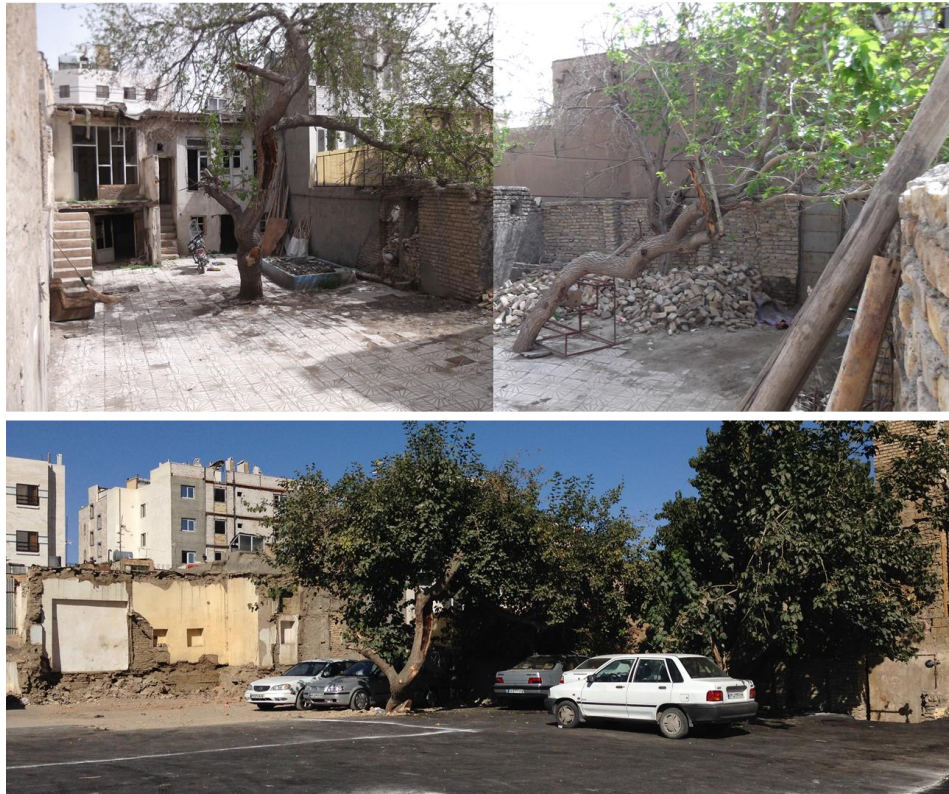
Figure 2.66 Bidari house before (2016) and after destruction (2017)

The third type of the house that belonged to this group is Bidari's House which was entirely abandoned in recent years, and wholly demolished in August of 2017. The habitation was located in *Tah-pol mahalla* the most popular alley of Noghan neighborhood, which is oriented towards Imam Reza shrine and Mecca (*roun-e-rasteh*). The entrance of the house was placed at the end of an inclined dead-end path that was a roofed corridor to provide indirect access to the courtyard.

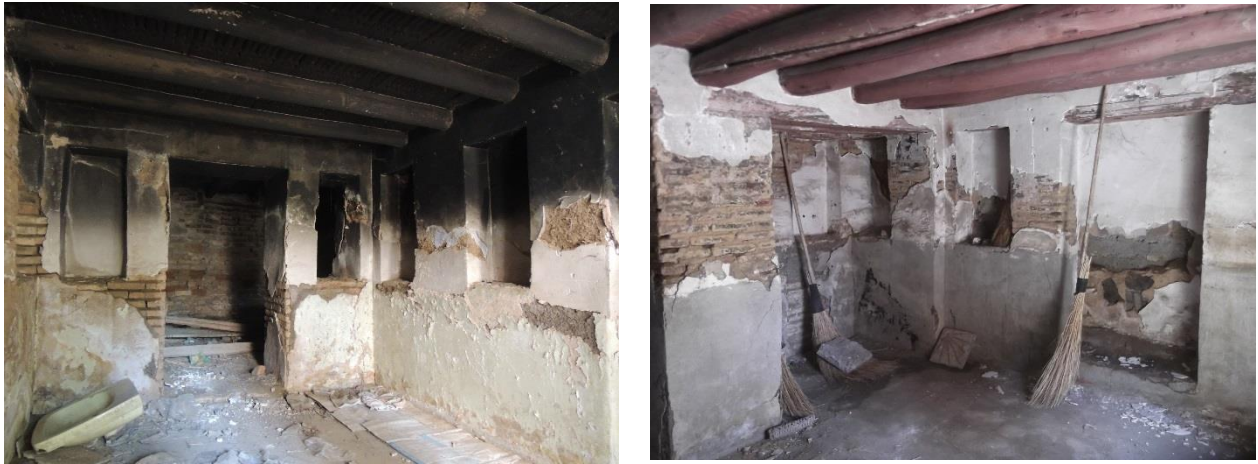
The yard had a rectangular shape in which was located a central reflecting pool (*hoz*) and the accompanying trees. The two building masses were positioned on the transverse axis of the yard. The lower floor functioned as the secondary zone and was allocated to cooking, resting, service area and food storages, each of which contained different spaces internally connected by apertures. The central room with an L shape configuration has been served as a resting room during the summer days. Unlike the other ground floor chambers, only a central opening provided the connection between the central room and courtyard. *Matbakh* or cooking area was located on the western sides of the ground floor which was directly connected from the north to a pantry and from the south to the yard by three apertures.¹²⁴ The space under the stairs together with the eastern room were perhaps

Figure 2.67 The Cooking room and living rooms on the ground floor, northeastern building mass.

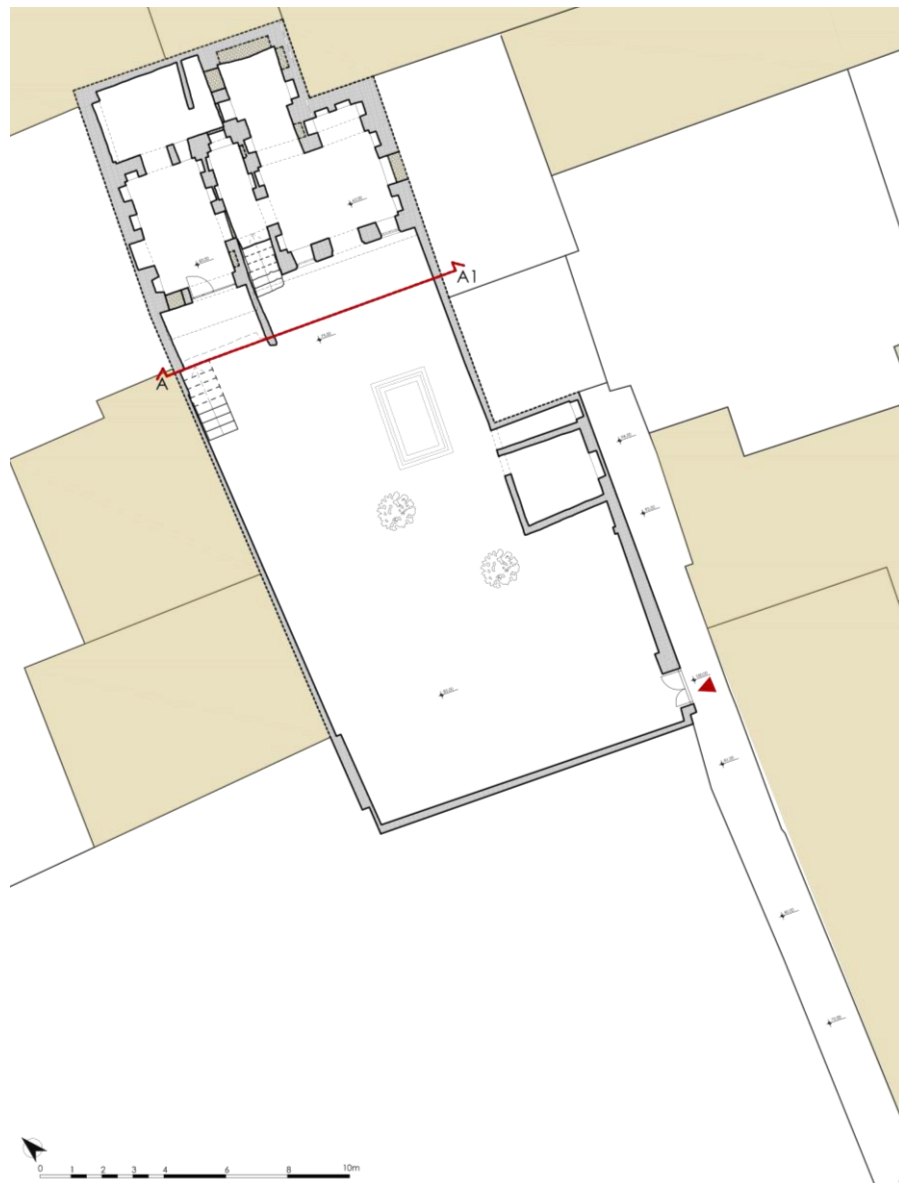
Figure 2.68 The design depict the latest outlines of courtyard and ground floor before demolishing.

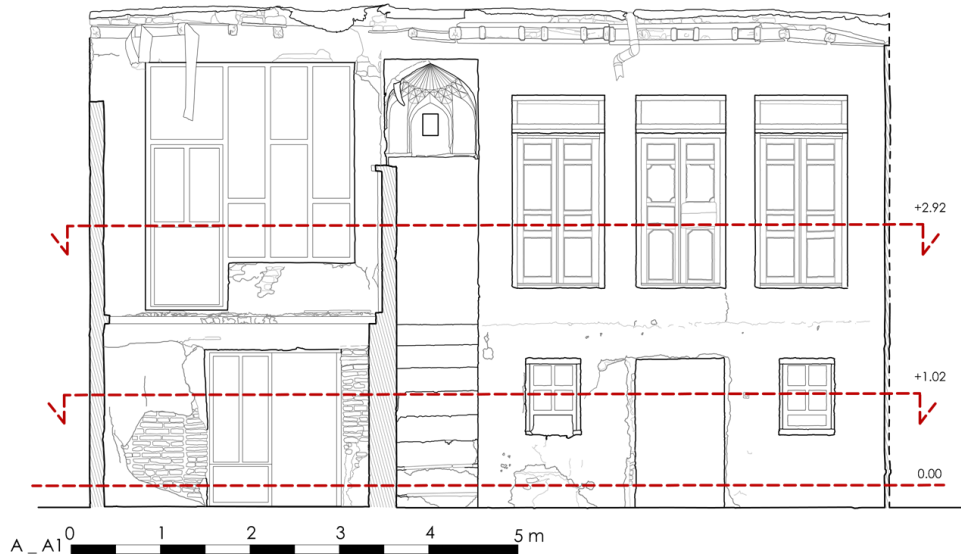
Figure 2.69 The façade of northeastern building mass.

Through nine openings on both stories and two *iwans*, the combination of architectural and ornamental components in the façade represented a harmony and symmetry of Iranian philosophy and architecture. Based on the north eastern quarter orientation towards sunlight, this portion was probably reserved for the cold months. However, the shape of the principal hall and its ventilated

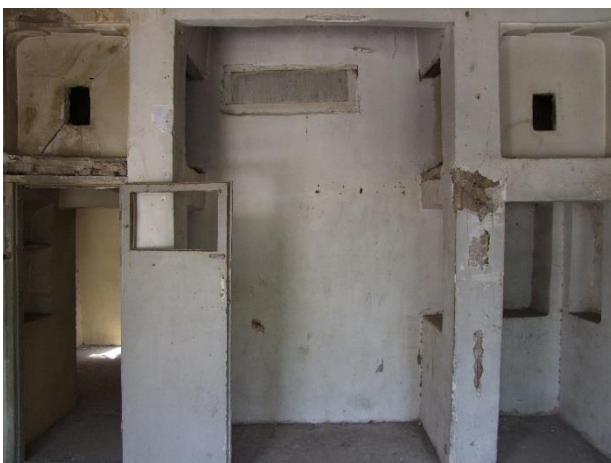
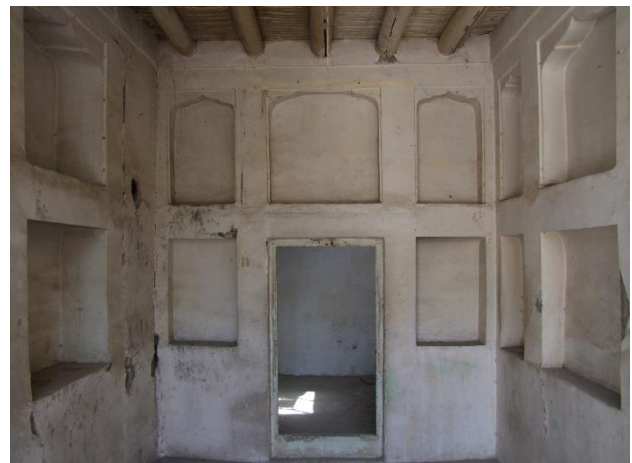
Within the niches in the northern wall of the main chamber, small holes have been made that allowed for ventilation of air inside the room. The holes permitted turning the hot air into a cold wind by semi-enclosed spaces placed at their back which were directed to the roof. It seems that type of channel acted as a *badgir* (windcatcher), but no signs of such structure were visible on the roof of the habitation.

Figure 2.71 The internal façades of living main chamber with the *shahneshin* are at center and the guest room.

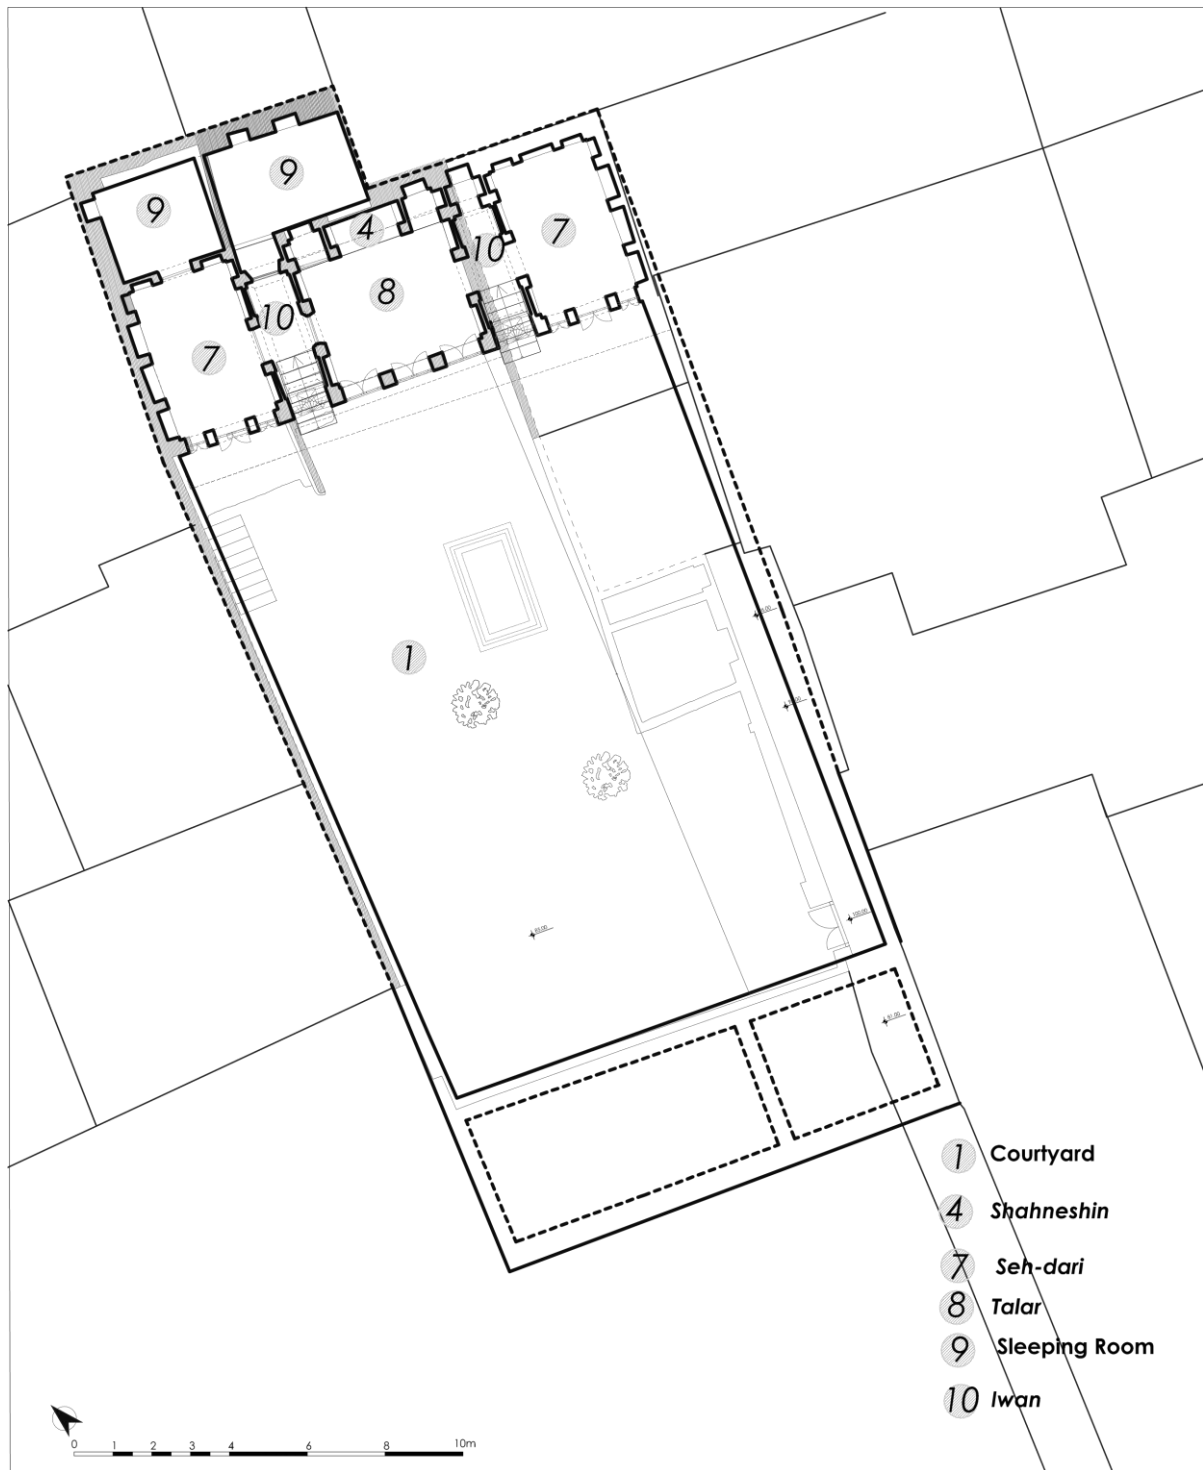
The spatial distribution of the northeastern living quarter on the first level had a rhythm consisting of *seh-dari* (three-opening room), *iwan*, central chamber, *iwan*, and another *seh-dari*. It was divided into householder and guest zones linked together by an *iwan*. The family zone included a main chamber with a cross shape, inside which there was a *shahneshin* circulated by two semi-closed storages and three openings to the yard. It also contained a secondary room for sleeping and a three-door room (*seh-dari*) on the eastern side. The main chamber served as the hall for family members' daily activities, contrary to *seh-dari* room which was used to work or rest. Another three-door room on the west was reserved for reception where guests could be lodged without entering the area reserved for householders. On the north, in the longitudinal direction of this room, there was a relatively small space that functioned as a sleeping-guest room. Here, *iwan*, as a major connector element, not only has internally connected guest and family areas, but it has also connected them through stairs to outside, the courtyard. It had the same characteristics of the Nili's *iwan* with an ornamental arch and an upper space for storing precious objects. The principal areas like guest and living rooms presented identical niches in two levels which were repeated in a regular way. Presenting a curved shape, the upper niches are more decorative than the lower ones with rectangular form. Since the sleeping rooms functioned as a subordinate zone, they contained just a few simple niches.

Figure 2.73 The earliest plan of the first floor, north eastern building mass, and division of areas.

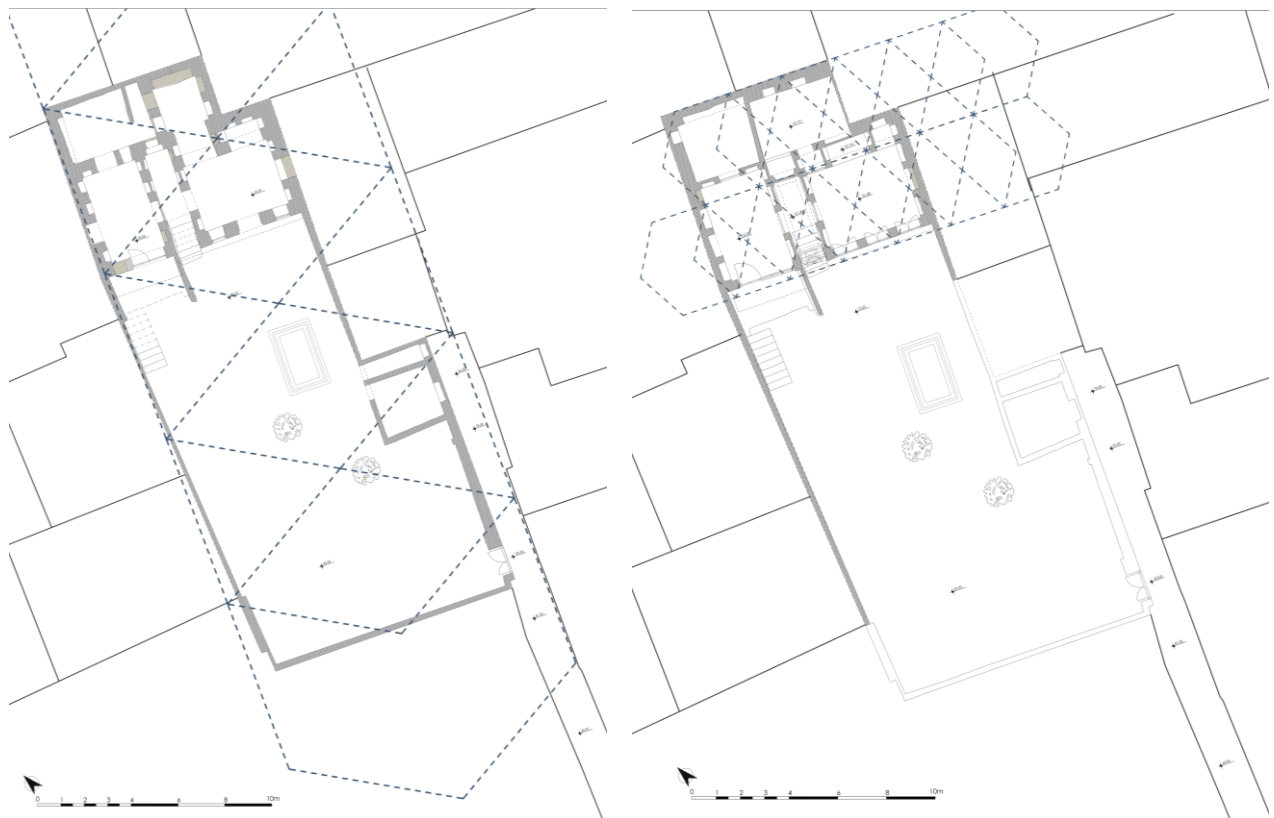
The land occupation ratio of the northeastern and southwestern building masses to the courtyard were respectively 25% and 15%. The ratio between length and width of the central yard was corresponded to the standard proportion of the Iranian Golden Rectangle by 1.5. Also, the interior spaces of Bidari's habitation are particularly loyal to the principles of Iranian architecture regarding proportion and size. The length of the sleeping room reserved for the guests corresponds correctly with that of the pantry on the lower floor. Since the living room is served as a social space with daily function, its width is more than its depth. While in space with sleep or work function, the rooms' width is less than their depth.

Figure 2.74 The analyzing the Bidari House proportion by placement of the Iranian Golden Rectangle.

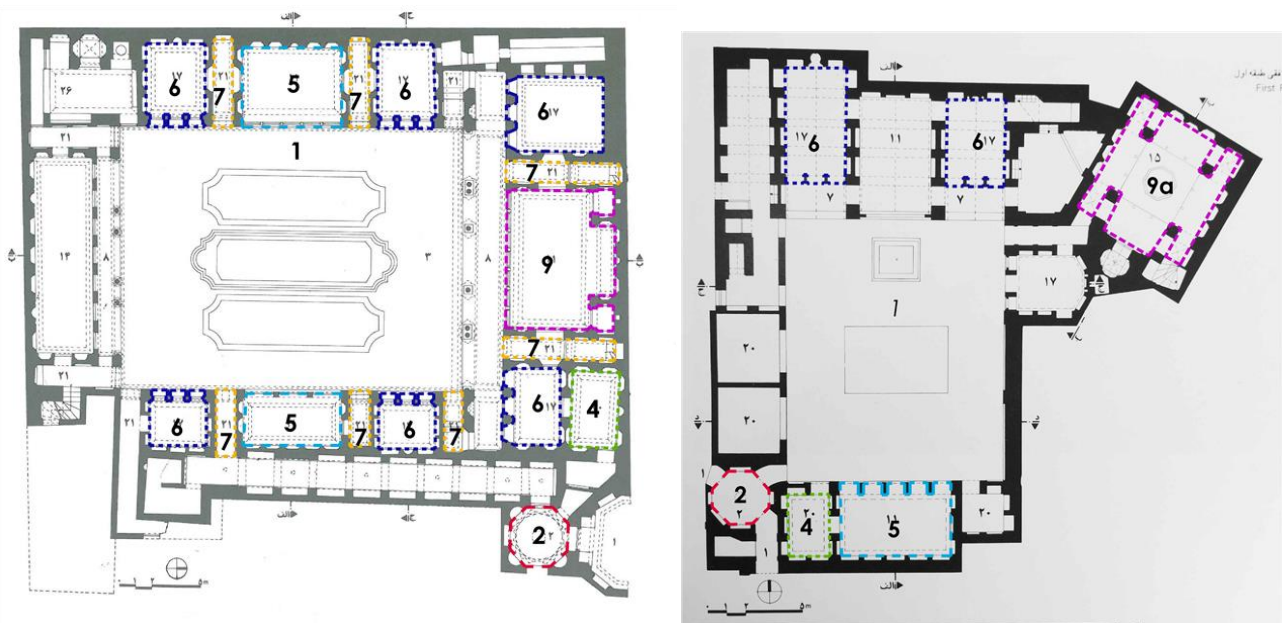
The first example to consider is Harandi Mansion that consisted of a central yard and three building masses on the north, south and west sides. Based on the orientation and proportions of the rooms, it can be realized that the northern front had been used in the summer days and the southern side as the winter quarter. The summer living front is formed of a chamber at the core of the composition accompanied by two three-opening rooms (*seh-daris*) on its both sides linked to the courtyard by two small *iwans*.¹³¹ This building mass also includes a *hoz-khaneh* (pool room) on the eastern corner that presents almost the common characteristics with the same area at Tehrani house regarding the shape and arrangement of niches, with several differences in proportion and decorative elements. On the other side, the middle hall and western rectangular room in the winter quarter are comparative with the *panj-dari* chamber (five-opening room) at Nili and its ending storage.

Figure 2.82 The mansions of Isfahan; A’lam and Harandi in which main spaces are identified as: 1) courtyard, 2) entrance, 4) sleeping room, 5) main living room (*panj-dari*), 6) *seh-dari*, 7) *iwan*, 9) *talar*, 9a) *hoz-khaneh*. (Haji-Qassemi 1998, 115,73)

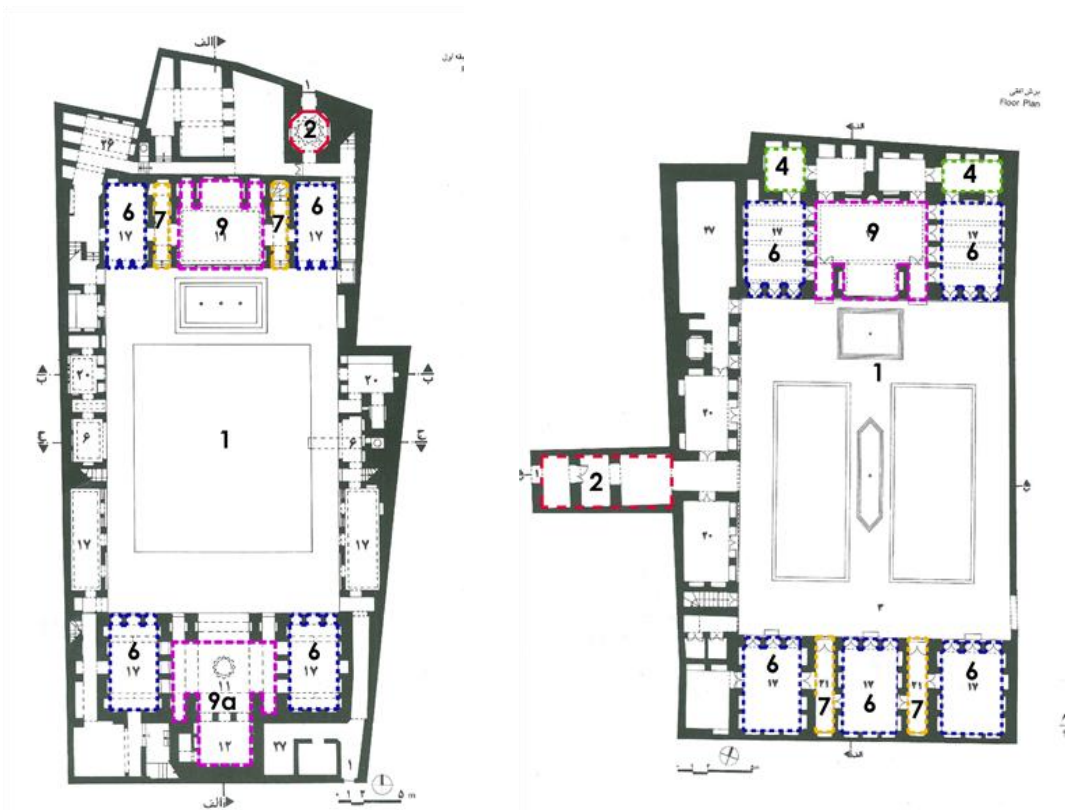
Figure 2.83 The mansions of Isfahan; Qodsiyeh and Sartipi in which main spaces are identified as: 1) courtyard, 2) entrance, 4) sleeping room, 5) main living room (*panj-dari*), 6) *seh-dari*, 7) *iwān*, 9) *talar*, 9a) *hoz-khaneh*. (Haji-Qassem 1998 63,95)

From the Qajar period, the aristocratic A'lam mansion is an excellent example in which one can observe all standard rooms of a traditional house. Living spaces occupy all sides of the courtyard and *talar* on the northern side is the most prominent among them. A long pool along with flower beds is laid on the main axis of the yard. The entrance located on the northeastern corner has an octagonal shape (*hashti*) connected to a long corridor to give access to the courtyard.¹³² Like the main hall in Tehrani's house, this chamber is allocated to family gathering by its cross-like shape, including a reserved place for the head of the family and two storage areas on its upper part. A large sash window (*orosi*) provides a view into the *iwān* and courtyard from inside and two *badgirs* (windcatchers) flanking the *shahneshin* ventilate this hall. The eastern and western building masses follow the same rhythm of space distribution (*seh-dari*, *iwān*, central room, *iwān* and *seh-dari*) as observed in the northeastern quarter of Bidari House, as well. In addition, the northern building mass of Qodsiyeh Mansion consisted of a cross-shaped hall flanked by two *iwāns* and *seh-daris* precisely correspond to the guest and householder zones in Bidari House.

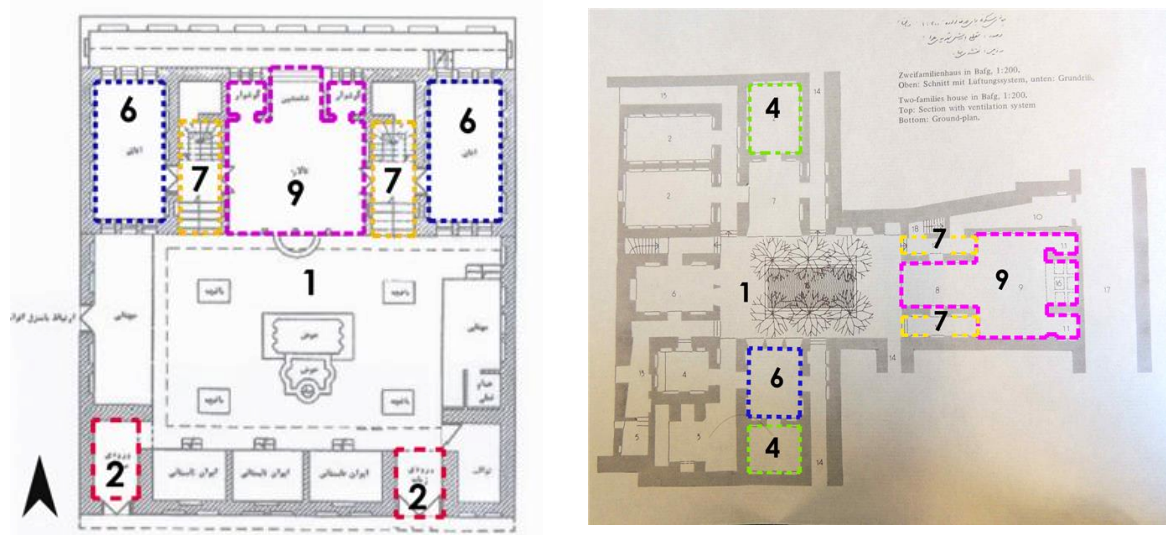
Figure 2.84 The houses of Babol and Bafq in which main spaces are identified as: 1) courtyard, 2) entrance, 4) sleeping room, 6) *seh-dari*, 7) *iwan*, 9) *talar*. (<http://www.zohreh-bozorgnia.com/fa/>, last access: October 10, 2016) (Rainer 1977, p.156)

Yazd is known as the capital of the desert and rich in traditional Iranian architecture. In the hot arid regions, a house with a courtyard can be utilized in all seasons, the northern part of the yard that receives more heat is used in winter and the rooms that are located in the southern side are used in summer.¹³³ Like Mashhad houses, they are oriented in both directions; northeast-southwest (*roun-e-rasteh*) and northwest-southeast (*roun-e-Isfahani*) due to the characteristics of Yazd, sun, and wind. They are also divided into various types regarding their number of yards and building masses.¹³⁴ Through a brief comparison of Yazd's mansions with the case studies, we would realize that large houses even with two courtyards display similar general divisions despite numerous differences. The majority of these mansions have consisted of householder zone and servant area where each one has a separate entrance. The reception hall, *iwans*, and *seh-daris*, as the principal closed or semi-open spaces, are laid on around the central yard. Each main living quarter, northern and southern building masses, comprises a central cross-shaped chamber or *iwan* surrounded by two three-opening rooms or *seh-daris* living rooms at the core of the composition enclosed by two *iwans*. Both sides contain one or more than one sleeping rooms at the end of their arrangement directly linked to side spaces.¹³⁵ In addition to selecting samples from the cities of Isfahan and Yazd (center), other similar examples have been chosen from different regions of Iran, such as Babol (North), Bafq (South) and Ardebil (West), which are presented in Fig.2.84.¹³⁶

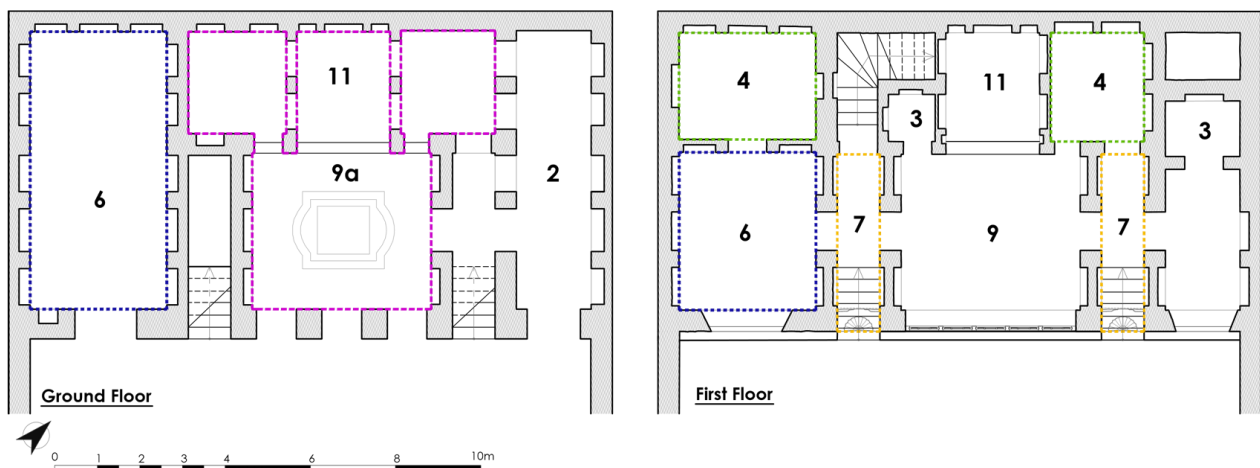
Figure 2.85 The traditional house located in Sarshoor quarter of Mashhad which can be compared with Bidari House by following the same rhythm in distribution of spaces. In present plans main spaces are identified as: 1) courtyard, 2) entrance, 4) sleeping room, 6) *seh-dari*, 7) *iwan*, 9) *talar*.

To assume the initial state of the demolished house of Bidari, two other traditional houses have also been identified to obtain an accurate comparative study. The first house located in Sarshoor quarter has currently lost the entire earlier appearance due to addition of new structures in the courtyard and facade. Apart from the wooden ceiling and brickwork of the entry, there is no component left from the primary aspect. However, some images and layouts are available in KH-CHHTO archive.¹³⁷ The rhythm of spatial distribution in this house could be the same as recognized in Bidari's house, including *seh-dari*, *iwan*, central hall, *iwan*, and *seh-dari* again.

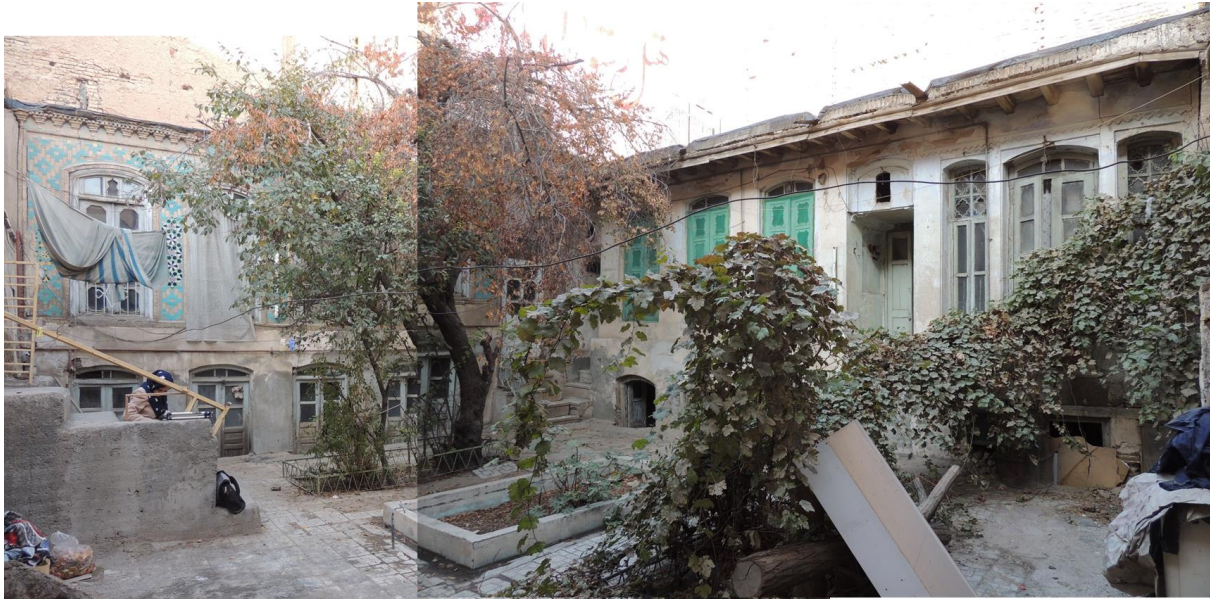
Figure 2.86 The traditional house located in Eidgah quarter in which the northern façade presents the similar façade characteristics in Bidari House.

Another habitation located in Eidgah neighborhood is the most similar case to Bidari House. It is still inhabited and in a pretty well physical condition. The house has two L-shaped living quarters. The western building mass is perpendicular to the northern facade and has covered a portion of it; therefore, it was integrated with the north facade in later periods. They perform two distinct styles of architecture and decoration, testifying to their being constructed in two different historical periods. In terms of proportions and distribution of spaces, however, the earlier mass entirely matches with the destroyed dwelling of Bidari. The building is composed of a hall in the center, surrounded by two *iwans*, and three-opening chambers at the corners. In this instance, the entrances of the *iwans* are not decorated with pointed vaults, but arches of crescent shape. On the ground floor, spaces are allocated to storages and *seh-dari* rooms on the first story served as rooms for sleeping or work. From the proportional point of view, the dimensions of the ground columns and openings are perfectly in line with these elements in Bidari House.

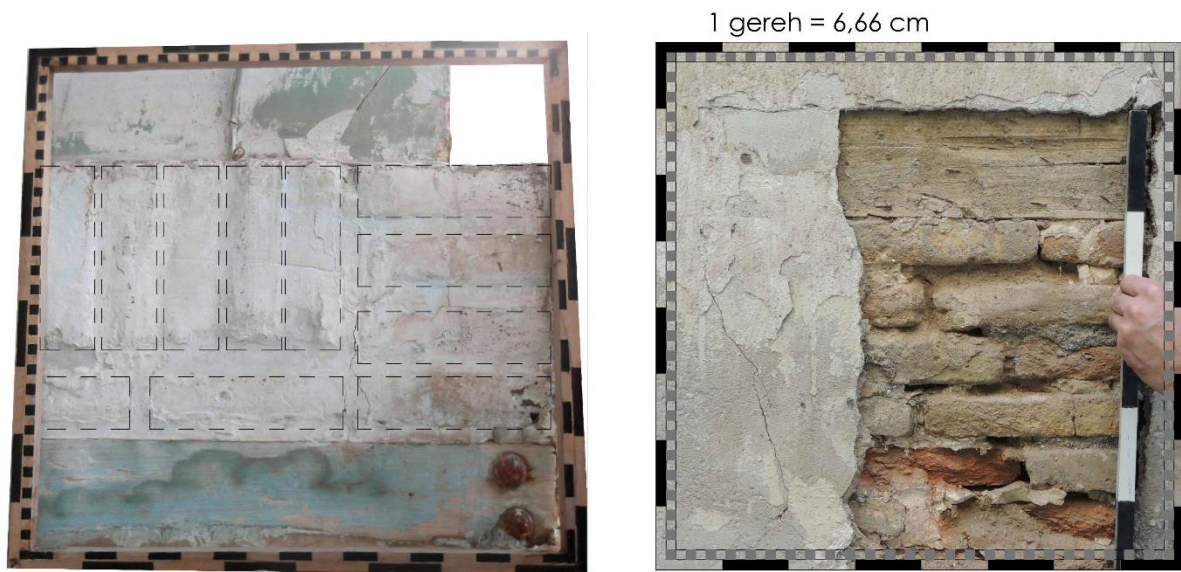
Figure 3.1 The placement of brick rows in the upper portion of the fired-bricks wall; Tehrani House, SE building mass, ground floor. **Figure 3.2** The construction of walls on the ground floor with burnt bricks and horizontal beams; Nili House, SW building mass.

- Figure 3.2** The construction of walls on the ground floor with burnt bricks and horizontal beams; Nili House, SW building mass. | 133
- Figure 3.3** Connection of horizontal beams by lap-joints in the ground floor of Bidari House. | 133

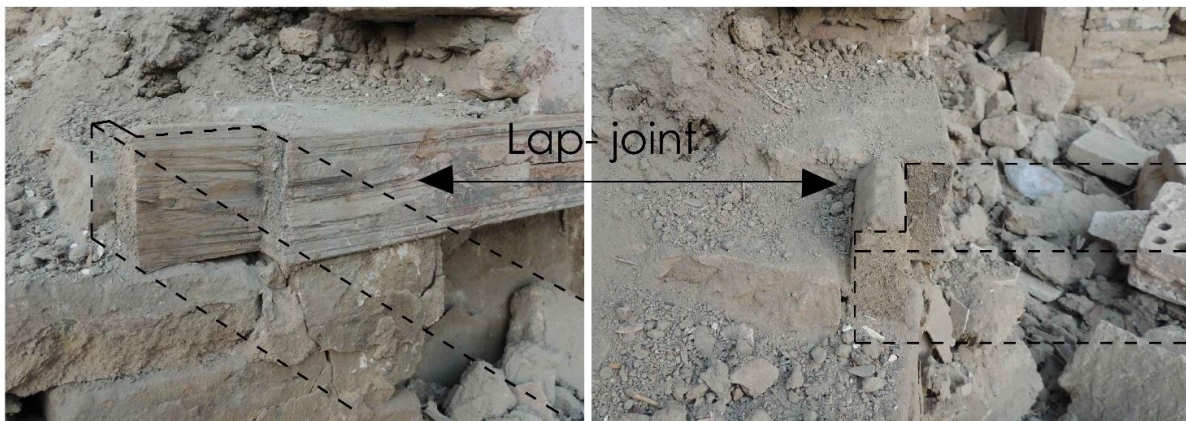
Figure 3.3 Connection of horizontal beams by lap-joints in the ground floor of Bidari House. (After the building demolition, 2017)

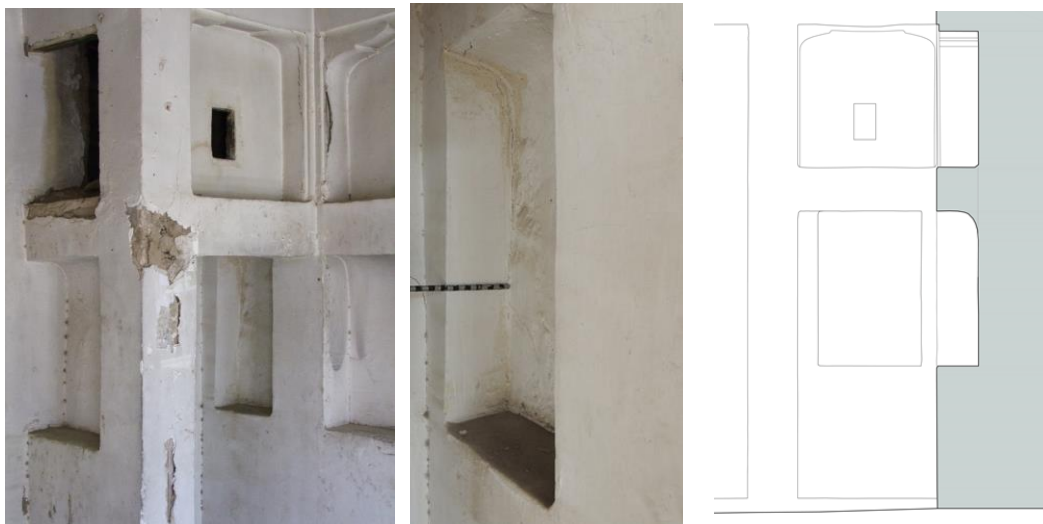
Figure 3.4 The curved ceiling of lower niches on the first floor. Location: Bidari House, NE building mass, first floor, principal chamber.
