SAPIENZA
UNIVERSITÀ DI ROMA

XXXI Ciclo Dottorato in Restauro dell'Architettura

**A STUDY ON THE ARCHITECTURAL FEATURES OF HOUSES
CONSTRUCTED FROM XVII TO XIX CENTURY IN THE CITY OF
MASHHAD**

Dottoranda: Rana Daneshvar Salehi

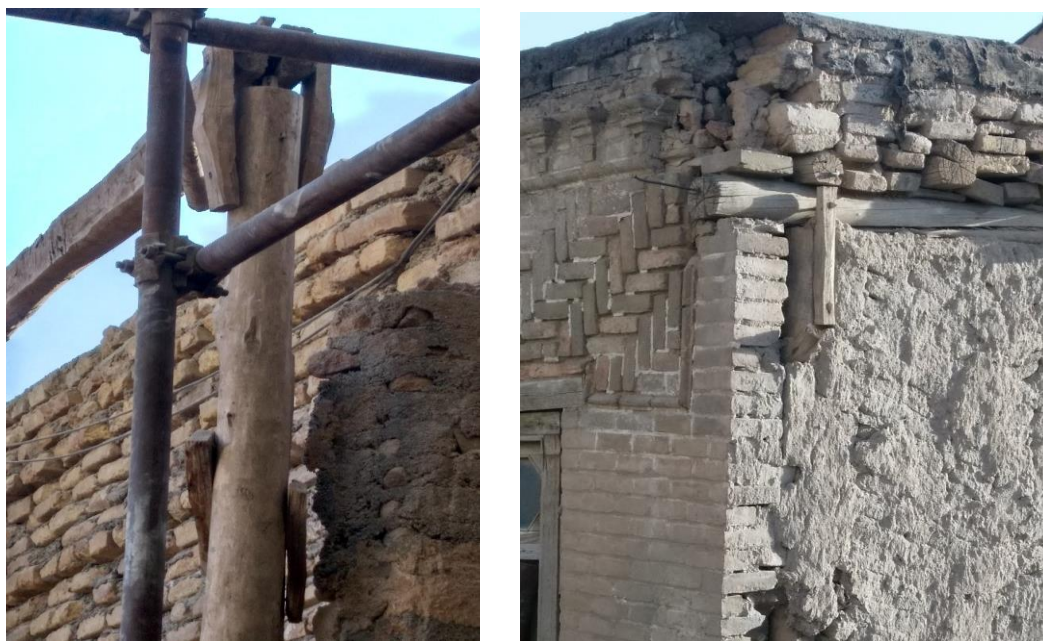
Figure 3.5 Connection of vertical joist and horizontal beam by Male and Female joint using wooden pins, Amiri House. **Figure 3.6** Integration of wooden joists and bricks and utilization of wooden pins to make a comprehensive joining between timber beams in a boundary wall in Ghomi House.

pieces of mud brick like rubbles are laid on one side of the joist in place of their square. Connected to horizontal beams by Male and Female joints in adobe walls, the vertical joists were used to increase the wall's stability against tensile forces.¹⁴⁵

They are glued to adobe bricks with mud-straw mortar that has a high adhesion and plasticity properties. Also, the combination of mud mortar and sun-dried brick delivers a compatible construction.

¹⁴⁵ The joining of timber beams would be completed through using wooden pins nailed to both elements.

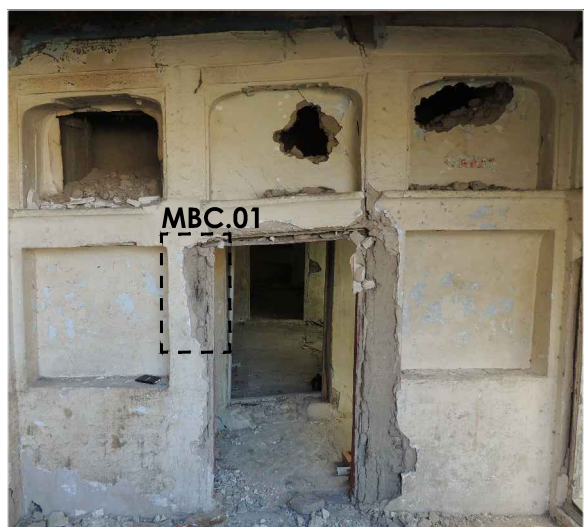
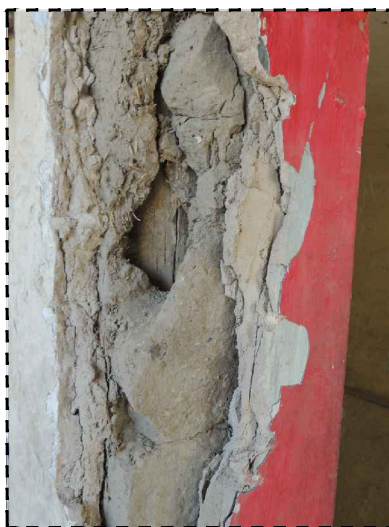
1 Mud-brick column (MBC.01), construction materials and techniques;

Fig. 3.1.1 Construction of northwestern columns in the guest room on the first floor; (a) in upper floors, to provide a lightweight structure, columns are built by square sun-dried bricks ($17 \times 17 \times 4$ cm) along with wooden poles, and the vertical joists are glued to adobe bricks with mud-straw mortar, (b) a schematic drawing of the construction method in the guest room implemented in all internal spaces on the first level.

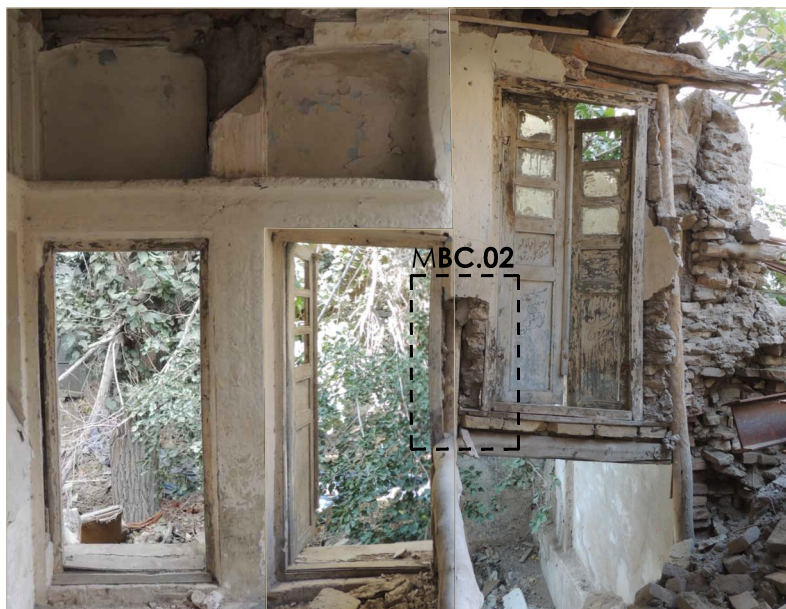
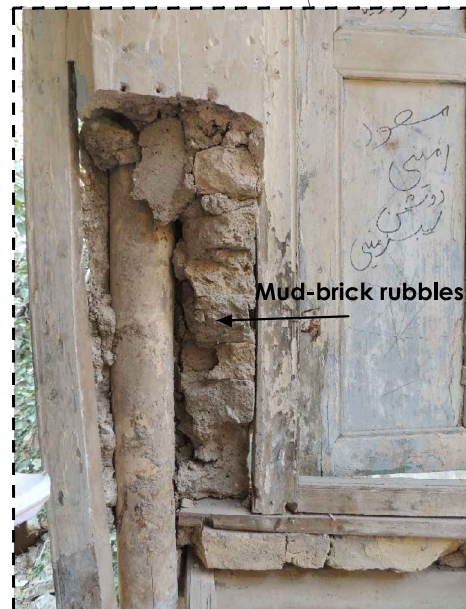
2 Mud-brick column (MBC.02), construction materials;

Fig. 3.1.2 Construction of northeastern columns in the guest room on the first floor; (a) in pillars with less thickness, mud-brick rubbles are employed along with mud-straw mortar in place of square mud-bricks.

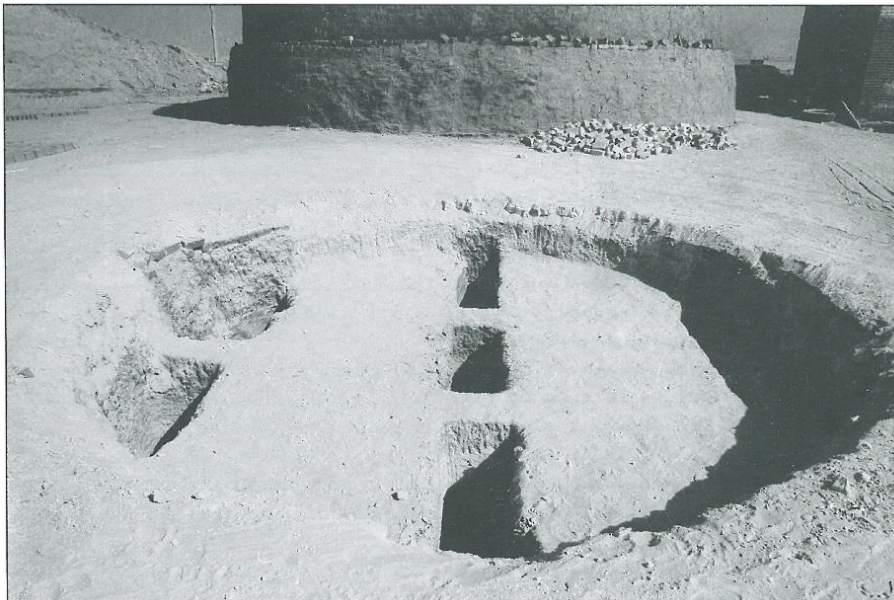
Figure 3.8 The Cylindrical kiln and the fire location. **Figure 3.9** The arrangement of mud bricks around the kiln from the lower row to the roof. (Maheronnaqsh 2002, 22-24)

The brick kilns are commonly located near to clay pits at outskirts of town. There were two types of kilns used to fire the bricks; *Cylindrical* and *Hoffman* kilns. As an intermittent type, the traditional Cylindrical furnaces were operated manually and the bricks made this way would not generally be uniform regarding shape and color. At present, Cylindrical furnaces are rarely found throughout the country. In this kind of kiln, the fire is inserted into the holes of 5-6 m deep and 2-3 m long. The raw bricks would be arranged in a radial way to the top and the gaps between them filled by gypsum. In

Since cylindrical kilns could produce non-uniform bricks in color, shape and durability, the bricks burnt in them would either have a high quality or be considered improper. For instance, the bricks arranged far from the fire presented a softer texture than ideal. However, many bricks exposed to the high temperature (nearby fire) presented a red color and proved to be more durable.¹⁵³

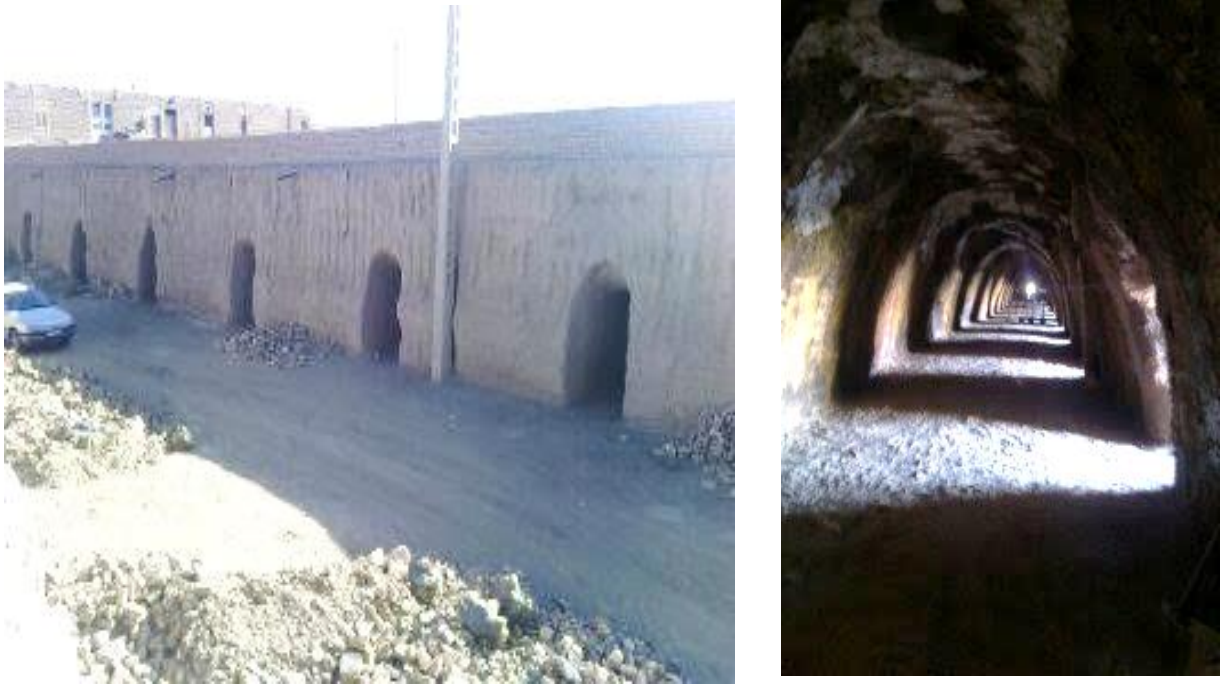
Figure 3.10 The Hoffman kiln near Gonabad (284 km to Mashhad) which serves as a traditional kiln to produce the bricks used for restoration of monuments

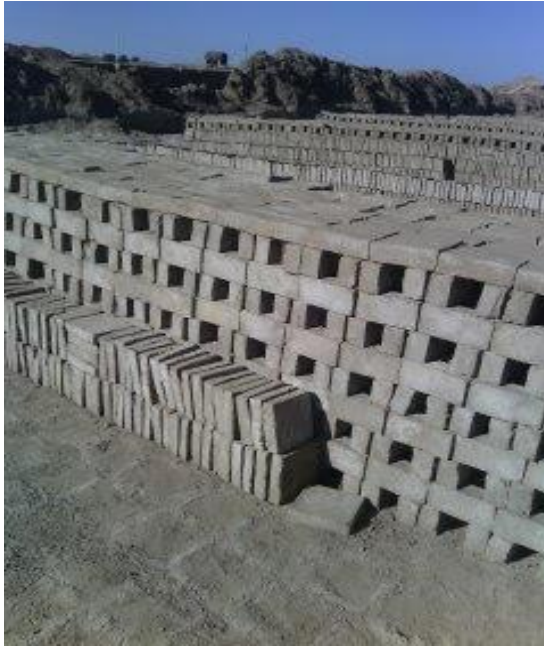
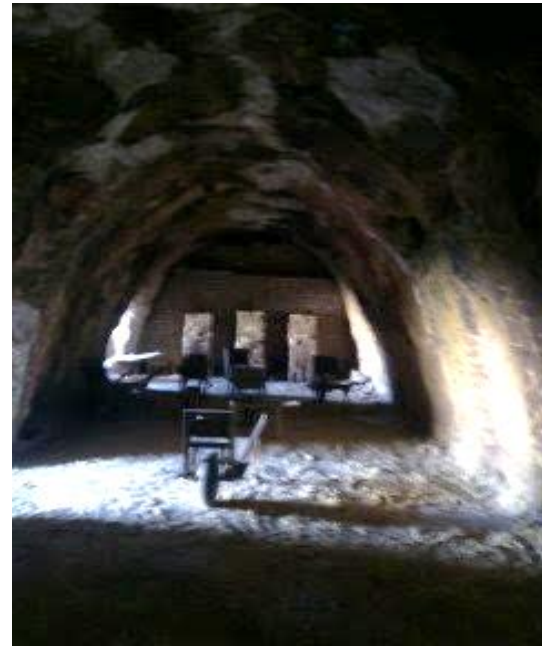
Figure 3.12 Drying of sun-dried bricks before firing in the kiln. **Figure 3.13** Setting of raw bricks in a Hoffman kiln.

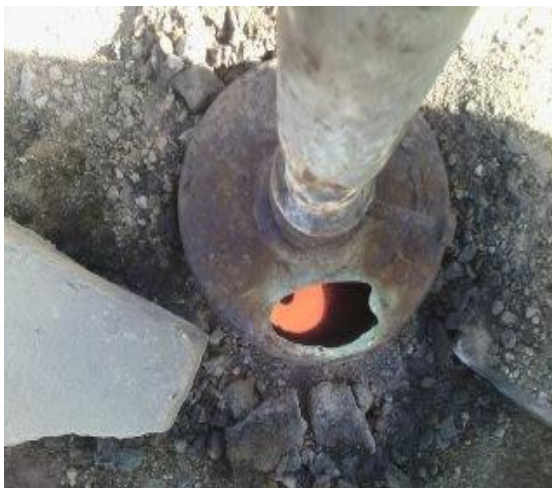
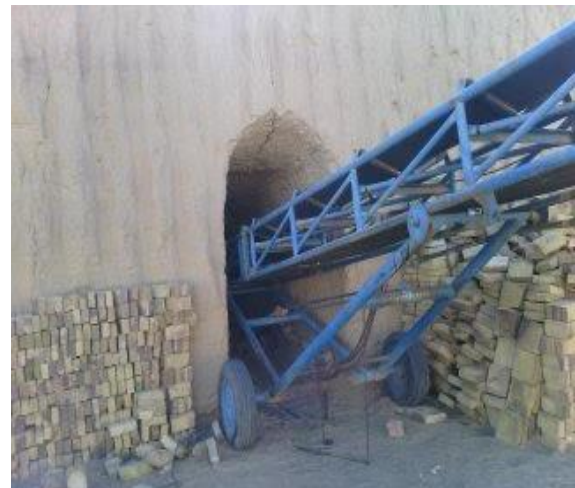
Figure 3.14 Burning the bricks by a gas flare. **Figure 3.15** Loading the burnt bricks.

Hoffman kilns produce high-quality bricks compared to earlier Cylindrical furnaces because of providing a uniform temperature. They are continuous in which sun-dried bricks are unloaded, pre-heated, fired and cooled. The oval-shaped plan has divided into rooms by using the blended walls. Each room has outer openings for mud bricks loading and draining in the kiln.

In this furnace, after being unloaded, sun-dried bricks get warmed by hot air before being directly burnt. The pre-heating is carried out by shifting the hot air along with gases from the back chamber to the adjacent rooms. The heat enters into other rooms through the holes embedded in the ceiling and below the walls of the kiln. The holes are connected to the central path associated with a high chimney that is constructed to direct the gas from fossil fuels to the outside. The bricks get burnt

through the hottest fire of gas flares accessed from the ceiling into the room. At the time of firing, in the farthest room, loading and unloading of bricks continue which brings fresh air into the kiln. Therefore, the airstream moves between the rooms where the burning operation has already taken place, and the cooling of the baked bricks proceeds.¹⁵²

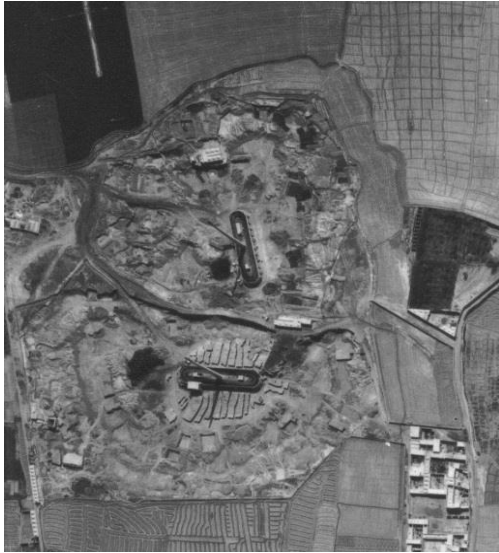
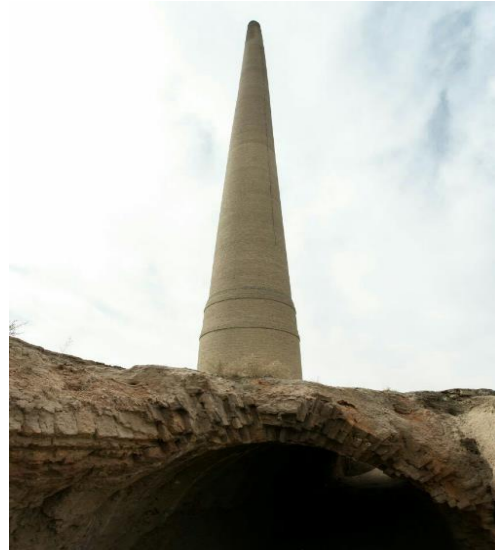
Figure 3.18 The 1968 aerial photo presents the location of Hoffman kiln in outskirts of Mashhad. **Figure 3.19** A ruined structure of Hoffman kiln along with a high brick chimney which are entirely abandoned. (Charbagh Chanel)

Besides, the bricks burnt in a Hoffman kiln are heavier and more compact than the ones baked in traditional furnaces. The 1968 aerial photo presents the locality of Hoffman kilns and the clay pits on the south of Mashhad. The clay used in the bricks came from the nearest pits by well wheels. Each

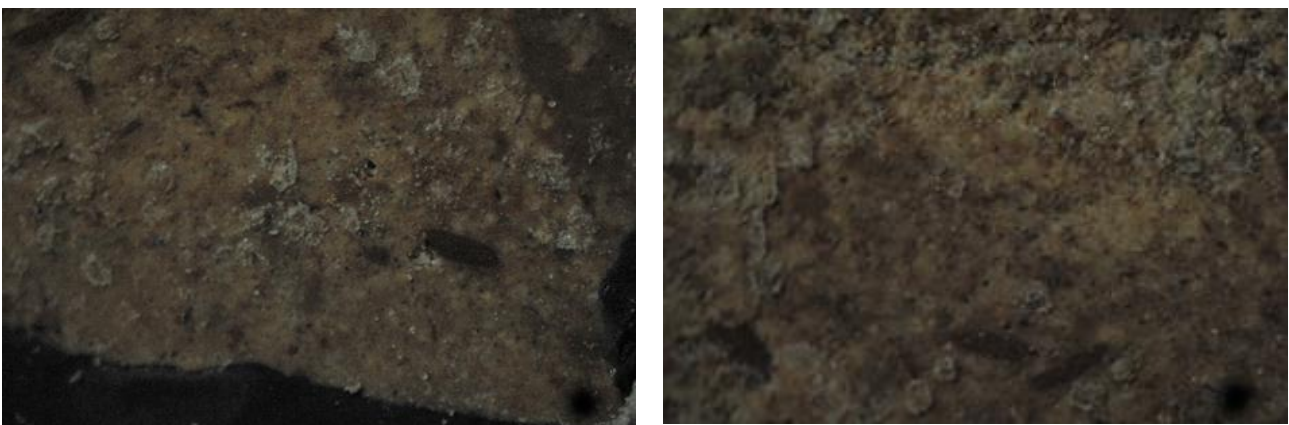
Figure 3.20 Burnt brick sample collected from Bidari House, NE building mass, ground floor, living room, western wall.¹⁵⁷

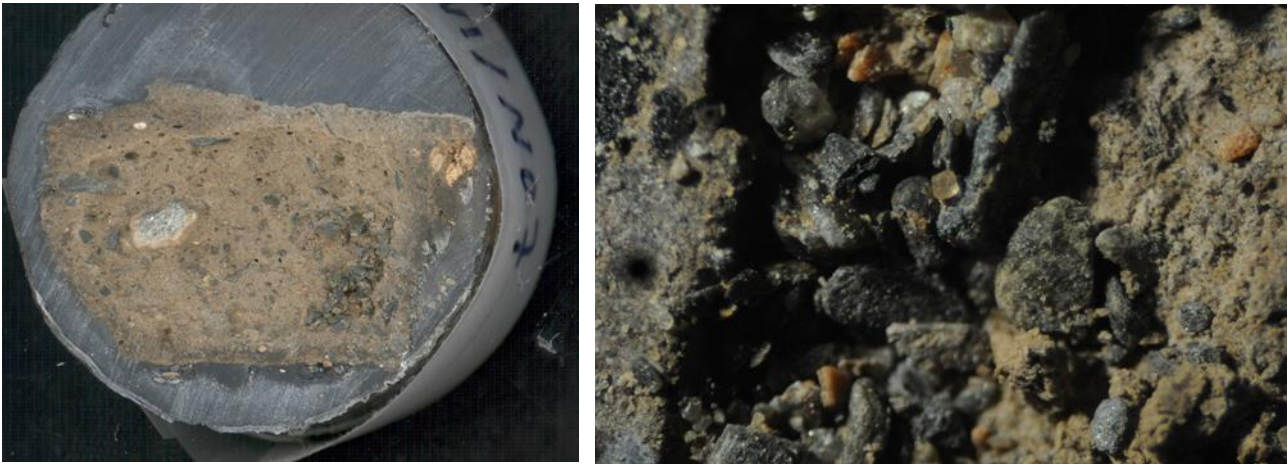
Figure 3.22 Mud brick sample collected from Nili House, SW building mass, guest room, NW wall.¹⁶³

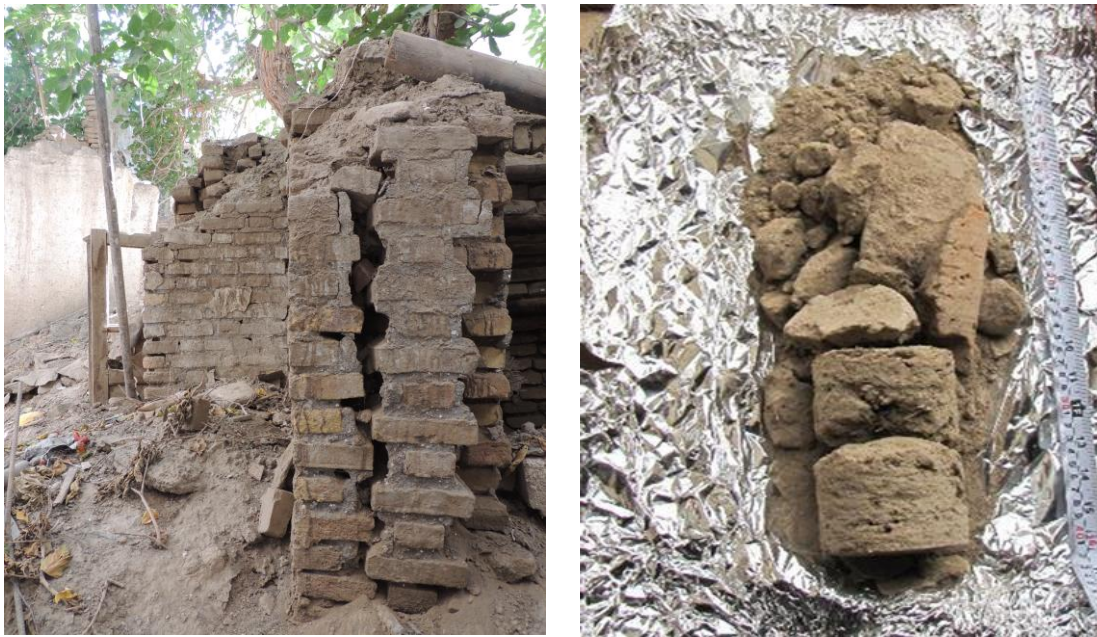
Figure 3.23 Splitting of burnt-brick masonry in the north-earthen quarter of Nili House. **Figure 3.24** The sun-dried brick rubbles found from the central part of masonry in the western building mass of Darugheh House. (Govahi, 2012)

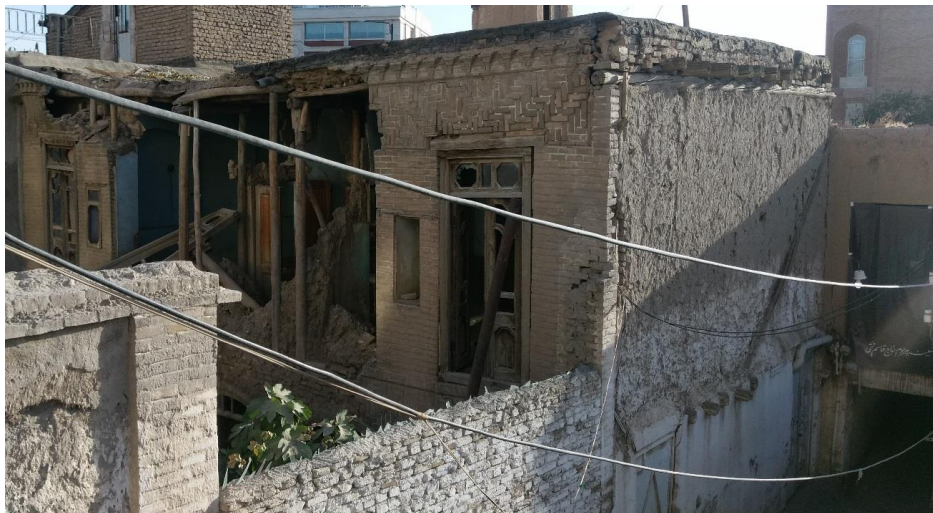
Figure 3.25 The present image shows the placement of poplar trunks as poles into brick columns, Ghomi House. (Date taken: 24 Nov 2017)

Through a study of report on the structural analysis of Darugheh House, we can claim that *Populus alba* trunks have commonly been used in the structure of houses. As white poplar trees are available in outskirts of Mashhad, they were mainly in use as the ordinary wood with a soft and flat surface. Physical and mechanical properties of poplar woods such as being lightweight, knot-free, and resistant to pressure loads and termite attacks encouraged builders to utilize them in vertical mode. In addition, poplar trees have the long lengths, thus, they could be employed in construction of large spaces.¹⁶⁹

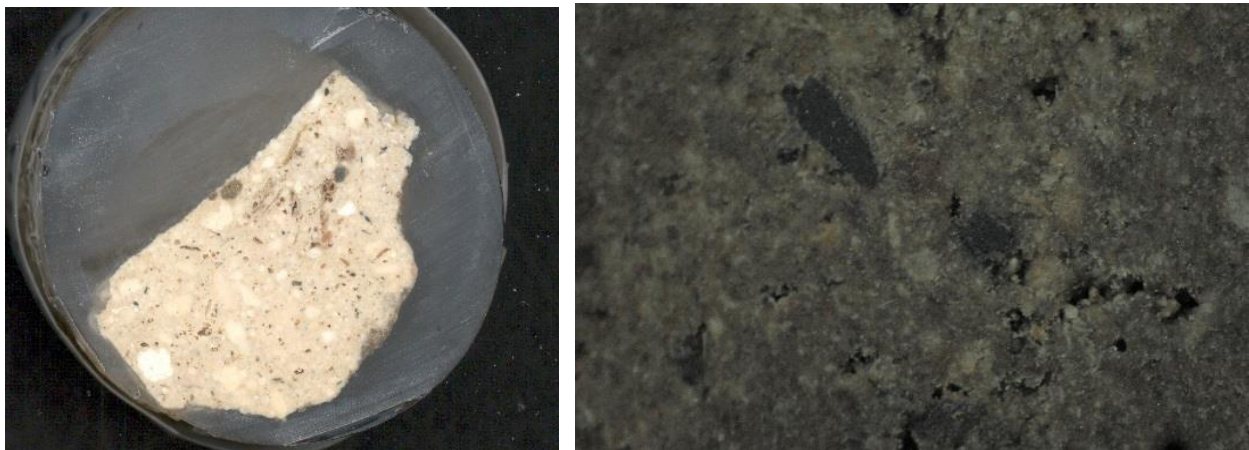
Figure 3.26 Gypsum mortar collected from Nili House, SW building mass, ground floor, storage, NE wall. **Figure 3.27** Appearance of sand mortar fragments under microscope observation. The present sample was collected from the living room at the ground floor of Bidari House.

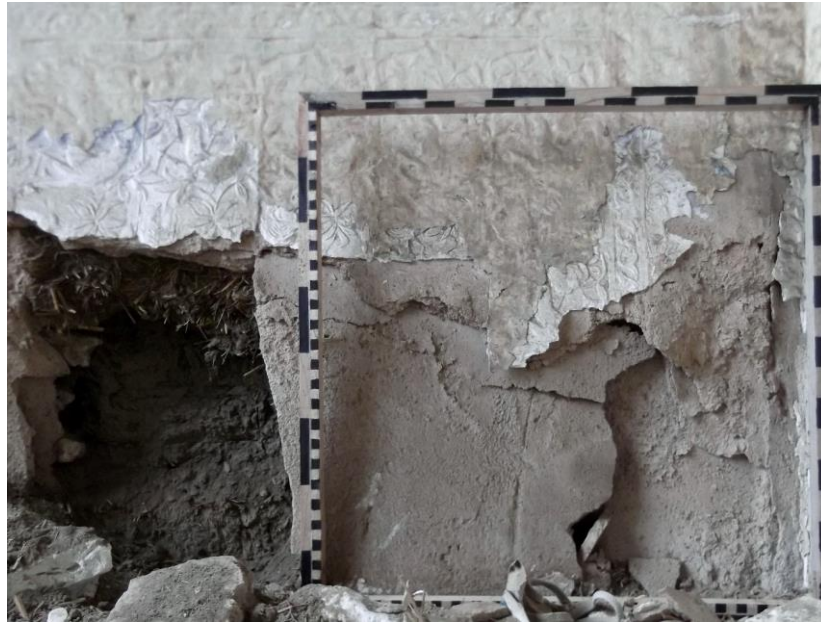
Figure 3.28 The blistering and delamination of mud-gypsum plaster layers caused by expansion of the humidity.

- Figure 3.28** The blistering and delamination of mud-gypsum plaster layers caused by expansion of the humidity. | 150
- Figure 3.29** Inner gypsum layer collected from Nili House, SW building mass, first floor, guest room, SW wall. | 151

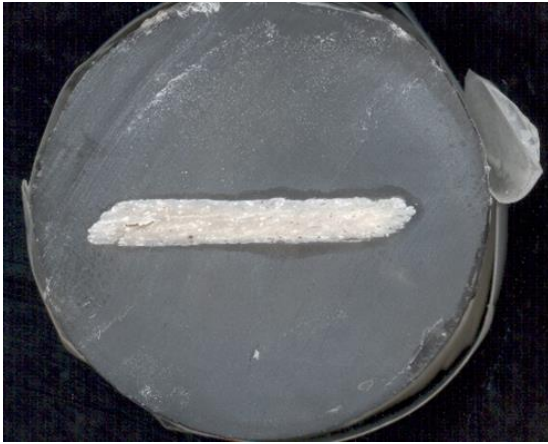
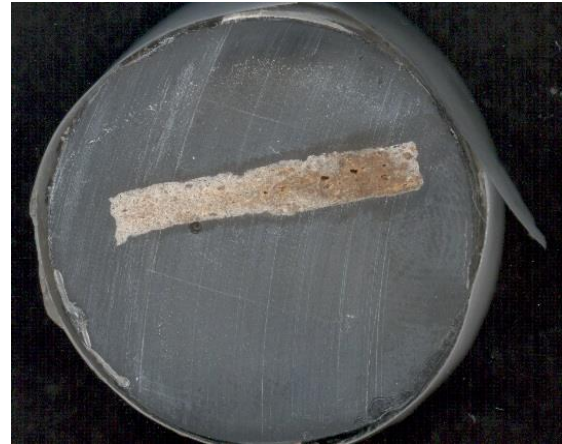
Figure 3.29 Inner gypsum layer collected from Nili House, SW building mass, first floor, guest room, SW wall. **Figure 3.30** Traditional plaster sample coating the external surfaces on the first floor and basically presenting a red-ochre color, (Nili House, SW façade).¹⁷⁶

¹⁷⁵ The gypsum-clay plaster should be free from sands and impurities, and if the distribution of gypsum and clay is one to one, it will be resistant to the pressure. (Golabchi 2013, p.46)

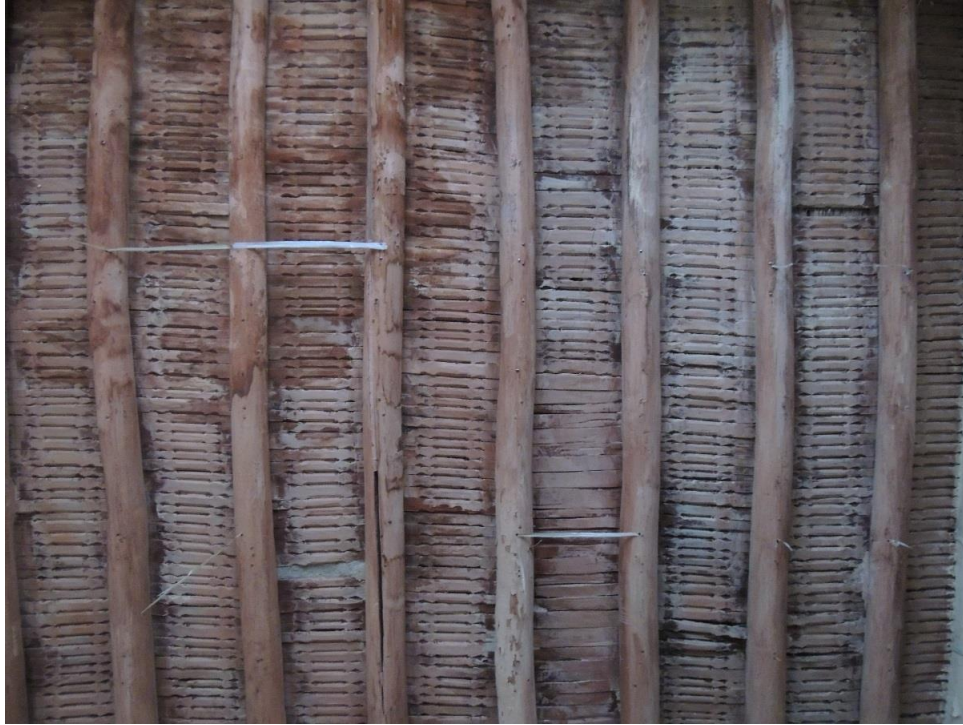
Figure 3.31 The combination of round beams and wooden planks in timber ceiling of living room in Nili House.

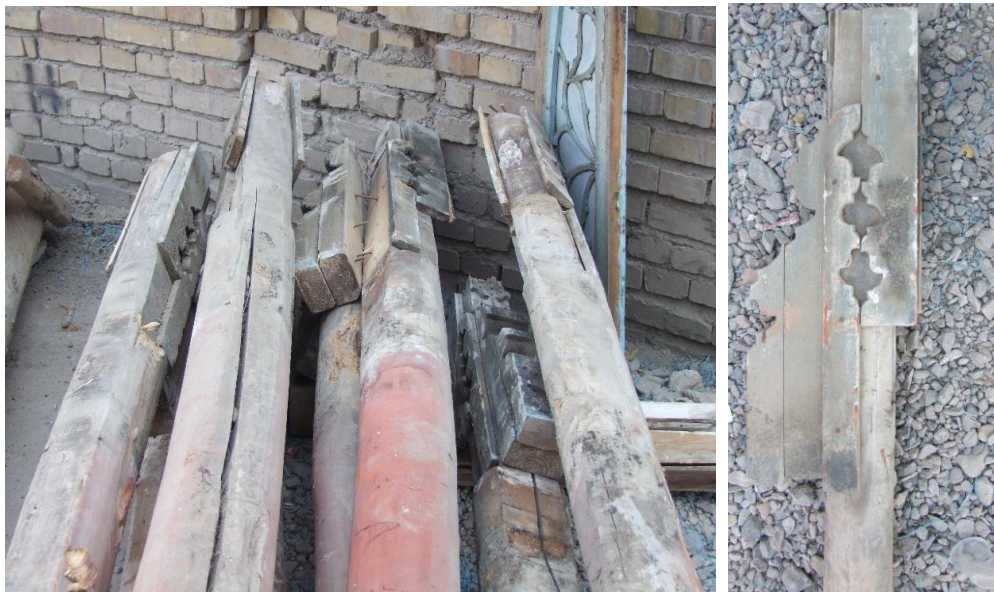
Figure 3.32 The connection of ceiling beams with the carved boards that are collected from a traditional house before its demolition.

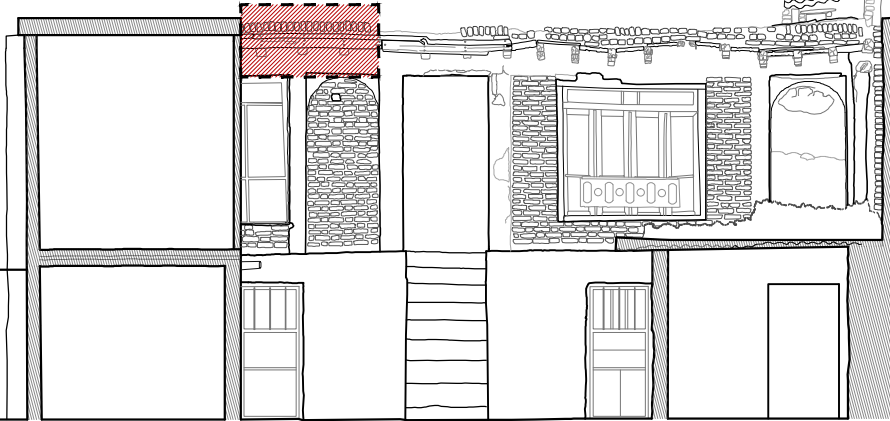
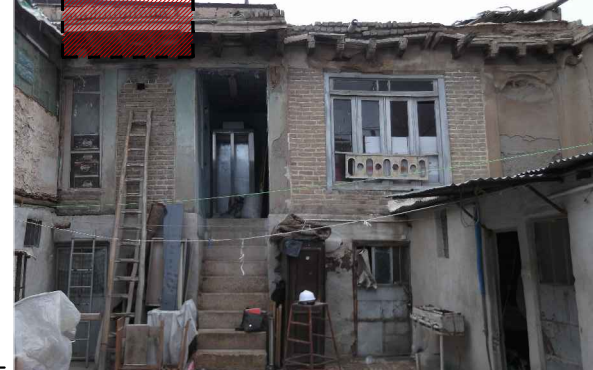
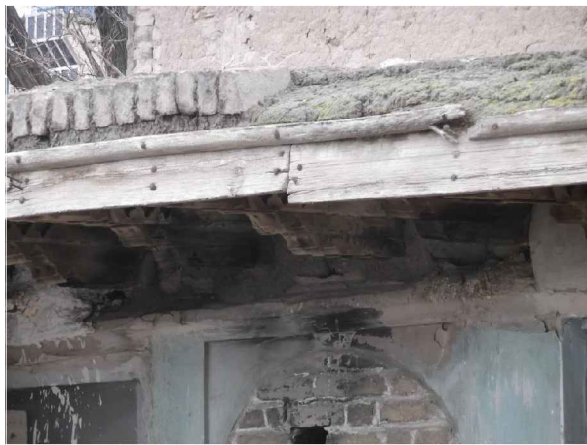
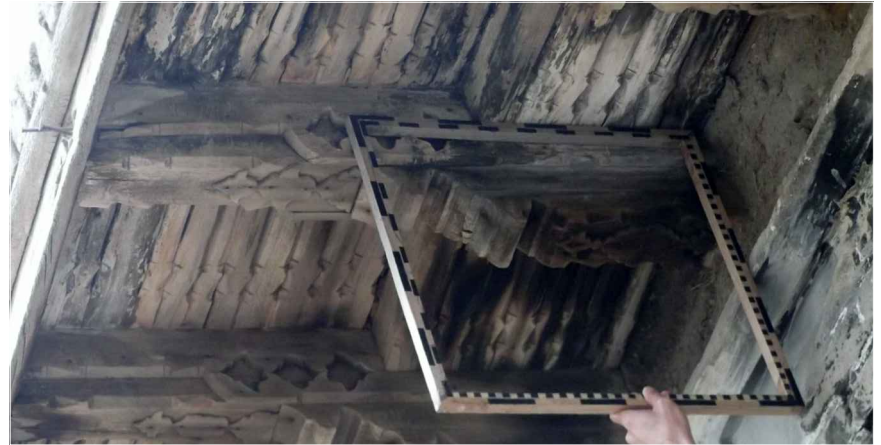
1 Roof details (RF.01), construction materials and technique;

Fig. 3.4.1 Study on construction method of the carved ceiling; (a) a sketch of the roof line presents the wooden ornamental elements (*sorou*) made of carved boards and brackets, (b) integration of structural ceiling-components and mud-brick masonry; jointing *sorou* and ceiling beam.

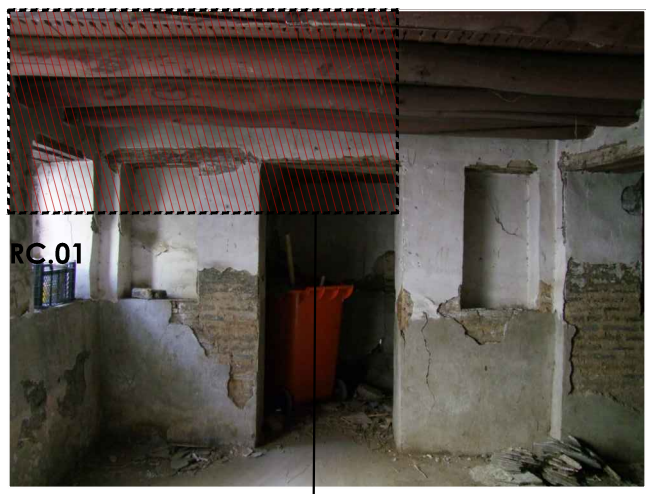
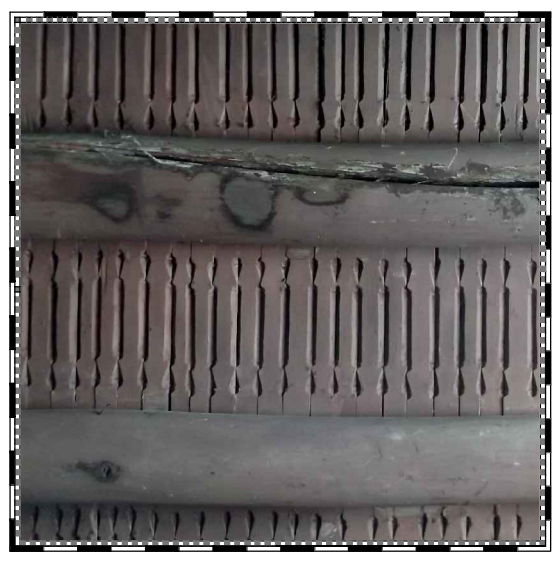
1 Roof covering details (RC.01), construction materials and technique;

Fig. 3.5.1 (a) basic structure of a traditional roof built up with round ceiling beams (20 cm), carved wooden planks (35 × 4 cm), wooden planks, straw matting and a layer of *ghoreghel* (mixture of clay, sand and water), (b) wooden ceiling details on the ground floor.

These well-insulated roofs would warm the room during the winter and keep it cool during the summer. However, the problem in this type of roof is that it can become too heavy and even absorb a high amount of moisture during wet days of the year. On the one hand, these high thickness of dirt mass exerted a lot of pressure on roofs which leads to bending of the ceiling.¹⁸⁰ On the other, the roof contains a high percentage of water which has infiltrated the lower components including wooden boards. Thus, wooden elements present white and brown rots formed by fungus attacks.

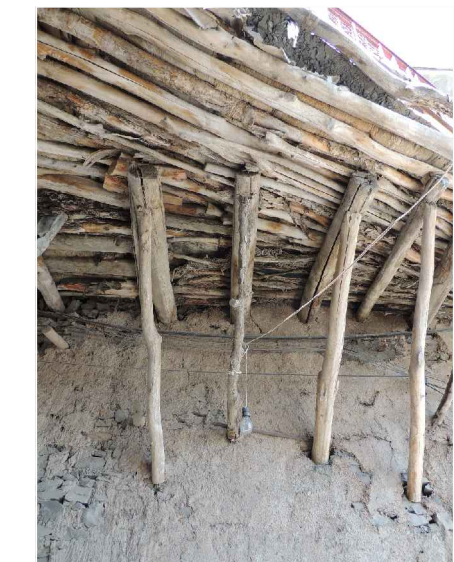
2 Similar examples; Kang, Iran and Tell Hammam at-Turkman, Syria;

Fig. 3.5.2 (a) balcony of a vernacular house located in Kang Village (28 km from Mashhad) showing utilization of medium-sized trunks, wooden struts, straw and sheets of linen in its construction, (b) placing the reed over the beams in the roof construction, Tell Hammam at-Turkman, Syria. (Claasz Coockson 2009)

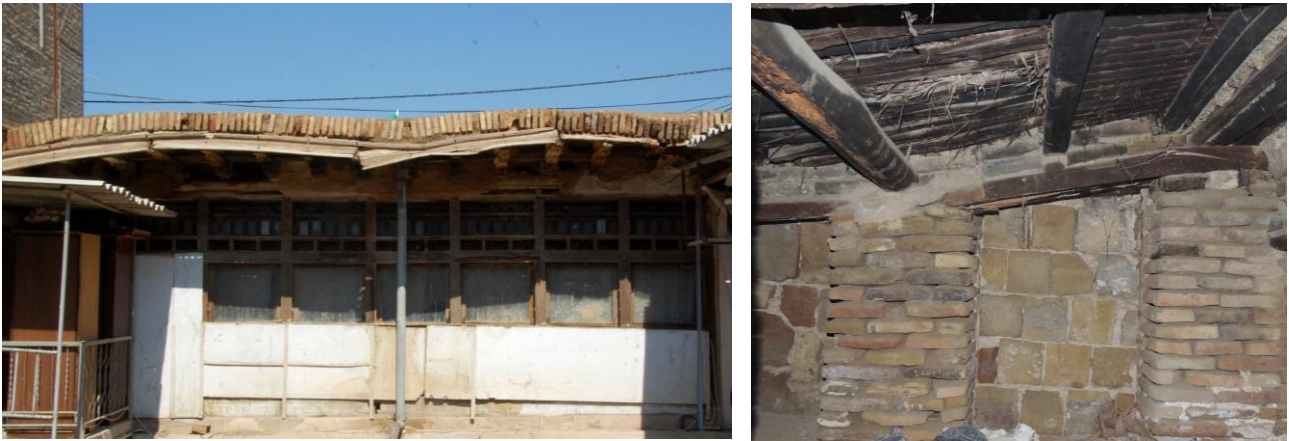
Figure 3.33 Deformation of the ceiling because of high pressure on the roof; Tehrani House, NW building mass. **Figure 3.34** Extreme inclination of the ground level due to flooring heaviness of the upper story, Nili House.

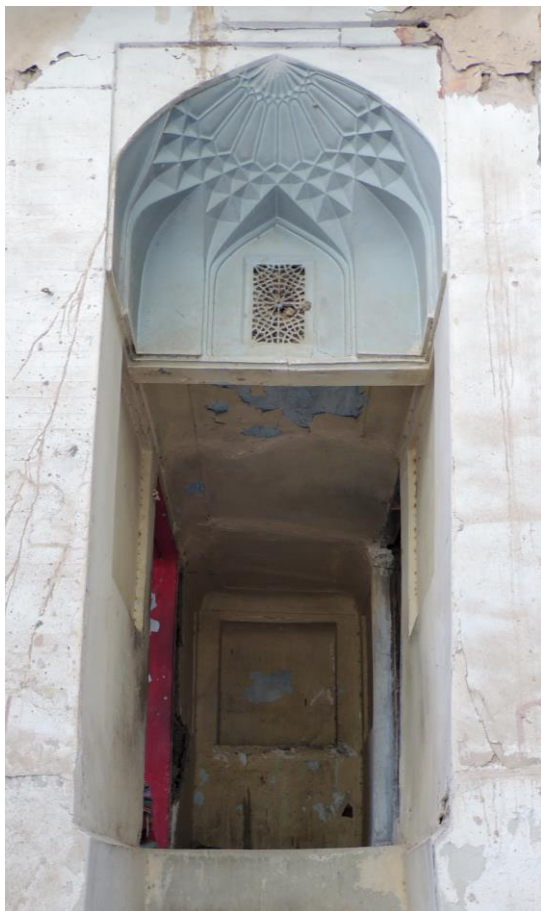
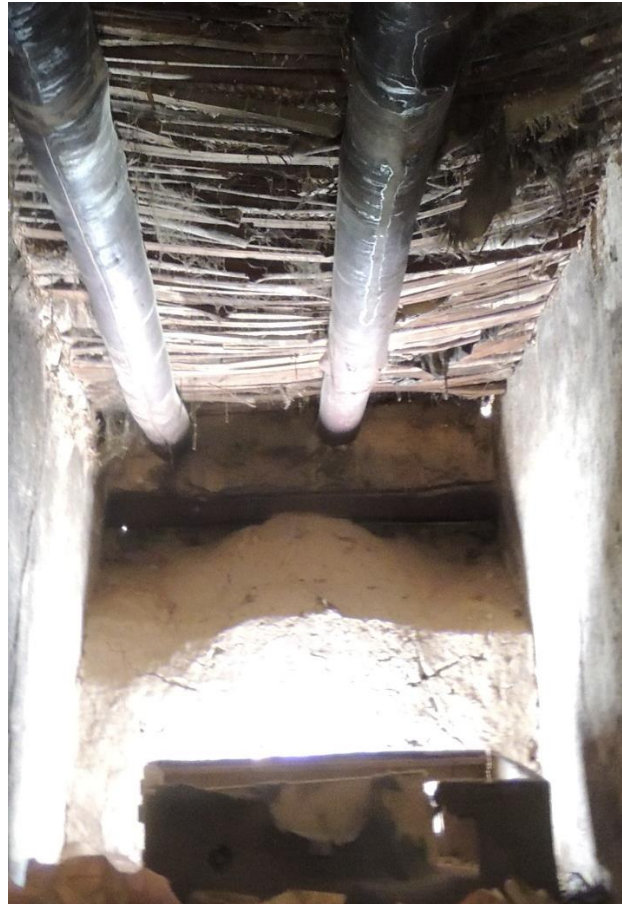
Figure 3.36 *Iwan* entrance in the summer quarter of Nili House that includes *panjohaft tond* arch. **Figure 3.37** Utilization of supporting timbers above the pointed arch (*panjohaft tond*), proving the implementation of vault as an ornamental component not a load-bearing arch. It also represents the space behind the vault that was allocated to keep valuable objects.

The entrance of *iwan* is adorned with a vaulted ceiling which identified as *panjohaft tond*, the most common arch in traditional architecture. It is considered as a load-bearing and decorative arch that has a high resistance and rarely breaks down due to the pressure of balanced loads. However, in case studies, *panjohaft tond* arch is not applied as a load-bearing vault but as decorative arc in which the pressure from the roof weight is onto the horizontal beam and, the arch does not bear any load.

panjohaft tond arches in Nili and Bidari Houses were adorned with *karbandi*, an arched covering pattern which is a suitable insulation for sound and movement. In Iranian architecture, there are different types of such decorative coverings. The type is specified based on dimensions of the surfaces on which *karbandi* is going to be implemented. In both houses, *karbandi* of *iwan* has a simple 12-sided type which includes an opening in its center. This aperture, carved with *giri*h (strapwork), is called gypsum plate that allows for circulation of air in the storage by its surface.

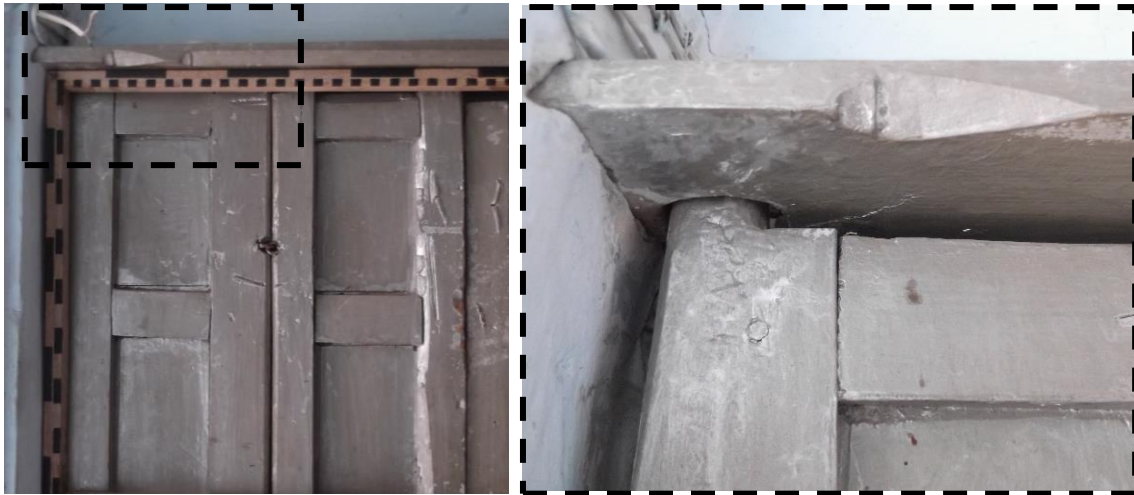
Figure 3.39 Wooden openings in the winter quarter (SE building mass) of Tehrani House with no hinges to turn.

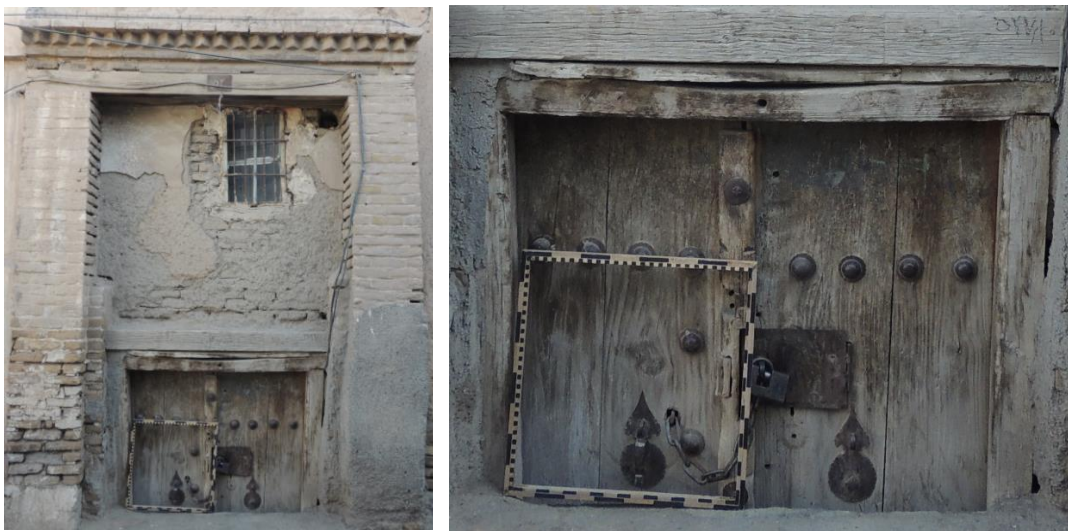
Figure 3.40 Integration of wooden planks and iron-works such as studs, door knockers, chains and padlocks in the main door entrance at Tehrani House.

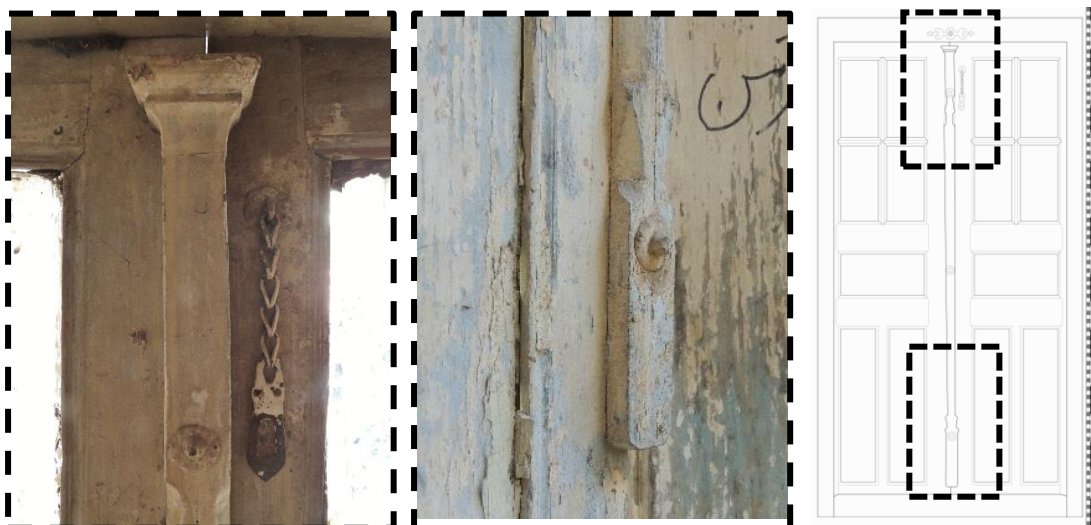
Figure 3.41 Structure of the openings in the living chamber at Nili House, including wooden doors with decorative studs (*golmikh*) and a staple and fastener at the center.

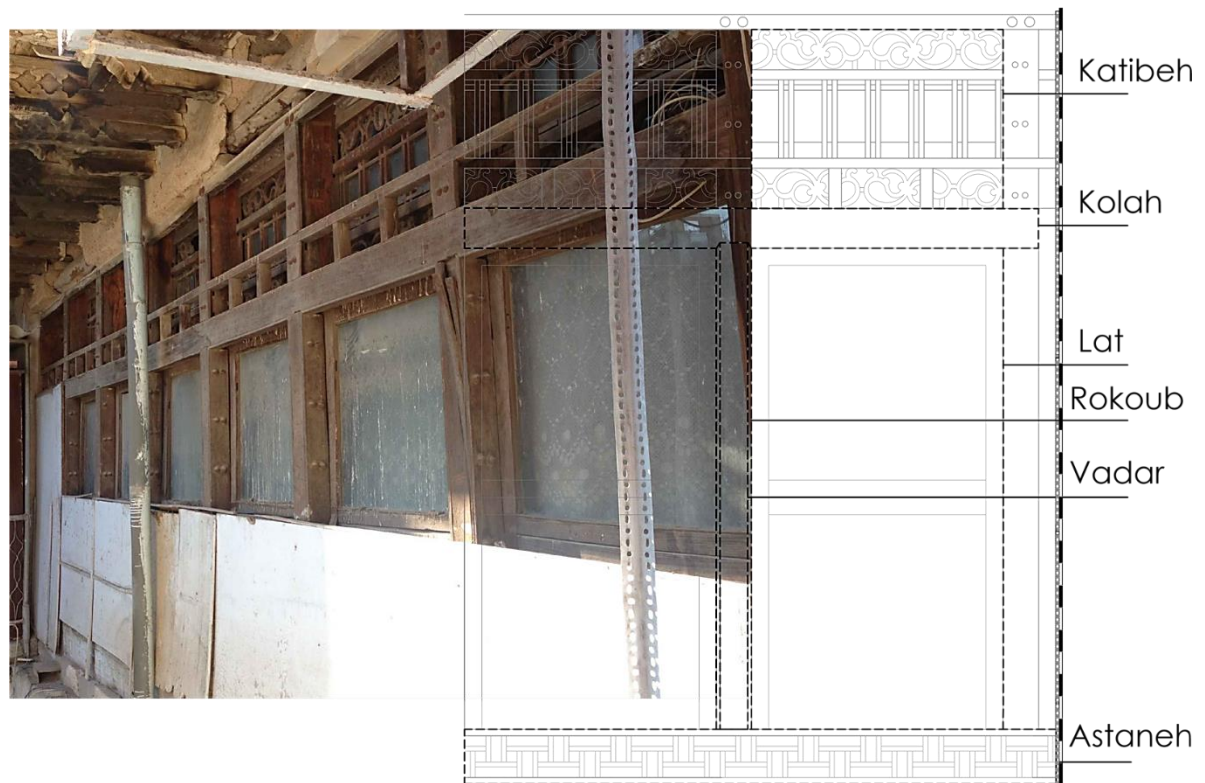
Figure 3.42 *Orosi* (sash window) components at Tehrani House, summer quarter (NW building mass), first floor.

Considering the *orosi* windows at Tabriz houses, the *orosi* in Tehrani's house belongs to the early 19th century due to the shape of its inscriptions, colored glasses and the number of doors.¹⁹⁰

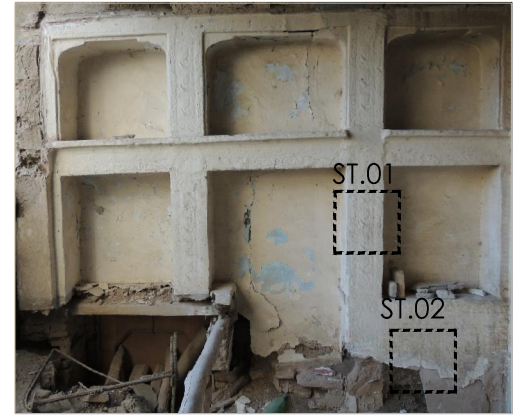
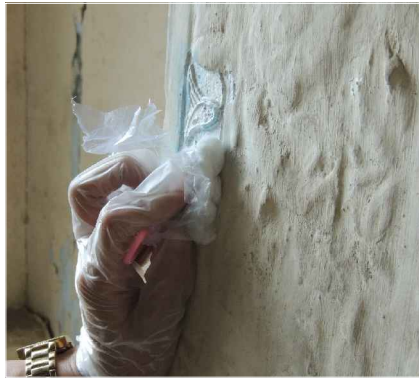
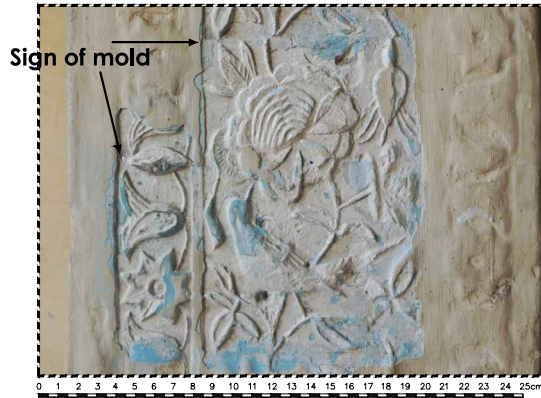
1 Cleaning process, ST.01, ST.02, *gol-o-morgh* pattern;

Fig. 3.7.1 Stuccoes with *gol-o-morgh* pattern after cleaning the layers of colors; (a) layers were removed using of a mixture of ammonia and acetone, scalpel and rubbing cotton swabs, (b) SW pier, ST.01 after cleaning in which the sign of using molds can be observed, (c) SW wall, ST.02 after cleaning, the edges of the stuccoes may present a sign for the mold position caused by the involvement of the frame and the plaster when detached.

In Nili House, the stuccoes with *gol-o-morgh* pattern were implemented by pressing molds (12 × 16 cm) onto wet plaster, called semi-dead gypsum mortar.¹⁹⁴

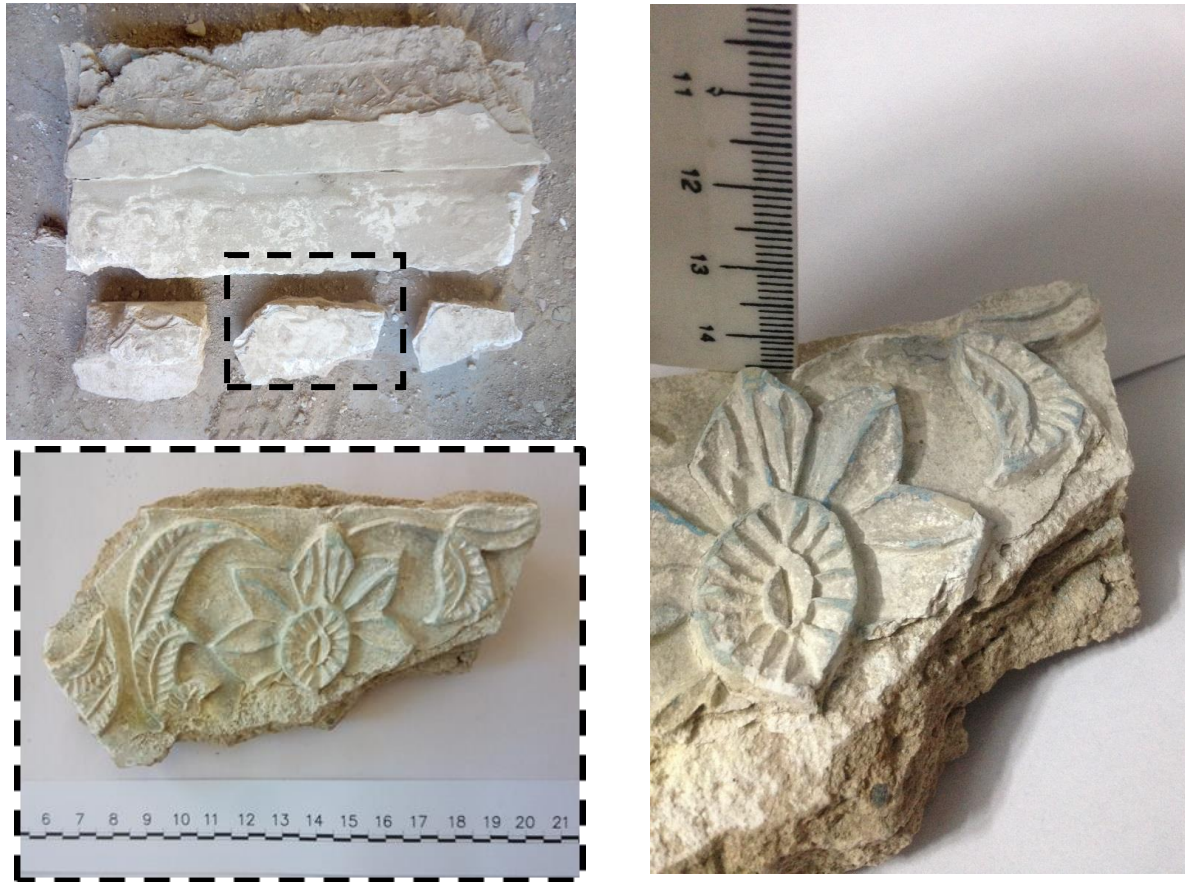
Figure 3.50 The fallen stuccos with floral motifs found in the guest room at Nili House that present only 1 mm thickness after the cleaning process.¹⁹⁷

- Figure 3.50** The fallen stuccos with floral motifs found in the guest room at Nili House that present only 1 mm thickness after the cleaning process. | 167

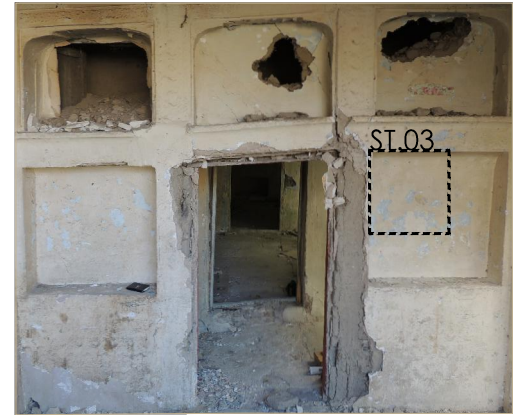
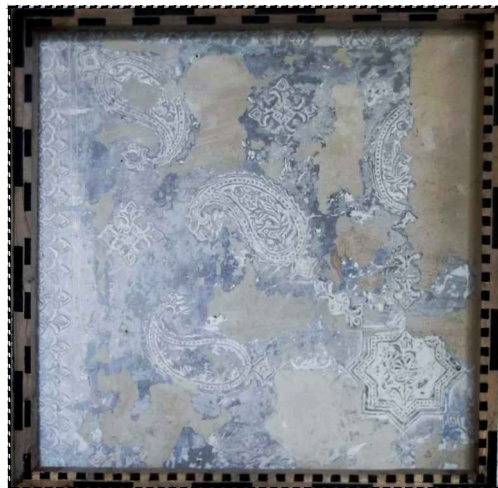
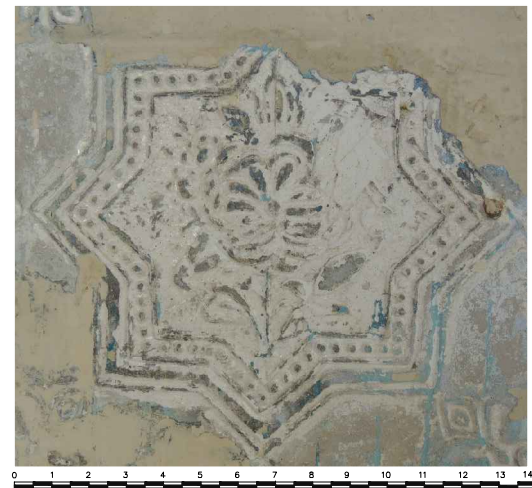
1 Cleaning process, ST.03, paisley and naturalistic motifs;

Fig. 3.8.1 One-fourth of the second type of the stucco work ornamenting the interior of the niche by repeating paisley and floral patterns; (a) cleaning process, (b) NW niche, ST. 03 after cleaning; utilization of paisley as the base pattern to design the floral and vegetal motifs, (c) 8-point star pattern at the core of the stucco work.

These stuccoes have been made by pouncing technique (freehand manner). In this method, after preparing a substrate surface that should not be polished but a bit rough, the plaster should be stretched to a thickness of one and a half centimeters on the desired surface and flattened with a trowel. A quarter of the original design is then drawn on the paper and its lines are drilled with a needle. The design is stuck on the spot and the edges of motifs will be transferred onto the surface through beating a canvas of soft ashes over the holes. After this stage, the design is begun to be cut with special tools. Firstly, the edges of the motif are scratched with a pointed tool to prevent it from being erased. Then, with a sharp pen, the patterns are cut off on the plaster layer, and the background coat sculpted.
