SAPIENZA
UNIVERSITÀ DI ROMA

XXXI Ciclo Dottorato in Restauro dell'Architettura

**A STUDY ON THE ARCHITECTURAL FEATURES OF HOUSES
CONSTRUCTED FROM XVII TO XIX CENTURY IN THE CITY OF
MASHHAD**

Dottoranda: Rana Daneshvar Salehi

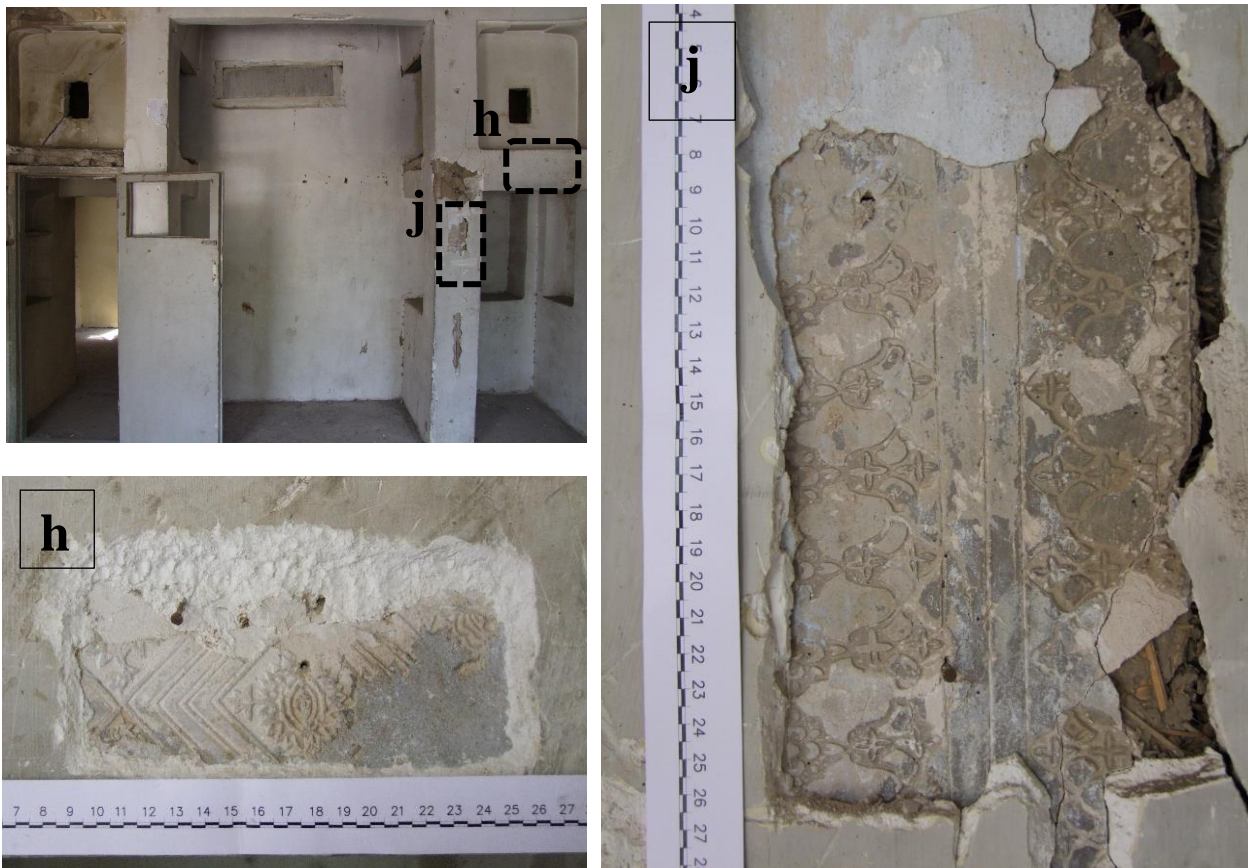
Figure 3.53 Vegetal and floral motifs in the main chamber at Bidari House; (h) Similarity of the central floral pattern to the carnation flower in Safavid motifs (1501-1736 AD); Bidari House, NE building mass, living chamber, NW wall.

The stuccoes of the central columns in the living chamber (family zone) at Bidari House have been implemented by both techniques, using molds and pouncing (freehand). They are present the vegetal and floral patterns that are similar to the naturalistic motifs designed on the Safavid porcelains in which the influence of Chinese art regarding motif and color is evident.²⁰⁰

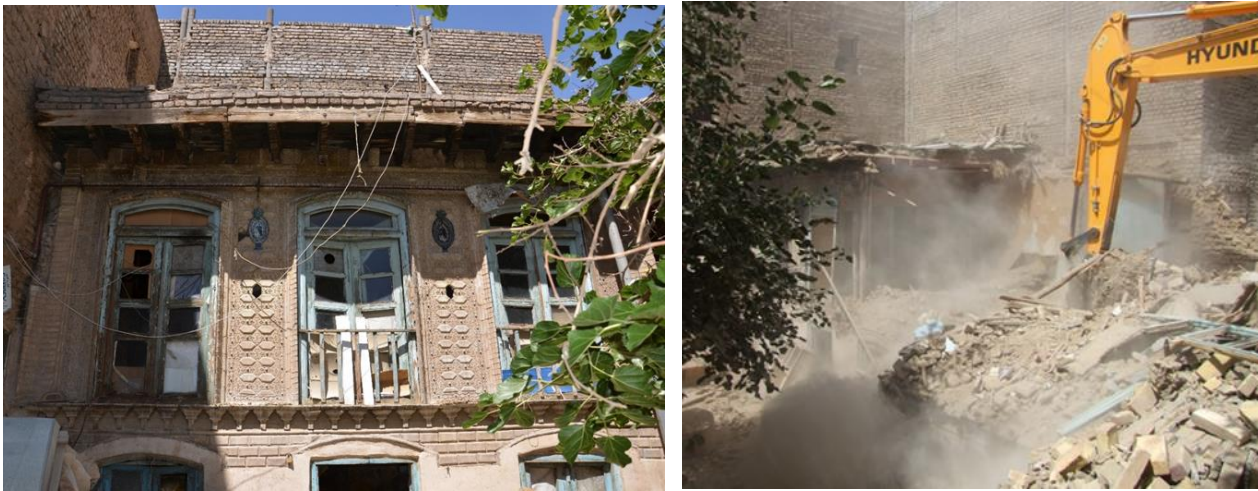
Figure 4.1 Darban Maghami House before and after the demolition in 2008 that occurred due to removal from the List of National Heritage. (Govahi 2013)

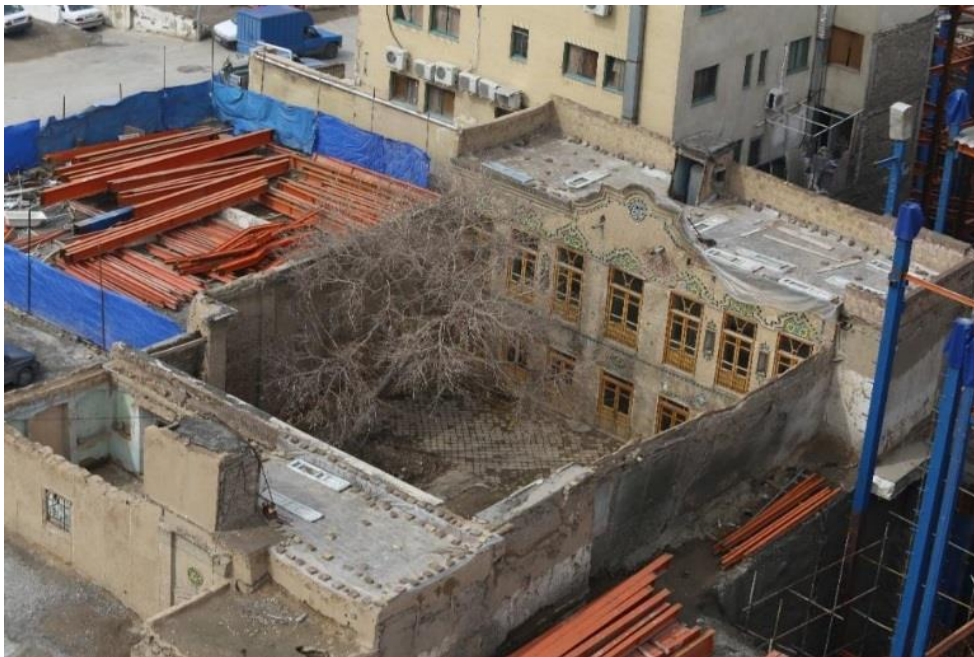
Figure 4.5 View of Amiri House before the onset of the innovative restoration project. (Govahi 2015).

Following the clean-up, there comes the establishment of a provisional safeguard system and scaffolding. The third main stage concerned the roof lightening and repairing the wooden ceilings following the original technique and using traditional materials. In the meantime, elements like the broken skyline (*taj*), which is placed on the roof, are also reinforced.

Without any components having been consolidated, the final measures under the original earlier patterns and materials consisted of restoring the ruined parts of the masonries and recoating the outer façades. The sheets below depict the traditional measures employed in Amiri House from September to December 2007.

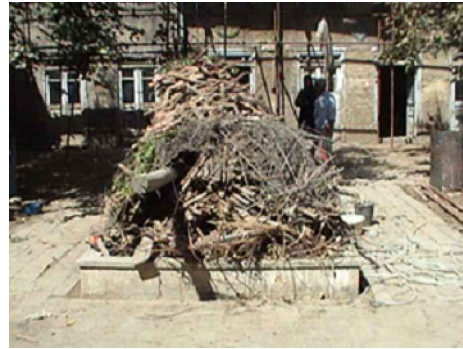
Fig. 4.1.1 Collecting branches of trees and cleaning the area to begin the restoration operation.

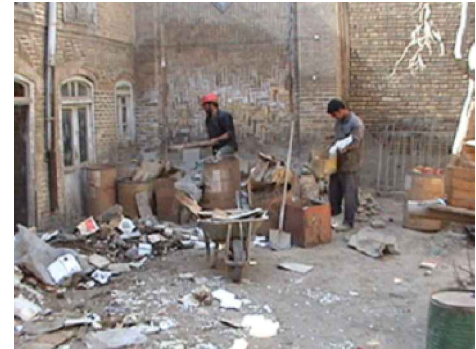
Fig. 4.1.2 Emptying the courtyard and rooms from garbage and waste.

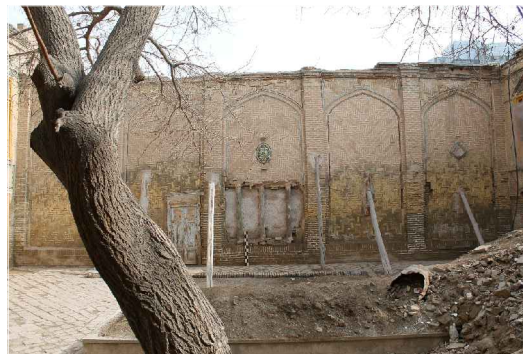
Fig. 4.2.1 Use of wooden props and beams to prevent the collapse of the northeastern boundary wall.

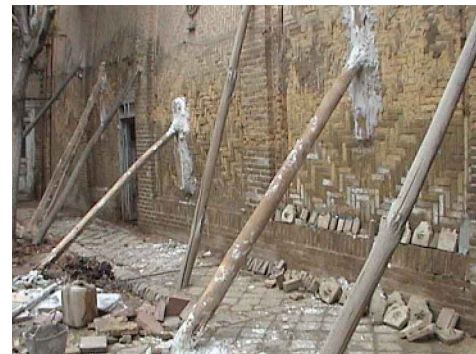
Fig. 4.2.2 Inappropriate connection between wooden props and the brick wall using gypsum mortar to paste.

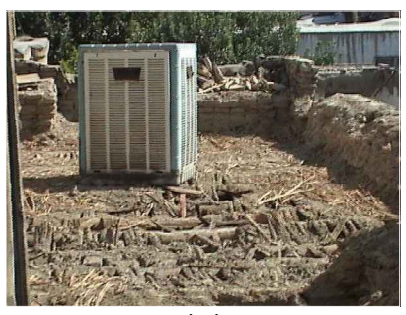
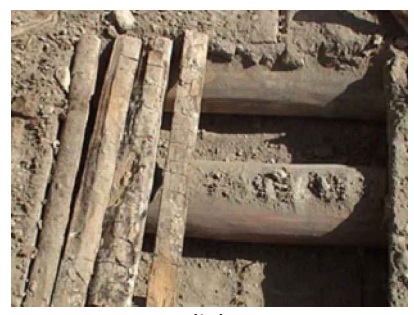
Fig. 4.3.1 Roof lightening; (a) removal of finishing layers like mud mortars, reeds or straw mats, (b) dismantling the elements that belong to the roofing structure, such as wooden planks, in order to reach the ceiling beams.

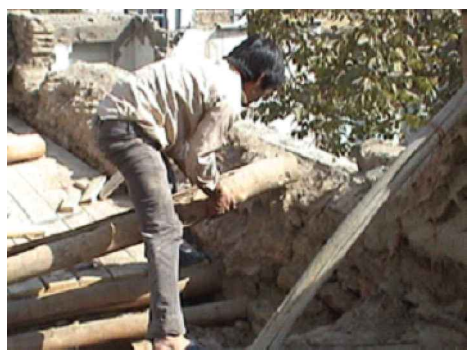
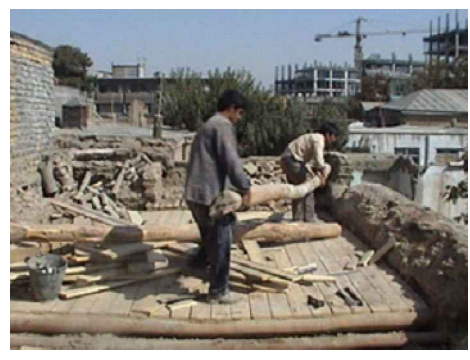
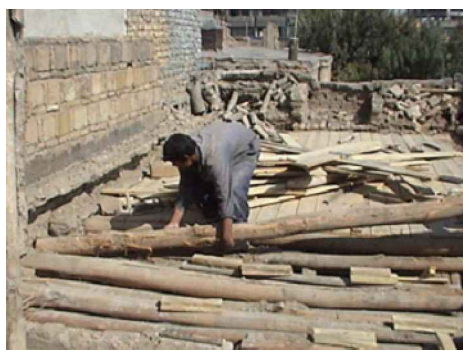
Fig. 4.3.2 Removal of rotten ceiling beams and placement of intact poplar trunks (original material) in place of the removed timbers; (a) dismantling the deteriorated beams, (b) their replacement with undamaged lumber, (c) placing the new trunk where the damaged timber has been.

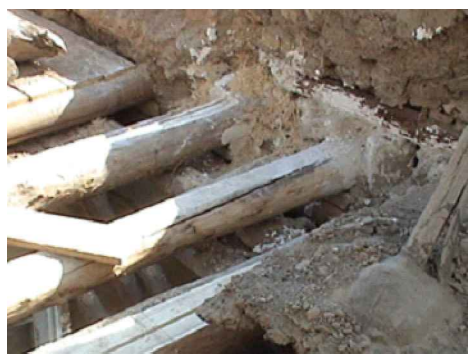
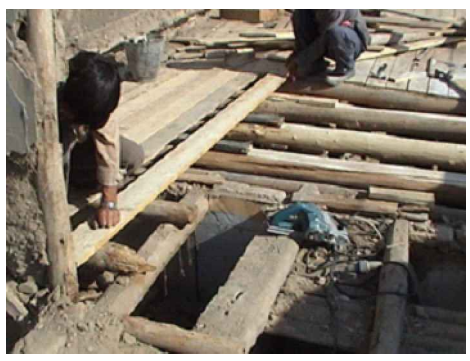
Fig. 4.3.3 Connection between the inserted beams and the roof parapet using a mixture of gypsum and water. **Fig. 4.3.4** Fixing the new long boards on the ceiling beams with iron studs.

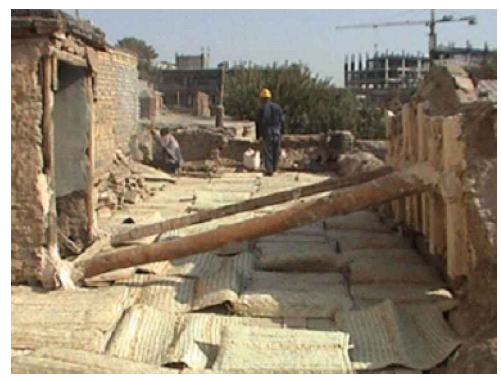
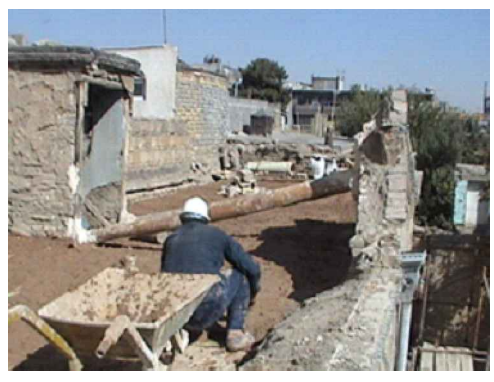
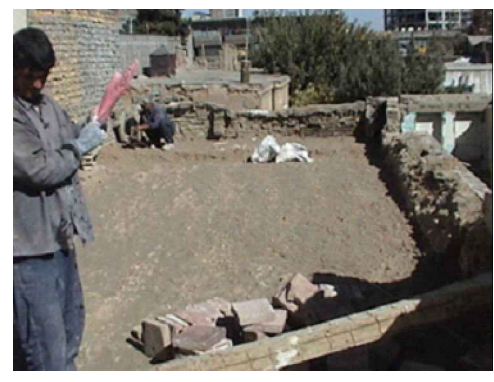
Fig. 4.3.5 Roof insulation; (a) covering the boards with straw mats, (b) smearing a 10-cm layer of *ghoregel* (mixture of clay, sand and water) over the mats, (c) covering *ghoregel* mortar with a coat of dirt.

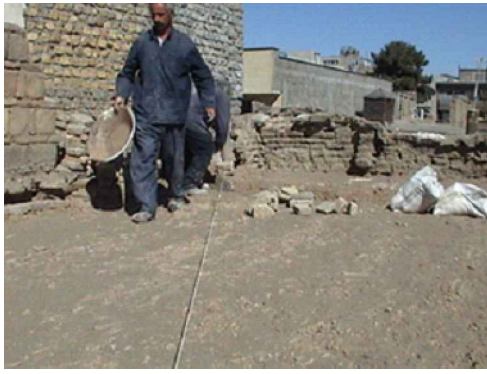
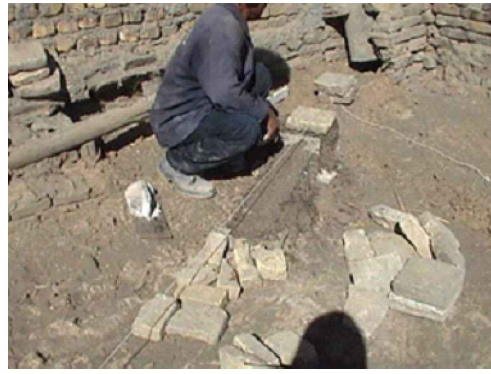
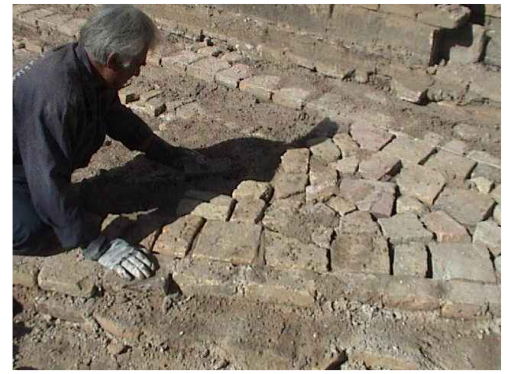
Fig. 4.3.6 Roof inclination; (a) creation of slopes by layers of dirt (b) implementation of square bricks and gypsum-sand mortar to make the perimeter of the first flooring, (c) utilization of brick rubbles to fill the empty spaces between the brick lines.

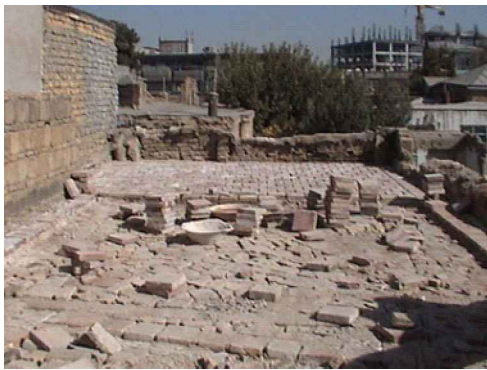
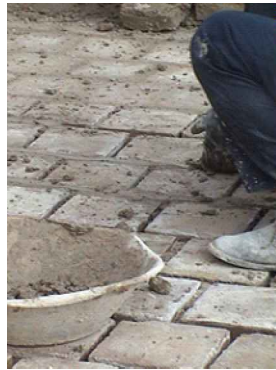
Fig. 4.3.7 Paving the roof; (a) covering the surface of the roof with square bricks (20 X 20 X 5 cm), (b) pointing the sand-gypsum mortar between the brick courses.

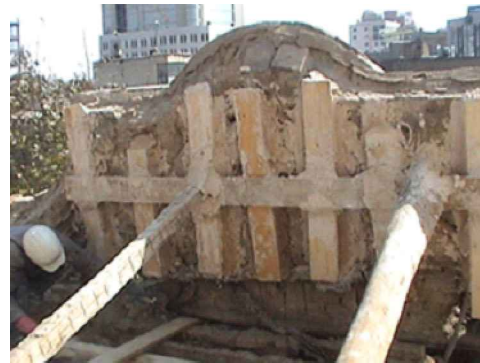
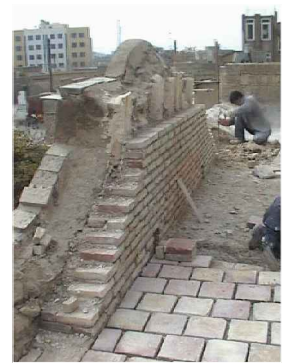
Fig. 4.3.8 Reinforcement of *taj* (broken skyline element); (a) consolidation of *taj* using wooden planks, glued with chalky mortar to a thick layer of gypsum-clay coat covering the brick structure, (b) construction of a 30-cm thick brick wall behind the element.

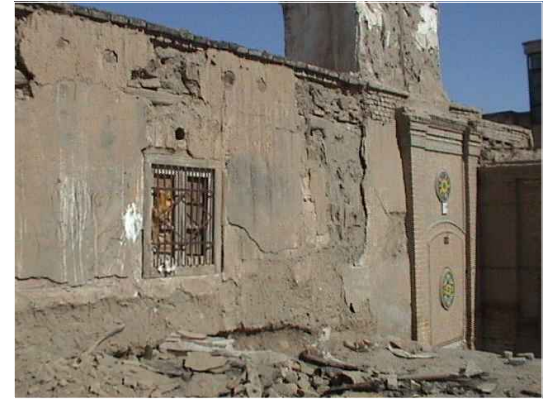
Fig. 4.4.1 Physical condition of southwestern wall before the onset of restoration operation

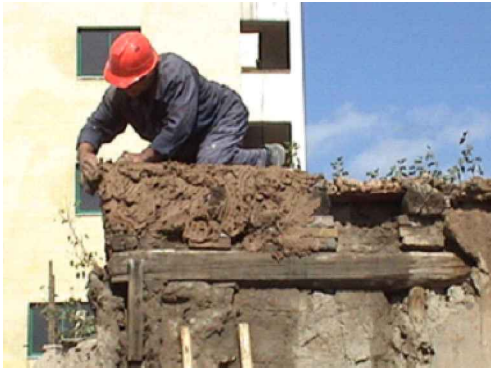
Fig. 4.4.2 (a) utilization of *ghoregel* mortar (mixture of clay, sand and water) to infill and cover the ruined parts of the outside façade, (b) removal of eroded bricks and their replacement with the new ones (20 X 20 X 5 cm), (c) completion of the wall reconstruction.

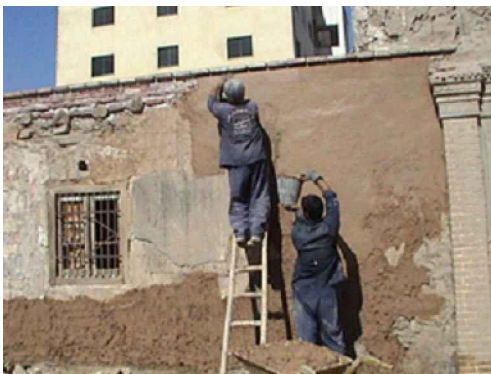
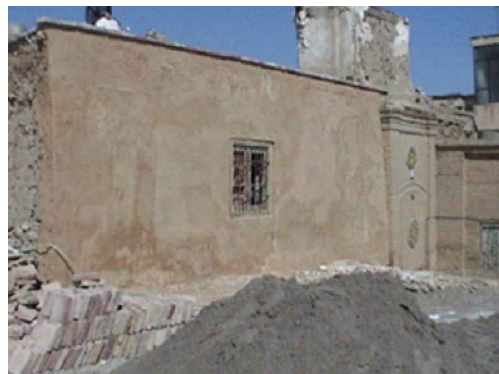
Fig. 4.4.3 (a) coating the wall by a finishing traditional layer of straw-mud mixture like the original method, (b) completion of plastering.

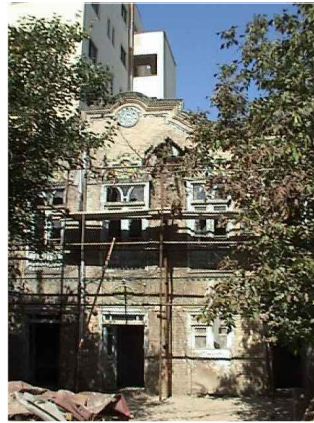
Fig. 4.5.1 Physical condition of northwestern façade before the onset of reconstruction and repair.

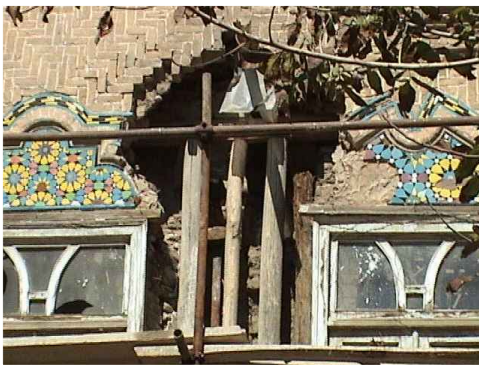
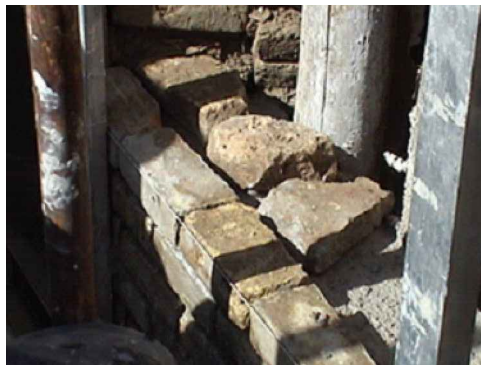
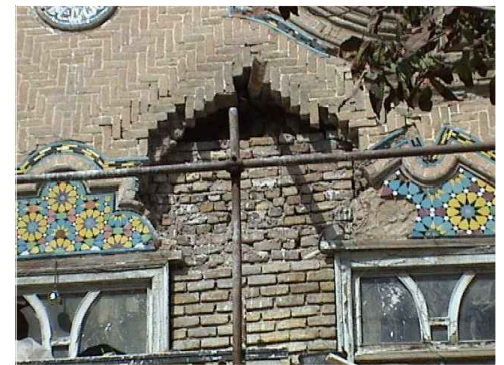
Fig. 4.5.2 (a) removal of original materials, such as raw bricks and mud mortar, which have lost their characteristics and durability, to reconstruct the masonry with fired bricks, (b) using the bricks in half form in the front row, brick rubbles in the back row and a mixture of gypsum-sand as mortar, (c) completion of the brick wall.

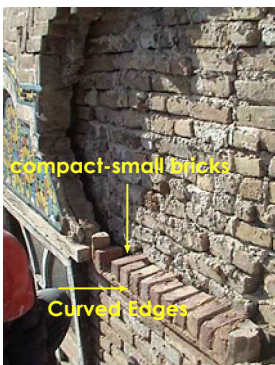
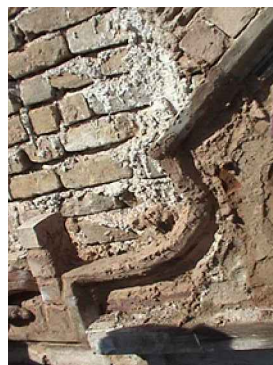
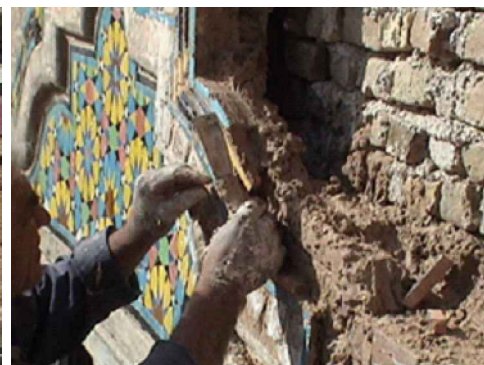
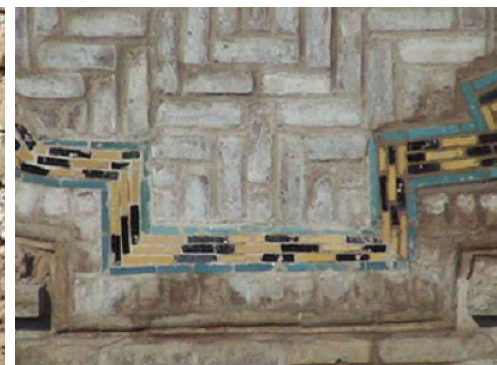
Fig. 4.5.3 (a) implementation of bricks with curved edges in the first row, and compact and small bricks (5 X 5 cm) in the second course, (b) remaking the arch according to its earlier form with curved-edge bricks and mud-gypsum mortar, (c) laying the tiles (15 X 1.5 cm) around the frame of the window with respect to the traditional arrangement, (d) completion of reconstructing the damaged portion of the northwestern facade through pointing the mortar (sand-gypsum mix) between the brick courses.

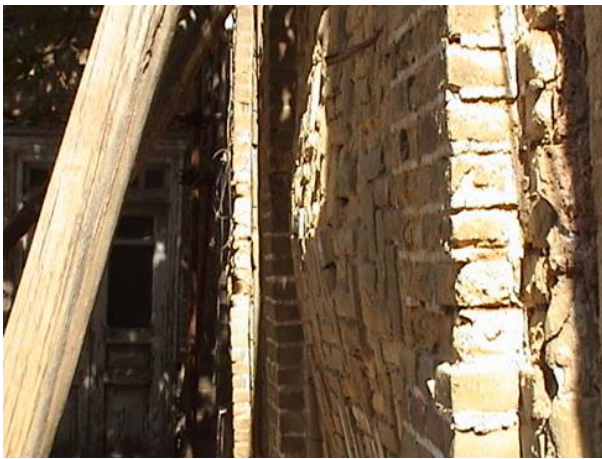
According to the general criteria for conservation and restoration of architectural heritage, it is mandatory to know the kind of structure, material characteristics and the cause of damage and decay prior to any intervention. The outcomes of the system and materials describe that the primary principles defined for the preservation of a historical building have not been taken into account. The first incorrect action is the use of an inappropriate system of safeguard which has caused the collapse of the northeastern boundary wall. The protective mean is composed of only wooden beams arranged as props implemented without using any additional supporting elements and consideration of wall deflection. Neglecting the vulnerability of the building, lack of intervention to reinforce the masonry and mainly the weak function of the protection system against environmental factors and human activities, including the construction of a massive commercial center near the house, have led to complete destruction of the wall.

Figure 4.6 The implementation of weak safeguard system without considering the deformation of brick northeastern brick wall. **Figure 4.7** The collapse of the northeastern boundary wall in 2015. (Govahi 2015)

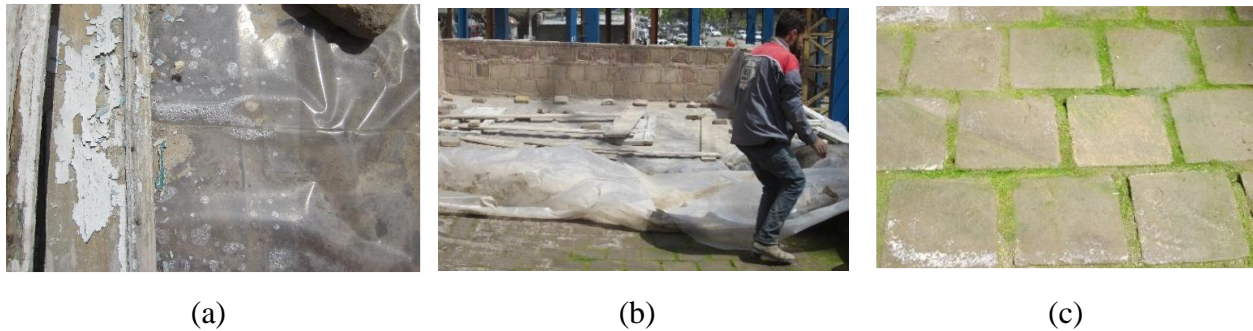
Figure 4.8 (a) moisture retention on the roof of the northwestern mass due to the use of plastic as a protective cover, (b) removal of plastic cover, (c) weeds growth between brick rows. (Govahi 2015)

- Figure 4.7** (a) Moisture retention on the roof of the northwestern mass due to the use of plastic as a protective cover, (b) removal of plastic cover, (c) the growth of weeds between brick rows. | 194

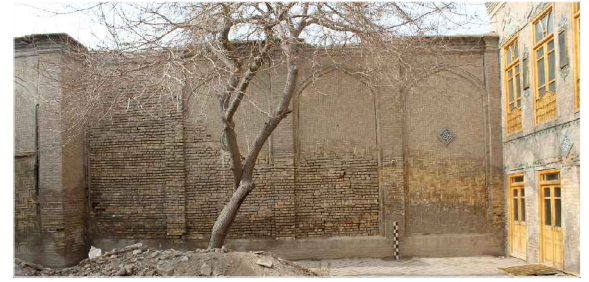
Fig. 4.6.1 Physical condition of southwestern boundary wall before the onset of restoration operation.

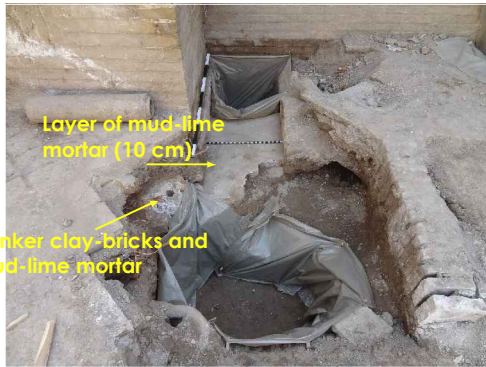
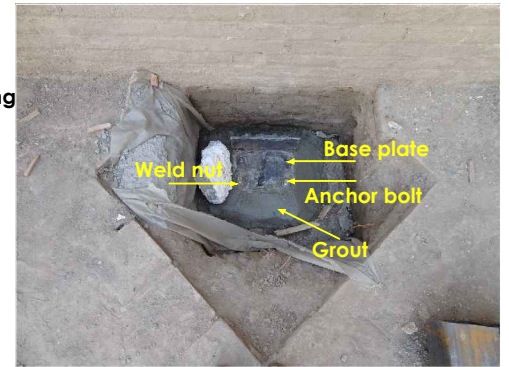
Fig. 4.6.2 Establishing the foundation for erection of safeguarding structure; (a) digging a pit in a width of 40 and the depth of 50 cm adjacent to each brick pillar until reaching the original foundation, placing a layer of nylon over the artificial ground before concreting (using a mixture of cement and coarse sand) in order to prevent the absorption of cement water from the ground and get the concrete to its ultimate resistance, (b) the scheme of the original traditional foundation in Amiri House, (c) the concrete foundation.

In the innovative method, creation of a temporary protective system with steel columns and beams supported on concrete foundation brought a stability to the southwestern boundary wall. As a result, excavation of the adjacent land did not cause any damage to the wall. In fact, for the implementation of the protective structure, it was necessary to establish the concrete foundation only near the brick semi-pillar, which strengthen the existing foundation and provided the connection between the steel columns and horizontal elements of the temporary safeguarding structure. Therefore, the use of reinforced concrete in a continuous way was not necessary (Sheet. 4.8).

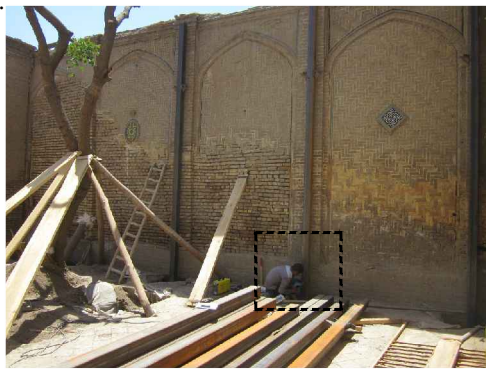
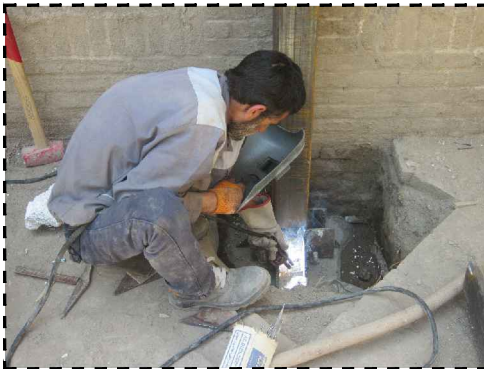
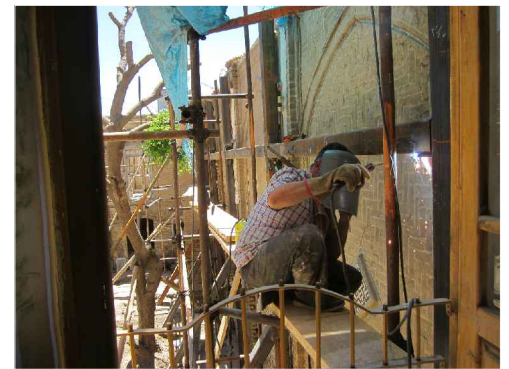
Fig. 4.6.3 Implementation of provisional protective system; (a) placing steel columns in line with the position of brick semi-columns, (b) connecting the pillar with the base plate using steel corners by welding, (c) jointing columns and horizontal beams through welding.

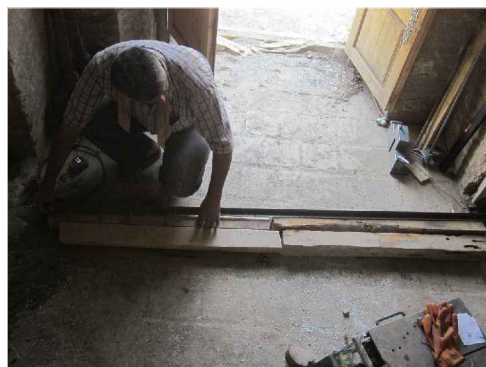
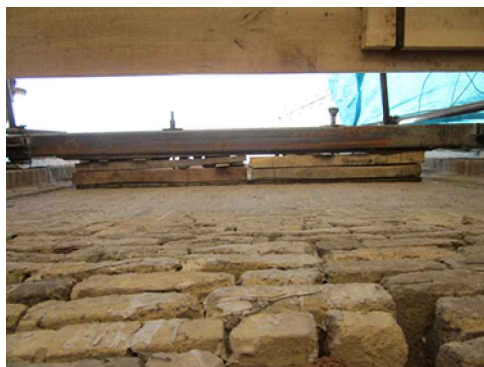
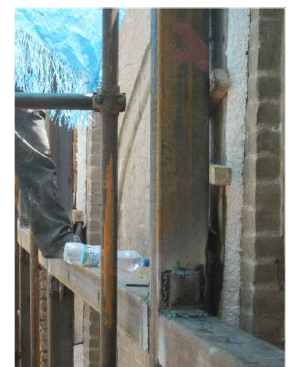
Fig. 4.6.4 Jointing brick walls and iron protective structure; (a) preparation of wooden elements to attach to horizontal iron beams to prevent the direct contact of the structure with the wall, (b) screwing the wooden boards to the horizontal iron beams, (c) utilizing the Styrofoam sheets and wooden sticks between the protective structure and brick walls.

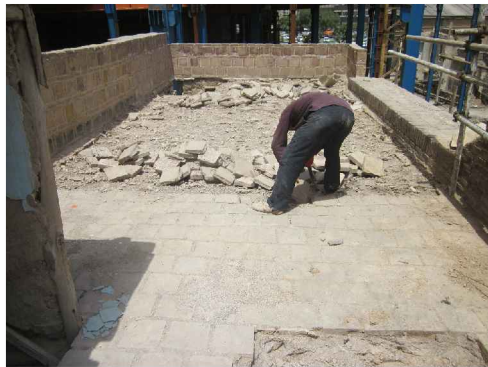
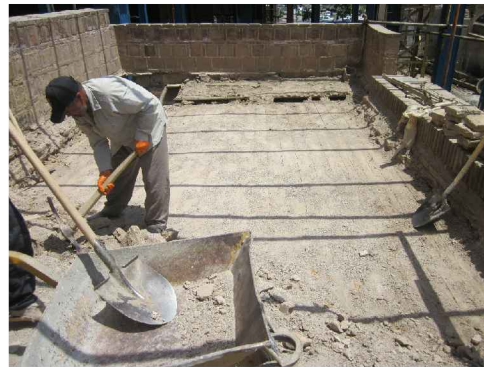
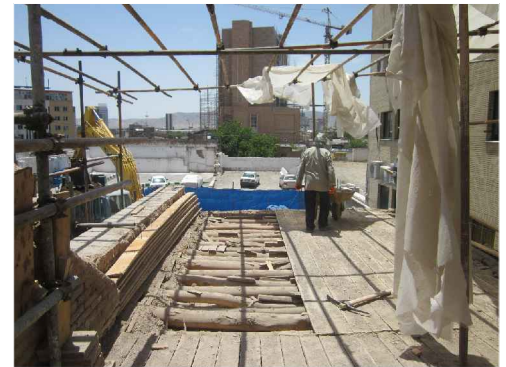
Fig. 4.7.1 Roof cleaning and lightening; (a) removal of roof bricks , (b) cleaning the roof from layers of *ghoragel* (mud + sand) and dirt covering the panels, (c) removing the wooden boards to spot the decayed beams and replacing them with undamaged trunks.

In the present method, roof became lighter in weight by removing of layers of brick and mud mortars that was executed in the previous restoration and exposed a lot of pressure to the ceiling. Also, the construction of a brick wall in the traditional method behind *taj* (broken skyline element) added more load into the roof. For this reason, the destruction of the wall could help to lighten roofing and to avoid cracking *taj*. Even if dismantling the *taj* structure and materials has not been much acceptable, in this case it was certainly the only possible means to conserve it.²⁴³

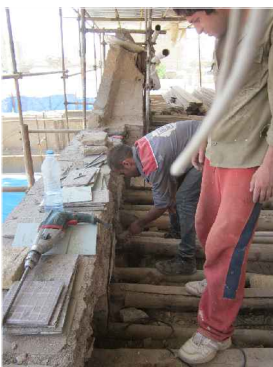
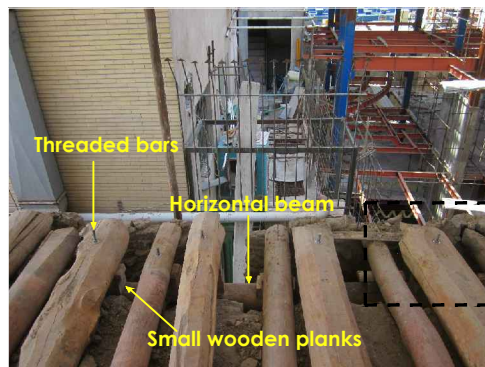
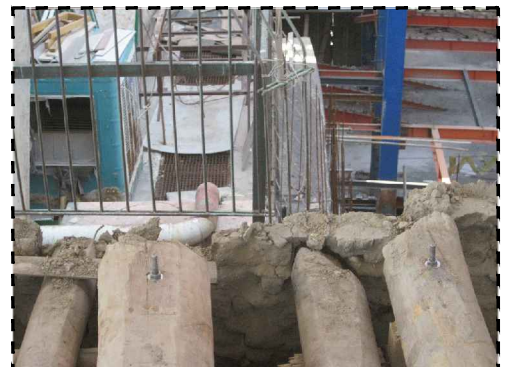
Fig. 4.7.2 Reinforcement of the ceiling timbers joints; (a) freeing the timber heads to create a hole for fastening the bolts, (b)-(c) bolted jointing the ceiling timbers with horizontal beams laid on the top of wall using small wooden planks and threaded bars.

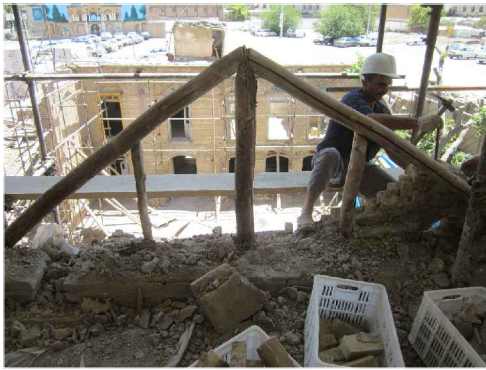
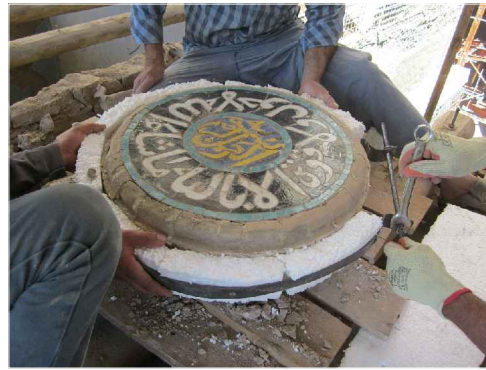
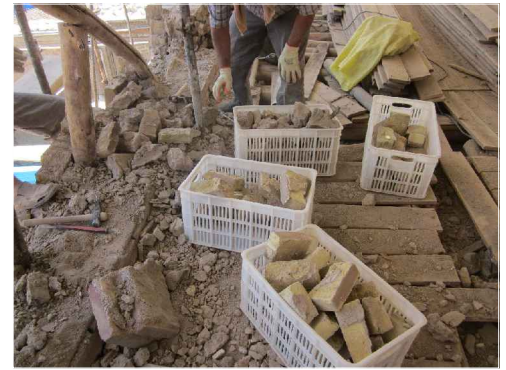
Fig. 4.7.3 Dismantling *taj* construction elements; (a) demolishing the brick wall built in the 2007 restoration project and dismantling the materials of the broken skyline element, (b) removing the inscription from the structure as a single piece and consolidating it using a Styrofoam frame with a bracket mounted on it, (c) collecting the disassembled components and conserving them in warehouse to reassemble *taj*.

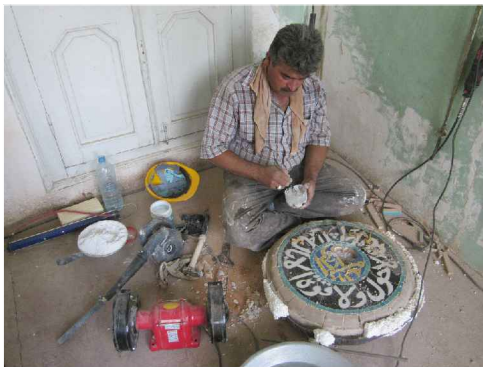
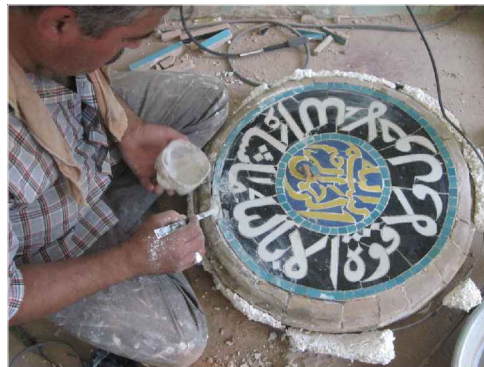
Fig. 4.7.4 Restoration of the inscription; (a) filling the missing parts with new tiles and gluing them to the base with a mixture of gypsum and organic glue, (b) finishing the restoration with repairing the parts that have almost been detached from the surface.

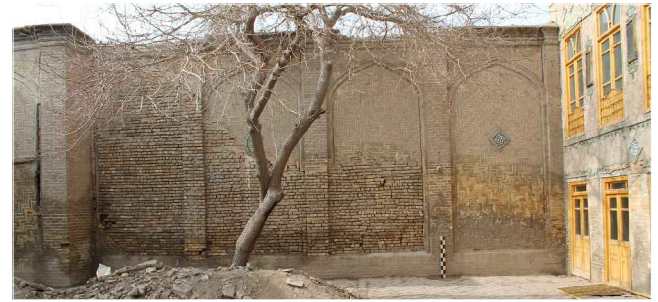
Fig. 4.8.1 Physical condition of southwestern boundary wall before the onset of restoration operation.

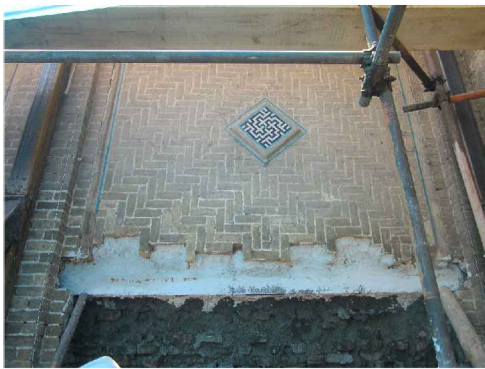
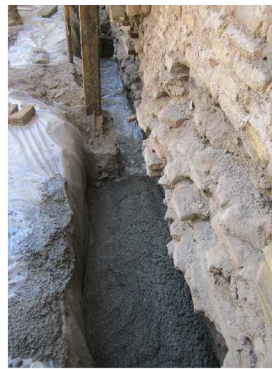
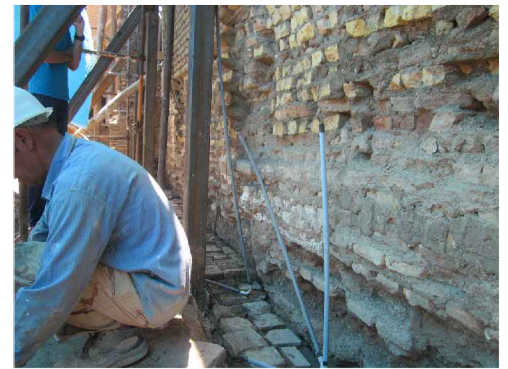
Fig. 4.8.2 Removal of bricks at risk and reinforcement of the southwestern-wall foundation; (a) dismantling the bricks from where the wooden beam is located and using the gypsum mortar to hold the upper portion and prevent the collapse, (b) excavating underneath the wall equal to its width and the depth of almost 50 cm, and placing a layer of plastic before concreting (using a mixture of cement and coarse sand), (c) making the internal flooring before reconstruction of southwestern wall.

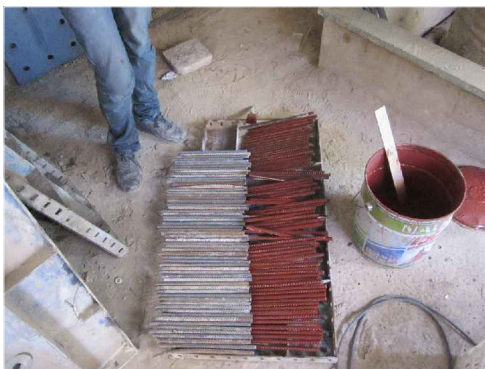
Fig. 4.8.3 Consolidating the structure and providing a safer connection to the new walling and the backing wall; (a) preparing the anti-corrosion steel rebar before insertion into some parts of the masonry, (b) using Geogrid for overlapping the space between the new wall and the backing one, (c) view of the lower part of the brick wall together with the upper portion unbuilt.

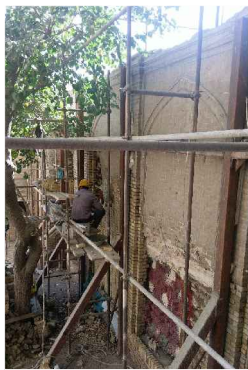
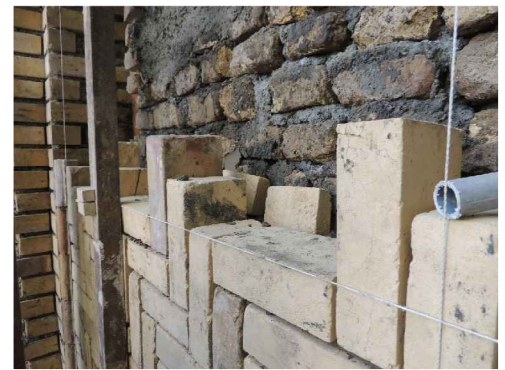
Fig. 4.9.2 Implementation of brickworks; (a) removing the bricks placed onto the walls contrary to the earlier pattern of brickworks and preparing the masonry for new walling by Geogrid sheet, (b) smoothing the edges of the bricks collected from adjacent historic houses and even cutting them into small pieces for reconstruction of the southwestern boundary wall as materials, (c) reconstructing the wall with reused bricks using cement-dune sand mortar by following the earlier original pattern

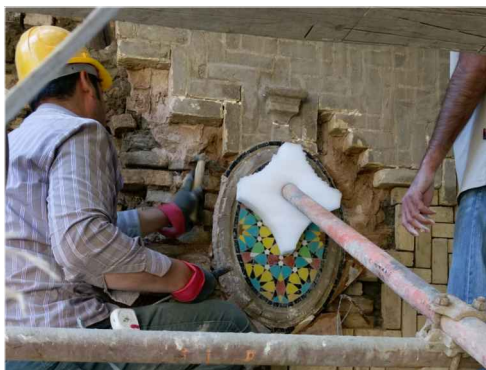
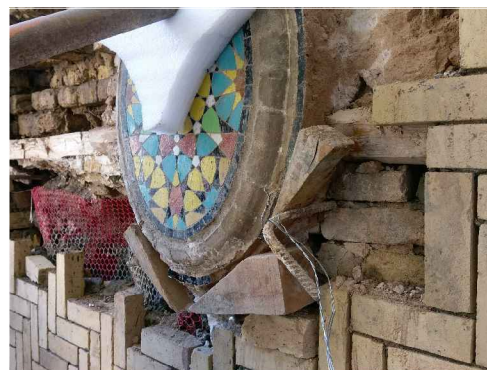
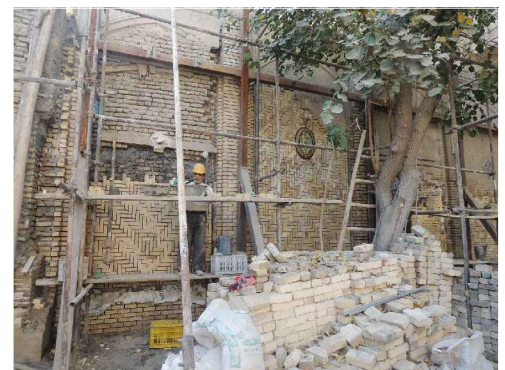
Fig. 4.9.3 Inscription preservation; (a) protecting the central geometrical inscription at its place for emptying the backing space, (b) utilizing a Styrofoam sheet, metal prop, and wooden pieces as bracket and steel bars, (c) view of the southwestern boundary wall after rebuilding the first and central niches.

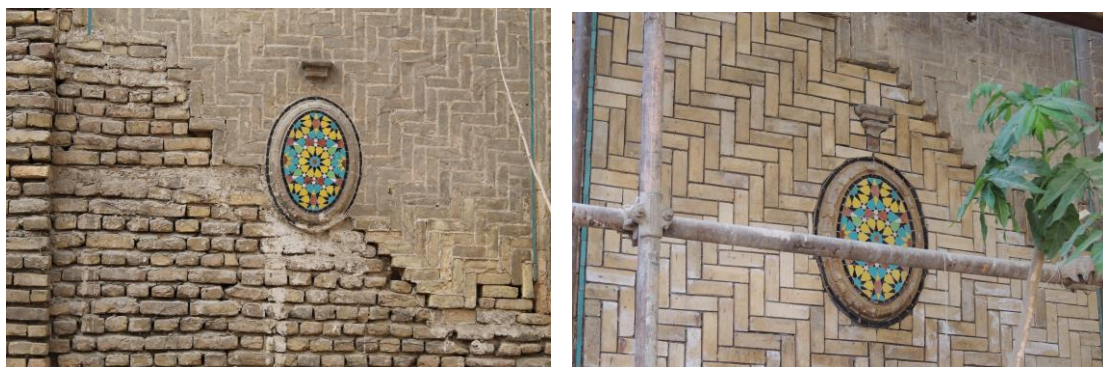
Figure 4.10 *Sottosquadro* method; leaving evidences between the restored and original portion of southwestern boundary wall, original (above) and restoration (below).

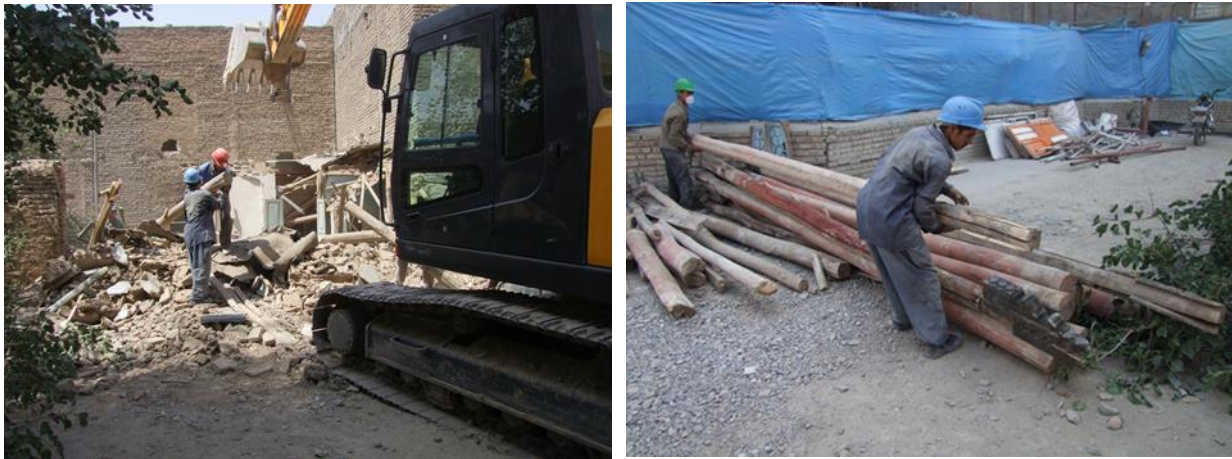
Figure 4.11 Collecting the materials during the demolition of a traditional house in Mashhad. (Govahi 2013)

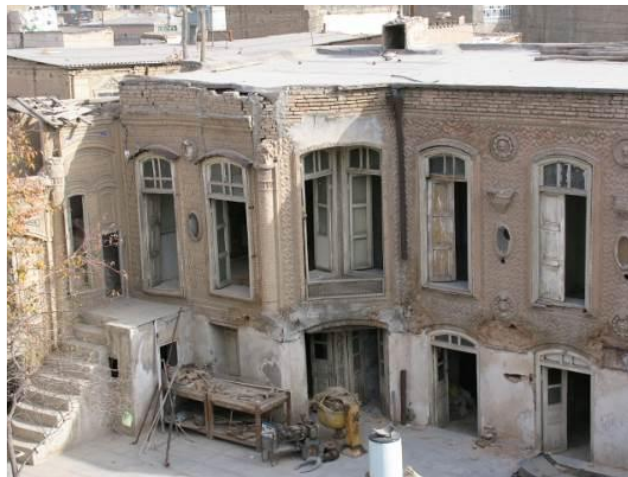
Figure 4.12 View of southeastern building mass in Darugheh House before starting the new restoration project. (Govahi, 2012)

The major destruction of *Noghan* Neighborhood (the location of the house) led to the loss of neighboring constructions that supported the building’s structure. In addition, due to the vibrations and build-ups of heavy machinery, Darugheh House has faced serious structural problems. The functional change from being a house to accommodating the pilgrims has also caused damages to the building. Non-standard additions, lack of accurate maintenance and moisture all contribute to the degradation of the structure. In the proposed restoration plan, consolidation of the building has firstly been considered against the environmental degradation factors, and for the new function the

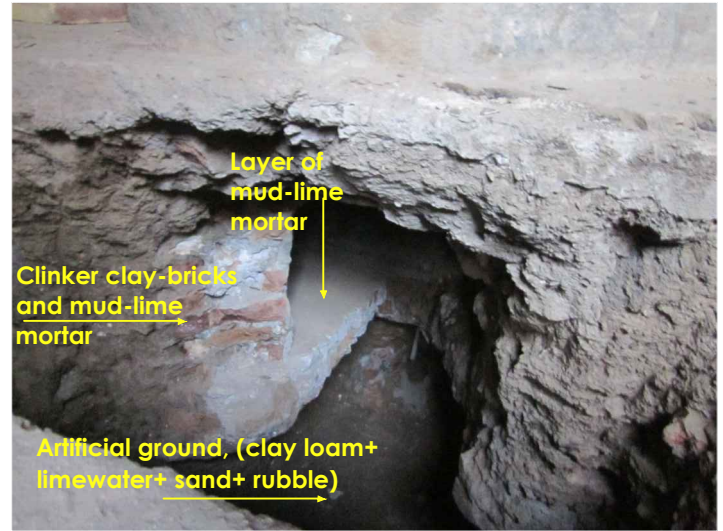
Fig. 4.10.1 The traditional foundation of Darugheh House, (location: *hoz-khaneh*, pond room); it is made of artificial ground on the virgin soil, construction of a layer of mud-lime mortar along with a wide brick wall at the lower part floor to diagonally transmit the force from the masonry to the foundation.

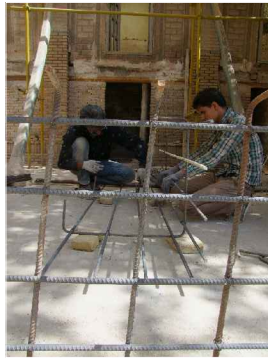
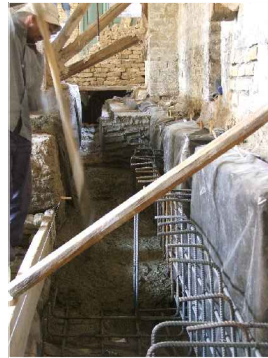
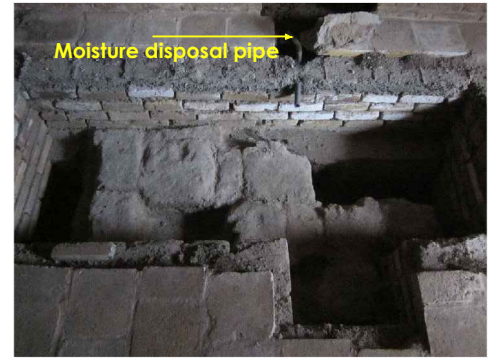
Fig. 4.10.2 Using the reinforced concrete for the parts whose foundation required to be strengthened; (a) a part of the floor, near the wall, is excavated for a width and depth of 50 cm, (b) workers tying steel reinforcing bars with wire to strengthen the foundation, (c) placing a layer of insulation nylon on the ground before the framework in order to prevent the clay from absorbing the cement water; concreting (using a mixture of cement and coarse sand), (d) final stage of making foundation; erection of brick rows on the concrete and inserting the moisture disposal pipes before flooring.

As mentioned on the sheet. 4.10, in the original foundation, the clinker clay-bricks along with the mud-lime mortar used to create a moisture-resistant foundation. However, in some parts of the building where it was necessary to strengthen the foundation, these materials are replaced by reinforced concrete. Although these current material are not compatible with the traditional elements, but, concrete has high compressive strength and is an available and low-cost material. In order to prevent moisture retention in the concrete foundation, during the flooring the moisture disposal pipes have been inserted at 1-m intervals from each other. In addition, the utilization of reinforcement bars as a frame in masonries can be a proper method to replace the vertical wooden poles inserted in traditional methods. Also, to increase the strength of the structures against earthquakes, an armed construction integrated with cement-coarse sand mortar will not undergo erosion or decay of traditional materials owing to moisture and insect attacks. Arch. Govahi, the supervisor of the restoration project, states about the use of cement mortar that, *“Although cement is considered to be an inappropriate material for repairing traditional-historical buildings, buildings constructed or restored in Mashhad with this material during the first Pahlavi era (1925-1941) are still durable and resistant after about a century. Also, the reason for not using more suitable mortar like bâtard (lime + cement + dune sand) is because of its high cost in Iran.”*

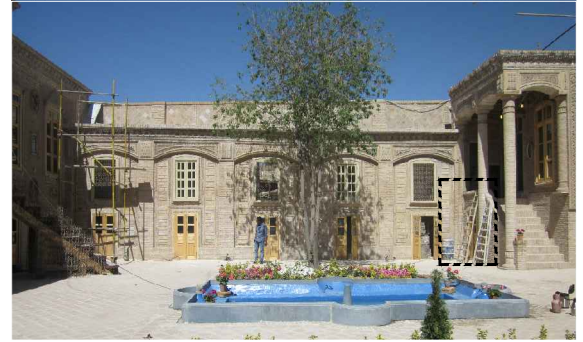
Fig. 4.11.1 The facade of northeastern building mass after the onset of the innovative restoration project.

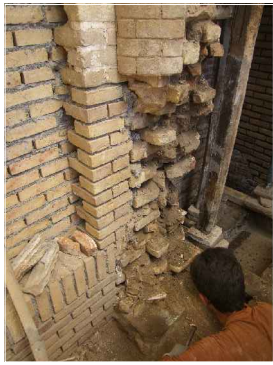
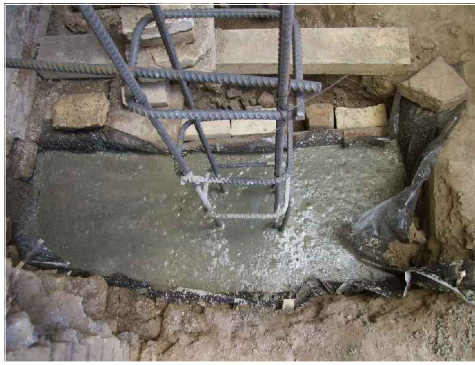
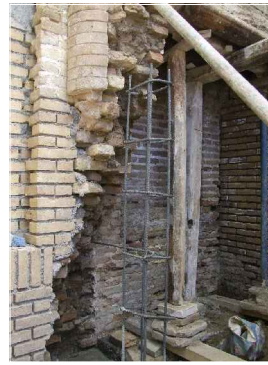
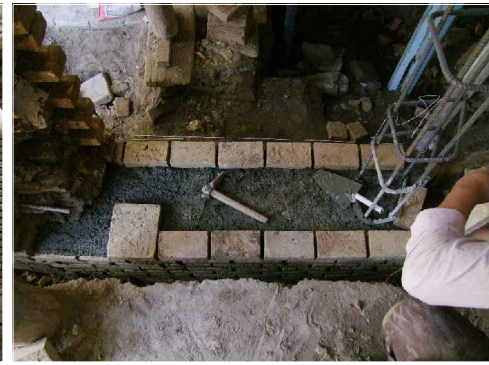
Fig. 4.11.2 Implementing the reinforcement steel in the masonry; (a) evacuating a portion of the masonry from one side to recreate it with a reinforced concrete core, (b) concreting (cement-coarse sand mixture), (c) using a tied rebar beam in the masonry before its rebuilding, (d) rebuilding the wall; making two flooring brick rows and implementing the next brick rows only at the edges; the empty central part of the masonry has been filled by a mortar of cement and coarse-grained sand.

The innovative measures implemented in both components: foundation and masonry, are invisible due to use of brick rows (traditional material) that brings a homogeneous aspect to the building. Although, in some treatments such as balcony consolidation use of the steel elements in a visibly manner was intentional to highlight between the restored and the original parts. Moreover, the high strength of the steel girder against pressure force was the main reason for placing it under terrace instead of utilizing wooden beam. Implementation of steel pillars and frames have been widely common in consolidation of Mashhad historical buildings since 1970s, which has made them durable after more than forty years.

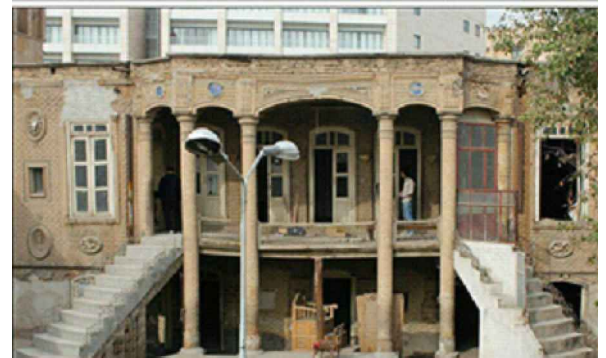
Fig. 4.12.1 Deformation of the balcony in the northwest building mass.

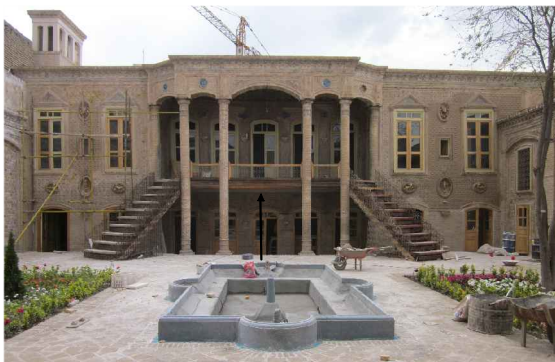
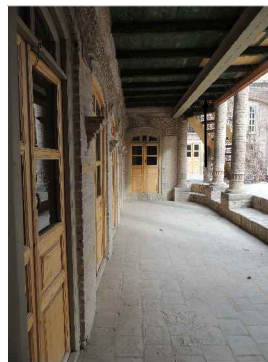
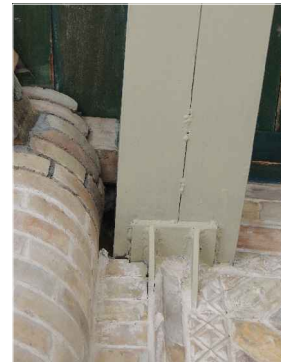
Fig. 4.12.2 Consolidation of the balcony; (a) a view of the balcony in the northwestern building mass after reinforcing, (b) utilization of steel girder under the balcony to reinforce the structure where deformed, (c) jointing the brick wall and steel girder by steel plates.

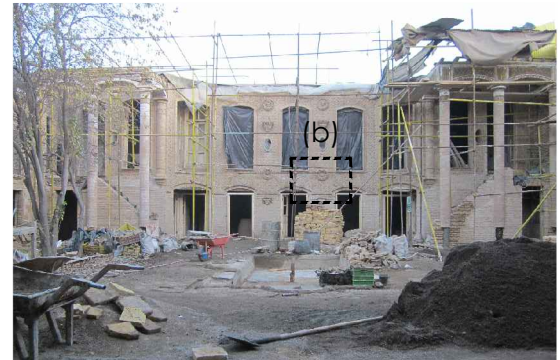
Fig. 4.13.1 The southeastern building mass in the last phase of the restoration.
