SAPIENZA
UNIVERSITÀ DI ROMA

XXXI Ciclo Dottorato in Restauro dell'Architettura

**A STUDY ON THE ARCHITECTURAL FEATURES OF HOUSES
CONSTRUCTED FROM XVII TO XIX CENTURY IN THE CITY OF
MASHHAD**

Dottoranda: Rana Daneshvar Salehi

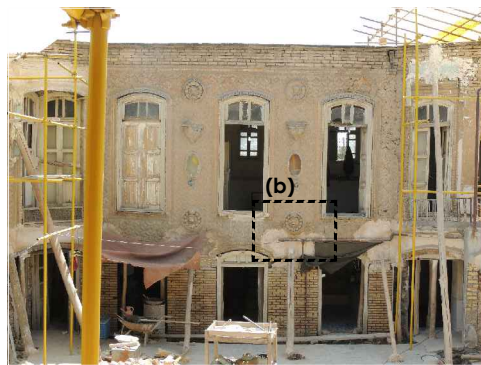
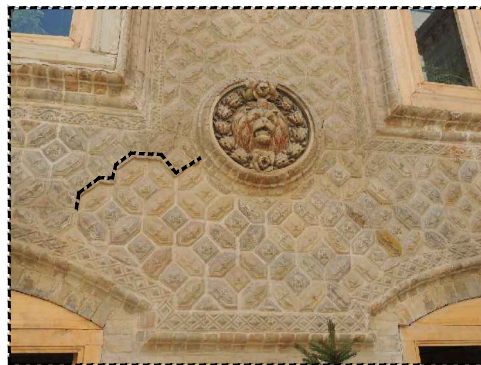
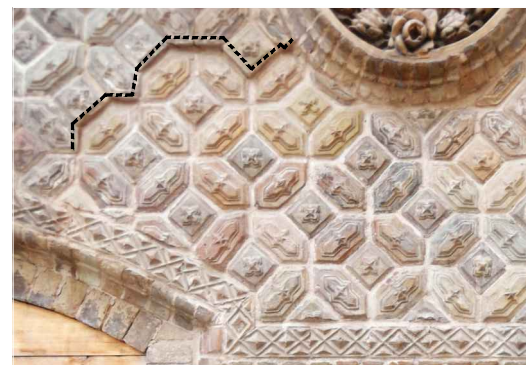
Fig. 4.13.2 Restoration of lacuna; (a) the southeastern facade after removing the white cement layer from the lower part and before the onset of restoration, (b) *sottosquadro* method; separating the restored part and earlier materials by leaving a little distance prior to the alignment of the original brick rows, (c) the strong sign of *sottosquadro*; original bricks (above) and restoration (below).

the original pattern. Unlike the traditional technique in which the repaired parts were not distinguished from the earlier ones, in innovative system, the reconstructed portions of the wall are distinguishable through *sottosquadro* method. In this way, the recycled bricks in restored parts are placed with a little distance prior to the alignment of the original brick rows. The reused materials have been gained from demolished historic houses corresponding to the building in terms of construction, architecture, structure and decorative elements. These houses would be studied and surveyed as far as possible before destruction, and their reusable materials were extracted during the demolition of the building.

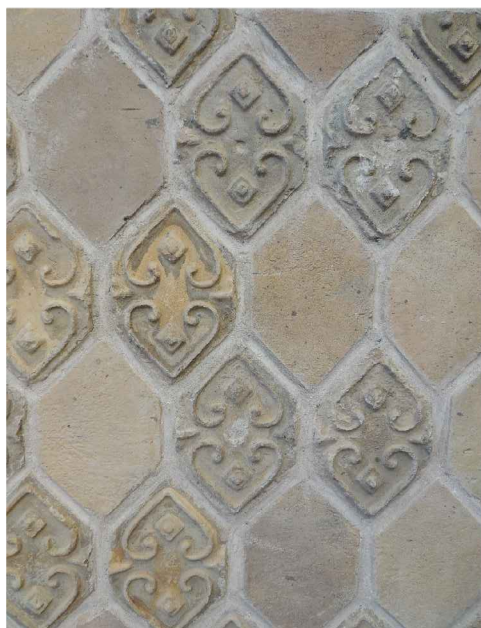
Fig. 4.13.3 Reconstructing the damaged part of the walls with recycled bricks that are the same in terms of shape and size, avoiding the use of bricks that have the geometric pattern to highlight the two types of material, reused and original.

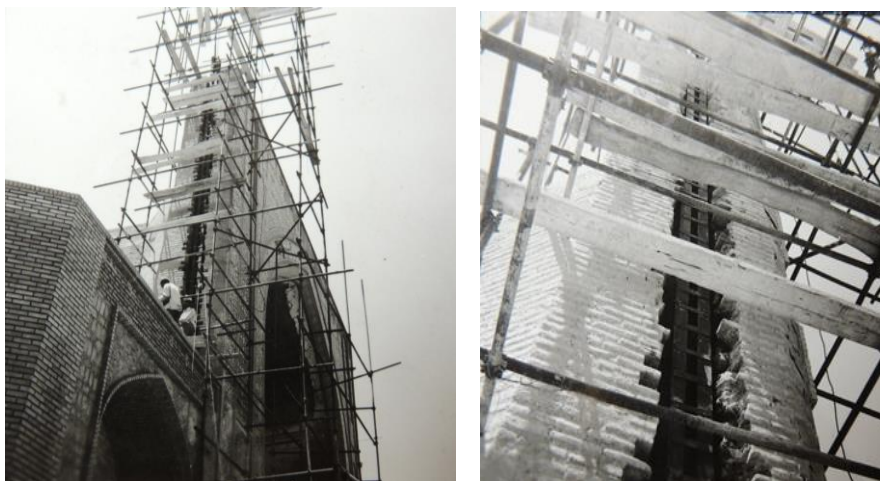
Figure 4.13 Implementation of steel structure in consolidation of Paien Khiyaban’s Mosalla, 1973; insertion of steel column in the brick masonry.

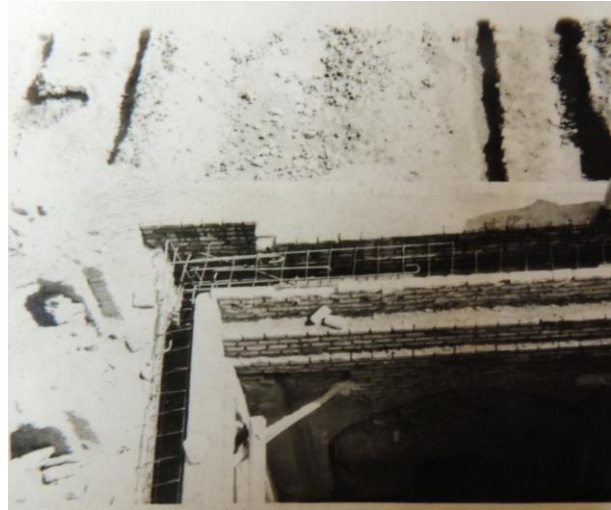
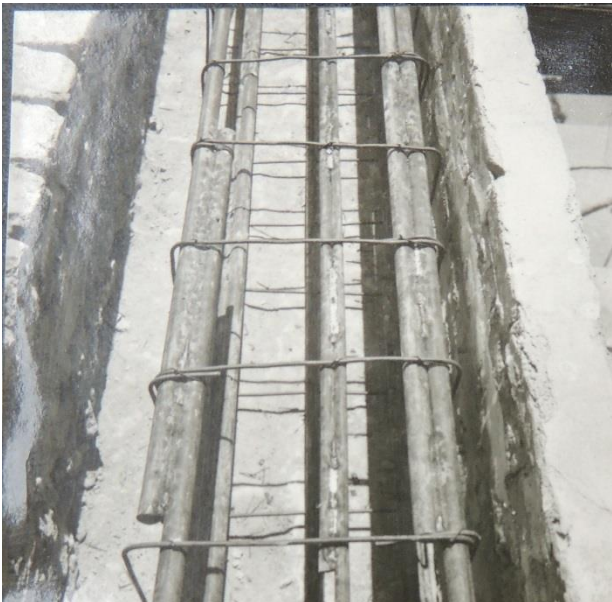
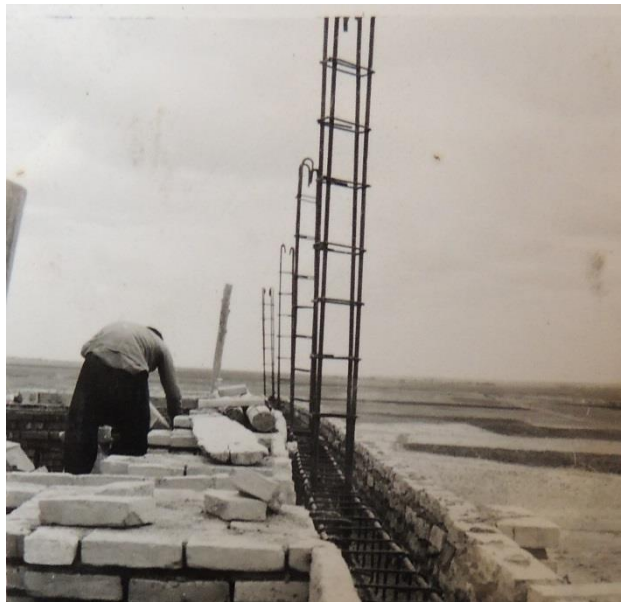
Figure 4.14 Implementation of steel structure in restoration of Harun Dome, 1974; (a) Harun Dome, a public building in which the higher portion of the ruined brick wall is reconstructed, (b) making the formwork for reinforcement of concert on the roof using the rebar, (c) close-up image; steel reinforcing bars are tied together with wires, (d) linking between the horizontal reinforcement and vertical steel armature.

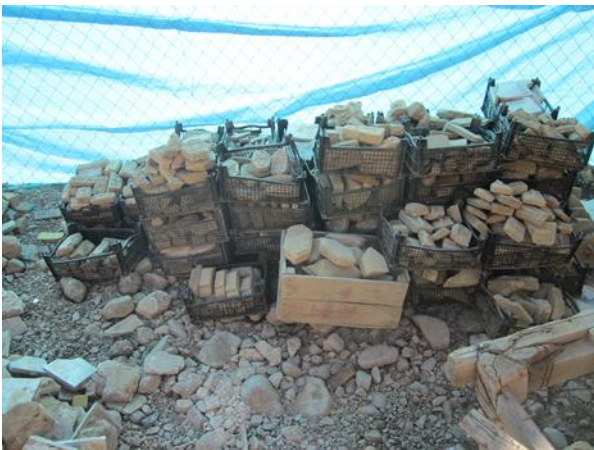
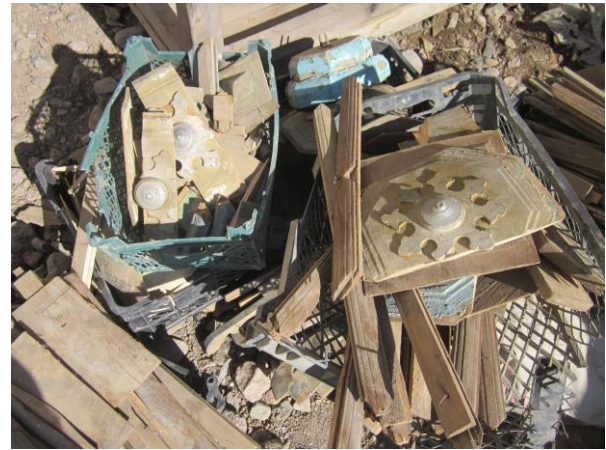
Figure 4.15 The bricks and decorative ceiling elements which collected from demolished houses and conserved for reusing. (Govahi 2014)

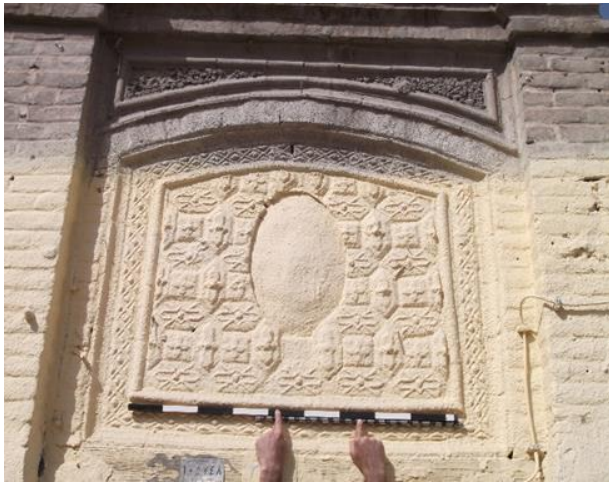
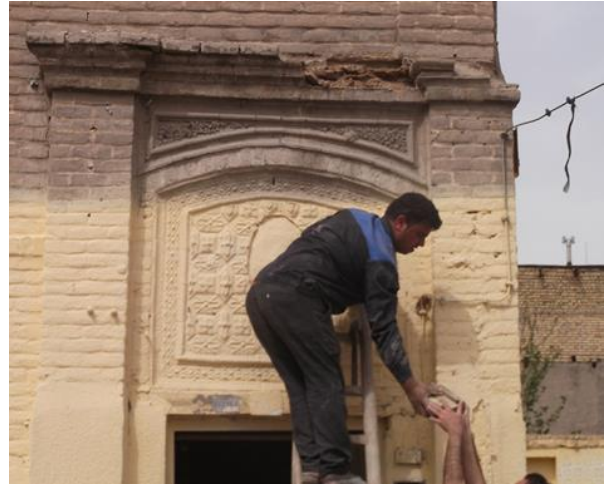
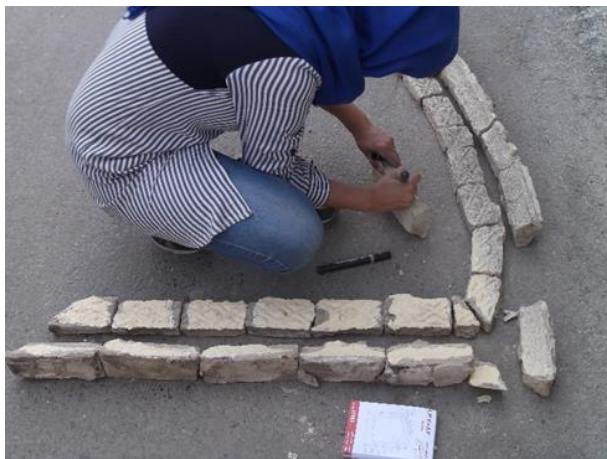
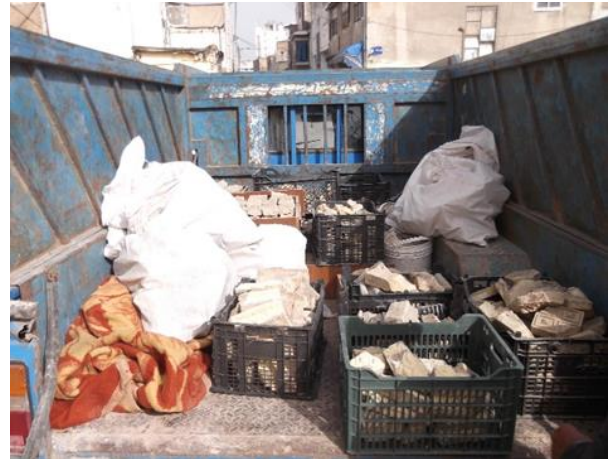
Figure 4.16 Dismantling process of the entrance materials in a traditional house located in Noghhan district; (a) survey measurement, (b) dismantling the brick fragments, (c) coding and arrangement of materials on the ground by following the original pattern, (d) packing the components in separated boxes and transferring them to the warehouse. (April 12, 2017)

Fig. 4.16 shows the dismantling process of a traditional house before its demolition in April 2017 caused by creation of an urban road (Razavi Sharestan). Almost all the spaces including the courtyard, rooms and the octagonal lobby entrance have been measured and the bricks have been coded with an identifying number based on their shape and patterns so that each piece could be reassembled accordingly in another site. At the end of the process, the bricks were packed and transferred to the municipality warehouse.

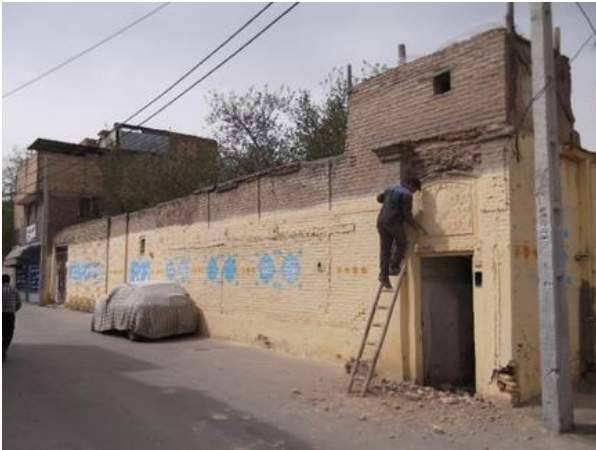
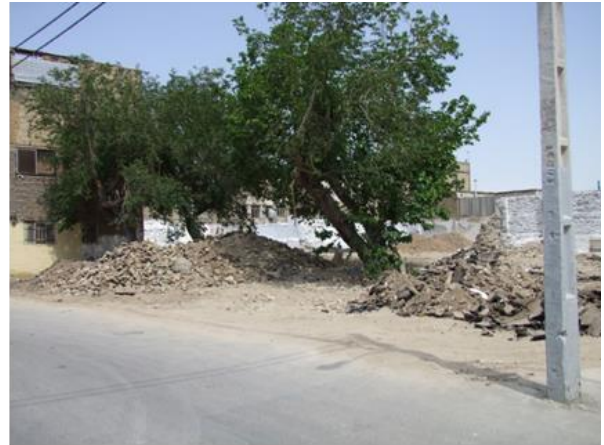
Figure 4.17 The state of the house and its location before and after the destruction. (May 1, 2017)

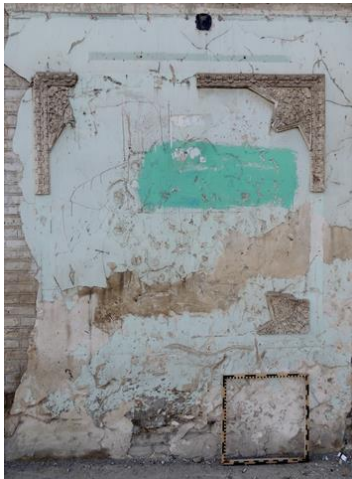
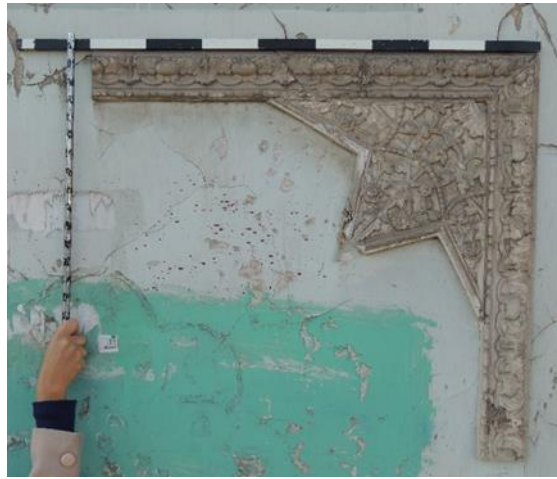
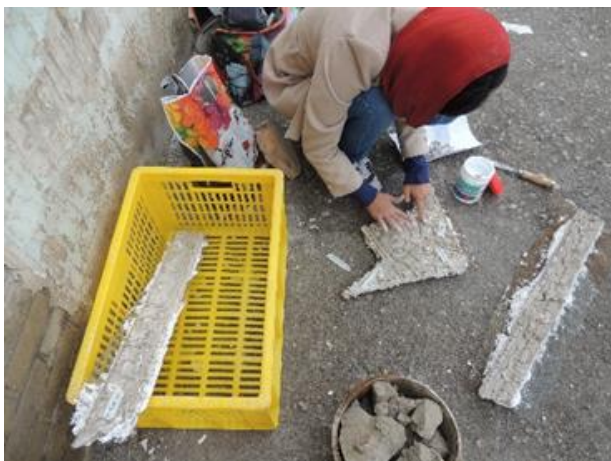
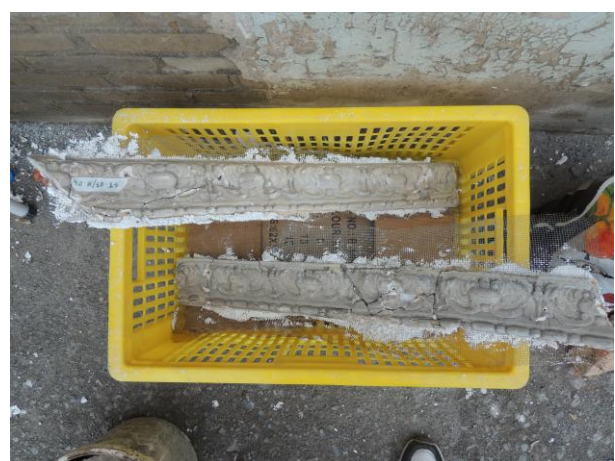
Figure 4.18 Removal of the historical stuccoes, including; (a) Position of the elements on the wall, (b) Survey measurement, (c) Dismantling, (d) Executing the first maintenance in place, and (e) Packing for relocation.

The same method is also applicable for dismantling the decorative elements that are at risk of destruction. Fig. 4.18 presents removal of stuccoes that were only elements remained from earlier Mashhad police office which was built under I Pahlavi era (1925-1941). The building was demolished by the municipality for the construction of a subway line, however, these decorations were still on the sidewalk. The removal of stuccoes has been undertaken by survey, measurement process, removing, coding the pieces with different numbers and primitive conservation in place by using of wire mesh and gypsum mortar. In the end, it was departed to the warehouse of the municipality to be decided upon in a new place. In exceptional situations, relocation is preferable to demolition, however, the removal and re-erection should be the last option when all else conservation methods have failed.

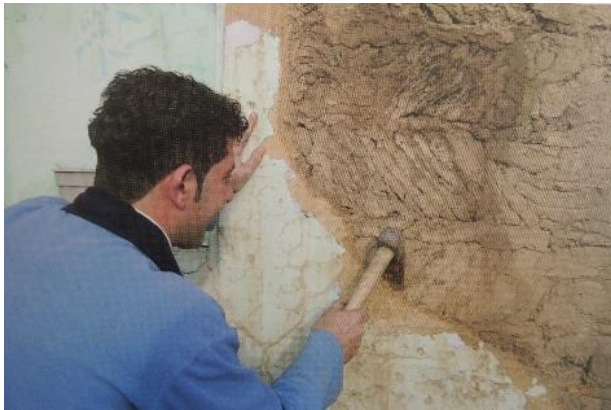
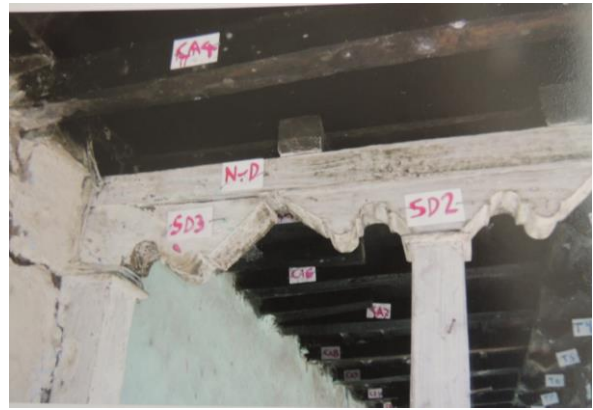
Figure 4.20 The removal project of Muosa Zadeh House; (a) dismantling the mud walls, (b) identification of architectural components. (Taleghani 2011)

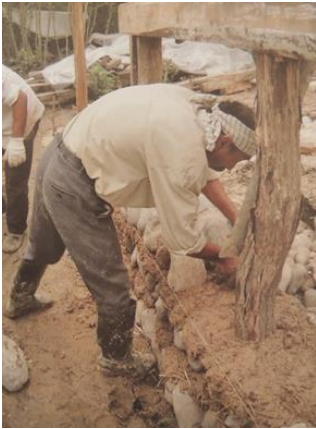
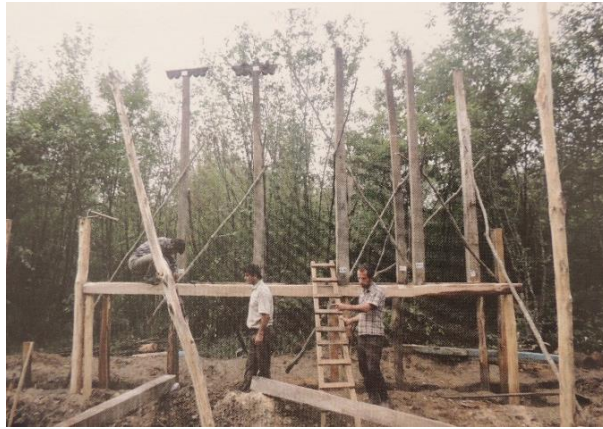
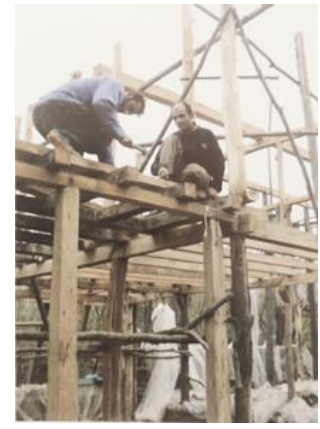
Figure 4.21 Rebuilding the dismantled pieces in a new site in Gilan Rural Heritage Museum. (Taleghani 2011)

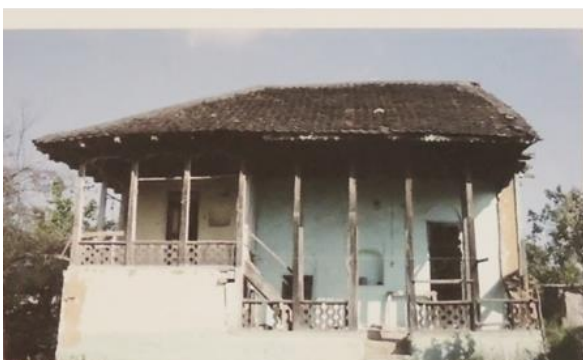
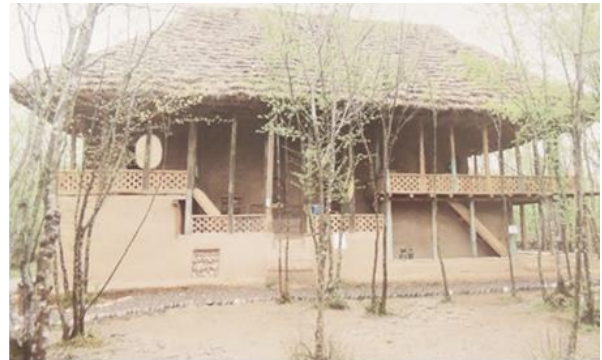
Figure 4.22 The earlier state of Muosa Zadeh House before dismantling and its current state in the new site. (Taleghani 2011)

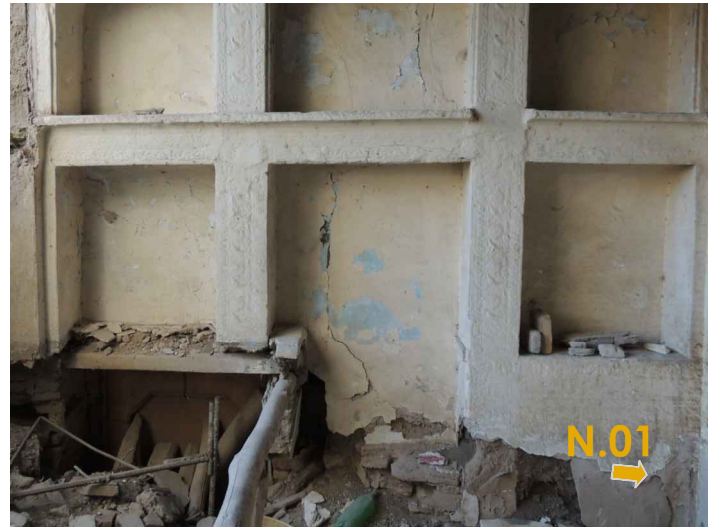
Nili's house, first floor, guest room, southwestern wall.

Mash/NI/N.01; Inner Plaster. In the guest room, the plaster of the lower half in the SW wall was falling in the form of a thin crust because of blistering and delamination of the substrate layer. In fact, the expansions of the humidity bring loss of adhesion and strength in the soil-gypsum coat which makes the finishing plaster on the walls extremely fragile. Thus, during the separation, another small portion of that also fell.

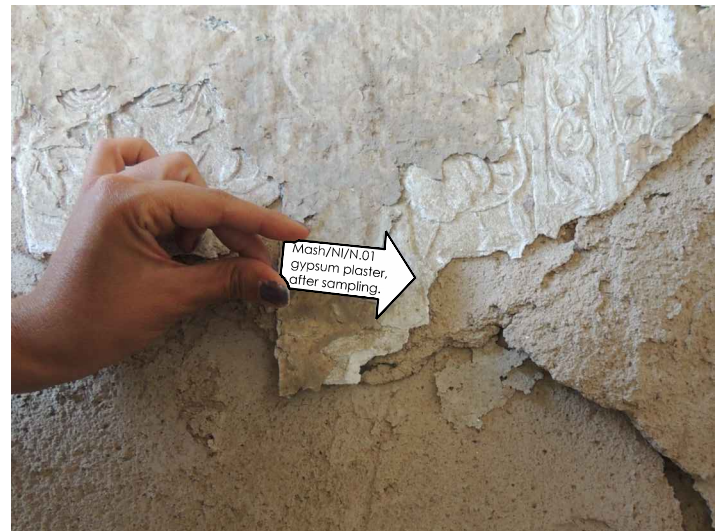
Nili's house, first floor, guest room, southwestern wall, after collecting sample Mash/NI/N.01.

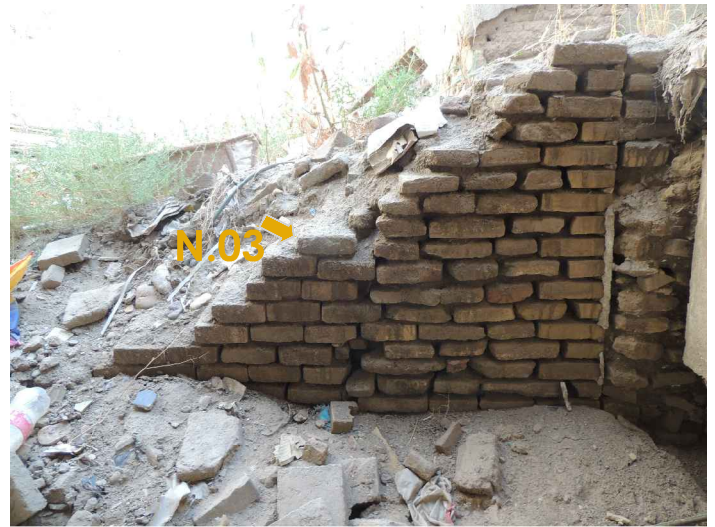
Nili's house, first floor, guest room, southeastern boundary wall.

Mash/NI/N.03; Burnt Brick. The upper portion of the SE wall has collapsed due to demolition of the nearby building. Therefore, the brick in this wall has been selected for sampling. As a burnt brick of a load-bearing wall, it presented a high quality and resistance that made sampling difficult.

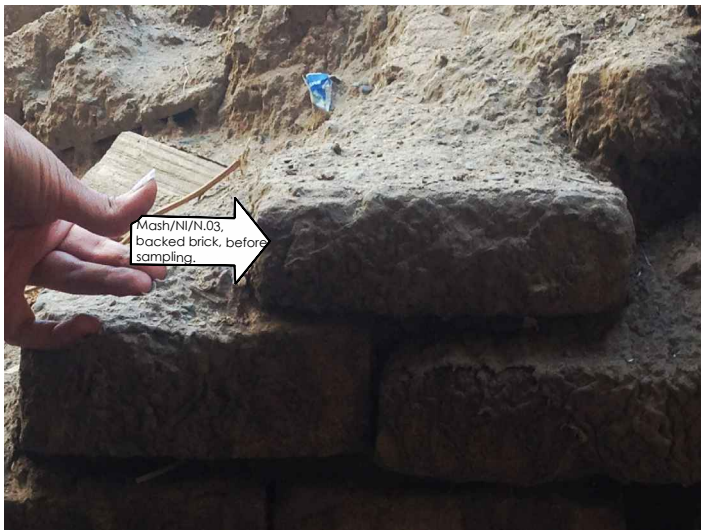
Nili's house, first floor, guest room, southeastern boundary wall, MASH/NI/N.03. Sampling of backed brick.

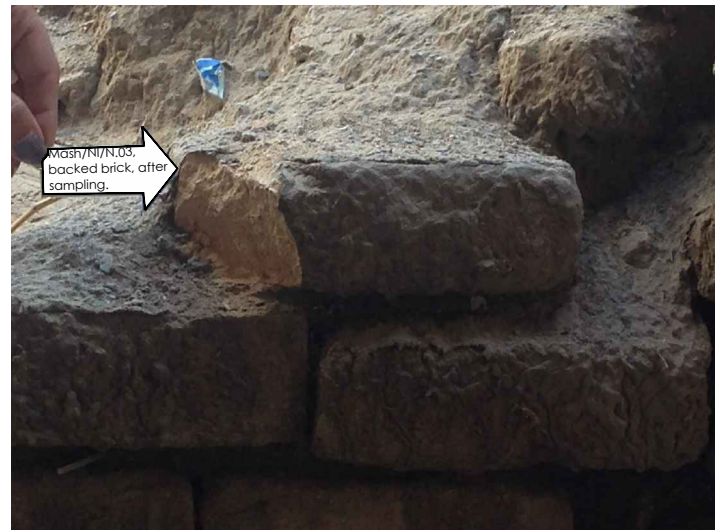
Nili's house, first floor, guest room, southeastern boundary wall, after collecting sample MASH/NI/N.03.

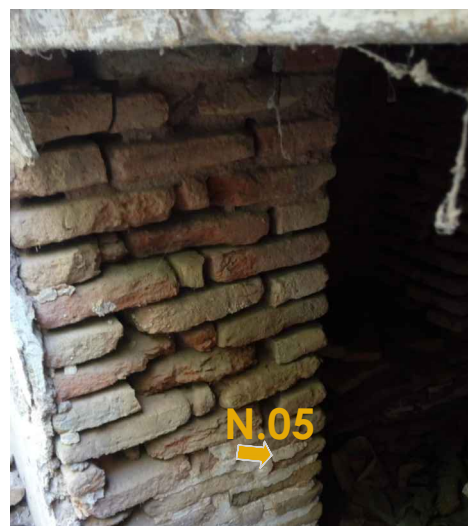
Nili's house, southwestern section, ground floor.

Mash/NI/N.05; Mortar. The mortar between the bricks of the storage room is relatively weakened or lost due to moisture and passage of time. However, the sample was easily collected from the remaining parts. During the removal process, a portion of the brick that had suffered a severe decay was separated from its base along with the mortar.

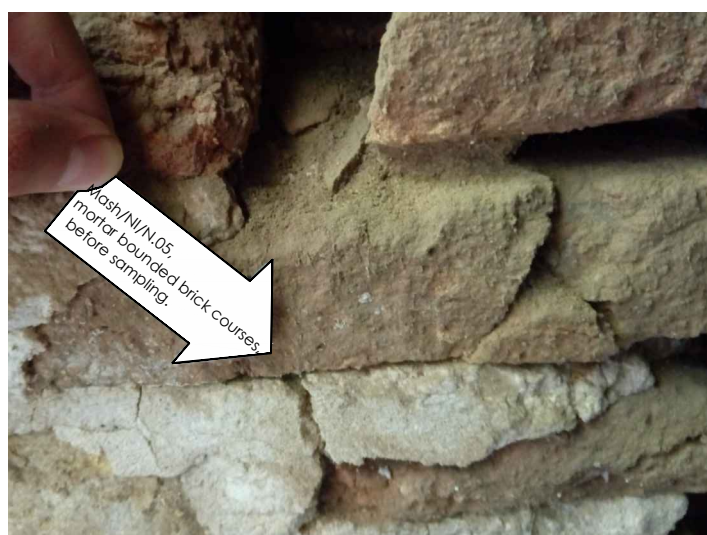
Nili's house, southwestern section, ground floor, Mash/NI/N.05, mortar bounded brick courses.

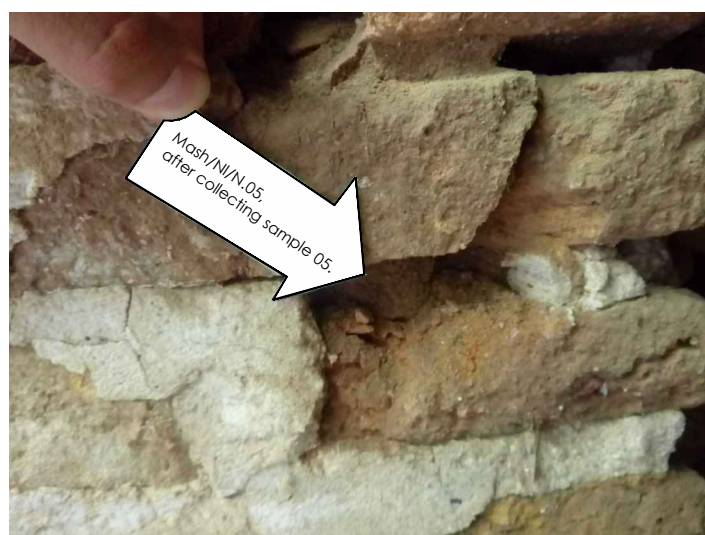
Nili's house, southwestern section, ground floor, after collecting sample Mash/NI/N.05.

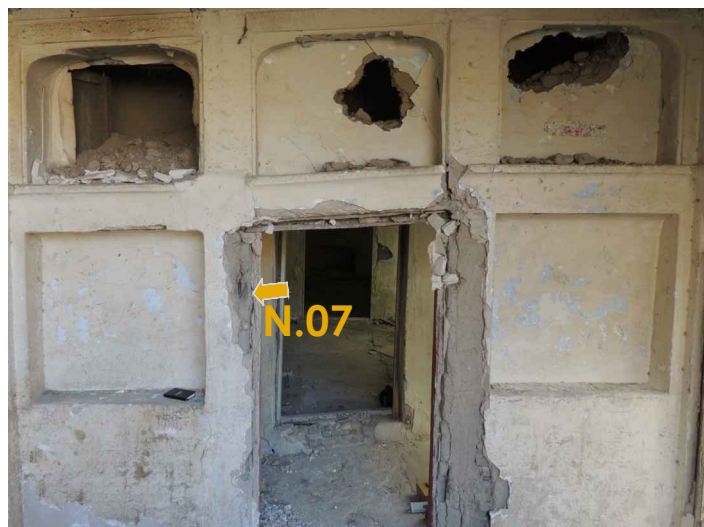
Nili's house, first floor, guest room, northwestern wall.

Mash/NI/N.07; Mud Brick. Mud bricks soaked up water and became eroded by humidity, losing their strength. Before the removal, a piece of raw brick was almost isolated from the base of the adobe. So, the detachment process was carried out quickly. This sample was not very resistant but when separated it came out as a relatively compact piece, without losing its solid form .

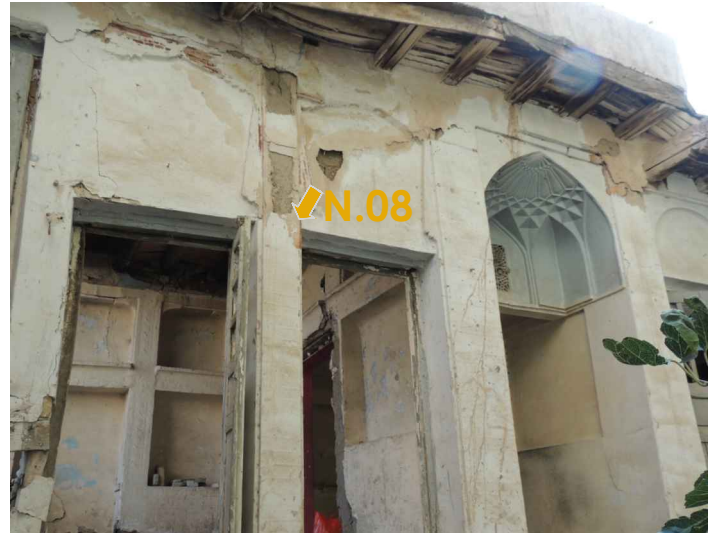
Nili's house, southwestern facade.

Mash/NI/N.08; Traditional Plaster of the Façade.

The southwestern facade was coated with a gypsum plaster. However, in some parts, the appearance of a plaster with dark red color is visible which was definitely the traditional finishing plaster of the façade. As the upper part had not seen much humidity, the removal of the sample was not done efficiently. It tended to remain durable and compact during the sampling process.

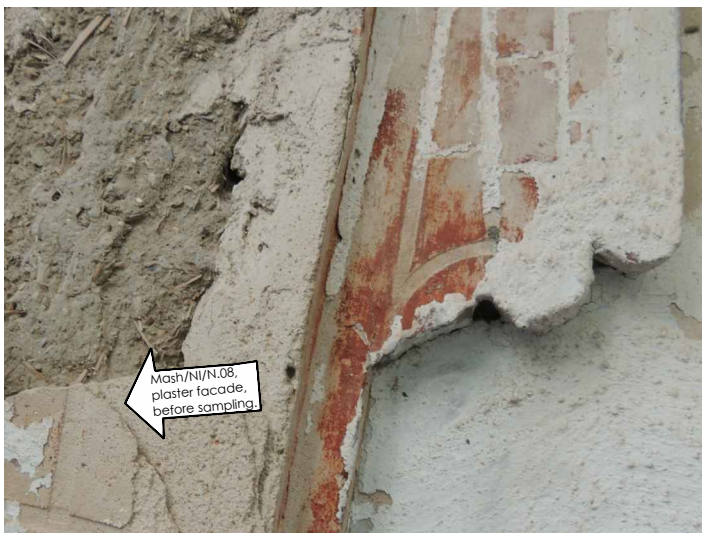
Nili's house, southwestern facade, MASH/NI/N.08. Sampling of plaster facade.

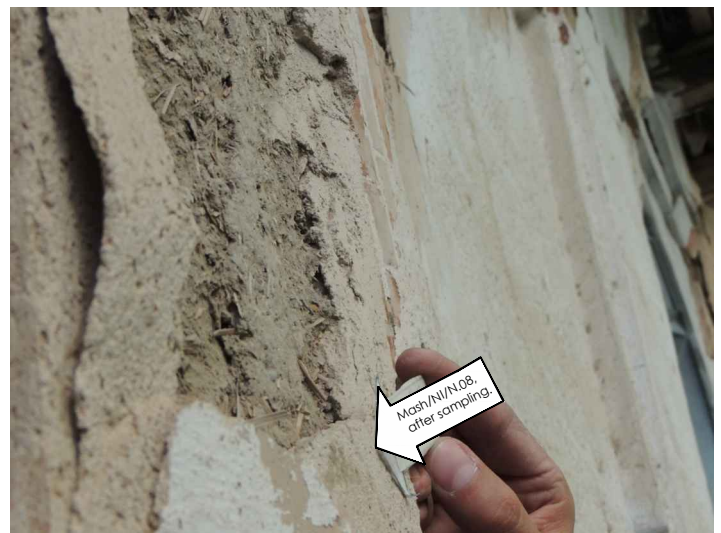
Nili's house, southwestern facade, after collecting sample MASH/NI/N.08.

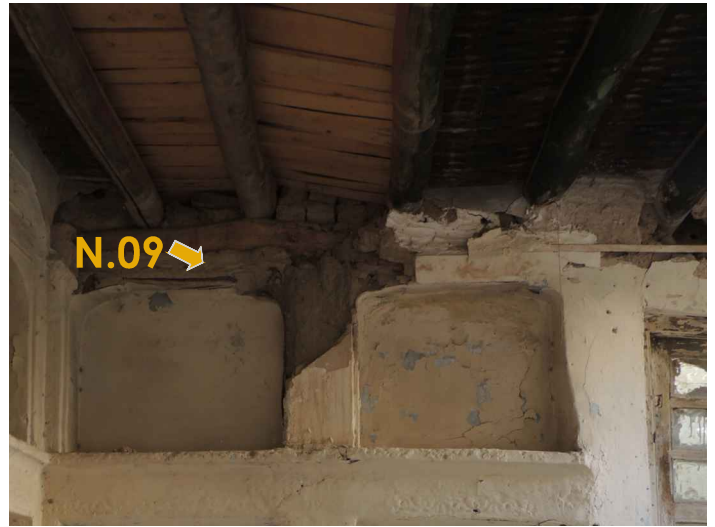
Nili's house, first floor, guest room, northeastern wall.

Mash/NI/N.09; Stucco. This sample is one of the fragments of the fallen stucco belonging to the walls of the guest room applied around the room as the frame. Following the cleaning process to remove the covering layers, the stucco was brought into the laboratory.

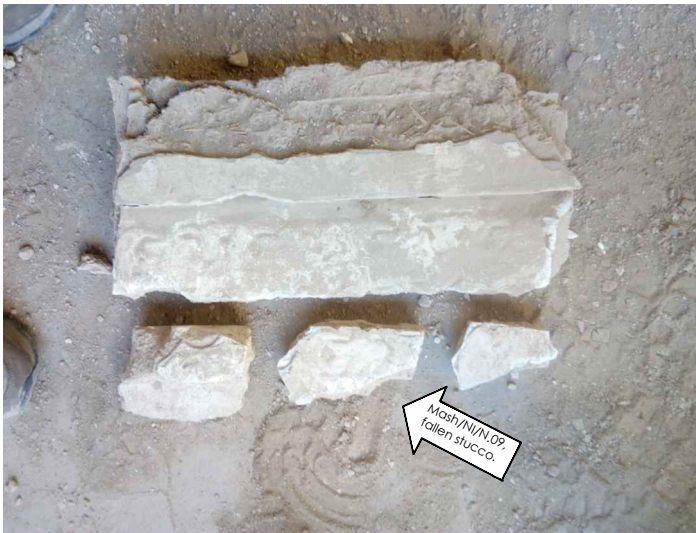
Nili's house, first floor, guest room, fallen decorative stuccoes.

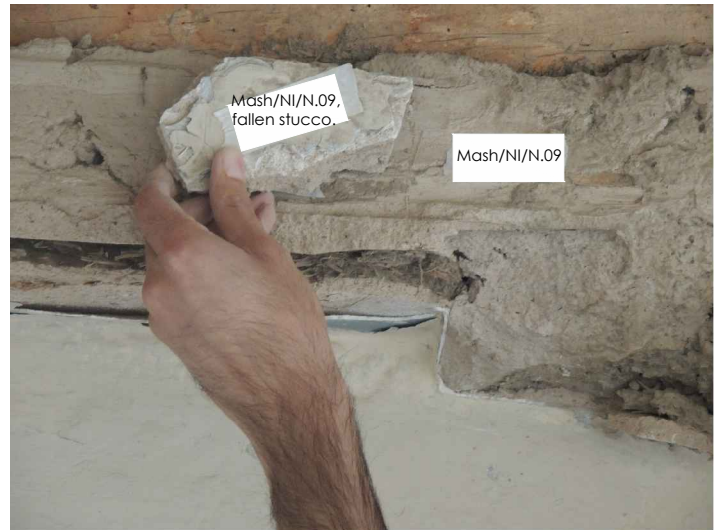
Nili's house, first floor, guest room, northeastern wall, Mash/NI/N.09, fallen stucco.

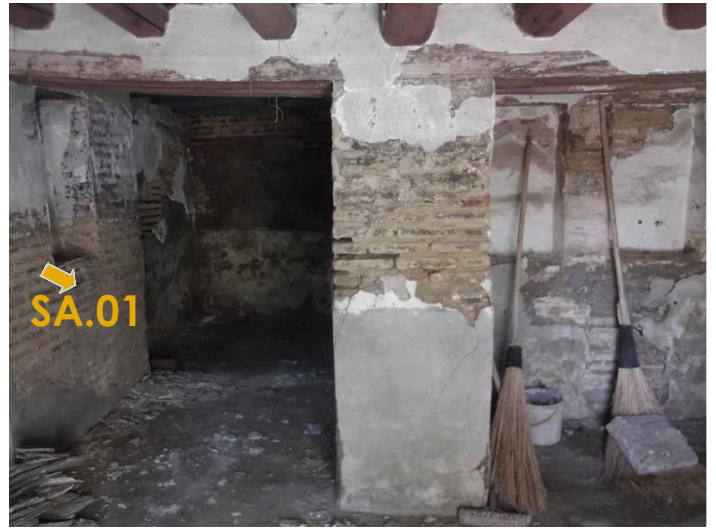
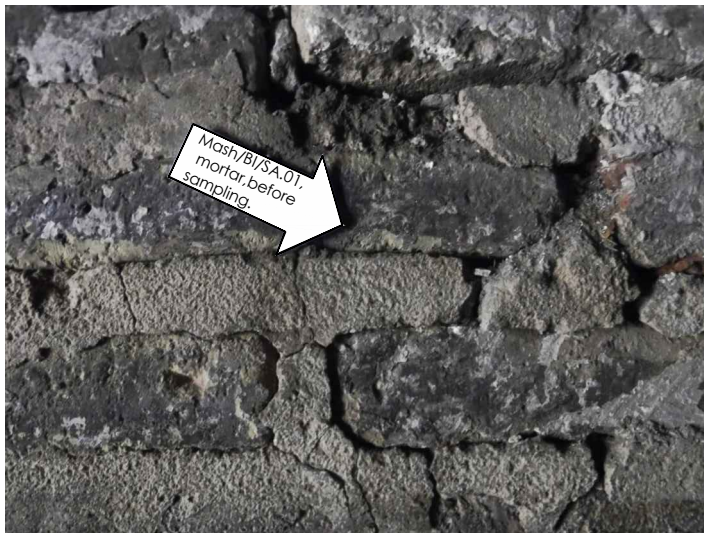
Bidari's house, ground floor, right side room, Mash/BI/SA.0, sampling of mortar.

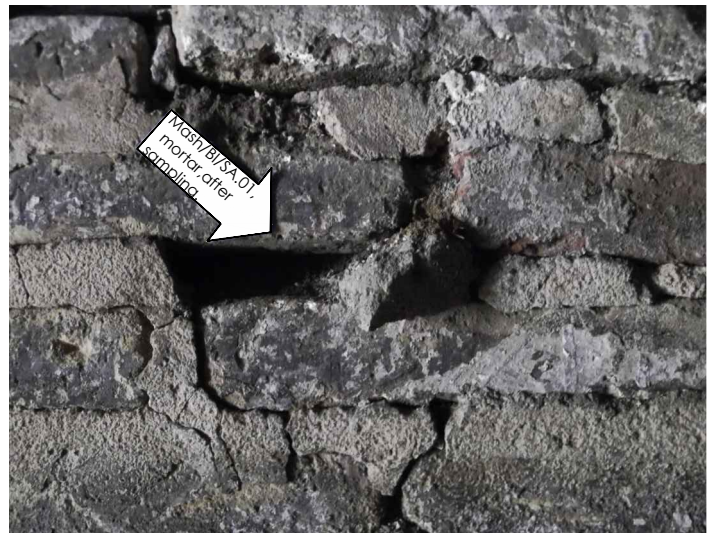
Bidari's house, ground floor, right side room, after collecting sample Mash/BI/SA.01.

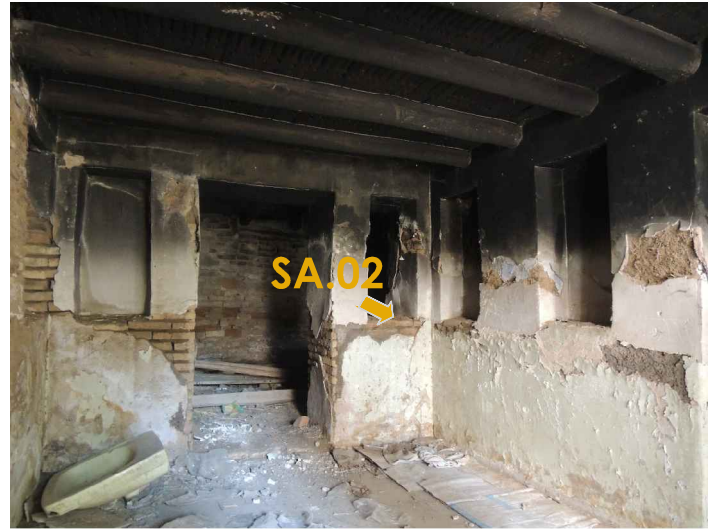
Bidari's house, ground floor, cooking room.

Mash/BI/SA.02; Burnt Brick. The sampling has not been easily taken because the brick (23 x 23x 4,5 cm) was very sturdy and durable, so the piece of brick (SA. 02) was removed in solid from its base.

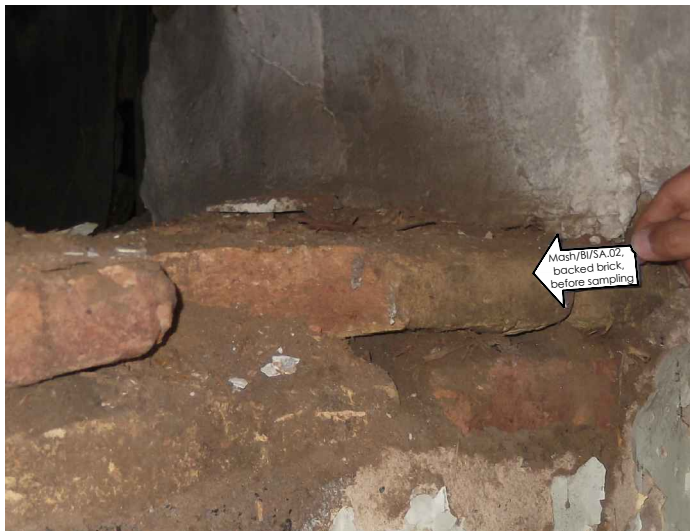
Bidari's house, ground floor, cooking room, Mash/BI/SA.02. Sampling of backed bricks 23 x 23 x 4,5 cm.

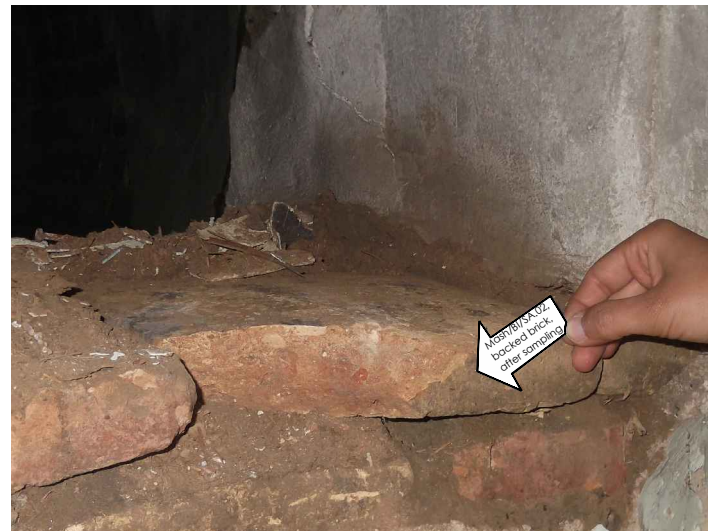
Bidari's house, ground floor, cooking room, after collecting sample Mash/BI/SA.02.
