Article

# The Case Study of the Medieval Town Walls of Gubbio in Italy: First Results on the Characterization of Mortars and Binders

**Keywords:** mortars; heritage; characterization

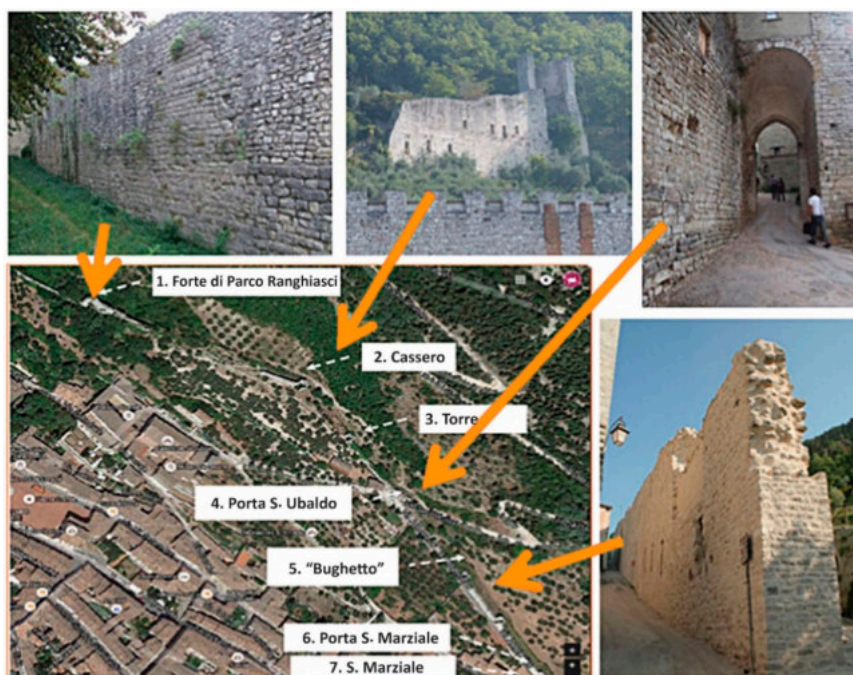
**Figure 2.** Old town wall—sample collection sites: Fort of the “Ranghiasi” park (1); “Cassero” (2); Tower (3); Gate of St. Ubaldo (4); “Bughetto” (5); Gate of St Marziale (6); St. Marziale Church (7).

At least three types of stones were used in the construction of the oldest part of the walls, namely, limestone, travertine, and sandstone joined by mortar. The medieval walls also present apparent material differences, resulting from successive construction additions, reinforcement of the structure, and restoration/renovations that occurred over the centuries. For the HERACLES Project, five zones of the walls were chosen as the focus for sample collection and material characterization in the laboratory (ex-situ analysis). However, the materials collected in Zone 1 do not correspond to mortar samples, and therefore are not included in this study. The location of the sampling zones shown in Figure 2 are: Zone 1—“Forte di Parco Ranghiasi”; Zone 2—“Cassero”; area between Zone 3—“Torre”—and Zone 4—“Porta S. Ubaldo”; area between Zone 4—“Porta S. Ubaldo”—and Zone 5—“Bughetto”; Zone 5—“Bughetto”.

It is estimated that the oldest part of the walls corresponds to Zone 1, completed in 1301. Zone 2, also built in the Middle Ages, underwent several changes in the late 14th and early 15th centuries and was largely destroyed in the nineteenth century. Zone 3 does not present signs of recent intervention. Zones 4 and 5 correspond to the same period of construction of Zone 1 but suffered the largest interventions in relation to the removal of accumulated land against the walls and actions of restoration and preventive conservation.

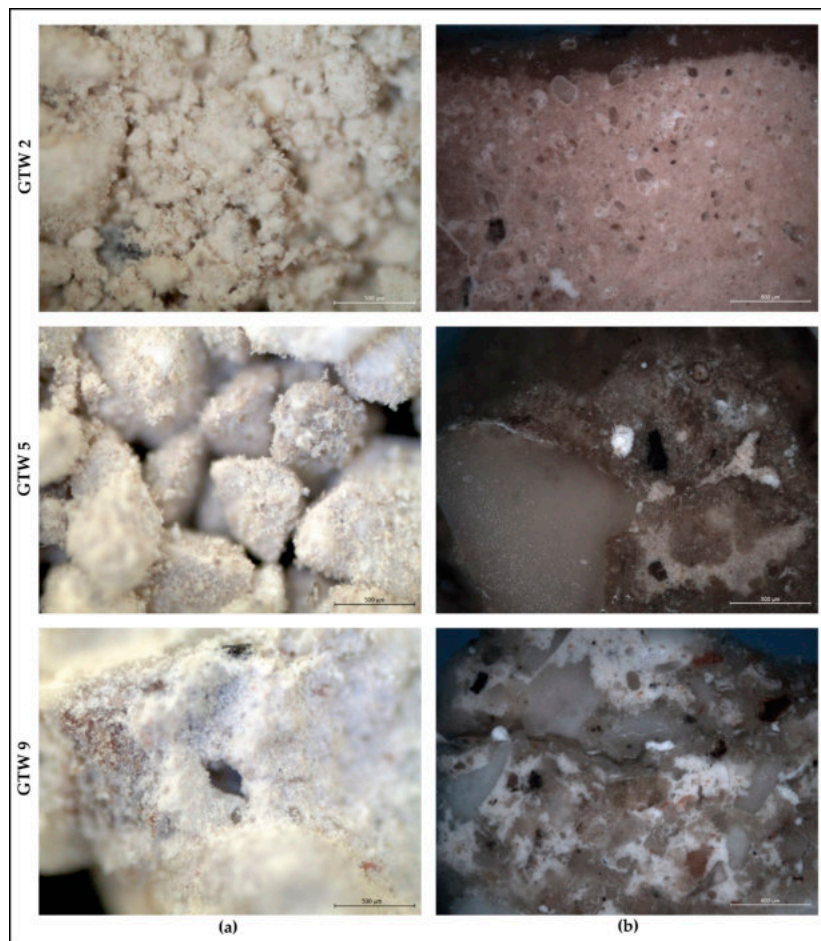
**Figure 3.** OM observation of mortar samples 2, 5, and 9, (a) direct mode and (b) polished sections. All observation was done in darkfield observation mode and 5× magnification.

Considering the morphology of the material, the mortar samples show a great variation of granulometry of aggregates. Through optical microscopy, it was possible to note that two of the samples exhibit relatively homogeneous dimension of grains, approximately  $75\ \mu\text{m}$  (GTW 2 and GTW 4), well distributed in the binder matrix. The regular size of the grains can be related with the quality of the mortar and the homogeneous distribution of aggregates suggests a good mixing process during mortar preparation [18]. However, for the remaining samples, the size, shape, and color of the grains are quite varied, as is the dispersion of aggregates in the binder. In general, the binder shows a pink homogeneous coloration but in some samples appears mixed with portions of lighter color. Figure 3 illustrates the main characteristics observed for the mortars of the medieval walls of Gubbio. The OM direct observation was performed on disaggregated parts of the samples, while the polished section observation was performed on fragments of these same samples. This variation of the observed morphology is not, apparently, reflected in the results of the chemical analysis.
