4
5 **CHARACTERIZATION OF HISTORICAL MASONRY MORTAR FROM SITES**
6 **DAMAGED DURING THE CENTRAL ITALY 2016-2017 SEISMIC SEQUENCE: THE CASE**
7 **STUDY OF ARQUATA DEL TRONTO**

32 The paper presents an experimental investigation on mortar specimens taken from buildings of a little
33 municipality in Marche region, Arquata del Tronto, heavily damaged by recent earthquakes in Central Italy
34 (2016-2017). Both diagnostic techniques as X-Ray diffraction, Fourier-Transform infrared spectroscopy and
35 calcimetry, and mechanical test as compression tests were carried out in order to correlate the obtained values
36 with the performance of the original masonry.

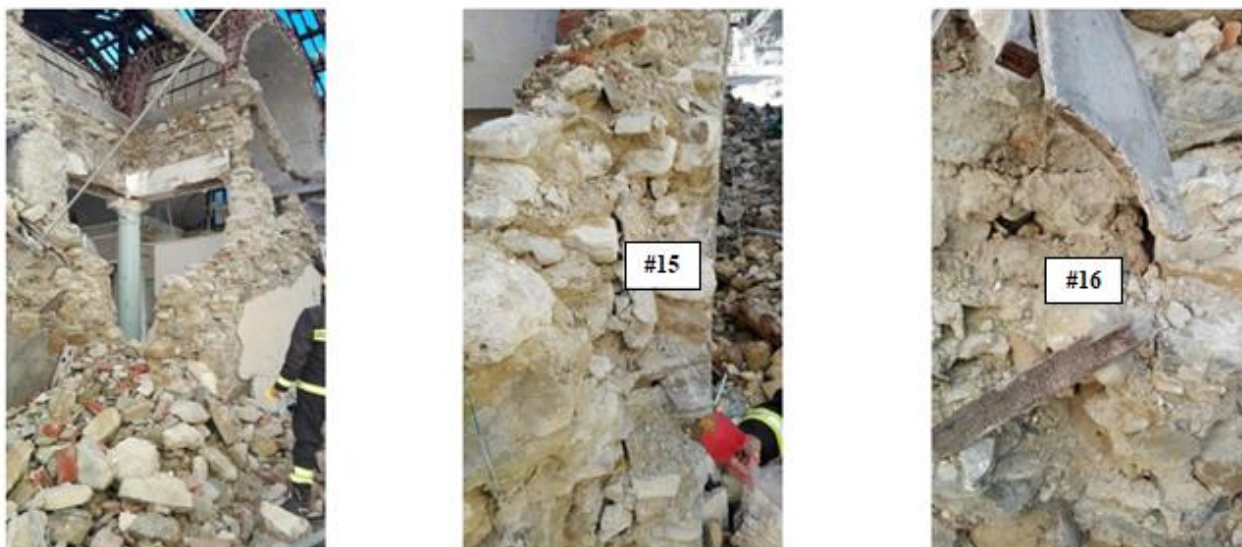
103
104 **Fig. 3. Mortar sampling campaign in Pretare - St. Rocco Church (Arquata del Tronto)**

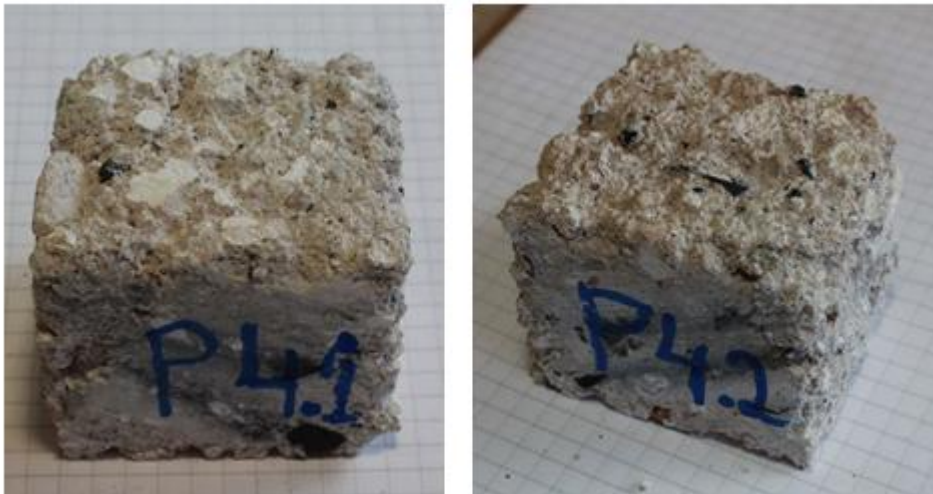
Fig. 6. Cubic samples obtained from sample 17: left, sample 17.1; right, sample 17.2

Their dimensions are reported in table 5, along with the corresponding shape factor.

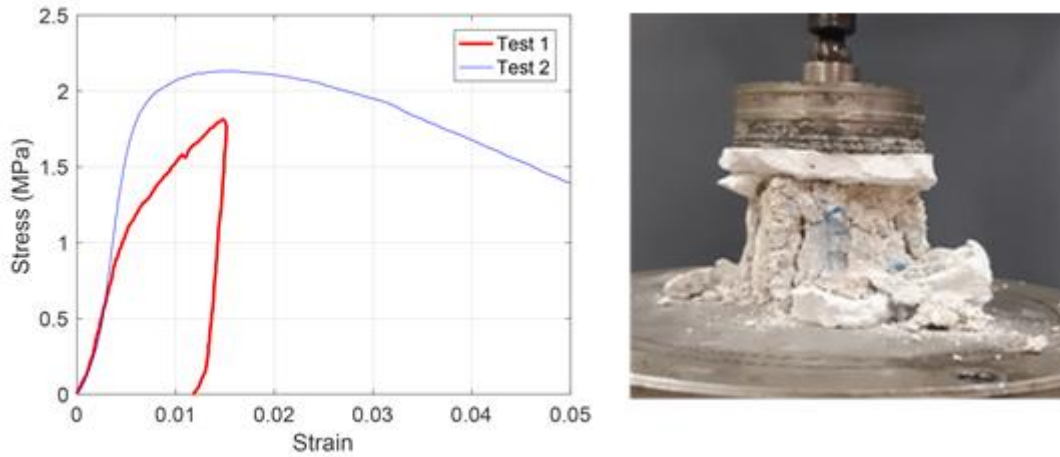
251 For sample 17.1, a first test was performed that did not reach failure, and a second test until failure. For sample
252 17.2, failure was reached at the first test. For each sample, the stress-strain curve is reported in figs. 7-8, along
253 with a picture of the sample at the end of the test.

Fig. 7. Sample 17.1: left, stress-strain curve; right, sample at the end of the test

274
 275 The two samples highlight an almost perfect match in terms of strength, but a significant difference in terms of
 276 strain at ultimate load. Such difference could be ascribed to sample scatter, to disturbance introduced during
 277 sample preparation or, more likely, to the fact that sample 17.1 underwent a first test before the failure one.
 278 The strength value can be compared with the 60 values collected from literature in [Liberatore et al., 2014] for
 279 clay brickwork: there are six samples with a smaller strength (the smallest being 0.28 MPa). If the 42 sample of
 280 tuffwork in [Marotta et al., 2016] are considered, Arquata's samples are larger of just four values (minimum
 281 value 0.55 MPa). Additionally, it is worth emphasising that the current Italian building code [DMIT, 2018]
 282 prescribes a minimum strength of 2.5 MPa for ordinary loads (Sect. 11.10.2), and 5.0 MPa under earthquake
