KAZI
SONUÇLARI
TOPLANTISI

24 – 28 MAYIS 2010
İSTANBUL

ELAIUSSA SEBASTE: 2008-2009 EXCAVATION AND CONSERVATION WORKS

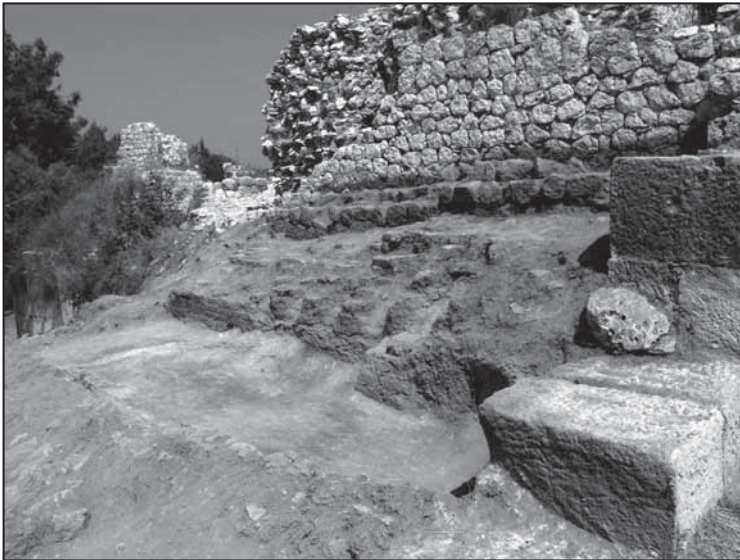
Fig. 4: Byzantine Palace: the kiln for LR1 amphorae production in room A23.

In the northern sector of the corridor (A23) a new kiln for the production of LR1 amphorae has been uncovered (Fig. 4): the structure clearly belongs to a phase later than the palace and is the evidence of a re-occupation and transformation of its structures for a different purpose in the first decades of the 6th century. The kiln is only partially preserved, due to the complete collapse of all the external walls, apart from the eastern one, which still rises for a height of approximately 1m. The whole superstructure of the kiln is therefore lost and the very few “*concolato*” debris which covered the area before the excavation may be pertaining only to a little part of the covering. The preserved lower part of the central corridor of the burning chamber and of the entrance had, as customary, a floor made by pressed clay and mortar, on which a large number of fragments of LR1 amphora together with ashes were found. Concerning the upper structure, only part of the eastern row of mud brick pillars, formerly supporting the arches on which the floor of the kiln proper was laid, remains. Through the analysis of the stratigraphic evidence we can argue that the kiln was in use from 530 to the first years of the 7th century A.D. when its entrance was closed with huge blocks. To the kiln must be related also the large square plastered basin (3.62 x 3.63 m) built inside room A18-A22, probably used for settling the clay. Both the rooms located immediately to the south of the kiln itself, present some arrangements connected to the ceramic production activities. Moreover a thick layer of wastes of LR1 amphorae filled the southern sector of the corridor (particularly rooms A22 and A19), therefore testifying the long and intense activity of the kiln.

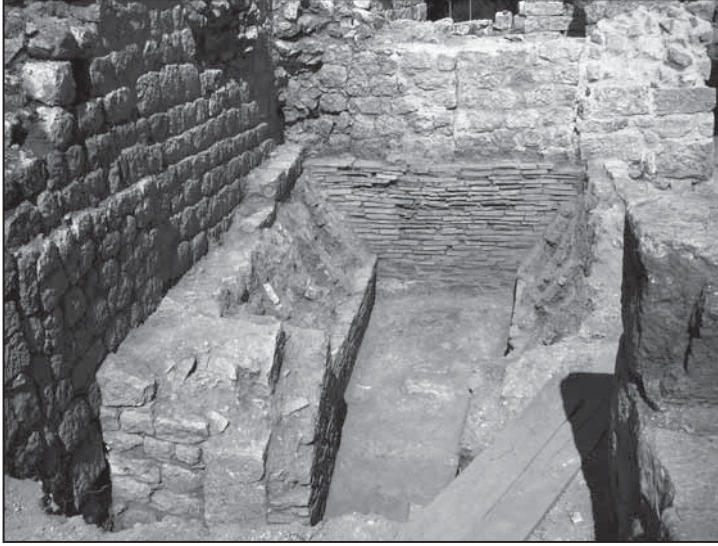
Fig. 5: Byzantine Palace: the kiln for LR1 amphorae production in room A20.

In room A20, at the south-eastern end of the palace's wing, the removal of the layer of rubble from the collapse of the palace's upper storey has allowed to bring to light a very well preserved kiln built of limestone blocks, clay and bricks (Fig. 5). The kiln used for the manufacturing of LR1 amphorae of large dimensions (covering a surface of approx. 3.50 x 3 m) seems to have been in operation only for a short period around the second half of the 6th century.

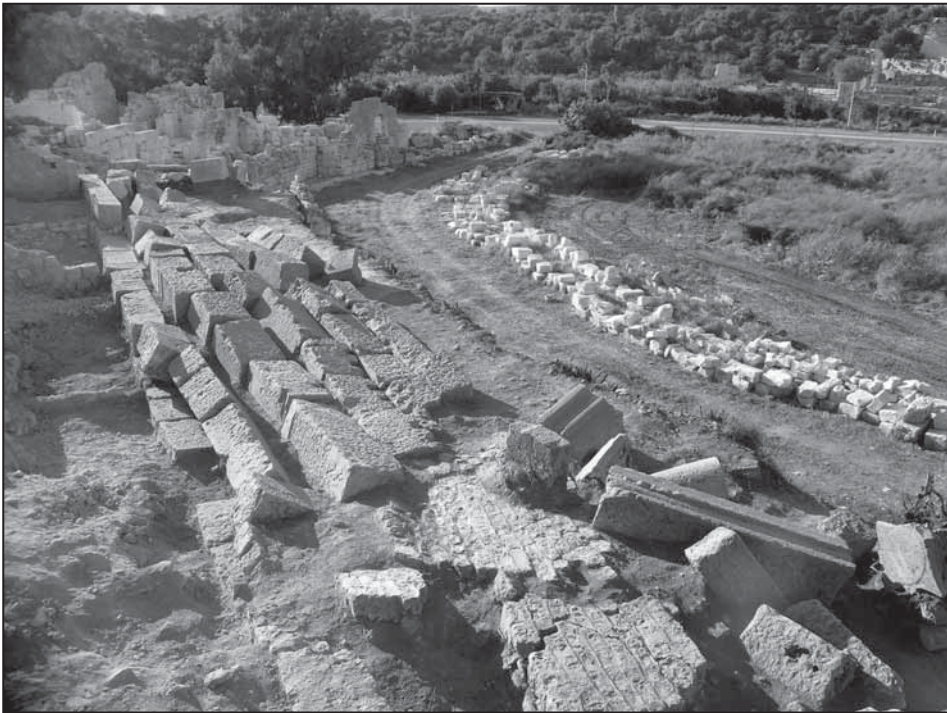
Fig. 6: Northern Harbour Front: the collapse of the upper rows of the *opus quadratum* wall and, on the right some architectural elements pertaining to the portico.

The northern sector revealed the most impressive remains, pertaining to the huge *opus quadratum* wall of Severian age closing on the rear the colonnaded portico and whose western sector, facing the Byzantine palace, had already been investigated. The removal of the modern agricultural earth layer allowed to expose the upper part of the wall until the terrace's eastern limit and the great collapse of its upper rows (Fig. 6) together with some architectural elements related to the colonnade (in particular two Corinthian capitals in proconnesian marble). Such elements have the same characteristics of those already found in the past campaigns in the collapse of the western sector of the monumental port front and can be dated to the second half of the 2nd century A.D. (the Antonine age or the first decades of the Severian age). After having cleaned and documented the collapsed elements (Fig. 6), we proceeded to remove them by means of a crane except for eighteen of them which were placed back in their original position. After concluding this phase, the excavation of the under-laying levels was undertaken. On the basis of the chronology suggested by the materials (second half of the 7th century A.D.) it can be assumed that the great collapse must have occurred in a period subsequent to the abandonment of the city.

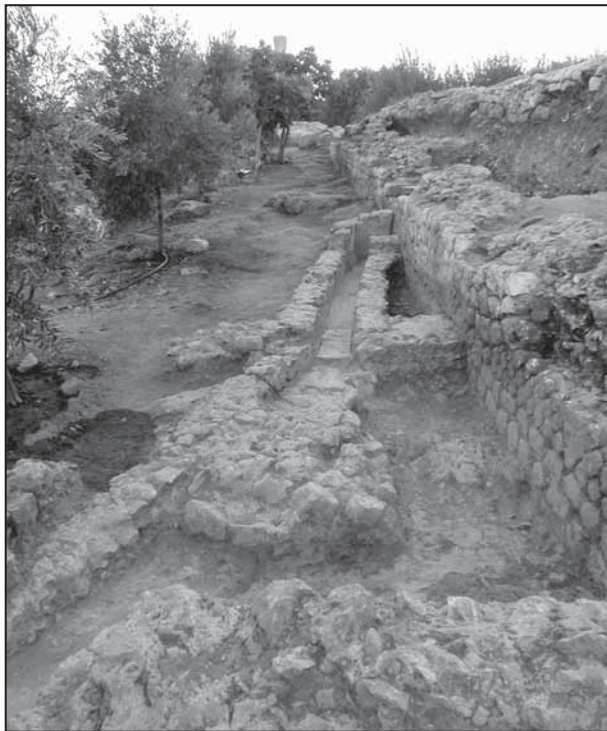
Fig. 8: Temple area: View of the east-west wall supporting the terrace north to the temple and of the channel system.

Concerning the temple area the investigations were aimed to determine, but with great difficulty due to the presence of also very recent plantations (lemon and olive trees) inside the archaeological area, the extension of the *temenos*. In the north-eastern area of the complex was brought to light an east-west orientated limestone wall (length of approximately 30 m) which most probably was a containment wall for the terrace overlooking the temple area (Fig. 8).

The wall, directly founded on the evened out rock bank and preserved for an average height of 1.15 m, presents various phases of construction, realized with different building techniques. On the basis of a preliminary structural analysis, it is possible to define a building sequence which, in a first phase, consisted of raising a wall in *opus reticulatum*, very probably pertinent to the first Roman imperial period and related to the construction of the temple. In a later period, to be dated after the end of the 3rd century A.D., probably after a collapse or in any case of a partial destruction of the wall, the structure was roughly cut down and rebuilt with a double curtain of irregular small blocks. To this phase should also be related a channel next to the western section of the wall, coated with hydraulic mortar and covered by irregular limestone slabs. The interruption of the investigations did not allow to defining the overall alignment of the conduit and its function: the most probable hypothesis is that it was a section of the rain water collection system draining into the sea, but it cannot yet be excluded that it could have been used for supplying clean water from the near-by aqueduct.

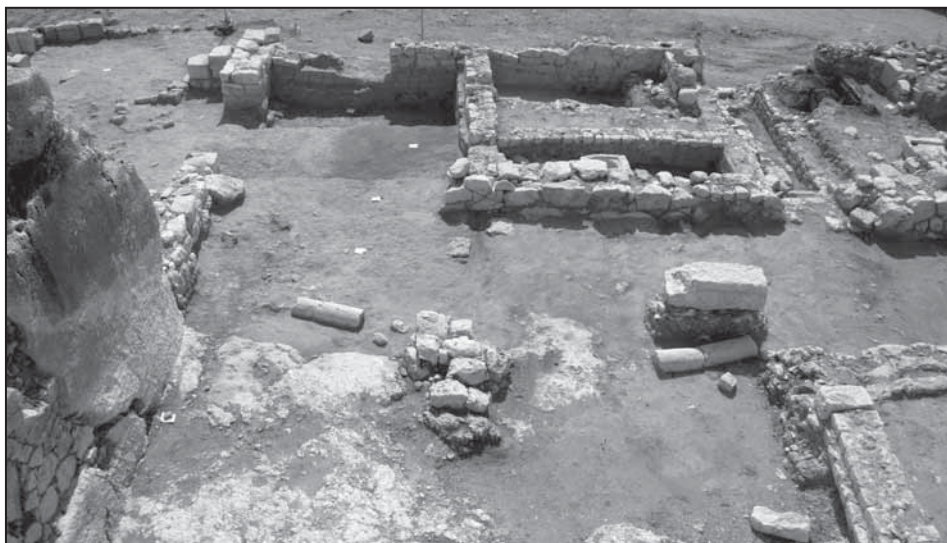
Fig. 9: Domestic and Artisanal Quarter: room Ig with the different hardened clay floor levels.

The excavation of room Ig (Fig. 9) allowed to bring to light a series of different hardened clay floor levels, which can be dated from the end of IVth to the VIIth centuries, all pertaining to the workshop for the production of Late Roman 1 amphorae.

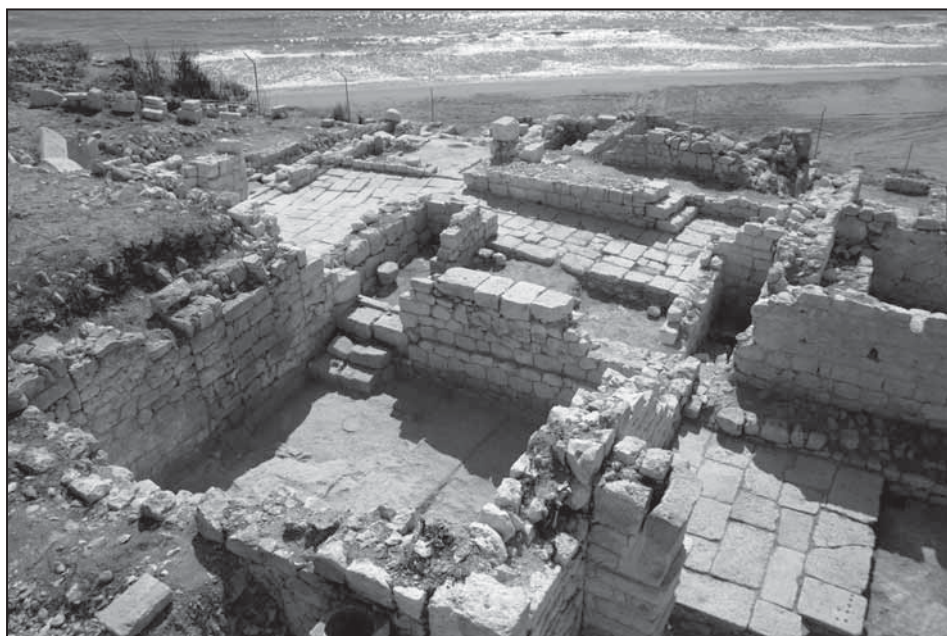
Fig. 10: Domestic and Artisanal Quarter: room IIh with a section of the pavement in limestone slabs (to the right) and room IIg (to the left).

Digging activities in the uppermost terrace of the quarter were carried out in two different rooms (II f and II h) (Fig. 10). Room II f had been partly excavated during 2006 and 2007 campaigns, when in its southern sector a pavement made out of limestone slabs was brought to light. The 2008 investigation, consequently, have been focused in the northern part of the room, where the slabs were not preserved. The excavation revealed a complex system of water channels, originally running under the floor: three distinct channels, leaning along the foundations of the northern and the western wall and in the middle of the room and running, respectively, east-west, north-south and northwest-southeast, were brought to light. They all consist of the channel proper, rectangular in section, completely cut out of the natural bedrock with a tile-covered bottom. The rocky sides of the canal were reinforced by small irregular blocks, supporting the covering slabs, quite all of which are missing. The situation revealed in room II f is very relevant for the study of the water canalization system of the whole quarter.

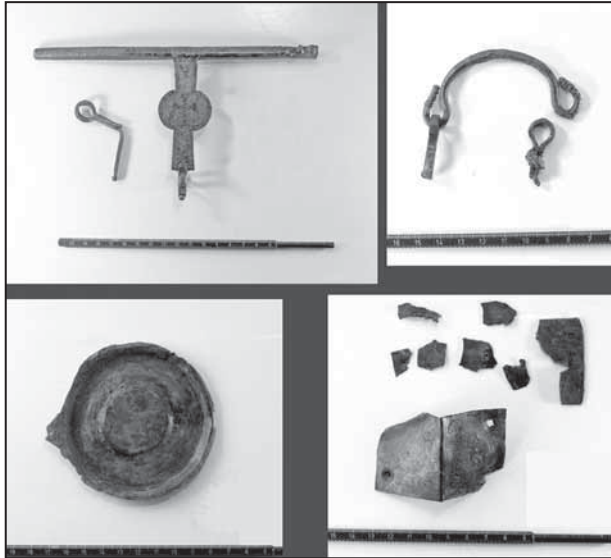
Fig. 11: Bronze objects found in the Domestic and Artisanal Quarter.

Room II h, to the east of the latter, was completely filled with debris dating to the 7th century A.D., whose removal provided some interesting material like two small Byzantine capitals and other architectural fragments in marble and limestone. It appears quite likely that the room did not have a second floor, since a high concentration of roof and bent tiles was noticed during the excavation of these obliteration layers. During the period in which it was used, the room underwent some changes, as also an accurate observation of its walls revealed. Two different floor levels and their preparatory layers were brought to light; both were made out of well pressed clay soil. The most recent of them, dating to the mid 7th century A.D., must be ascribed to the last restoration of the room, while the older one, built around the end of the 6th century A.D., seemingly represents its original arrangement. Under this latter level, some traces of the Roman phases as well came to light: these traces consist of a wall, of which only a single row of blocks remains, with an associated floor made of clay. A large number of every-day objects, such as clay cups and vases, bronze locks, candle handles, fittings for furniture and boxes, which came to light within this area, have been cleaned and restored (Fig. 11).

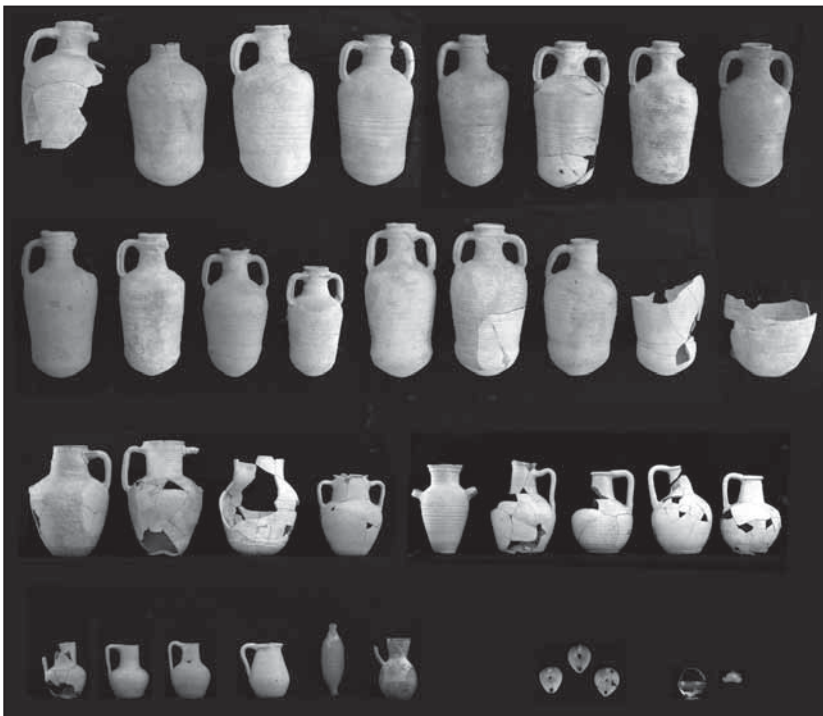
Fig. 12: Amphorae, other vessels and objects found into the cistern in room IVg.

On the whole, the context of the cistern's findings (Fig. 12) has appeared to be, in a preliminary analysis, quite homogeneous from the chronological point of view, covering a period of approximately 30-40 years from the first half of the 7th century A.D.

(therefore during the last phase of the city's life): LR1 type amphora, undamaged or in large fragments; small jugs related to the same production of the amphora (except for one coming from Cyprus) and a balsamary of Palestinian production. Among the findings there were also a painted amphora with the representation of a shepherd with his sheep (and an engraved figure of a peacock) (Fig. 13), three terracotta lamps and two bronze objects: a *situla* with a handle and an interesting example of a jug cover with chain.

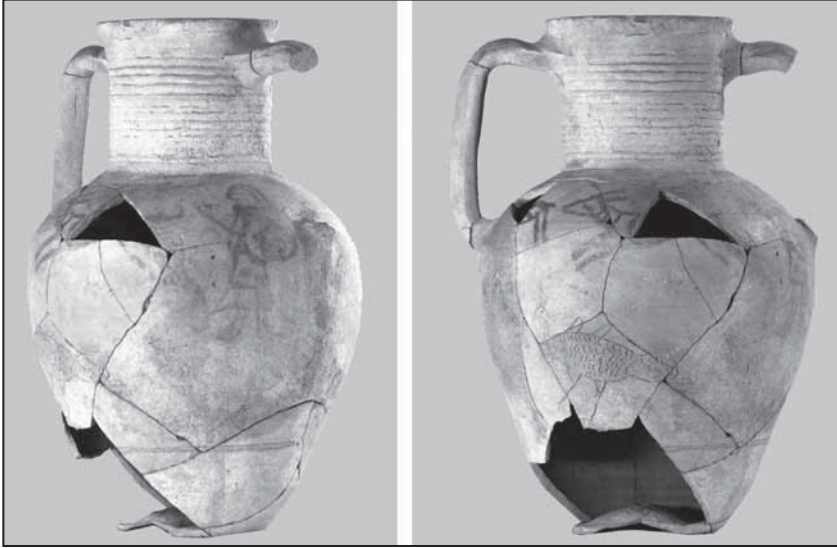
Fig. 13: Figured painted amphora found inside the cistern in room IVg.

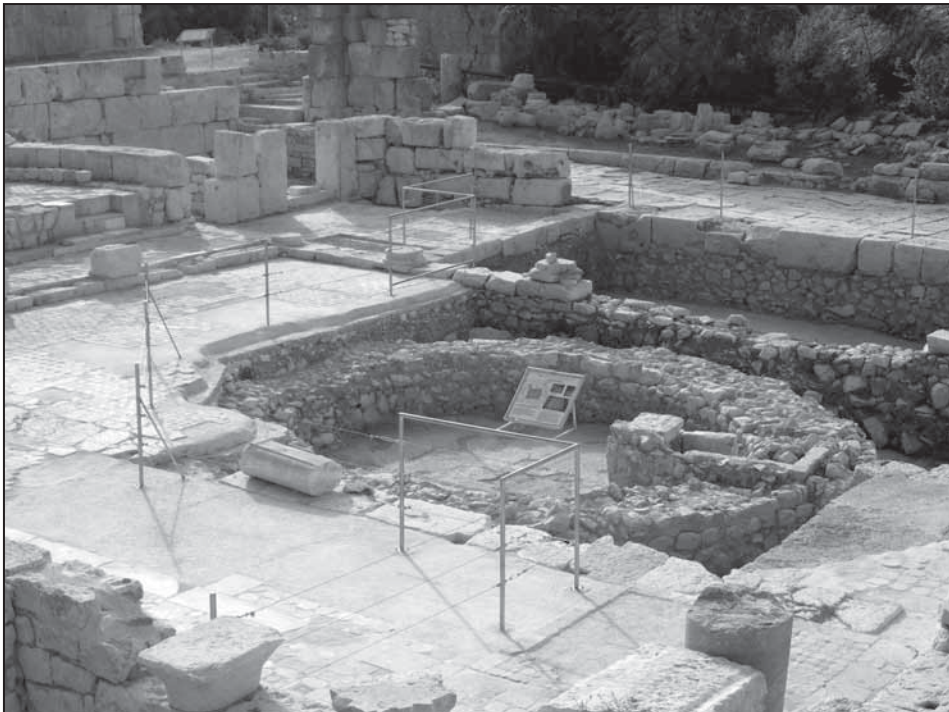
Fig. 14: Area of the Roman agora and Byzantine basilica: Visitor's itinerary with explanation panels.

The program of implementing and safeguarding the Agora-Byzantine basilica complex has been achieved, thanks to the restoration of the last *opus sectile* panels and the final consolidation of all the structures. Thus, the planned visitor's itinerary inside the archaeological area has been realised, following the same model as that of the theatre, with a non fence protecting the central area - where the three different phases of the building are visible - and covering, when necessary, the mosaics by a metal grid. English-Turkish explanation panels, located in the most significant sectors of the building, will contribute to a better fruition of the complex by the tourists (Fig. 14).
