Methodology and evidence from a case study in Rome to increase pedestrian safety along home-to-school routes

Maria Vittoria Corazza^{*}, Daniela D'Alessandro, Paola Di Mascio, Laura Moretti

Department of Civil, Building and Environmental Engineering, Sapienza University of Rome, Rome 00185, Italy

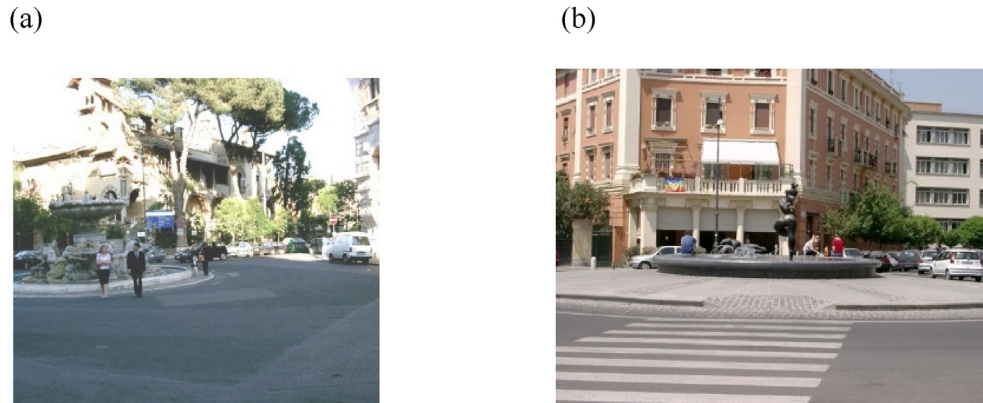
Fig. 3 – Squares in the case study. (a) Piazza Mincio. (b) Piazza Caprera.

The two areas first considered in this case study are in the II District, a central neighborhood in the Municipality of Rome. A square (respectively Piazza Mincio in Fig. 3(a) and Piazza Caprera in Fig. 3(b)) and several school premises around (high schools, a junior school and more nearby private educational establishments) are the common trait of both, which turn these areas into vibrant cores of the district everyday life.

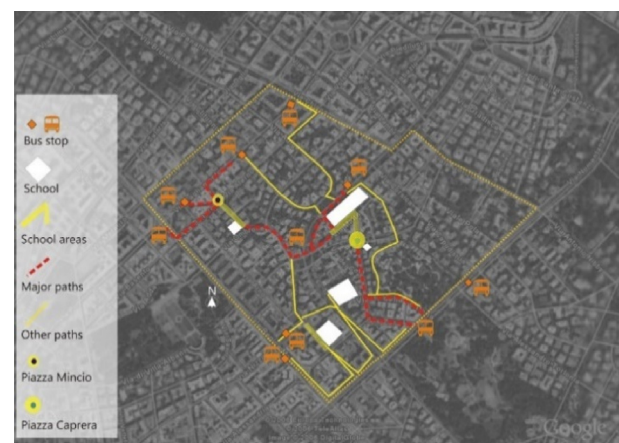
Fig. 4 – The Piazza Mincio-Piazza Caprera case study area.

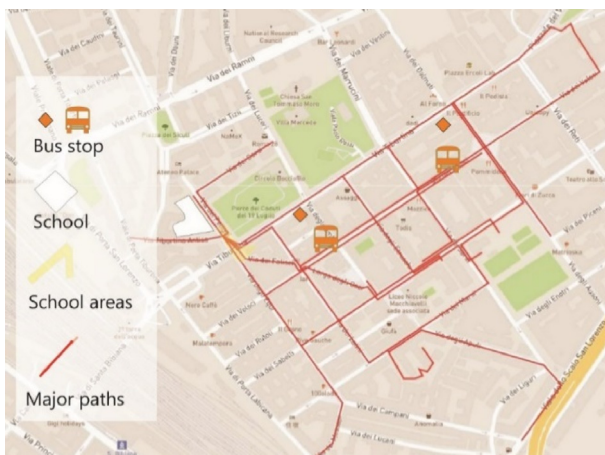
Fig. 5 – The San Lorenzo case study area.

The case study also included an additional test field in the nearby area of San Lorenzo, still in the II District (Fig. 5).

junior school (in white in Fig. 5), but large outdoors areas in front. This enables to compare similar but not equal areas, consistently with the different types of urban fabric and land use mix, typical of many European cities.

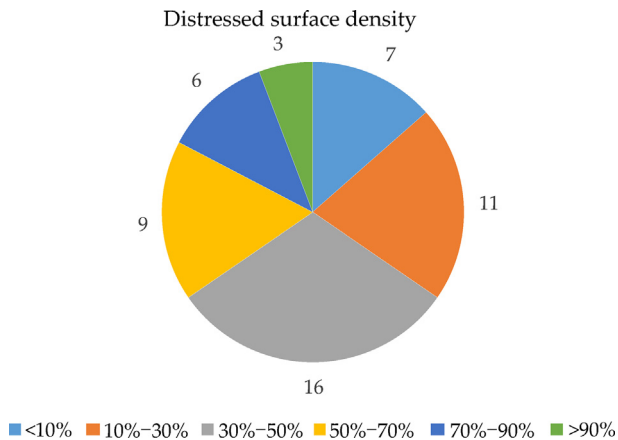
Fig. 7 – Distress density.

More considerations can be further elaborated for both the checklists application and the PCI analysis, as follows. For the latter, whenever in Table 4, the requirement on distress density (within maintenance index) was not met, the PCI index was calculated to have a more accurate assessment. In this case, a total of 52 sample units needed to be further analyzed. Fig. 7 shows how the percentage density of the deteriorated pavement ranges between 30% and 50% in 16 out of the 52 sample surveyed; in this range, the number of units in very good conditions (7 with deterioration density below 10%) exceeds that of units in very poor conditions (3 with deterioration density above 90%). Overall, 65% of the samples have a deterioration density of less than 50% and therefore the observed routes can be assigned a score of 1 for the maintenance index (“distress density”) of Table 4. Recurring distresses (those occurring more than 50%) are patches, holes, visco-plastic deformations and depressions. From the density of the individual distresses on each sample unit, the scores for the “Chinks and potholes” (as general absence of holes) and “Distresses” (as general absence of evenness) indices in Table 2 were also defined. The former set was not detected only on 11% of the samples units considered and then scored 0. For the latter, the set of distresses was not detected only on 8% of the units, which explains why the index was scored 0. These results were in full accordance to what already detected in the area, when analyzing the overall pedestrian network (Corazza et al., 2016a).

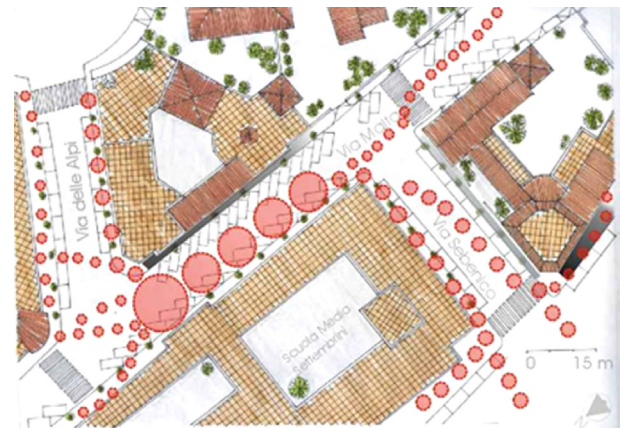
Fig. 8 – Approaching trajectories to one of the schools located in Piazza Caprera area.

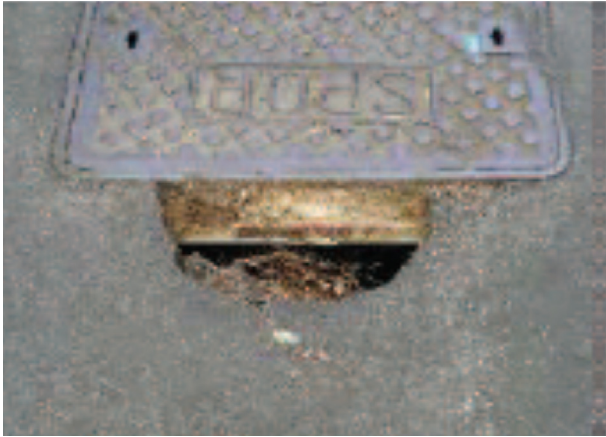
Fig. 10 – An example of poorly maintained sidewalks, in the home-to-school path near Piazza Mincio.

Fig. 10 shows a typical example of a high-severity distress along the path to the local school which compels the detours just mentioned.

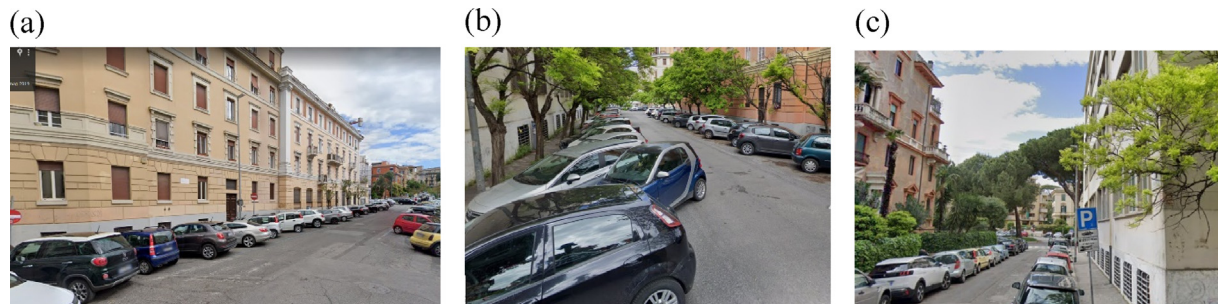
Fig. 11 – Examples of constraints due to traffic signs. (a) Via delle Alpi. (b) Via Malta. (c) Via Sebenico.

It should also be noticed that, in some cases, available areas to walk are reduced also by vegetation and vehicles illegally parked on the sidewalks. Focusing on the streets reported in Figs. 8 and 11 describes how the situation is worsened by the parking requirements, massive in the area (Fig. 11(a) at Via delle Alpi). Although compliant with regulations, angle parking creates the spillover effect which

decreases the actual walking clearance (Fig. 11(b) at Via Malta), and so do the parking signs (Fig. 11(c) at Via Sebenico, although here the scheme is parallel). Needless to say this strongly affects the rating of the streets associated with the school paths in the Piazza Caprera area, and so with the negative assessment if compared to the Piazza Mincio situation.
