Multi-temporal Maps of the Montaguto Earth Flow in Southern Italy from 1954 to 2010

Historical movement of the Montaguto earth flow in southern Italy has periodically destroyed residences and farmland, and damaged the Italian National Road SS90 and the Benevento-Foggia National Railway. This paper provides maps from an investigation into the evolution of the Montaguto earth flow from 1954 to 2010. We used aerial photos, topographic maps, LiDAR data, satellite images, and field observations to produce multi-temporal maps. The maps show the spatial and temporal distribution of back-tilted surfaces, flank ridges, and normal, thrust, and strike-slip faults. Springs, creeks, and ponds are also shown on the maps. The maps provide a basis for interpreting how basal and lateral boundary geometries influence earth-flow behavior and surface-water hydrology.

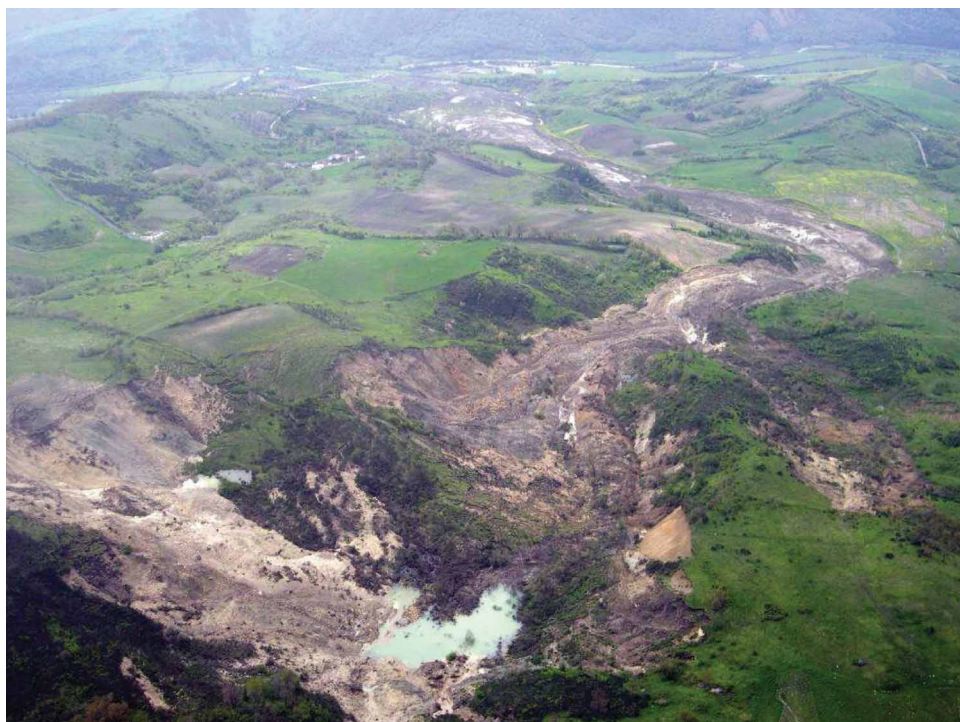
Figure 1. The Montaguto earth flow on 27 April 2006. Photo taken from a helicopter looking south toward the earth-flow toe.

The Montaguto earth flow (Figure 1) in the Apennine Mountains of southern Italy has been periodically active since at least 1954. The most extensive and destructive period of earth-flow activity began on 26 April 2006, when an estimated 6 million m³ earth flow mobilized, covering and closing Italian National Road SS90, and damaging several farm houses located next to it. Throughout this paper, we use the term earth flow when describing the Montaguto landslide because it is composed of predominantly fine-grained material and has a flow-like surface morphology (Hung, Evans, Bovis, & Hutchinson, 2001, 2012; Keefer & Johnson, 1983; Varnes, 1978). However, most movement of Montaguto takes place by sliding along discrete shear surfaces. This sliding movement mechanism was confirmed by structures mapped as part of our research.

between 1954 and 2010 have ranged from 1–2 mm/month to 2–5 cm/day. However, velocities during the large, rapid mobilization in 2006 (Figure 1) ranged from 1 m/day to 1 m/hour.

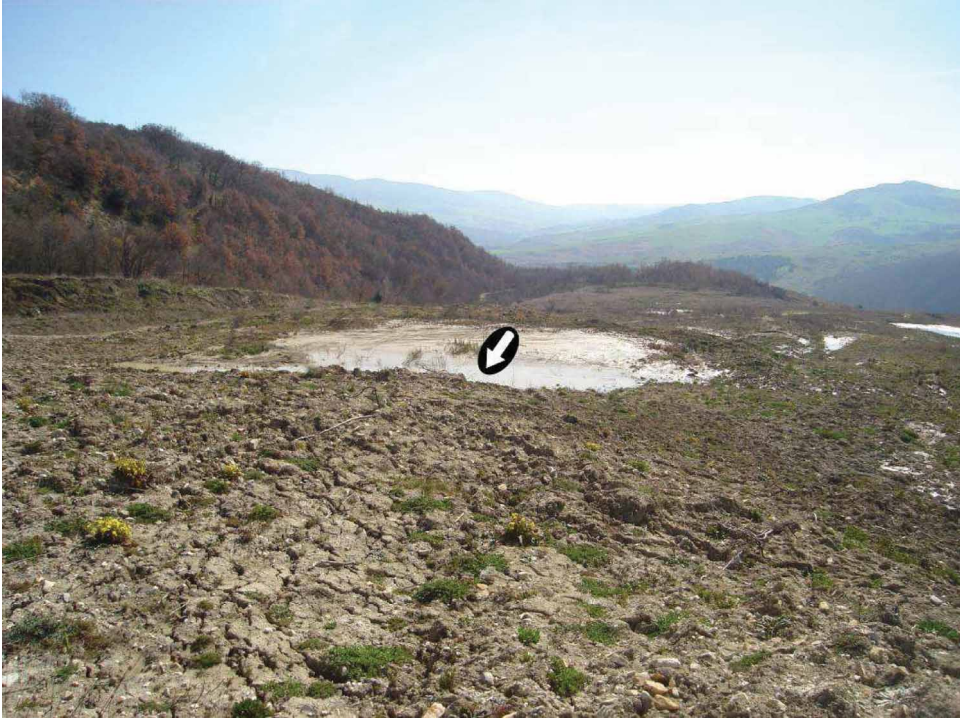
Figure 2. Back-tilted surface on the body of the earth flow with a small pond (about 7-m wide) located in the depression formed by back-tilting. Arrow shows the direction of back-tilting. Movement of the earth flow is from left to right.

For our mapping, we used terminology and classifications from structural geology because they accurately depicted the geometry and relative sense of displacements for the structures that we observed. Structures such as back-tilted surfaces (Figure 2), thrust faults and flank ridges (Figures 3 and 4), and normal and strike-slip faults (Figures 5 and 6) are expressions of local variations in earth-flow speed, volume, and boundary geometry (Fleming & Johnson, 1989; Fleming et al., 1999; Parise, 2003; Parise, Moscariello, & Fleming, 1997); variations in strengths of materials; and driving and resisting elements within earth flows (Baum & Fleming, 1991). For each map, we differentiated active from inactive earth-flow areas based on changes in earth-flow boundaries, changes in drainage, and differences in the relative topographic roughness or relief of structures. We identified and mapped shallow landslides where we observed relatively small (always ≤ 2.2 hectares) areas of displaced material with well-defined headscarps and/or scars (normal faults) that were laterally contiguous with well-defined, downslope deposits and toes (thrust faults).

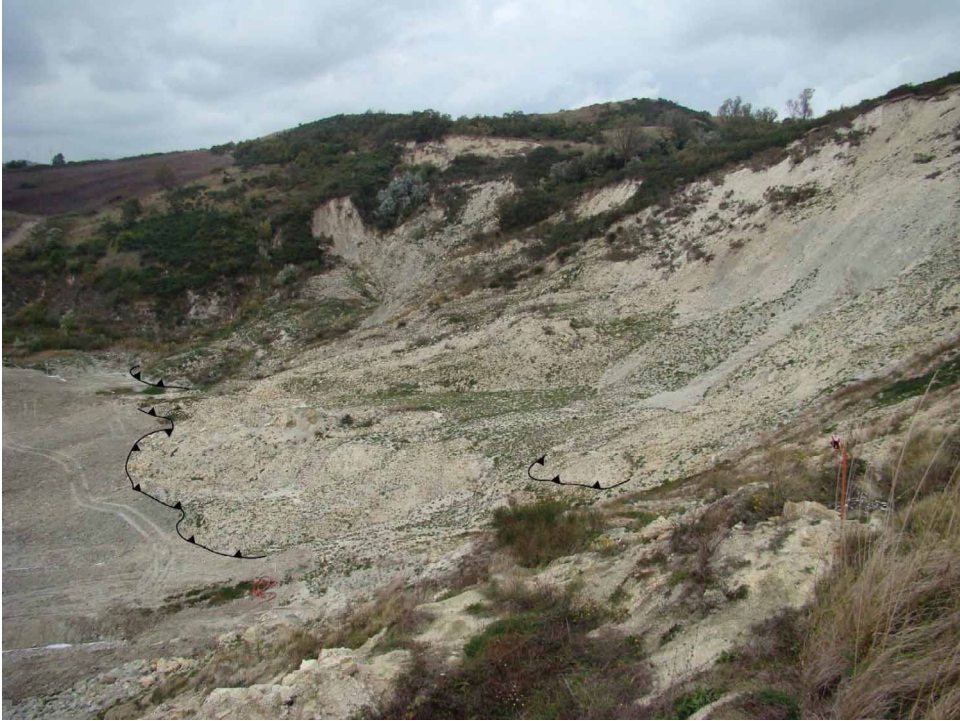
Figure 3. Thrust fault in the earth-flow source area. Linework shows the position of the mapped thrust fault. Thrust fault is about 100-m long at this location.

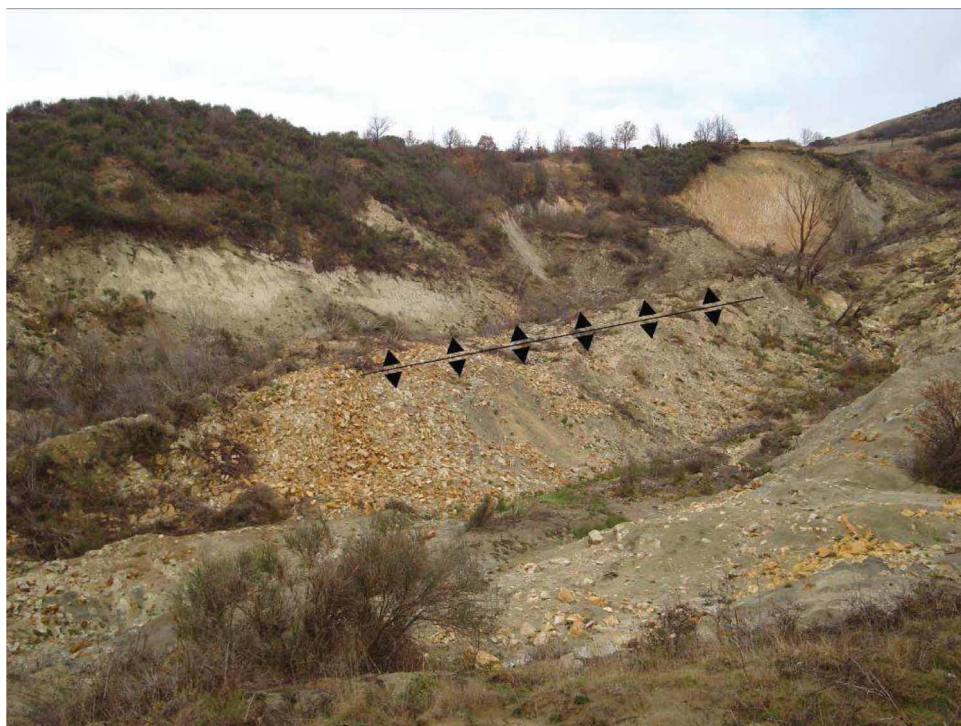
Figure 4. Flank ridge in the middle part of the source area of the earth flow. Linework shows the topographic crest of the ridge. Distance across the photo from left to right is about 150 m.

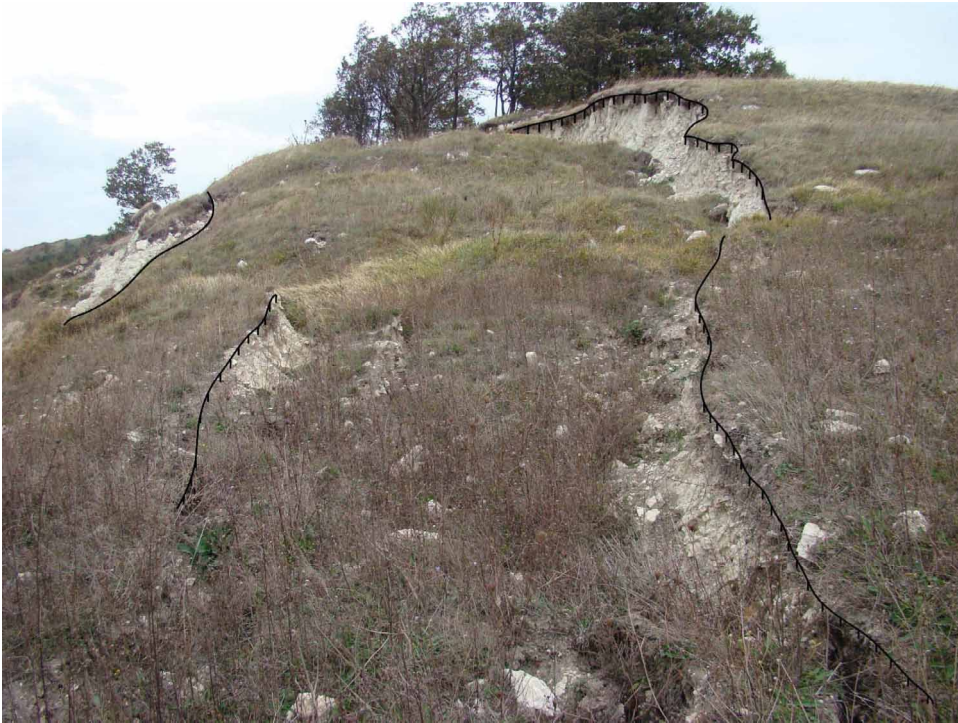
Figure 5. Normal faults at the head of the earth flow. Linework connects points along the top of the scarp. Height of the prominent scarp at the upper right is about 2 m.

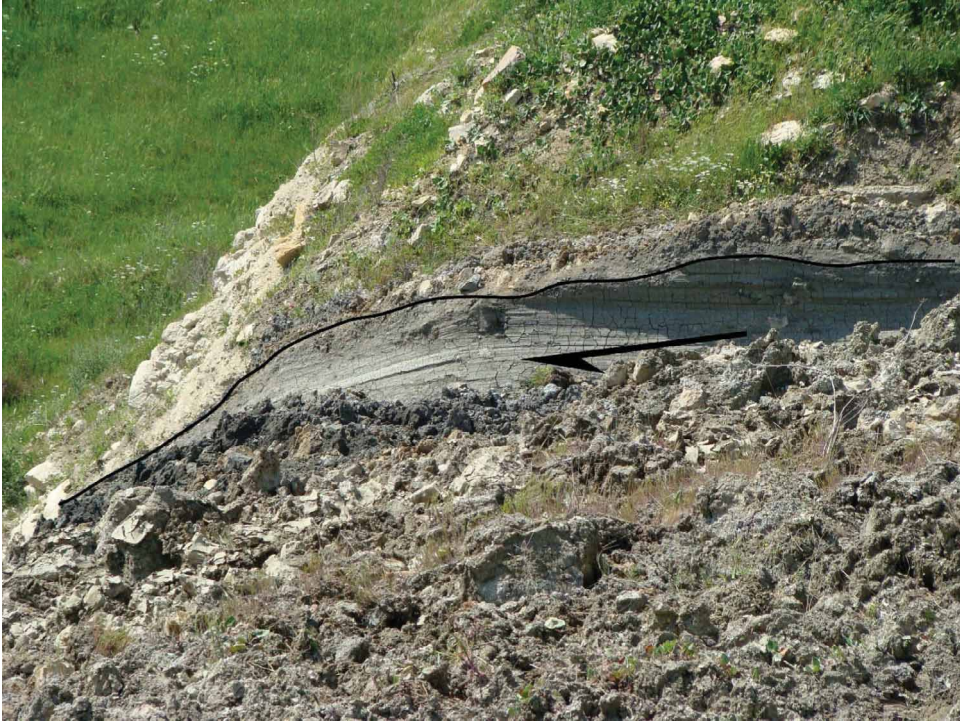
Figure 6. Strike-slip fault along the body of the earth flow. Slickensides and arrow show movement direction. Distance from left to right across the photo is about 4 m.
