ANALYSIS OF CASE STUDIES IN
RECOVERY AND RECONSTRUCTION

CASE STUDIES

THE CONSERVATION OF PALAZZO CARLI-BENEDETTI AFTER THE 2009 EARTHQUAKE IN L'AQUILA (ITALY)

Carla Bartolomucci, Donatella Fiorani

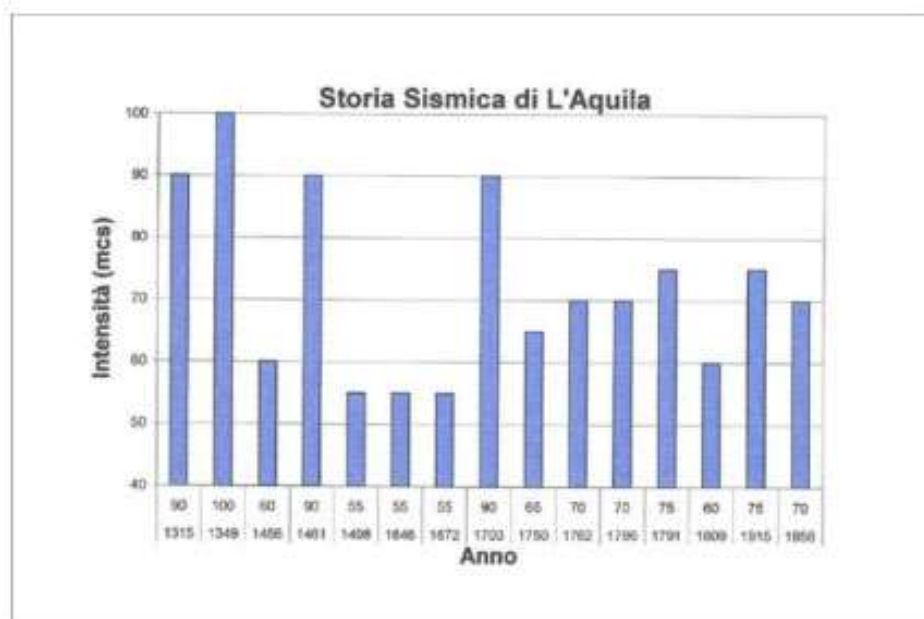
Abruzzo is one of the higher seismic risk regions in Italy. L'Aquila has been hit by destructive earthquakes several times; among the more serious events recorded are those in 1315, 1349, 1461, 1703, 1915 and the recent ones of 2009 and 2017 (fig. 9).

► **Fig. 9.** The seismic history of L'Aquila before 2009 (INGV data)

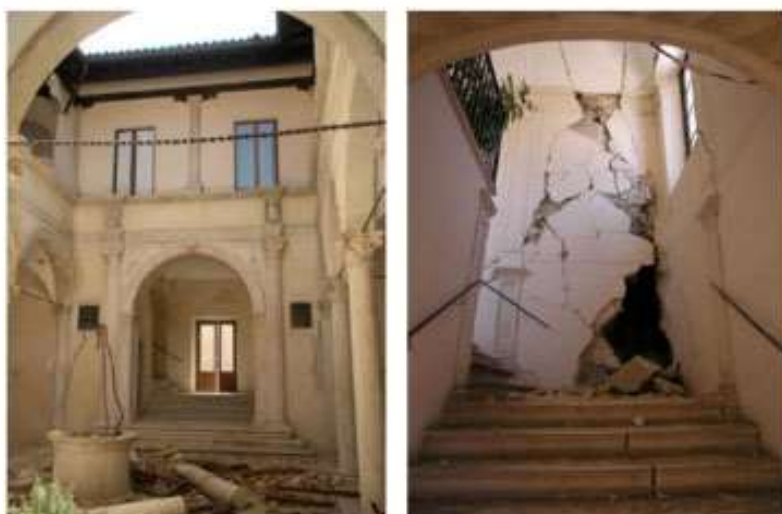
From left to right:
Fig. 10. Palazzo Carli Benedetti after the earthquake: the courtyard (ph. Bartolomucci 2009)
Fig. 11. Palazzo Carli Benedetti after the earthquake: the collapse in the staircase (ph. Bartolomucci 2009)

The 2009 earthquake caused serious damage to the Palazzo Carli-Benedetti: the collapse of the northern upper loggia in the courtyard, the loss of the corresponding eighteenth-century inner ceiling vault (fig. 10, 12), the partial ruin of the staircase wall (fig. 11) and the extensive damage to walls, most pronounced on the upper floor. Luckily, no loss of life occurred.

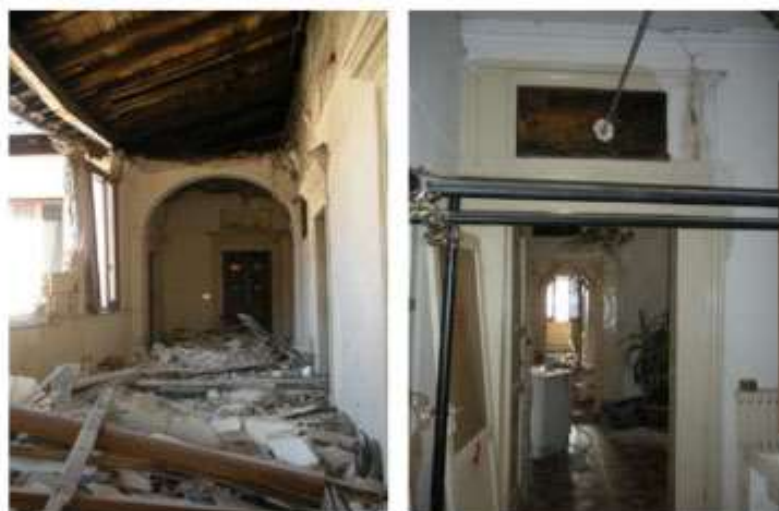
Fig. 12. Palazzo Carli Benedetti after the earthquake: the collapse in the loggia (ph. Bartolomucci 2009)

Fig. 13. The painted "sovrapporta" pierced by tie rods during the shoring work (ph. Bartolomucci 2010)

During these works, wall paintings were damaged by the insertion of metal wire ropes, which was done without the necessary attention to the decorative elements (fig. 13).⁷ Moreover, some fragments of stucco frames and wall paintings were lost during the removal of rubble.

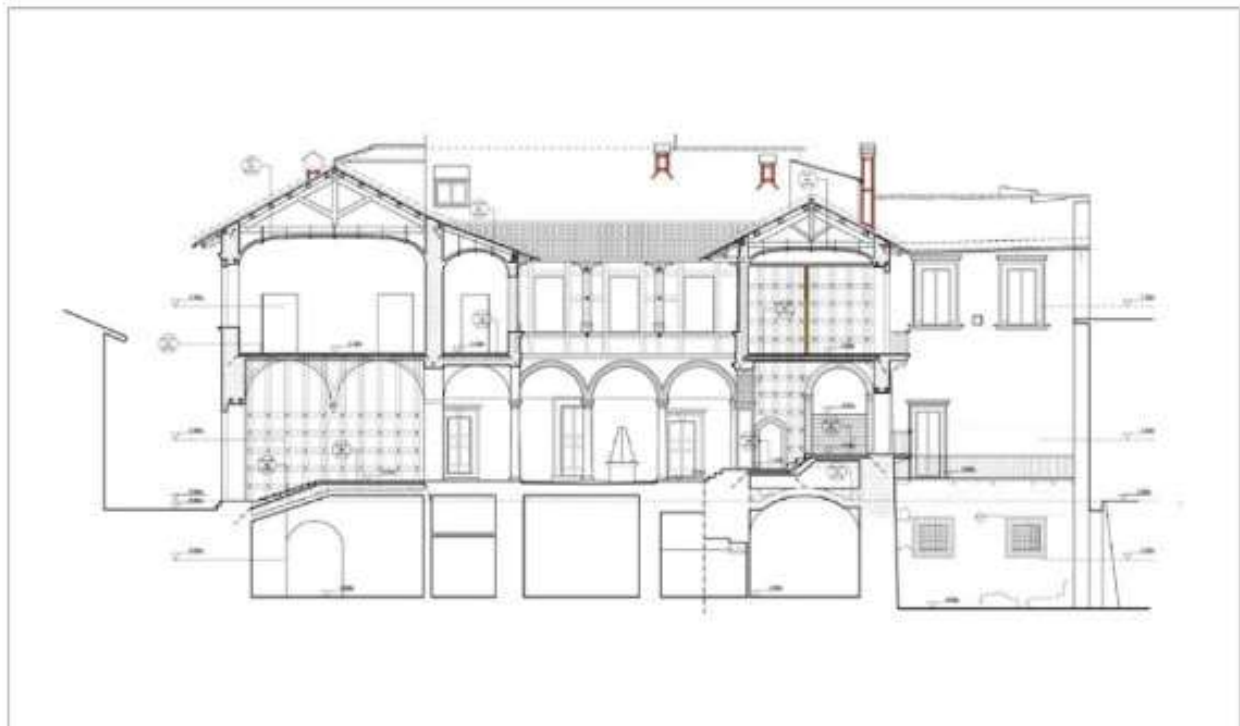
Fig. 14. The consolidation project: the section along the courtyard shows the reinforces on the more damaged walls (drawing by F. De Cesaris, 2012)

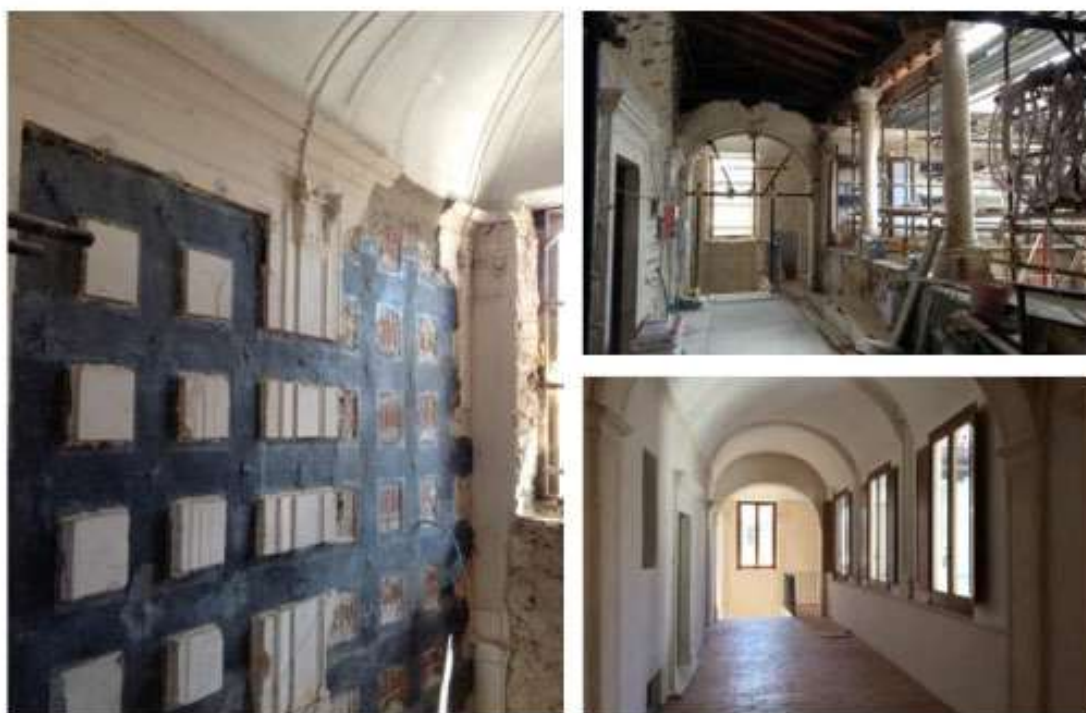
Fig. 15. The reconstruction of the loggia in progress: the collapsed columns have already been recomposed with anastylosis (ph. Bartolomucci 2015)

Fig. 17. Reconstruction of the walls surrounding the staircase: the damaged masonry was integrated and connected by FRP reinforcements (ph. Bartolomucci 2015)

The final choice was to reconstruct the fallen wall using thin panels so as to leave the columns visible inside and outside (fig. 16). This means that the new structure is distinguishable from the still preserved eighteenth-century façades (Bartolomucci 2018: 115, 125).

Similarly, the damaged walls were repaired and reconstructed in a recognisable way, using materials other than the original ones (fig. 17). The inner plans of the apartments have been carefully revised, looking

Following this criteria, integration of the missing parts of the walls and vaults have been done using traditional materials, mostly bricks, while the structural consolidation took advantage of the introduction of fibre-reinforced ribbons, located on the internal surface of the walls and above the vaults (figg. 17, 22).

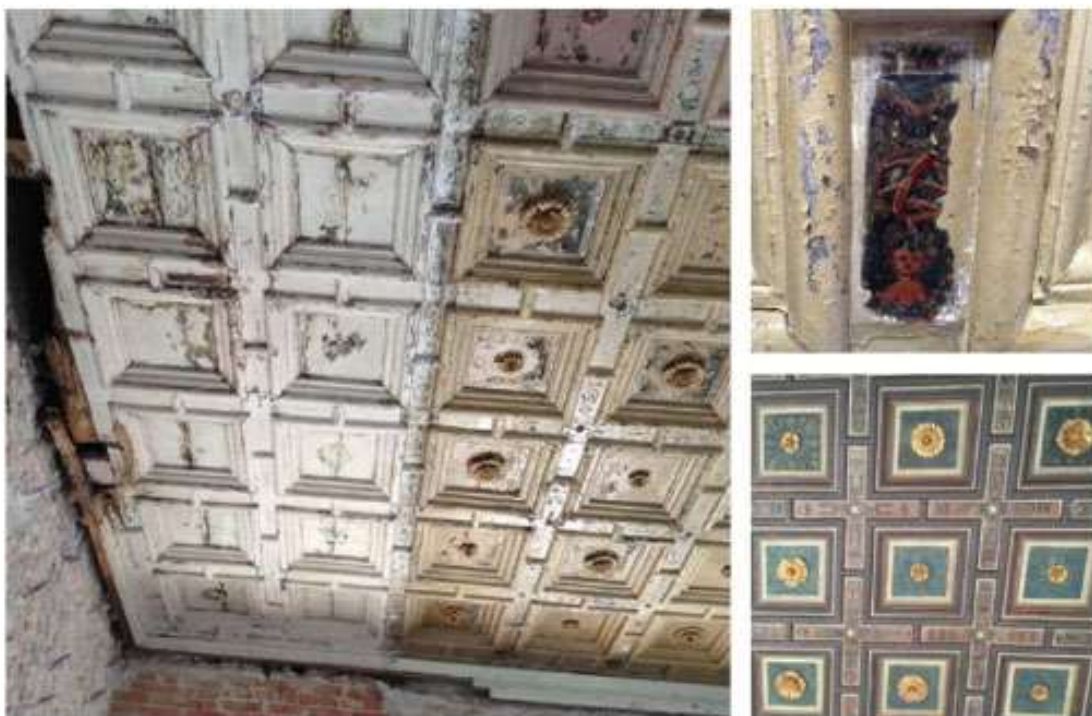
The analysis of seismic damage revealed some pre-existing structural vulnerabilities caused by earlier renovations of the apartments: cracks in the masonry due to the insertion of services, changes in room layout and new openings cut through the walls. In addition, some modifications had altered previous configurations. In some cases, the false ceilings had hidden vaults, wooden roofs and wall paintings (figg. 18-20), in others, the superimposed layers of plaster and painting had covered frescoes from the fourteenth and sixteenth centuries (fig. 21).

Fig. 18. One of the decorated wooden ceilings that were hidden by false ceilings and repainting (ph. Bartolomucci 2015)

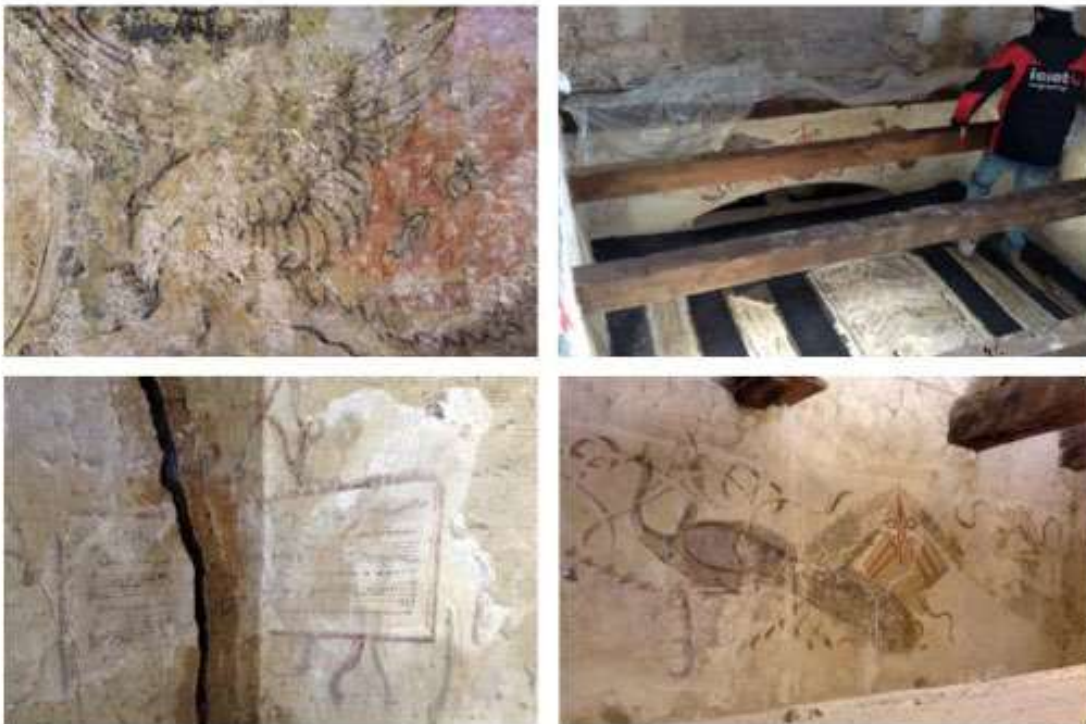
Fig. 21. Detail of the frescoes discovered under a fifteenth-century painted ceiling (ph. Bartolomucci 2015)

Fig. 24. Detail of a musical score discovered under the same floor, attributed to the early sixteenth-century. Note the wall damage, already repaired in the past (ph. Bartolomucci 2014)

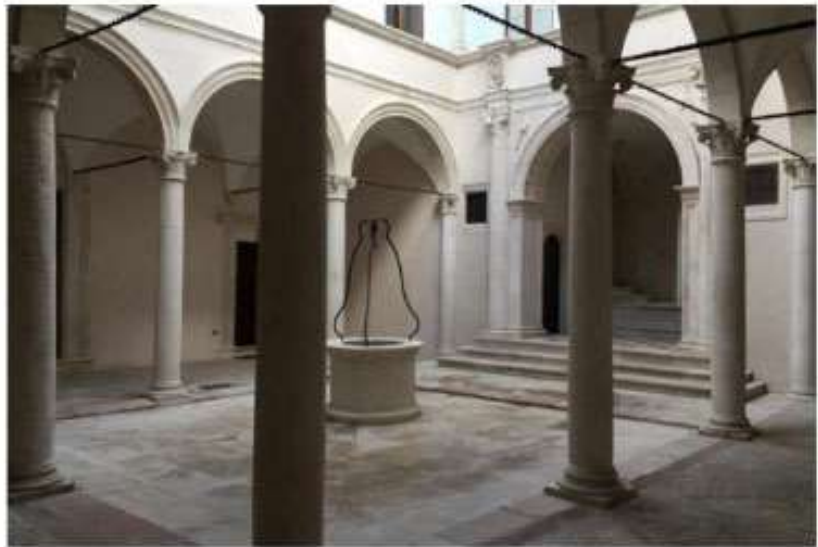
Fig. 25. The courtyard at the end of the works: the air colour on the loggia returns the sense of the open loggia, without denying the eighteenth-century transformation (ph. Bartolomucci 2018).
