Low-impact techniques for seismic strengthening fair faced masonry walls

Two techniques for the seismic strengthening of fair faced rubble masonry walls are proposed and tested on a shake table. The first solution entails the use of carbon fibre reinforced polymer connectors installed from outside through the natural stone units, without perforating the entire wall thickness, thus leaving the internal wall surface undisturbed. In the second solution, stainless-steel cords are embedded in repointed mortar joints of the fair face and connected, by means of stainless-steel bars, to a thermo-insulating composite reinforced mortar applied to the internal side. Shake table tests were performed under natural accelerograms on real scale multi-leaf rubble masonry walls, built with the stone units retrieved from the debris of a hamlet heavily damaged in the 2016 Central Italy earthquakes. Both strengthening solutions proved effective in enhancing the seismic capacity by preventing leaf separation and masonry disintegration, and in limiting damage development under earthquake excitation. Thanks to the compatibility with original materials and the preservation of the fair face, they are suita

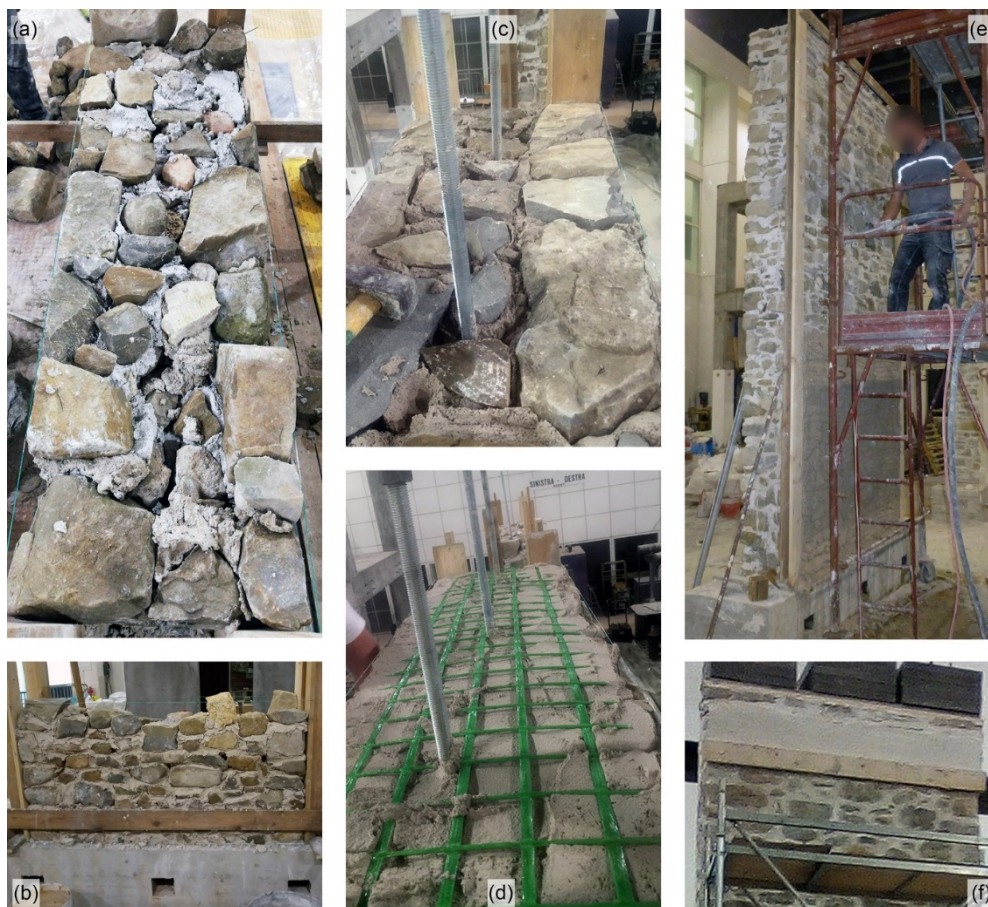
Figure 1. Construction phases and details of the wall specimens: horizontal stonework layer (a), elevation of the fair faced side (b); top vertical connectors (c); reinforced masonry top beam (d); machine application of the plaster layer on the internal side (e), plaster band on the crowning beam (f). Pictures referred to CC wall.

To simulate the dead load of a roof, fifteen steel plates (for a combined weight of 15 kN) were placed on top of the wall and connected with threaded bars (Figure 1c, Figure 2a). Each bar was provided with an eyebolt and secured by steel ropes hanging from the crane bridge, to protect the shake table from the possible collapse of the top beam, as well as to ease the demolition of the specimen at the end of the tests.

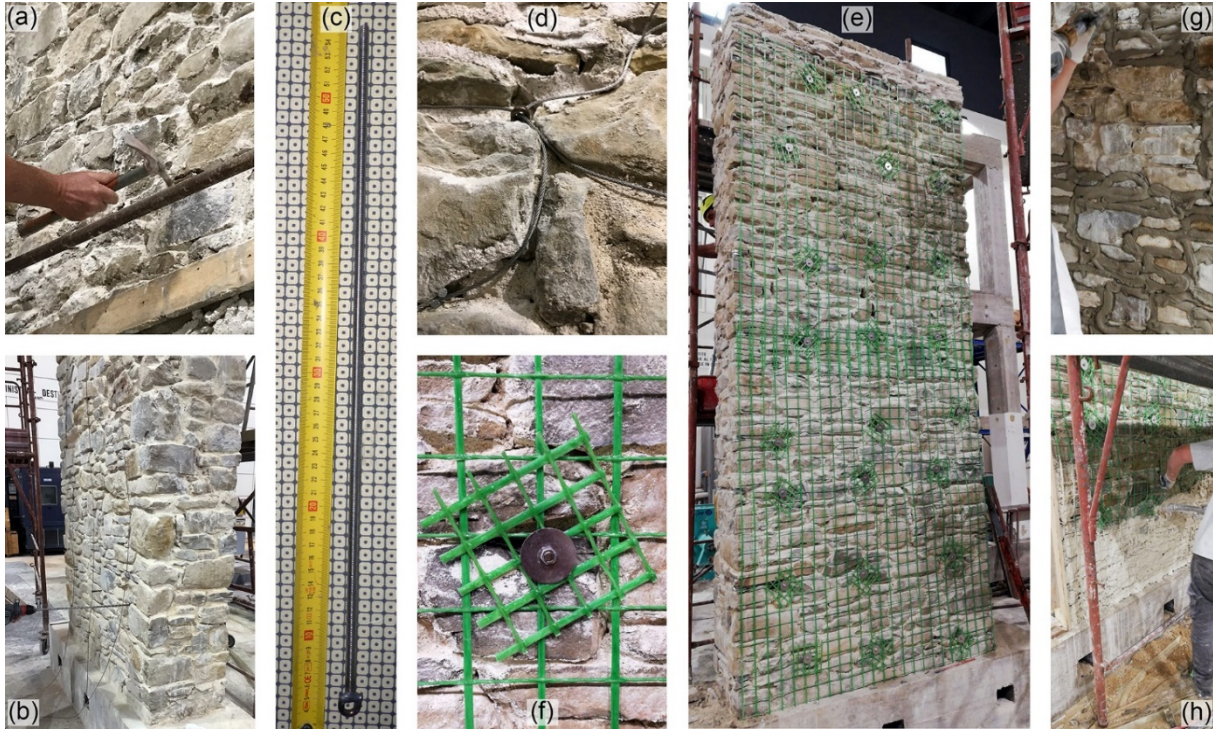
Figure 5. Phases of the strengthening works on CR wall: removal of the mortar from the joints of the external side (a); drilling of the holes for the connectors (b); stainless steel connector (c); stainless steel cords placed in the mortar joints (d); GFRP mesh laid over the internal side (e); nut-washer-patch at connector-mesh intersection (f); repointing of the mortar joints of the external side (g); machine application of the thermo-insulating mortar over the GFRP mesh of the internal side (h).

- 2) *Drilling of the holes and installation of stainless-steel connectors.* The original mortar was removed from the joints of the fair faced side (Figure 5a) and 24 Ø 12 mm holes were drilled, starting from the bed joints (the stone units were not drilled), through the entire thickness of the wall (Figure 5b). In each hole, a Ø 8mm threaded AISI316 (American Institute of Steel Industries) stainless-steel bar was inserted, which was provided with a ring welded at the end on the external side (the fair faced side, Figure 5c).

5g). This mortar enhanced the adhesion of the steel cords with the original substrate and made the strengthening system invisible, preserving the fair face.

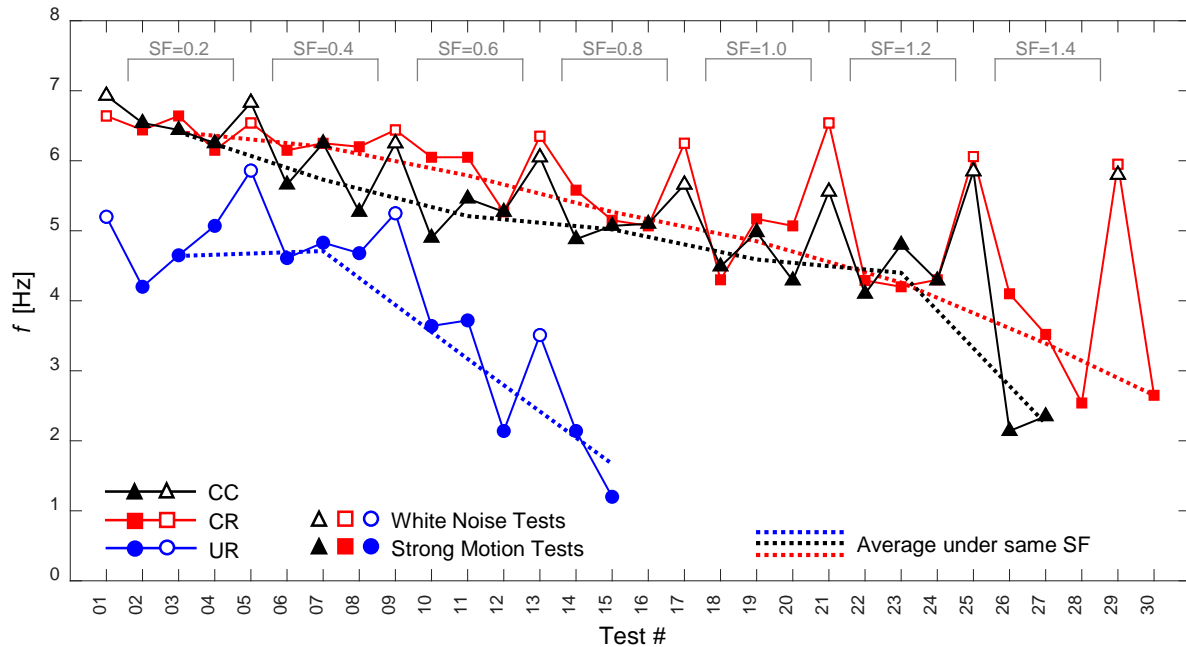
Figure 14. Fundamental frequency of CC, CR and UR walls during the shake table test sequences.

The fundamental out of plane frequency of the wall (f) was calculated with a multiple-input-multiple-output approach [49]. The four markers on the RC foundation were considered for the seismic input and the top 48 markers on the wall (from the 3rd to the 8th row) were taken for the output. Acceleration time histories were obtained by double derivation of marker displacements and no filter was applied. The 192 transfer functions calculated for each output-input couple of markers were averaged to derive information on the overall dynamic properties of the specimens. The resulting frequencies are shown in Figure 14 for the three walls under all the strong motion and white noise tests. The mean frequencies for the three tests with the same SF were also calculated (and are plotted with the dotted line in the graph).

On the other hand, the lower values of the UR specimen can be explained by the different stiffness of the top restraint. Indeed, the frequency increase after Test #04 (from 5.2 Hz to 5.9 Hz) was related to a modification of the top boundary [11], delivering a value close to those of the strengthened walls, especially in white noise tests. The comparison of the frequencies of CC and CR walls with those of UR indicates that the strengthening systems did not significantly increase the stiffness of the wall in the undamaged state, but effectively limited progressive damage accumulation under repeated earthquake base excitations.
