# Development of parametric seismic fragility curves for historical churches

## Abstract

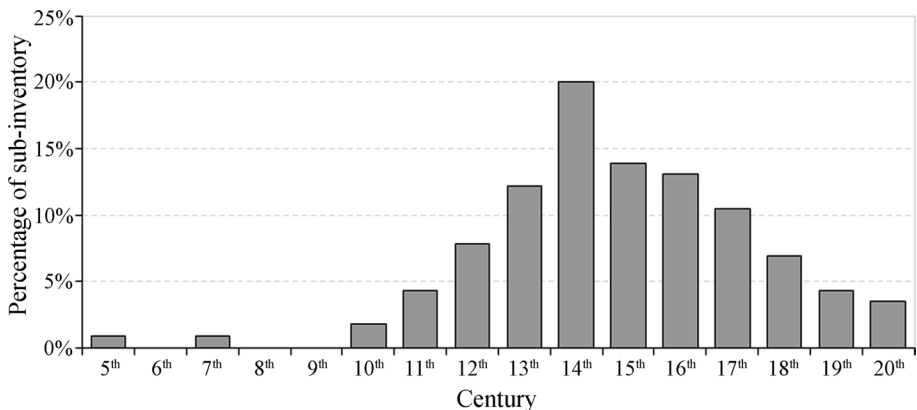
**Fig. 2** Occurrence of investigated URM churches according to century during which construction started. Sub-inventory of buildings for which this information is available

Among the sample of 158 URM churches assessed in the struck regions, 73 were located in Marches, 41 in Umbria, 32 in Latium, and 12 in Abruzzi regions. In Fig. 2 the investigated churches are sorted according to the century during which construction started, an information known for a sub-inventory of 73% of them. The majority of this sub-inventory was established in the Middle Ages (5th–14th centuries, 48%) and in the Renaissance (15th–16th centuries, 27%). The age statistic confirms the heterogeneity of the sample and that Central Italy ecclesiastic masonry-construction heritage was built over a wide time span, compared to other countries. Several churches were enlarged and/or refurbished during the centuries following their foundation, further contributing to the complexity of the investigated sample.

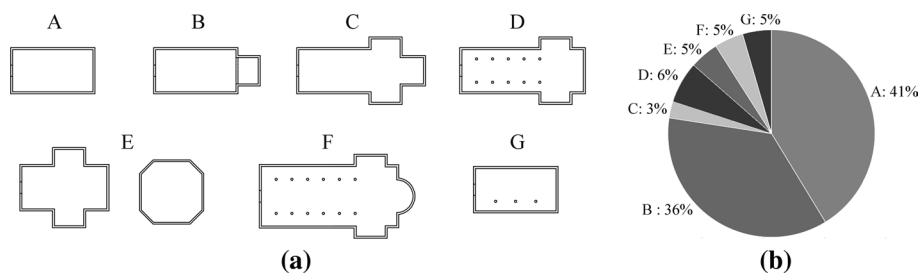
**Fig. 3** **a** Typological classification of investigated URM churches in Central Italy and **b** their distribution among the sample. **A** single nave, **B** single nave with apse; **c** single nave with apse and transept; **D** three naves with apse and transept; **E** central plan; **F** basilica; **G** asymmetric plan

Following the approach previously developed for New Zealand churches (Marotta et al. 2015), a typological classification based on plan and spatial features is developed, and churches are classified into seven types, as outlined in Fig. 3a, whereas the frequency of the types among the entire stock is shown in Fig. 3b. The relative majority of churches (41%) belongs to the A type, while the B type, that includes the presence of the apse, accounts for 36% of the portfolio, highlighting that the majority of churches has a simple plan. The remaining 23% is distributed among churches with transept and apse having one (C) or

three naves (D), central plan churches (E), basilica churches similar to D but much larger and with three or more naves (F) and churches with two naves or with an asymmetric nave arrangement (G). Similar results can be found in Canuti et al. (2019), over a sample of 541 URM churches belonging to the Marche region alone.

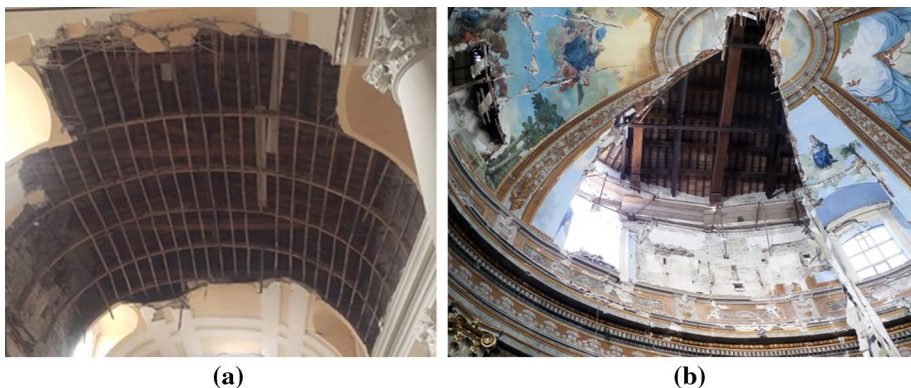
**Fig. 4** Examples of “camorcanna” vaults: **a** Santa Chiara, Camerino; **b** Santa Maria in Via, Camerino, released by the Corps of Firefighters ([www.vigilfuoco.it](http://www.vigilfuoco.it))

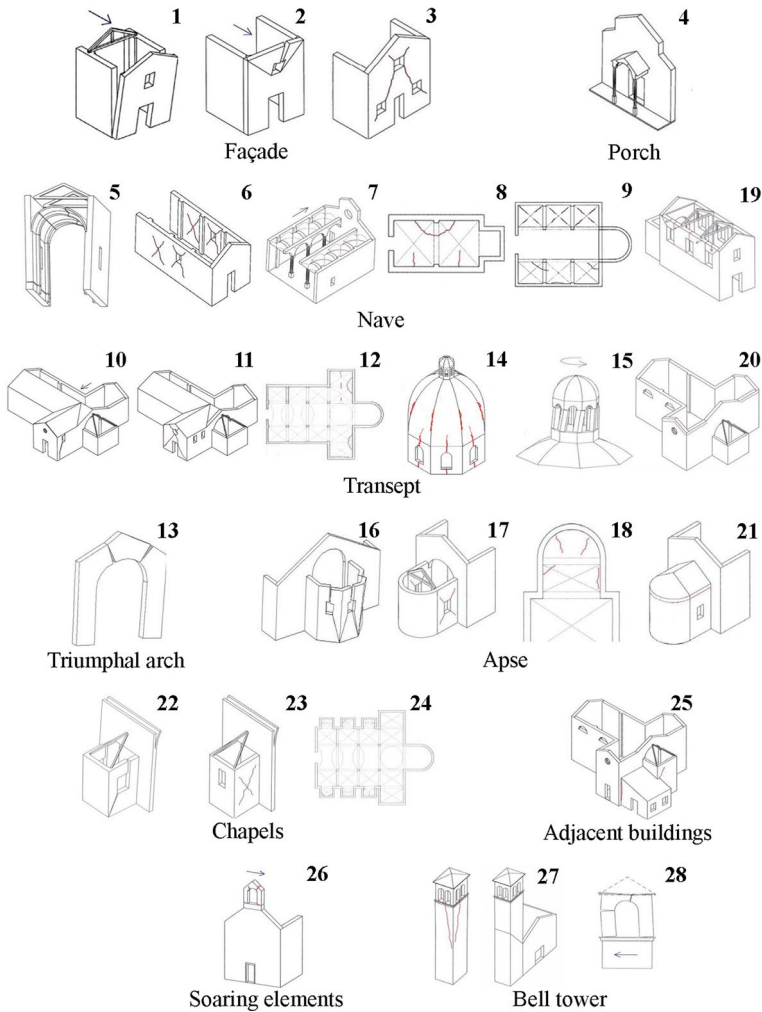
**Fig. 5** Graphic schemes of the 28 damage mechanisms of the Italian form (PCM-DPC Mibac 2006) sorted according to macro-element

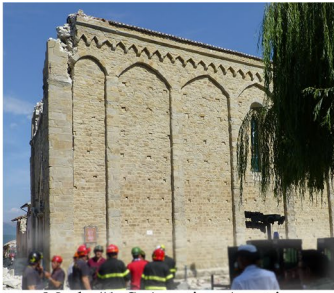
Mech. #1: S. Agostino, Amatrice

**Fig. 6** Selection of most common mechanisms. Mech. #4 courtesy of Romina Sisti, #5 released by the Corps of Firefighters ([www.vigilfuoco.it](http://www.vigilfuoco.it)), #8 courtesy of Angela Straffi, #13 courtesy of Marta Giaretton, #18 courtesy of Ezio Giuriani

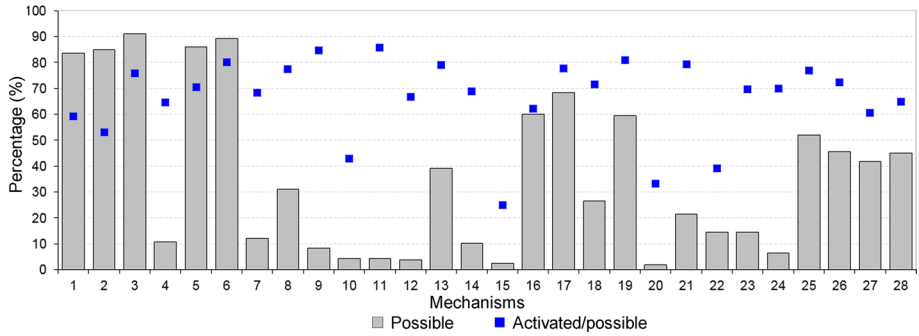
**Fig. 7** Percentages of possible (over the sample of 158 churches) and activated (over the sample of possible) mechanisms in Table 1

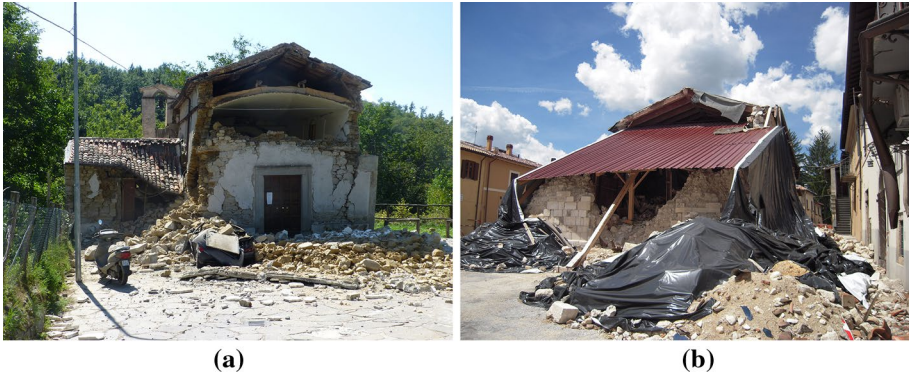
**Fig. 8** Examples of poor masonry quality causing wall disintegration: **a** San Lorenzo Martire, Cossito (Amatrice); **b** Santa Rita, Norcia

Although not included in the current Italian form, poor masonry quality was found to be crucial for 20 mechanisms. It is also important to highlight that the presence of poor masonry quality can lead to wall disintegration (examples in Fig. 8), before a rigid-body mechanism can be activated. In the case at hand, this phenomenon was observed in 21% of the activated mechanisms.

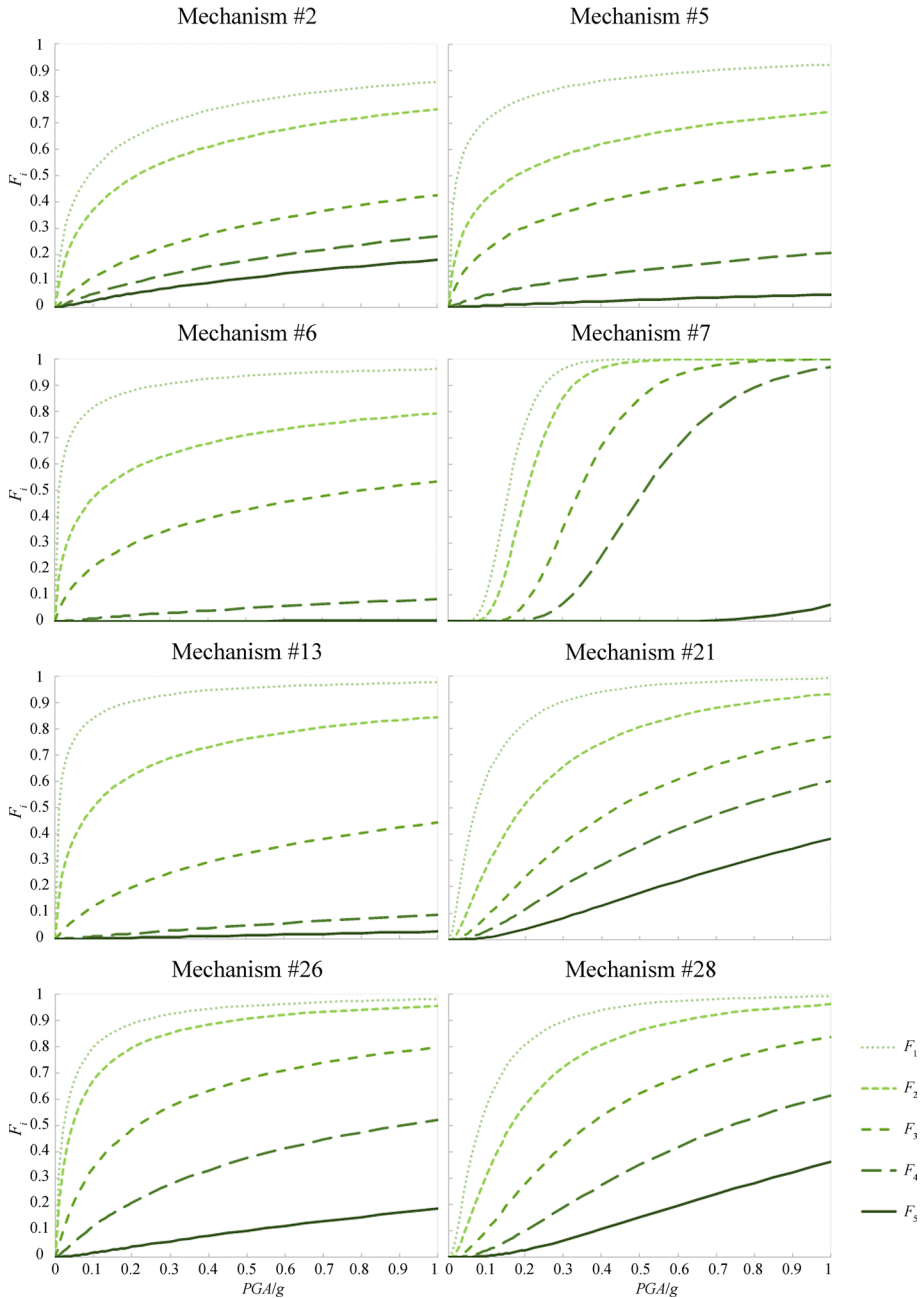
**Fig. 10** Sample parametric fragility curves for a church having the average score of relevant vulnerability modifiers

The proposed procedure delivers tailor-made fragility curves for each church, based on the vulnerability modifiers actually present and on their score. Therefore, the five-damage-levels fragility curves of each possible mechanism need to be computed on a case-by-case approach, as shown in a worked-out example in the Appendix. Sample fragility curves related to eight mechanisms are presented in Fig. 10. These mechanisms are among the most populated (Table 5) and related to several macro-elements, namely: façade, nave (including longitudinal walls and colonnade), triumphal arch, soaring elements, bell tower. The curves of another two mechanisms are shown in the Appendix. The scores assumed for the relevant modifiers are the average values of the churches in the investigated portfolio and are reported in Table 6 for all 21 mechanisms, not just the eight presented in Fig. 10. In the same table the standard deviation of the scores and the frequency of each modifier, scoring more than zero, for each mechanism are reported as well. Therefore, combining Tables 4 and 6, it is possible to compute the fragility curves for each mechanism, assuming an “average” church. The curves in Fig. 10 differ from mechanism to mechanism under several aspects. First of all, some mechanisms (e.g., #13, 21) are more fragile than others (e.g., #2), encouraging a mechanism rather than a global approach as privileged so far in the literature. Additionally, mechanisms #2, 28 present curves closer one to the other compared to #6, 13, emphasizing that for the former once light damage is activated, heavy damage follows more rapidly. Despite all curves being log-normal by definition, some mechanisms (e.g., #7, 21, 28) present an

evident “S” shape, while others present a very short initial horizontal tail, noticeable if a logarithmic scale is adopted for the horizontal axis. Such shape is customary for large  $\beta$  values compared to  $\mu$  values. It is possible that a future, more populated database will

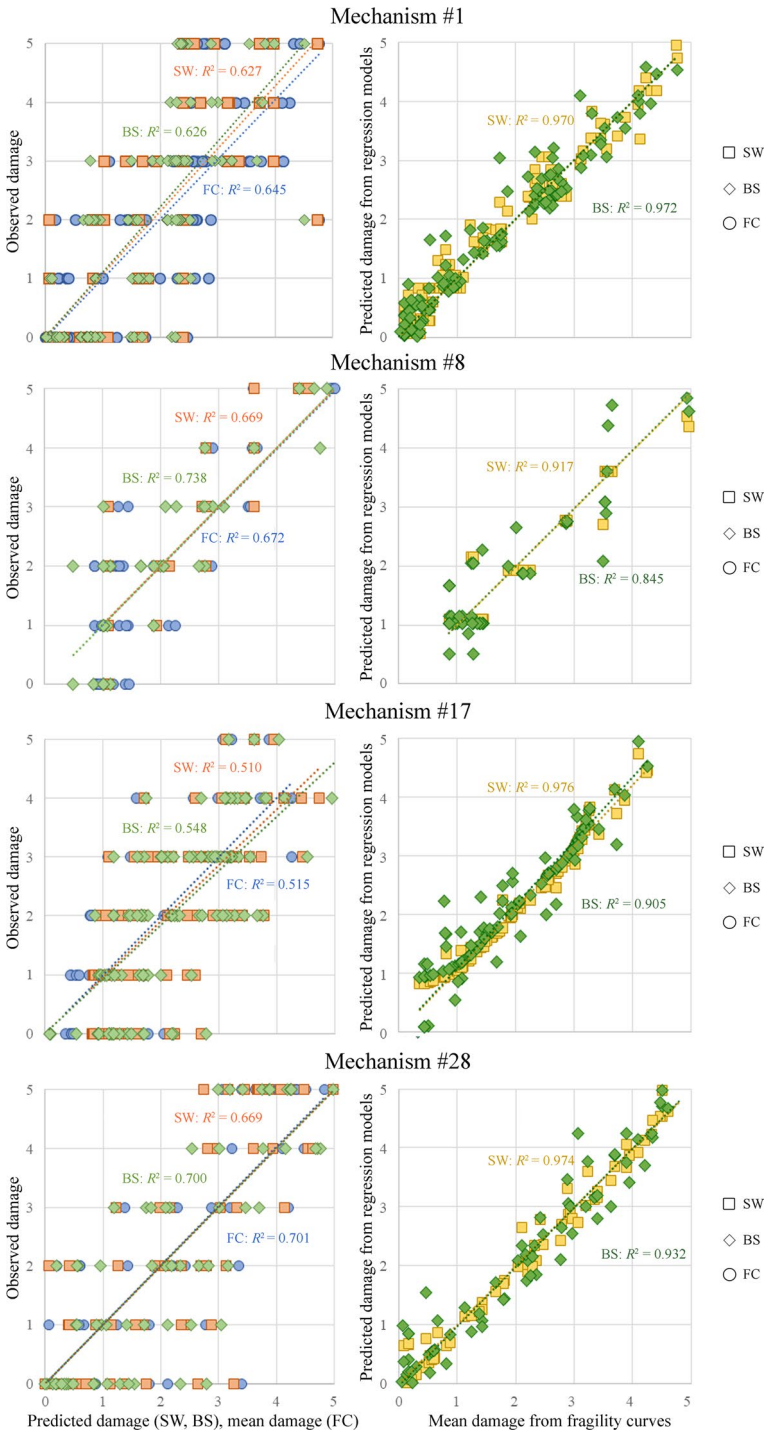
**Fig. 11** Left column: comparison of observed damage with predicted damage from regression models and mean damage from fragility curves; Right column: comparison between predicted damage from regression models and mean damage from fragility curves. SW = *stepwise* regression; BS = *best subsets* regression; FC = fragility curves

In all mechanisms a good correlation and a coefficient of determination  $R^2$  equal to or greater than 0.5 are found. On the left of Fig. 11 comparisons related to four mechanisms, among the most populated and corresponding to different macro-elements (namely: façade, nave, apse, bell tower) are shown. Performance of regression models and fragility curves in reproducing observed damage is similar. In fact, the comparisons between predicted damage of regression models and mean damage of fragility curves show a noteworthy correlation, with values of  $R^2$  in all cases larger than 0.8 and in most cases larger than 0.9 (right of Fig. 11).

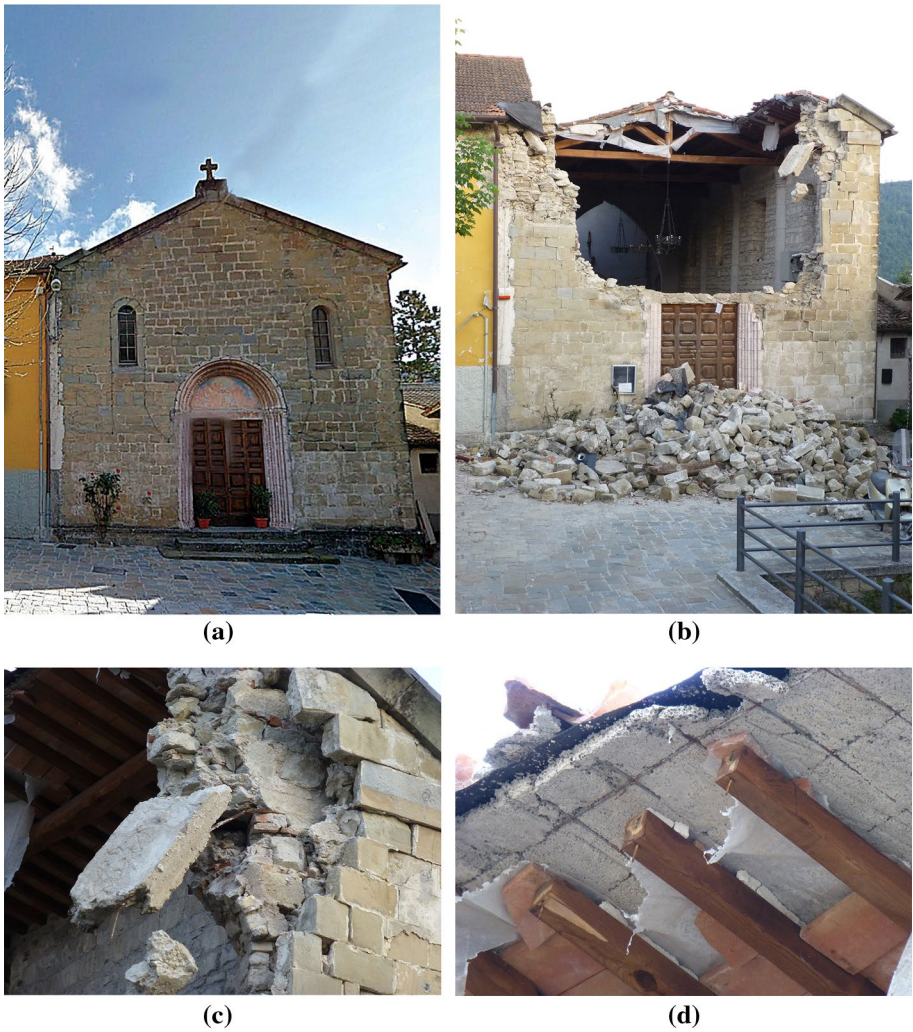
**Fig. 12** Worked-out example church: **a** external view before the 2016 earthquakes (source: <http://www.chiesadirieti.it/>); **b** external view after the August 24, 2016 shock; **c** close up of the façade masonry section and ring beam; **d** close up of the nave roof

In Table 7 an overview of the modifier attribution is reported, varying between 0 and 1 depending on the presence and effectiveness of vulnerability increasers and earthquake-resistant elements. For the sake of conciseness, only some modifiers are discussed in detail. Since the façade does not present buttresses whatsoever, a zero score is attributed to the corresponding modifiers of mechanism #1. Likewise, the absence of tie rods implies a zero score for the same mechanism, whereas the presence of an undersized ring beam leads to a 0.67 score assigned to mechanism #3. A unity score is introduced to account for the poor masonry quality, because the church is made of undressed natural stone units with an external regular facing and an inner core of rubble masonry.

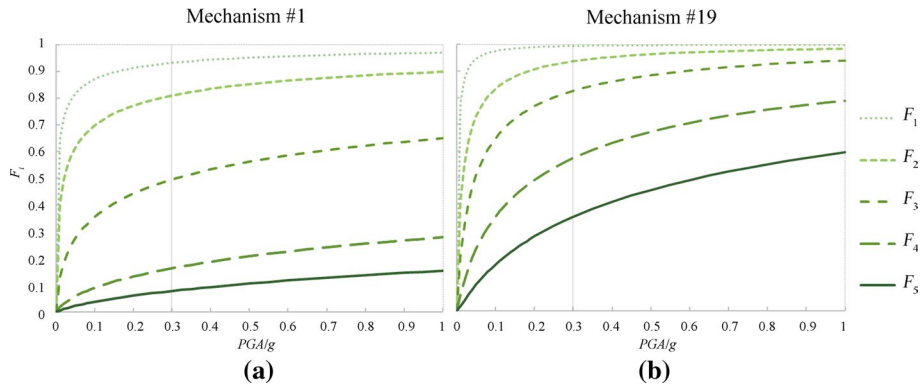
**Fig. 13** Fragility curves of mechanisms #1 and 19 of the sample church

The second part of Table 7 shows the parameters of the fragility curves: the values of  $\mu_i$  associated with the different damage levels computed according to Eq. (6), the probabilities to reach each damage level  $i$  given  $PGA/g$  according to Eq. (4a–c), the mean damage  $D_m$  derived from fragility curves according to Eq. (11) and the damage  $d$  observed after the August 24, 2016 shock. The good agreement between  $D_m$  and  $d$  can be noticed. In Fig. 13, fragility curves of two mechanisms of the sample church are shown. An example of the effect produced on the set of fragility curves by the modifier  $x_{13}$ , related to the poor masonry quality, is shown in Fig. 14.

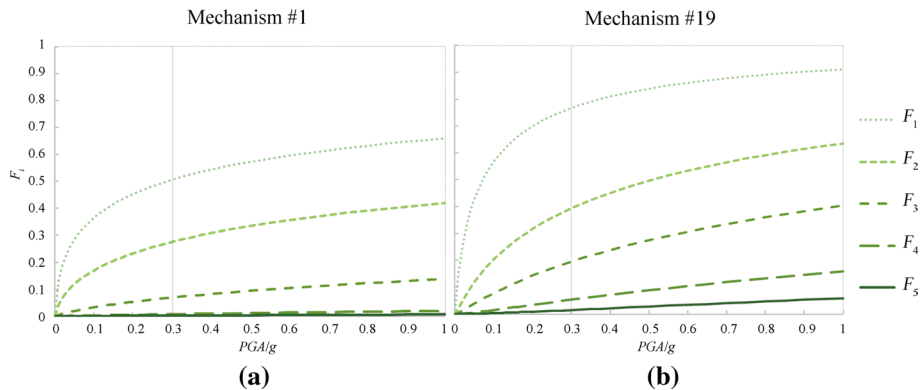
**Fig. 14** Fragility curves of mechanisms #1 and 19 of the sample church in case of good masonry quality ( $x_{13}=0$ )
