Seismic behaviour of rubble masonry: Shake table test and numerical modelling

Abstract

DEM modelling, experimental test, FEM-DEM modelling, fragmentation, motion camera tracking, out-of-plane behaviour

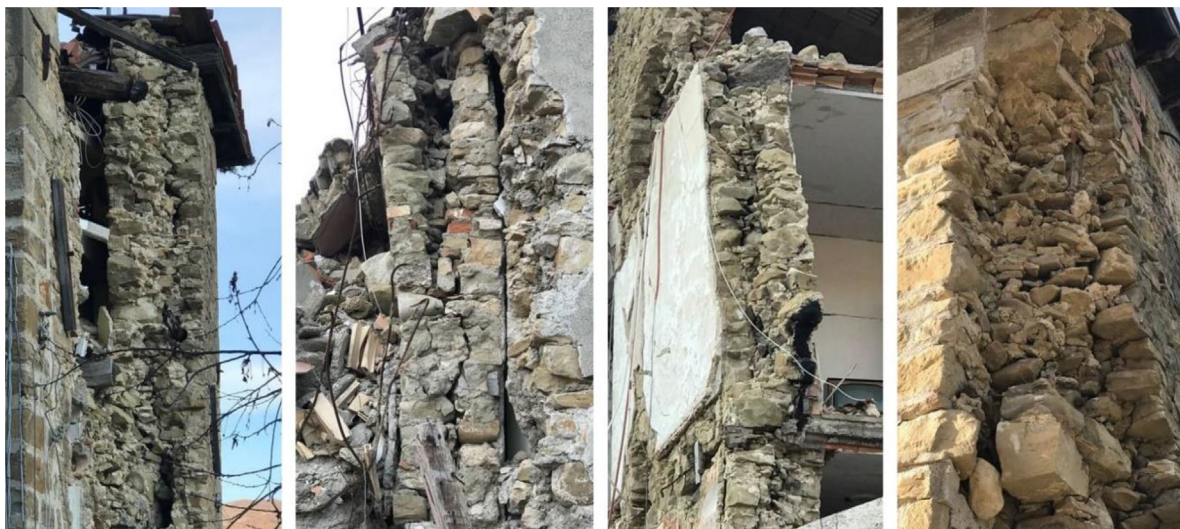
FIGURE 1 Wall sections and seismic damage after the 2016 Central Italy sequence

adequate safety level. Inspections and damage surveys (Figure 1) after the earthquake sequence showed that the poor performance was not a matter of insufficient in-plane shear or compressive strength. In some cases, the collapse occurred due to out-of-plane rigid-body overturning of the external walls lacking connections to the rest of the building, but in most cases the collapse was triggered by the loss of wall compactness with the external face detaching from the rest of the wall. Such fragmentation of stone masonry was observed also in other countries, such as Greece,¹ Iran,² Nepal,³ New Zealand⁴ and Pakistan.⁵

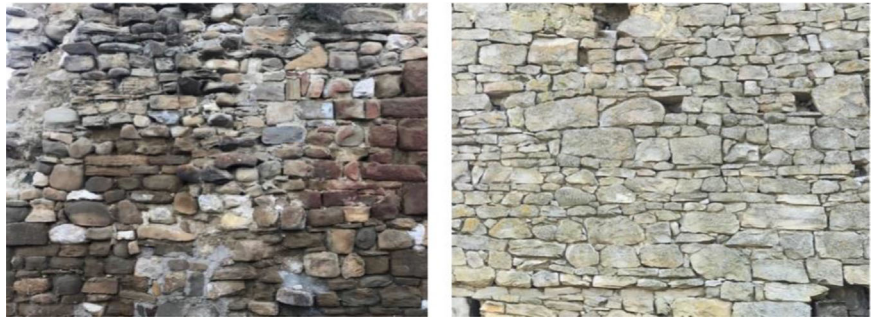
FIGURE 2 Wall fair face of rubble masonry stonework in Central Italy Apennines

As a first step in the design of the prototype, a preliminary survey of typical features of masonry walls in the municipalities of Amatrice and Accumoli and in the surrounding villages was carried out. The severe damage caused by the 2016 seismic sequence allowed for a detailed survey of stonework from both geometric and mechanical points of view, including typical dimensions of stone units, joint pattern, height and thickness of the walls, aspect ratio and boundary conditions. A total of 21 wall sections were surveyed: the average wall thickness is about 0.55 m and height to thickness ratio of about 7.5. The external masonry leaves systematically lack in connection because the stone units are generally small and undressed, with the internal nucleus made of small size, irregular and poorly cemented units (Figure 1). As for bond pattern, horizontal joints are rarely continuous along the façade and vertical joints are mostly not regularly staggered (Figure 2).

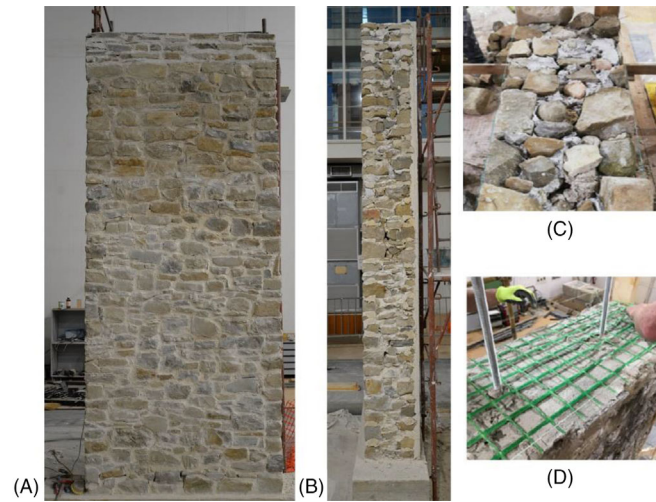
FIGURE 3 Wall specimen: front elevation (A), right side (B), top view of the wall during construction (C), reinforcement mesh placed in the top bed joints and vertical steel bars grouted in the stonework (D)

The wall specimen was built with a thickness of 0.50 m, a height of 3.73 m and a width of 1.63 m (Figure 3A and B), in agreement with common values surveyed in the area. The bond pattern simulates a typical rubble stone fair-face wall, with two external leaves, no bond stones and a central nucleus roughly filled with smaller elements. An ad hoc mortar was designed to reproduce that encountered on site during the post-earthquake inspections. The back of the wall was finished with plaster, to simulate the internal side of a residential building wall. The testing setup is meant to mimic a vertical spanning wall fixed at the base on a foundation beam and restrained at the top by a steel frame simulating a floor connection. Aiming at releasing vertical displacements while preventing horizontal ones, the top restraining steel beams are equipped with low-friction rubber rollers, as it is shown in Figure 4 and described in detail later in the paper.

The wall is built on a reinforced-concrete foundation beam fixed to the shake table by means of two steel profiles and bolts. The upper part of the wall is reinforced with glass fibre reinforced mesh ($66 \text{ mm} \times 66 \text{ mm}$) placed in the last three bed joints for a height of 260 mm, using a natural hydraulic lime mortar with improved mechanical characteristics ($f_m = 6.20 \text{ MPa}$) provided with three vertical steel bars with diameter 20 mm (Figure 3D), grouted for about 0.36 m depth in the wall, to prevent localised damage where the rollers constrain the lateral top displacement of the specimen. The total weight of the wall specimen is about 85 kN.

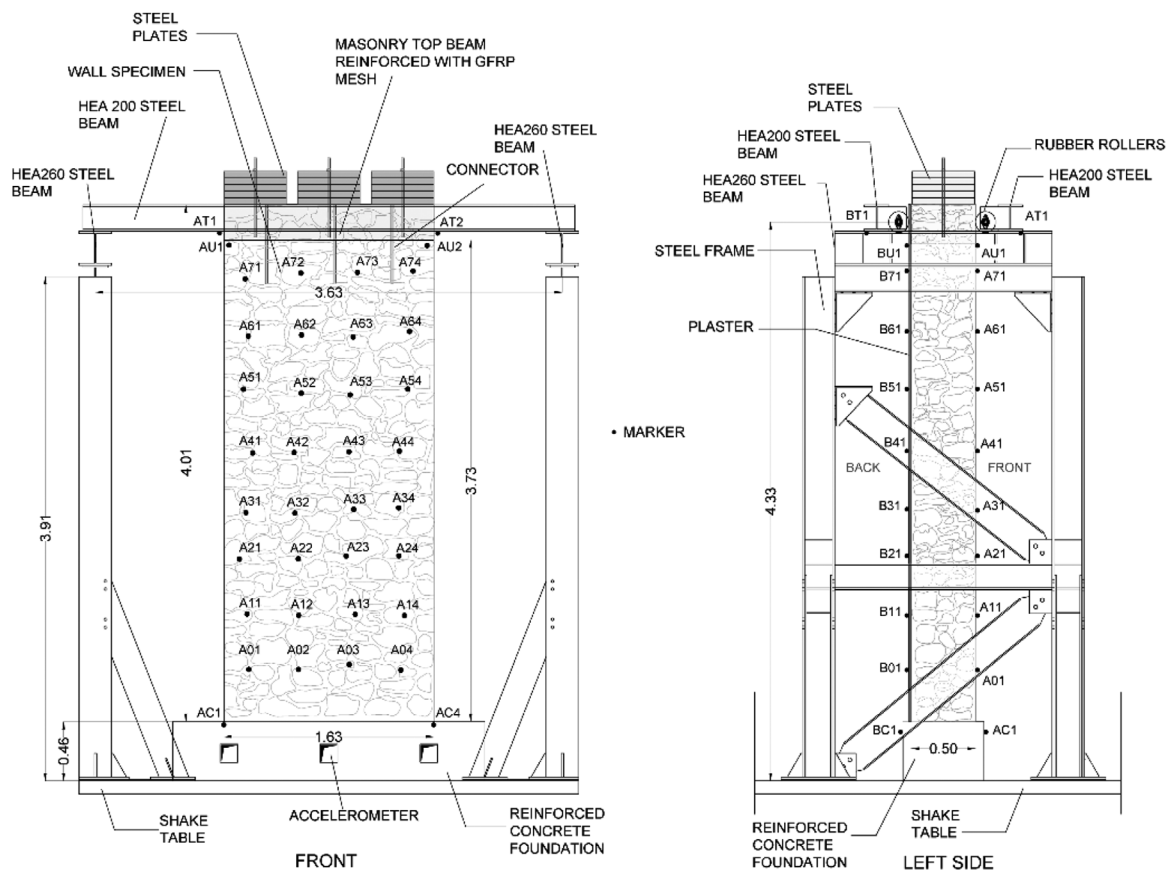
FIGURE 4 Test setup

The tested specimen is restrained at the top by a steel frame fixed to the shake table. The steel structure is made of two braced frames, at the two sides of the specimen, and two girder beams, bolted on top of the frames, on the front and the back side of the wall (Figure 4). Rubber rollers, fixed to the girders, are tightened to the top of the wall, to restrain out-of-plane displacements while releasing vertical displacement and rotation. The setup has proven to be effective to simulate floor restraint²⁷ and is designed to allow the relative displacements between top beam and foundation of the wall as can be expected in historical constructions. The dead load of a typical roof was simulated by 15 steel plates (total weight of 15 kN) placed over the top of the wall and connected by vertical bars to the top beam. The plates and the top beam are secured to the crane bridge by fixing eyebolts at the end of each bar and hanging them at loose wire ropes to prevent their collapse at high intensity shakings, when the wall is expected to fail ruinously below.

the view is switched from front to lateral (Figures 13B and D), letters turn into A and B, indicating that a stone unit is on the front fair-face side (A) or on the back side finished with plaster (B), consistently with the marker identifiers already reported in Figure 4 and adopted throughout the previous sections.

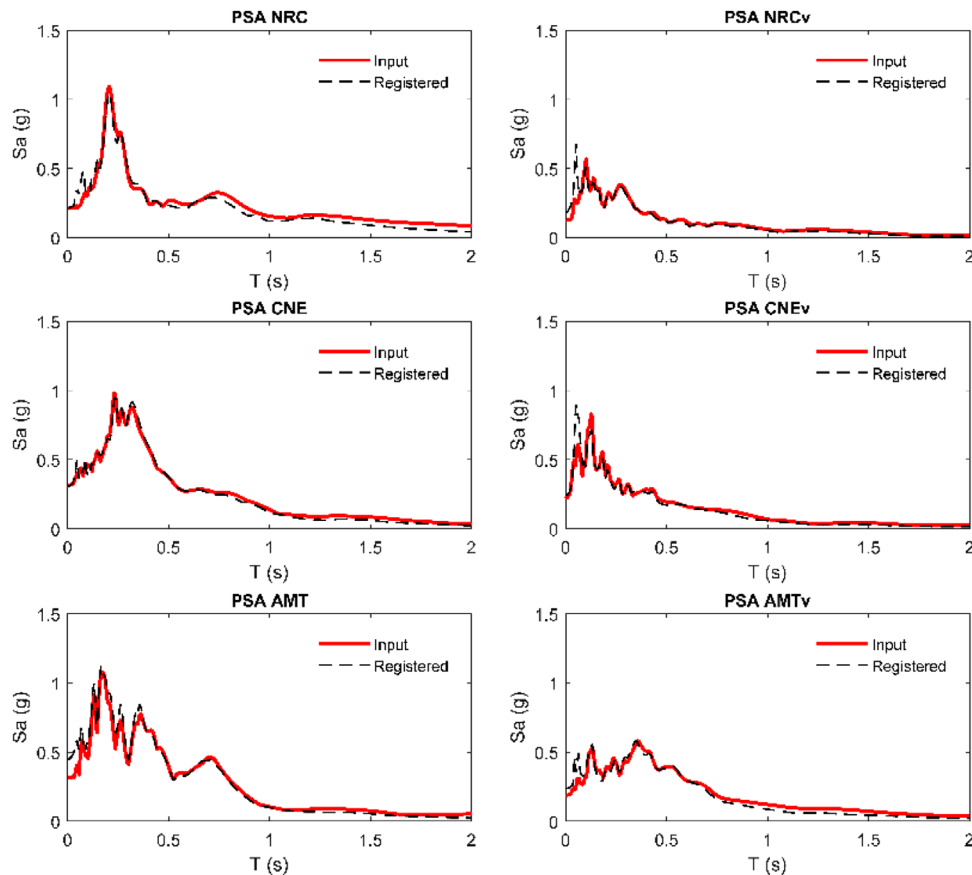
FIGURE 5 Pseudo-acceleration response spectra of the horizontal (left) and vertical (right) components of the input signals and of those recorded on the reinforced concrete foundation at scale factor equal to 0.6

In both models, the stiffness and the block density are left unchanged. Conversely, strength parameters were increased (cohesion c is now equal to 0.18 MPa and tensile strength $f_t = 0.15$ MPa). This choice stems from the mechanical characterisation performed on mortar samples taken during construction. The seismic input is modelled assigning to the foundation and top beam the velocity time histories recorded on the shake table (acceleration input is adopted in case of FEM-DEM simulations). Accounting for the seismic signals experimentally recorded during the tests allows to implicitly consider the real boundary conditions at the top beam, which could play an important role in the response of the wall and the slight variation between the input signal assigned to the table and the recorded ones, as reported in Figure 5.

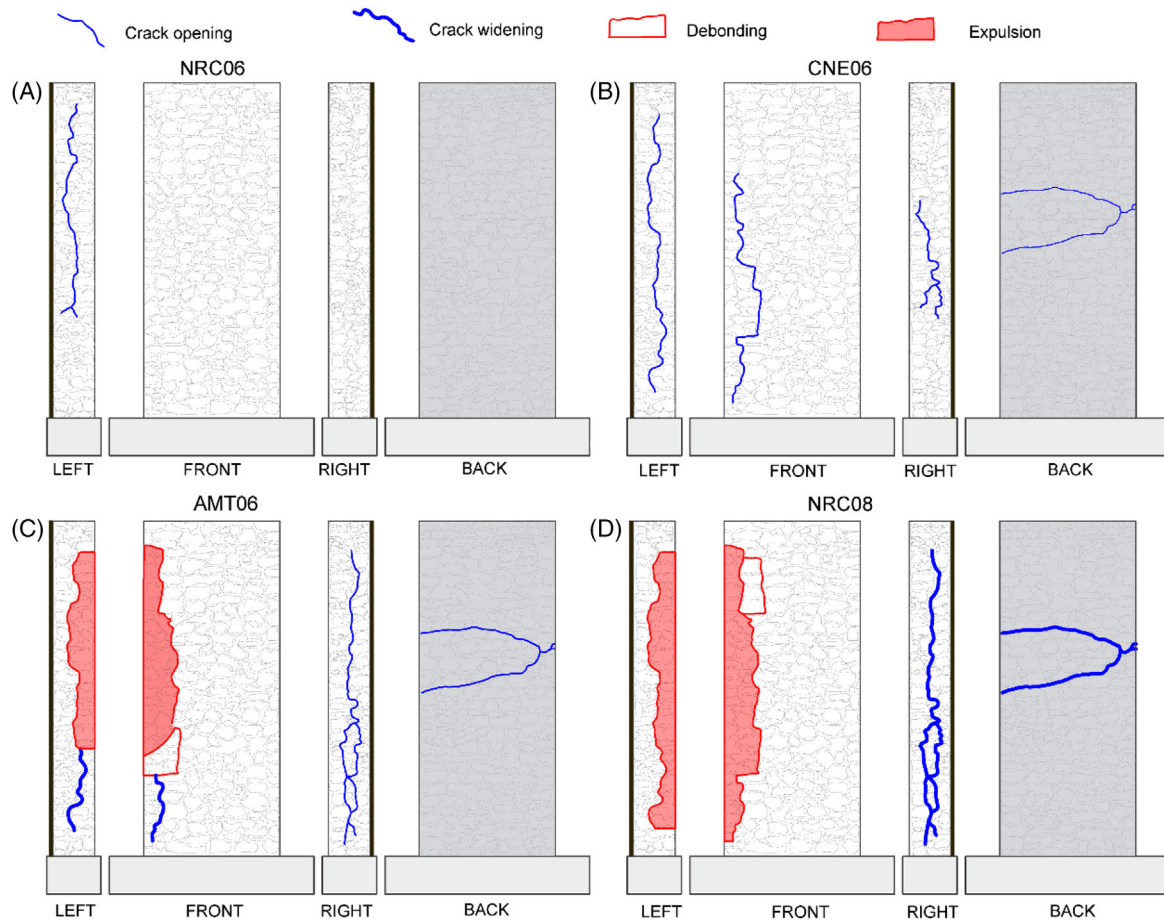
FIGURE 6 Progressive damage development (eye observed)

($a_{h,max} = 0.22$ g) and included the expulsion of dust and small stone fragments from the front side of the wall, near the top left corner and the development of a vertical crack in the middle of the left side, revealing the onset of a local separation between the two wall leaves (Figure 6A). Thin horizontal cracks were also detected on the plaster on the back. It is not surprising that the crack pattern developed even if the maximum acceleration did not monotonically increase, because damage progressively accumulated test after test. Moreover, the maximum base acceleration does not necessarily fully represent the intensity of an earthquake in terms of structural demand. Going forward, the cracks widened during CNE06 on both wall sides. Those on the front side extended and, at this stage, involved most of its height; furthermore, some stone units near the top left corner appeared detached from the surrounding ones (Figure 6B).

The width and length of the vertical crack on the left side also increased, indicating the progress of leaf separation. A first partial collapse occurred during AMT06 ($a_{h,max} = 0.45$ g), involving the stone units of the front leaf from about 1 m height to the top (Figure 6C). Further stone units fell down from the same corner during NRC08 ($a_{h,max} = 0.29$ g), whereas, despite a widening of the cracks on the plaster, no failure took place on the back side (Figure 6D). The wall collapsed completely during CNE08 ($a_{h,max} = 0.42$ g). The front leaf separated from the back one, suffered the formation of a horizontal crack along its entire width at about 3/4 of the height, and then collapsed with a two-block out-of-plane bending mechanism, associated with the fragmentation of the masonry (Figure 7A–C). As a consequence, the back leaf remained isolated as a slender single-leaf wall, and, eventually, collapsed as well (Figure 7D–F). The progressive separation of the two leaves of the wall was monitored by calculating the relative displacement (δ) between the markers near the corners on the front side and the corresponding ones on the back side. The relative displacement between three couples of markers on the left corner, namely A41–B41, A51–B51 and A61–B61 (A), as well as between three on the right corner, namely A44–B44, A54–B54 and A64–B64 (B) is portrayed in Figure 8. Positive values of δ indicate that the corresponding markers were moving apart, whereas negative values indicate that they were moving closer. The values recorded during all the strong motion tests are plotted in sequence to identify the leaf separation occurring during each test and its residual value progressively developing test after test. The first three strong motion tests with SF = 0.2 are omitted because no leaf

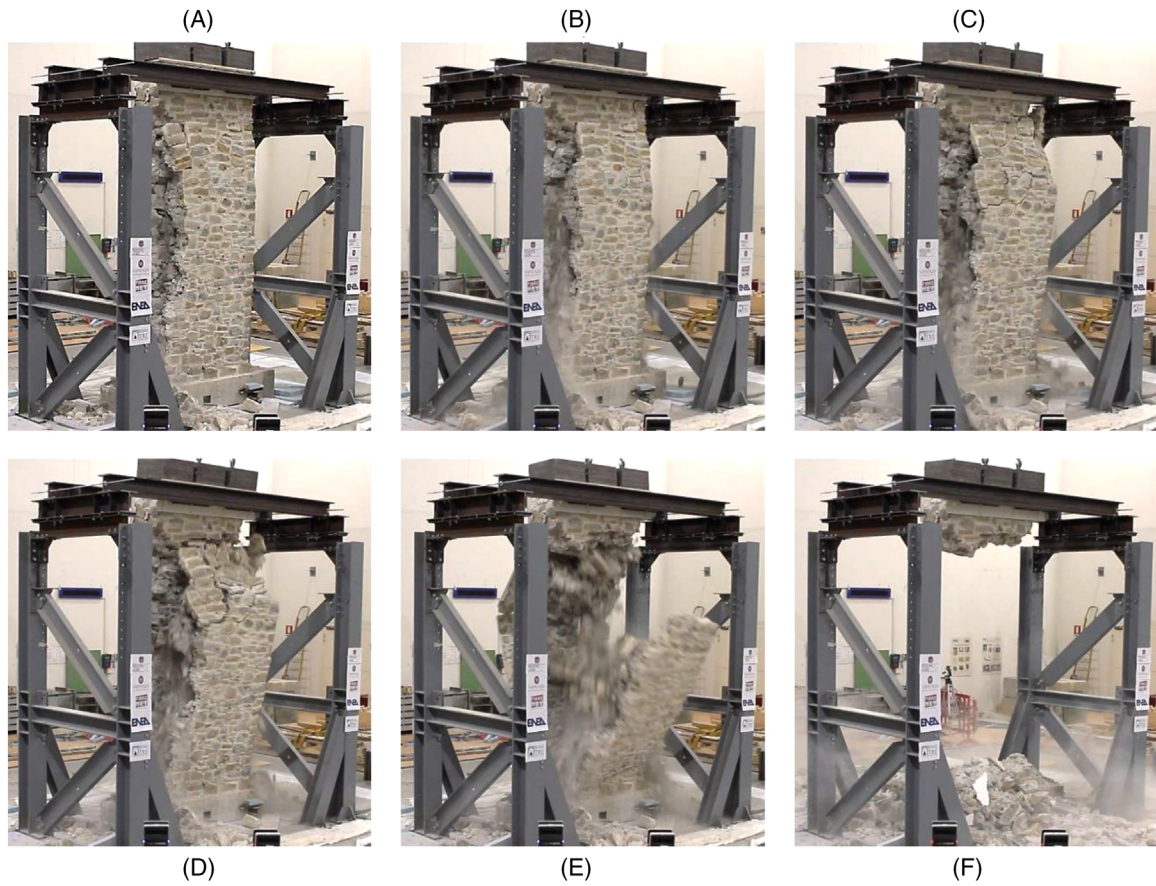
FIGURE 7 Failure mode

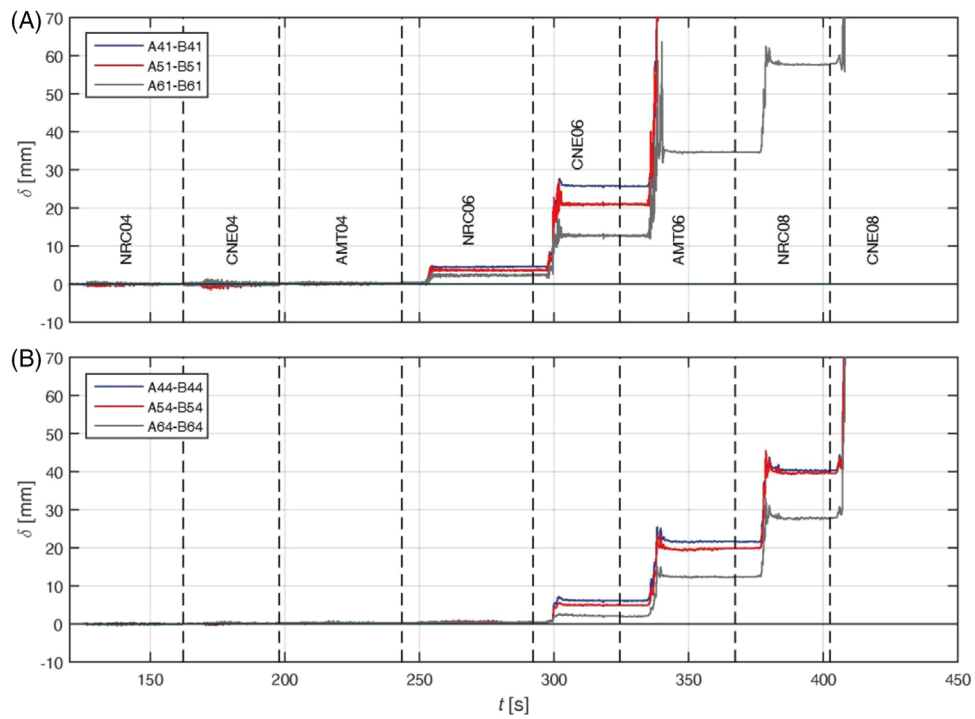
FIGURE 8 Progressive leaf separation at the left (A) and right (B) corners of the wall

separation took place and, for this reason, the time (t) on the x -axis starts at 120 s. The curves show the occurrence of a non-negligible leaf separation from NRC06 on the left side (residual displacements of 2–5 mm) and from CNE06 on the right side (2–6 mm), progressively increasing in the following tests. Large jumps of δ are associated with crack occurrence (due to the brittle nature of the mortar), whereas final values at test end are associated with residual crack width. Such residual values are larger on the left (2–5 mm after NRC06, 13–26 mm after CNE06, 35 mm after AMT06 and 58 mm after NRC08) than on the right (3–6 mm after CNE06, 12–22 mm after AMT06 and 28–40 mm after NRC08). The largest values of δ were recorded at $z = 2.09$ m (A41–B41 and A44–B44), consistently with the crack pattern displayed in Figure 6. Note that for A41–B41 and A51–B51 data are unavailable after AMT06 due to the collapse of the stone units from the corner.

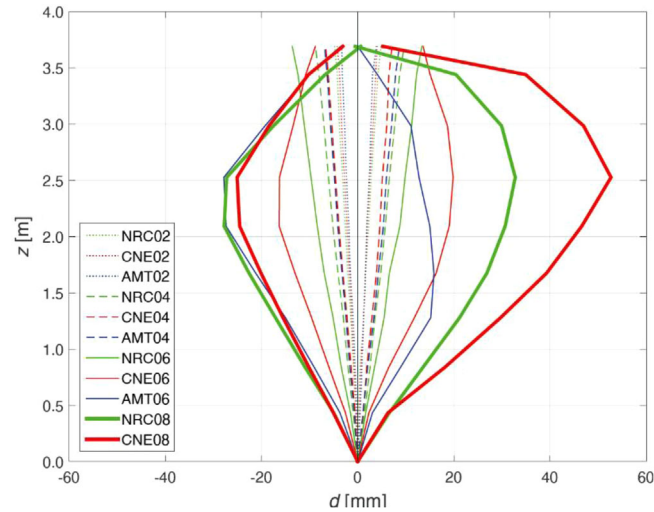
FIGURE 9 Displacement profiles

The profiles of the out-of-plane displacements of the wall (d) were derived starting from the data of the markers placed on the front and back sides, averaging those at the same height as shown in Figure 9 for all the strong motion tests. They are calculated in the time instants when d_A and d_B were attained, respectively (each profile provides a picture of one specific time instant, those of the front and of the back do not coincide). In the first tests, when no significant damage developed, the profiles are basically linear with a rotation at the base of the wall.

On top, as expected, the restraining system prevented the out-of-plane overturning of the wall but allowed for some horizontal displacements (vertical displacements and rotations, instead, were free). Such top horizontal displacements increased from 3–4 mm in the first tests ($SF = 0.2$), to 7–9 mm ($SF = 0.4$) and to 8–13 mm ($SF = 0.6, 0.8$), with negligible differences between front and back sides. From AMT06, the onset of a failure mechanism is clearly detectable, as the profiles exhibit their larger displacements at mid-height, where the horizontal cracks formed. Masonry fragmentation took place after the attainment of d_A and d_B and, therefore, did not affect the portrayed displacement profiles until NRC08 whereas, for CNE08, a time instant was selected before collapse. Finally, it is worth noting that, especially in the last three tests, the displacements of the front side were larger than those of the back one, due to the plaster layer applied to the latter.

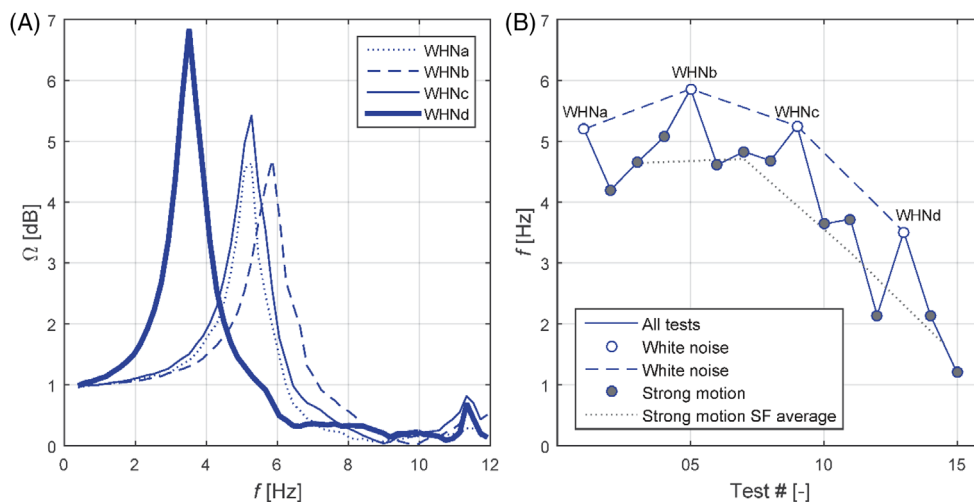
FIGURE 11 Transfer functions for seismic tests under white noise (A) and variation of the fundamental frequency during the entire test sequence (B)

The transfer functions calculated in WHN tests are plotted in Figure 11A. The fundamental frequency f is determined as that corresponding to the main peak of $\Omega(f)$. The frequencies for all the shake table tests are shown in Figure 11B. At the beginning, for the undamaged wall, f resulted equal to 5.20 Hz (WHNa) and decreased to $f = 1.20$ Hz for CNE08. It is

worth making some remarks on the variation of f . First, it results higher in WHN tests than in strong motion ones, due to the smaller acceleration and displacement amplitudes. This behaviour is consistent with that of a non-linear system whose frequency is higher for small oscillations. Second, the increase of the frequency after AMT02 (compare WHNb, $f = 5.86$ Hz, with WHNa, $f = 5.20$ Hz) was due to the modification of the restraint system. Finally, the non-linearity of the structural response and the different amplitude and energy content of the seismic inputs, actually affected the values of f , which even increased in some cases from one test to the following one. The overall trend is however well represented by the values of f averaged over each set of tests with the same SF (4.6, 4.7, 3.2 and 1.7 Hz), which starts decreasing after the end of the second sequence (with SF = 0.4), consistently with the trend shown by the dissipated energy in Figure 10B.

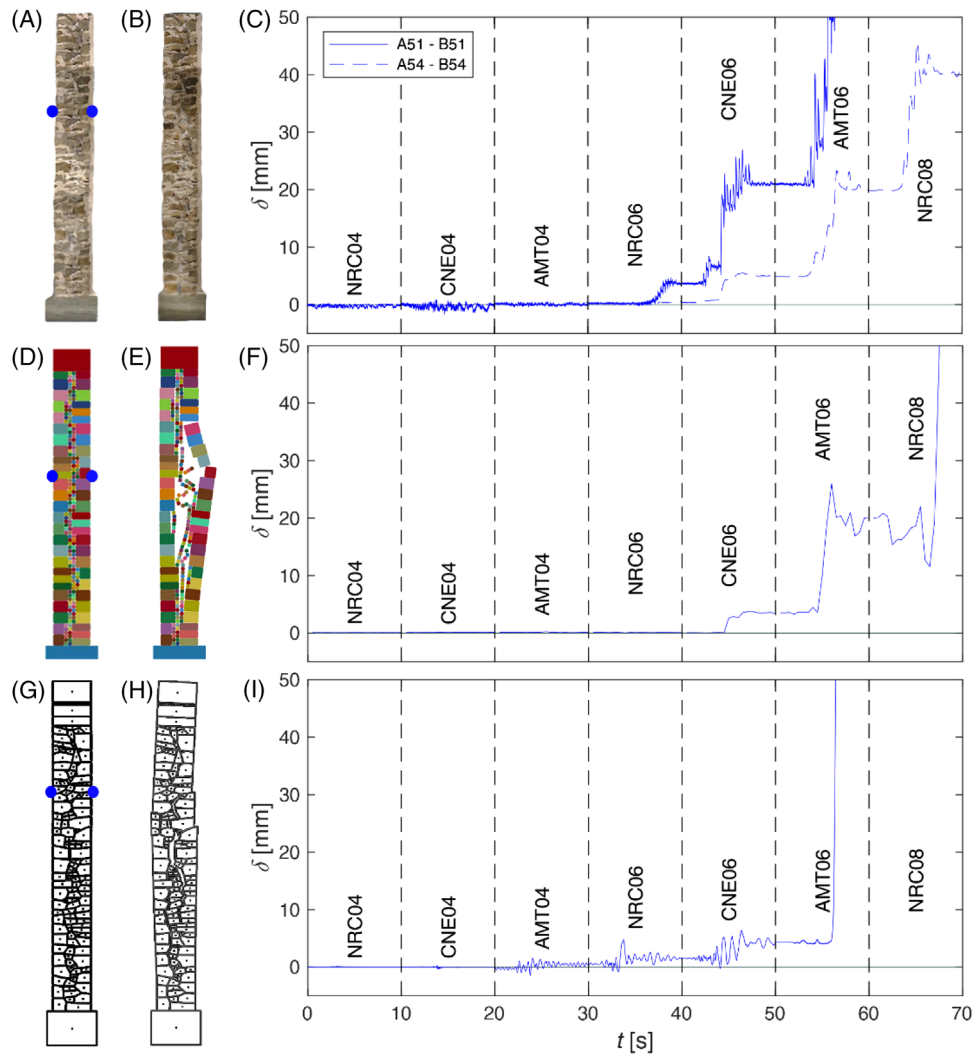
FIGURE 12 Experimental (C) and numerical (F,I) time histories of the leaf separation at selected point locations (A,D,G) up to collapse (B,E,H). (D–F) FEM-DEM; (G–I) DEM. DEM, discrete element method; FEM, finite element method

The experimental and numerical results are shown in Figure 12. The undeformed experimental, FEM-DEM and DEM configurations are reported in Figure 12A, D and G, respectively. These pictograms also report the location of A and B points on the front and back sides, respectively, whose displacement was monitored either experimentally (these points correspond to the location of two markers on the left, A51 and B51, and right sides, A54 and B54) and numerically (two points at the same height of the fifth markers row), calculating the relative value plotted on the right (Figure 12C, F and I). The progressive leaf separation (δ) is plotted starting from SF = 0.4 up to failure. This choice is motivated by the fact that prior to that series of signals the behaviour of the wall remained essentially in the elastic range. The experimental response, as commented in the previous section, exhibits a different evolution of the crack pattern on the two sides of the wall, reflected in the fact that, looking at the first column of markers, collapse is attained at the AMT06 signal, while referring to the fourth column of markers, closer to the right side of the wall, a higher seismic capacity is attained prior to failure (occurred during the NRC08 event).

It can be observed that during the experiments, the two faces of the wall experienced very little relative displacement during the first series of shakings, with some pounding and inner core crushing during NRC04 and CNE04 tests, leading to some oscillation of the δ time history as reported in Figure 12C. The FEM-DEM model is not significantly sensitive to these small excitations and this behaviour might be ascribed to the relatively regular pattern that characterises the mesh, to which also a prevalence of shear sliding mechanism on the horizontal planes could be related. The DEM model, on the contrary, despite a shift to the AMT04 signal, shows comparable small δ perturbations, most probably because of the more irregular discretisation. Looking at the time histories reported in Figures 12F and I it is possible to observe how the two

numerical models essentially agree in terms of relative cumulative displacement under the CNE06 signal, which is also in line with the experimental evidence on the right side of the specimen. Differently from the FEM-DEM model, which shows an additional capacity and fails under NRC08 signal, the DEM model rapidly attains collapse during the AMT06 test, and this resembles what experienced on the left corner of the wall. The overall behaviour depicted by the results of the FEM-DEM simulations, however, seems to be consistent with the A54-B54 relative displacement time history. Figure 12B, E and H report the failure configuration, that is the last converged step in case of numerical simulations, which are both characterised by separation of the two leaves and, in case of the FEM-DEM simulations, by a more marked out-of-plane flexural mechanism involving the external front leaf.

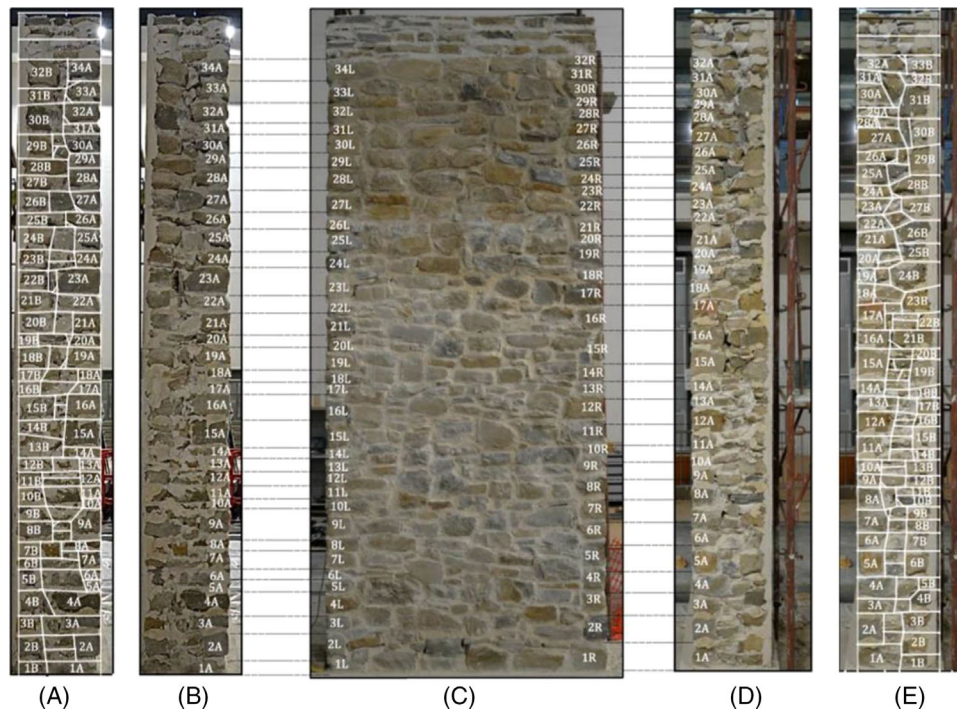
FIGURE 13 Discrete element method (DEM) geometric micro-modelling discretisation

The process of definition of the geometry for the left (A) and right (E) side of the specimen is presented in Figure 13. In detail, stone units were first identified on the front side of the wall (C), then labelled with a number denoting the course and ascending from bottom to top and a letter indicating whether a unit is placed on the left (L) or right (R) side. When

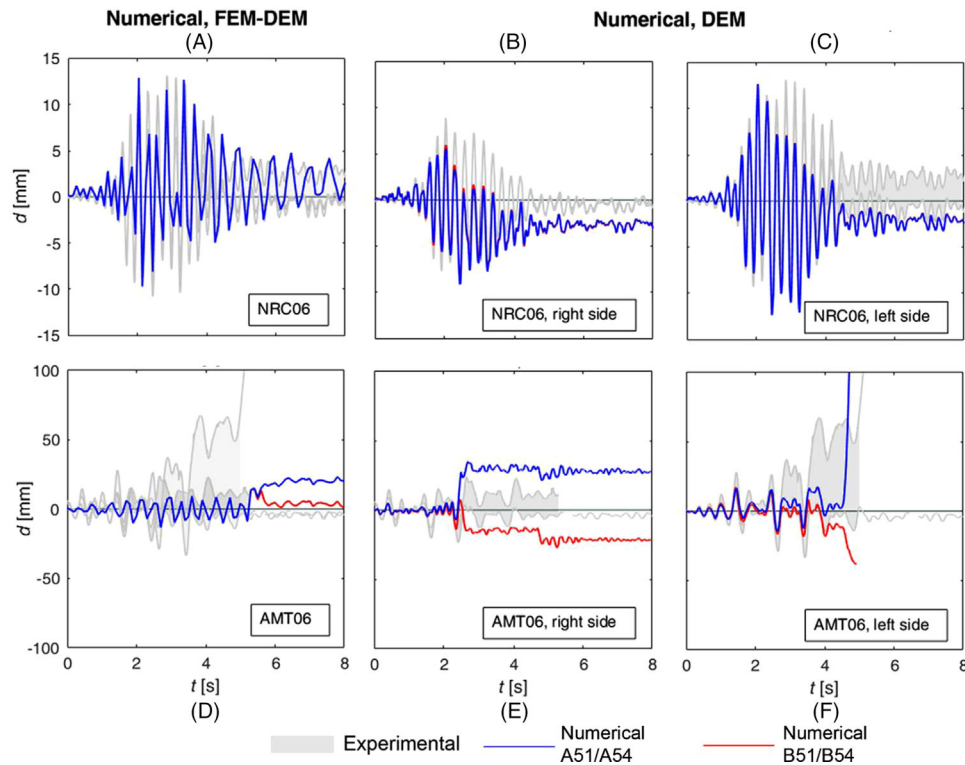
FIGURE 15 Numerical and experimental displacement histories at markers A51, B51 (left side) and A54, B54 (right side)

Figure 15 summarises the most representative results in terms of displacement on the front (A marker) and back (B marker) side of the wall at the sixth marker row height. The experimental time histories, plotted in gray, are compared with those of two selected points on the FEM-DEM (Figures 15A and D) for the NRC06 and AMT06 signals, respectively, while, having performed two different DEM analyses for the left and right sides, two plots for each signal are reported in this case (Figure 15B, C, E and F). The results are plotted for the SF = 0.6 seismic sequence, the last completed for all three records. It can be observed that the FEM-DEM model under the NRC06 signal (Figure 15A) provides an overestimation of the displacement while correctly replicating the absence of separation between the two leaves. In the DEM model (Figure 15B), a rigid sliding of both leaves without mutual separation is responsible for the shift of the numerical curves in the negative portion of the displacement graph. While for the right side, apart from the shift, the DEM model correctly reproduces the experimental time histories, in the case of the left side (Figure 15C), the model does not replicate the separation that is instead experimentally measured in the second half of this record. Looking at the AMT06 graphs, the FEM-DEM model results show, differently from the experiment, a delayed trigger of the leaf separation process but, on

average, the displacement trend on front and back side seems to be captured. The DEM numerical model captures the local failure mechanism occurring on the left portion of the wall front side, with just a limited delay (Figure 15F). The right side simulation is in fair agreement with the experimental 3DVision measures too (Figure 15E) though, on average, the numerical model provides a 40% higher estimate of the relative displacement between the two selected points.

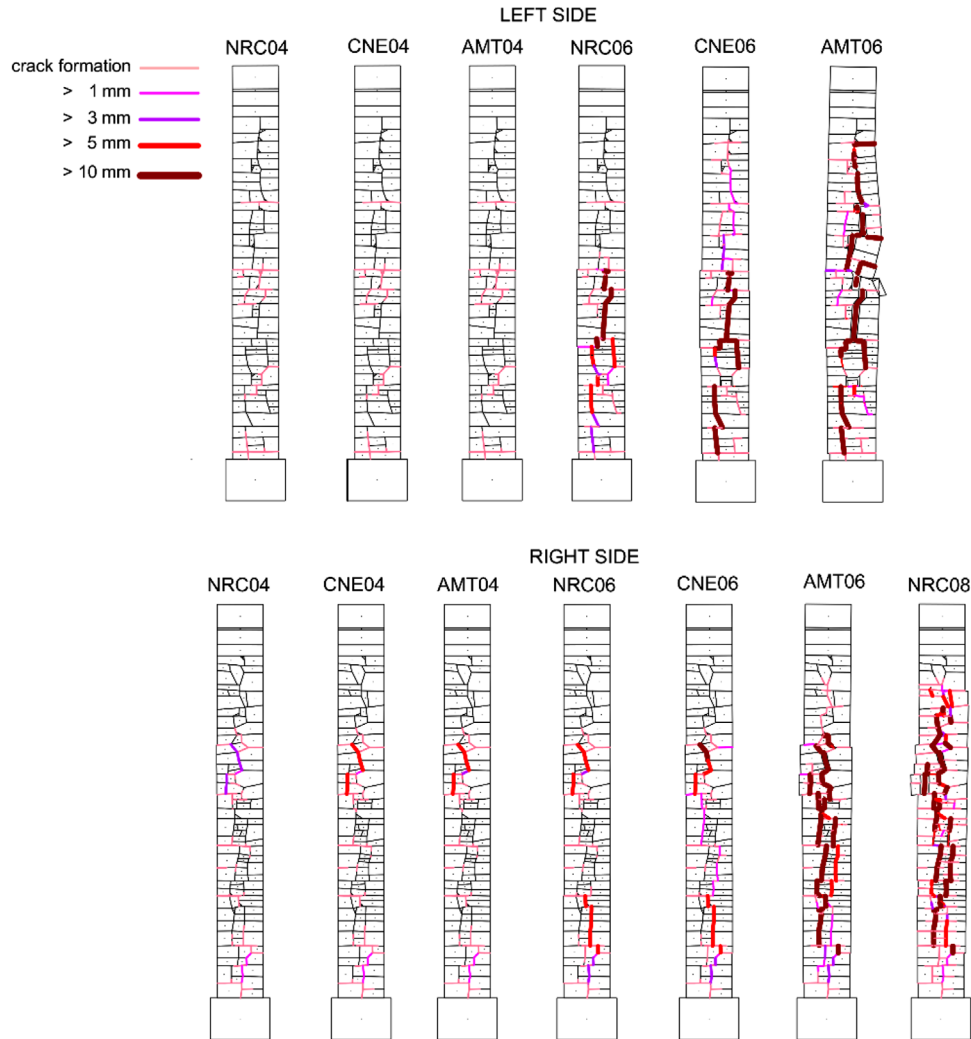
FIGURE 16 Progressive crack opening at the left and the right sides in the discrete element method (DEM) model

The cracking process that the DEM model undergoes during the sequence is portrayed in Figure 16. The combination of thickness and shade changes marks the evolution from early crack formation to significant separation (>10 mm), which is in very good agreement with the experimental damage accumulation observed by eye (Figure 6). On the left side, in fact, the first cracks are visible after the NRC06 test, propagating along the height of the wall and widening until the partial collapse of the front-left edge under the AMT06 test. On the right side, crack formation in the numerical model starts a bit earlier than what experimentally measured, but the final picture obtained from the simulations very faithfully reproduces the detected crack pattern at the end of the last completed test before collapse (NRC08).

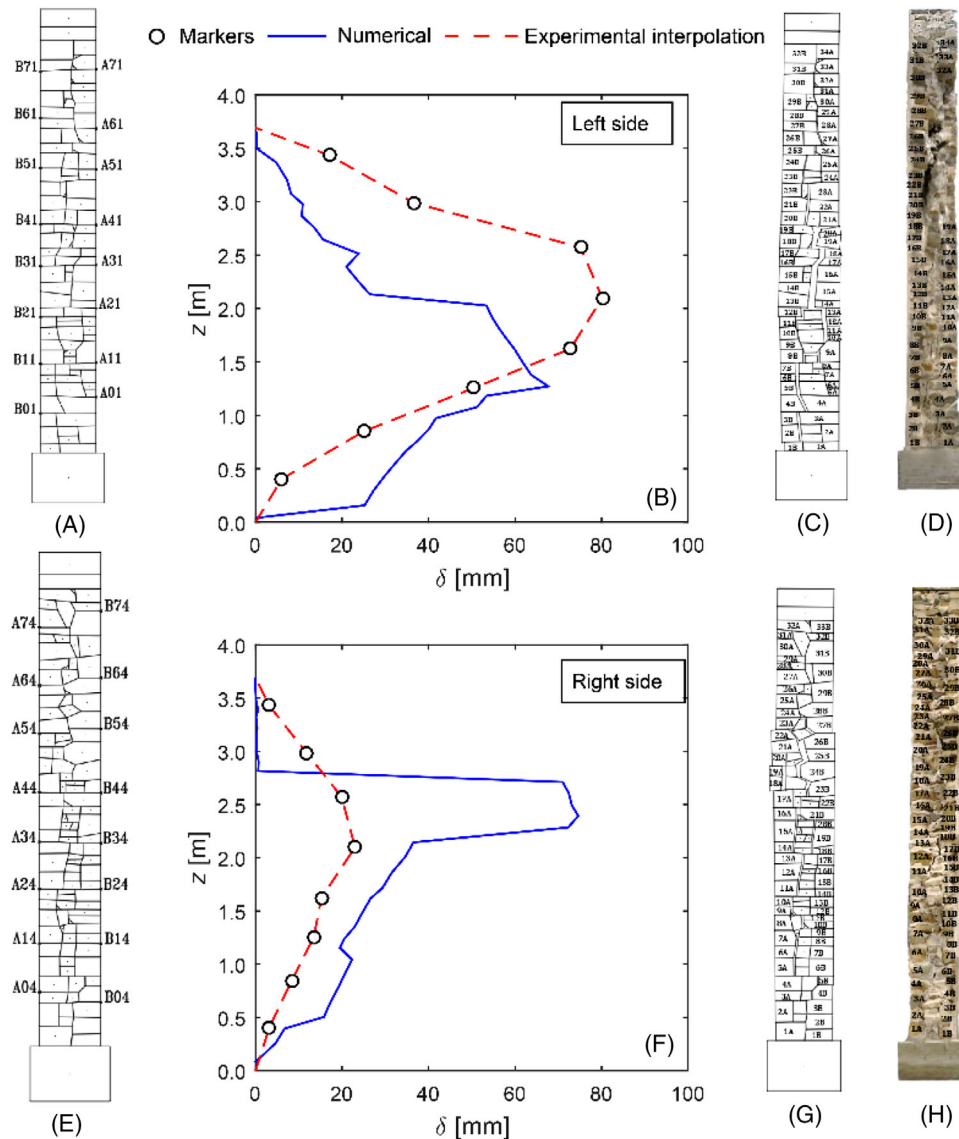
FIGURE 17 Experimental and numerical leaf separation profiles for AMT06 signal. AMT, Amatrice

In order to represent the different behaviour as observed on the left and right sides (and consistently reproduced via the DEM model), leaf separation profiles are plotted in Figures 17B and F, at the time instant of maximum relative displacement between front and back sides along the first and the fourth marker columns and along the wall sections of the model for left and right sides, respectively. Numerically obtained relative displacements are extracted along the height of the wall on n pairs of points on the opposite sides of the specimen (being n the maximum number of rows in the discretisation, i.e. 34 for the left profile and 33 for the right one) while the dashed red lines are obtained interpolating the relative displacements between the eight pairs of equally high markers, whose position is also reported in Figure 17A and E. On the left side, in spite of a slight underestimation of the actual leaf separation, the model is able to account for the formation of the failure mechanism, with the height of the central hinge almost coincident with the experimental one. On the right side, the localised increment of the relative displacement, for a height between 2.0 and 2.7 m, is due to the sliding of the blocks 18A through 22A (Figure 17G). In general, along the height of the right side of the wall, until the localised failure, the numerical model shows larger relative displacements, as already anticipated in Figure 15F) for a specific pair
