5 **An Aggregated Non-destructive Testing (NDT) Framework for the Assessment of**  
6 **Mechanical Properties of Unreinforced Masonry Italian Medieval Churches**

49 Keywords: medieval churches; URM buildings; non-destructive testing (NDT)  
50 techniques; masonry types; masonry mechanical properties; *MQI*; rebound hammer  
51 testing; pulse velocity testing; SonReb technique.

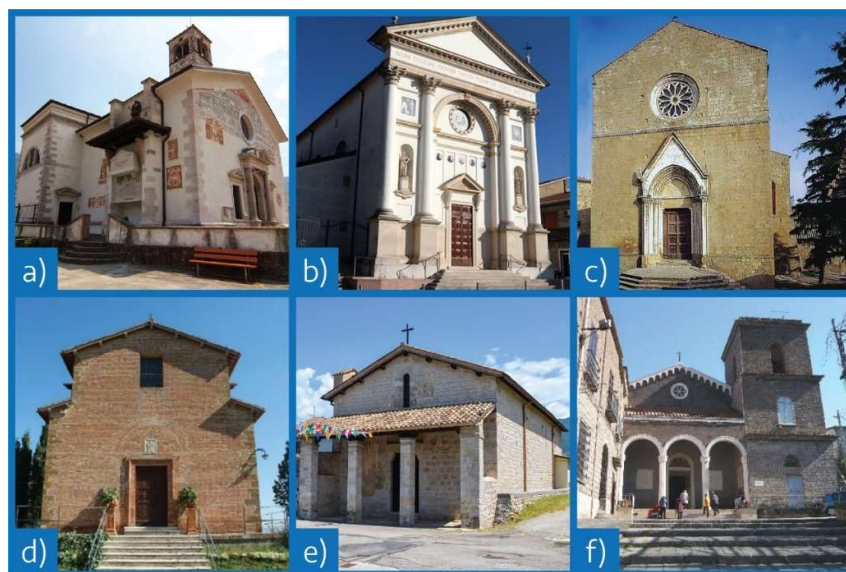
74 *Figure 1 – Prototypical examples of churches surveyed: a) Santa Maria Assunta (Dasindo, Trentino – Alto Adige); b)*  
75 *San Matteo Apostolo (Cavazzale, Veneto); c) Santi Leonardo e Cristoforo (Monticchiello, Toscana); d) Sant'Ansano*  
76 *Martire (Petrignano del Lago, Umbria); e) Maddalena (Alatri, Lazio); f) Santa Maria di Casarlano (Casarlano,*  
77 *Campania).*

71 of Italian architectural heritage was built [5]. Some examples of the prototypical considered churches  
72 considered in the current study are shown in Figure 1.

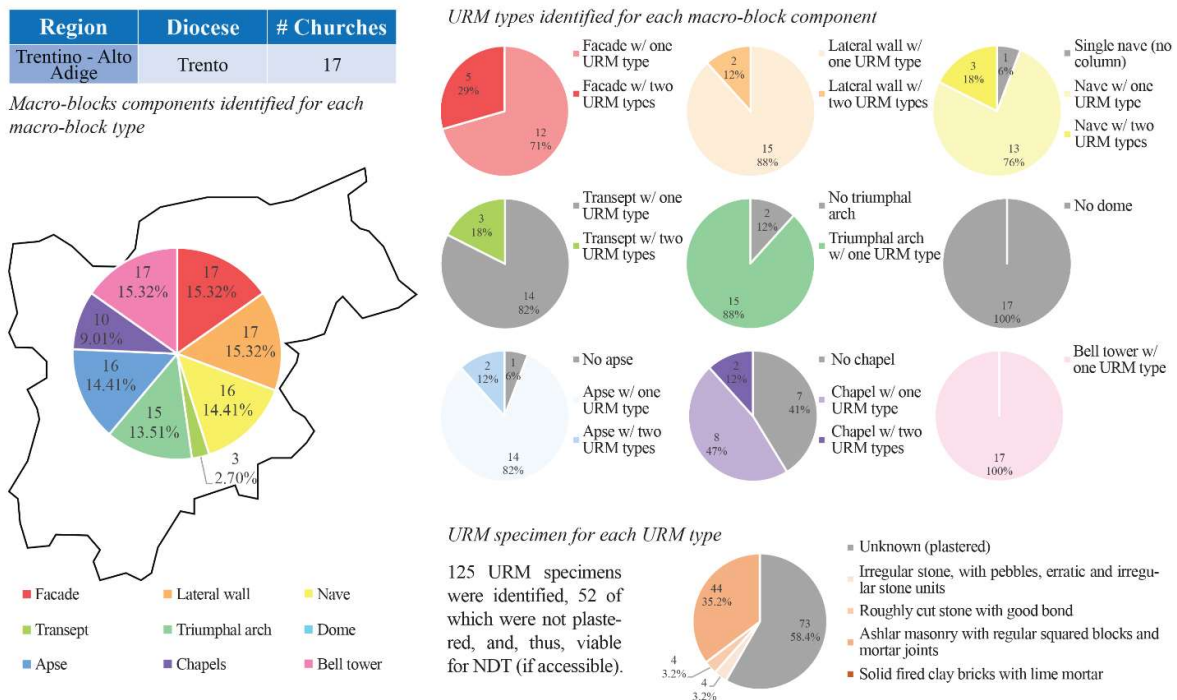
196 *Figure 5 – Region: Trentino – Alto Adige; top left: number of surveyed churches; bottom left: number of macro-blocks*  
 197 *components identified for each macro-block type; top right: number of URM types identified for each macro-block*  
 198 *component; bottom right: number of URM specimen for each URM type.*

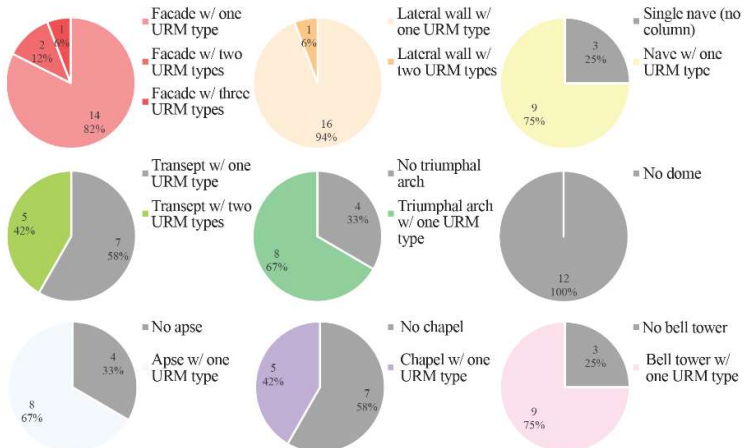
204 Figure 7 – Region: Toscana; top left: number of surveyed churches; bottom left: number of macro-blocks components  
 205 identified for each macro-block type; top right: number of URM types identified for each macro-block component;  
 206 bottom right: number of URM specimen for each URM type.

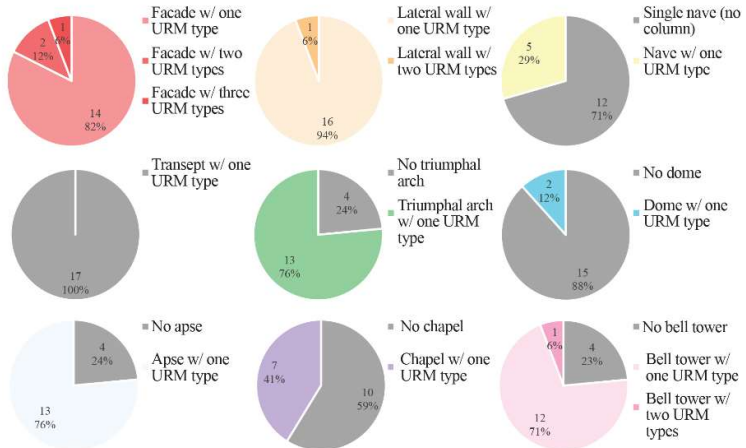
93 URM specimens were identified, 61 of which were not plastered, and, thus, viable for NDT (if accessible).

208 Figure 8 – Region: Umbria; top left: number of surveyed churches; bottom left: number of macro-blocks components  
 209 identified for each macro-block type; top right: number of URM types identified for each macro-block component;  
 210 bottom right: number of URM specimen for each URM type.

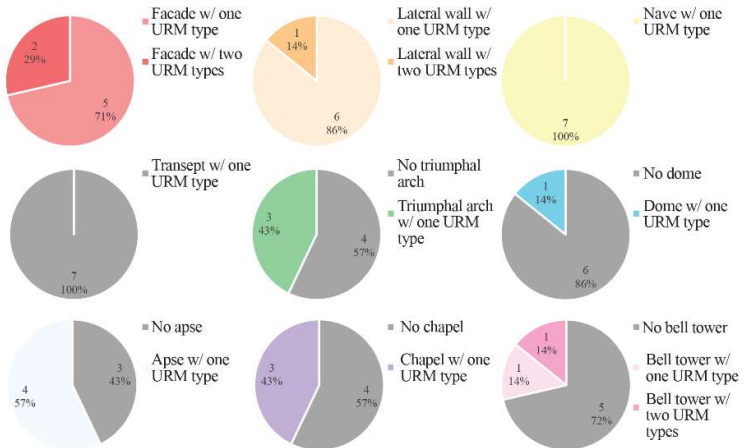
38 URM specimens were identified, 13 of which were not plastered, and, thus, viable for NDT (if accessible).

212 Figure 9 – Region: Lazio; top left: number of surveyed churches; bottom left: number of macro-blocks components  
 213 identified for each macro-block type; top right: number of URM types identified for each macro-block component;  
 214 bottom right: number of URM specimen for each URM type.

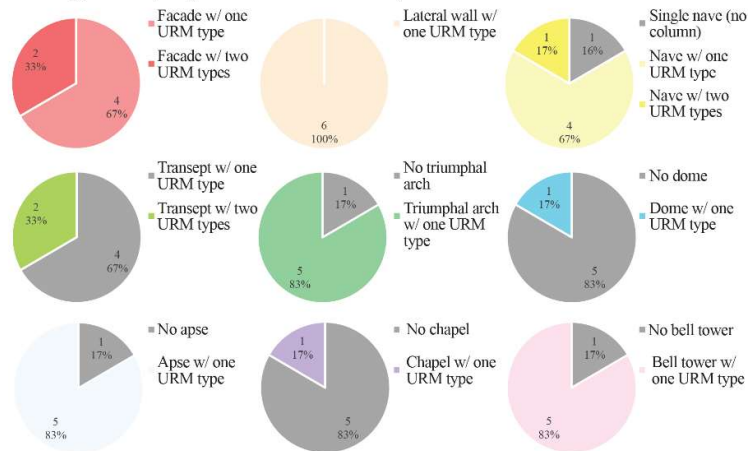
216 Figure 10 – Region: Campania; top left: number of surveyed churches; bottom left: number of macro-blocks components  
 217 identified for each macro-block type; top right: number of URM types identified for each macro-block component;  
 218 bottom right: number of URM specimen for each URM type.

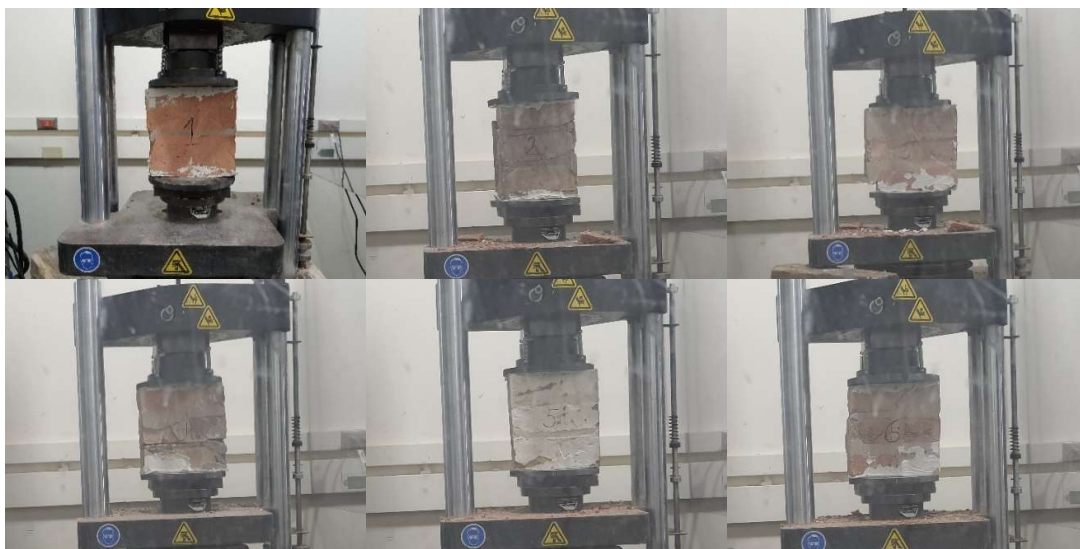
543  
544  
545 Figure 21 – URM prisms extracted from the Dillon Hall.

538 Furthermore, sixteen brick samples and six URM prism samples were extracted from the walls  
539 and tested for compressive strength in the lab using a SATEC universal testing machine (Figure 21),  
540 in accordance with ASTM C67/C67M [51] and ASTM C1314 [62]. The results for the tested  
541 compressive strength of the brick and URM prism samples are given in Table 15 and Table 16,  
542 respectively.

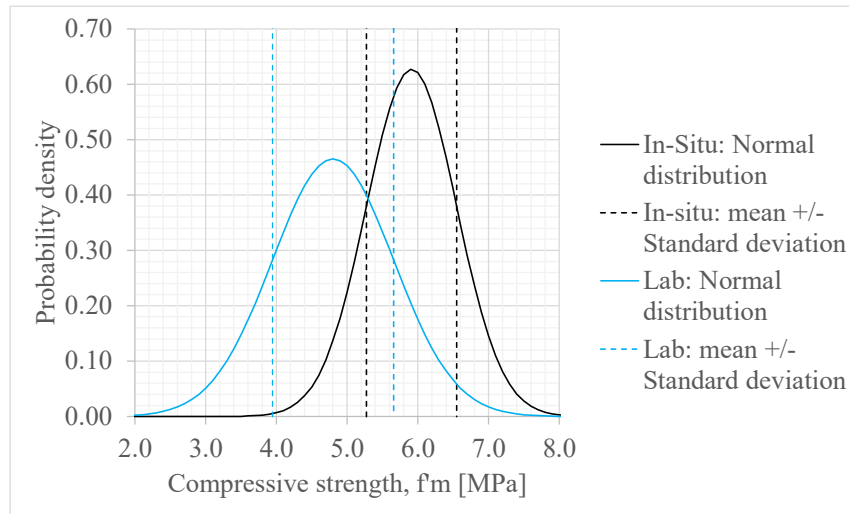
554 *Figure 22 – Normal distribution of the compressive strength,  $f'_m$ , obtained from the sample tested in-situ via aggregated*  
 555 *NDT method, and prism tested in lab via destructive testing.*

548 Finally, the results for the compressive strength,  $f'_m$ , of both the lab-tested URM prisms (via  
549 destructive testing) and the in-situ tested URM samples (via aggregated NDT method) were normally  
550 distributed and compared in Figure 22. It might be noticed that the mean compressive strength  
551 determined in-situ is unconservatively overestimating the mean compressive strength determined for  
552 the lab-tested URM prisms by 23%.
