# What Future for the Skyscraper? A Sustainable Recovery of Rai Building

Emanuele Chiffi<sup>1</sup>, Giuliana Di Mari<sup>1</sup>, Emilia Garda<sup>1</sup>, and Alessandra Renzulli<sup>2</sup>

**Abstract:** The aim of this work is to analyse the recovery methods and strategies of a high-rise steel building, an approach to restoration of the modern that may not always be based on specific standards and pre-established procedures. In the present case, the report raises the topic of the recovery of a structure from the 1960s, a symbol of International Style and Rationalism, commissioned by the State TV and built on the project by Domenico Morelli: the RAI skyscraper in Turin. Since this is a unique work in its design and architectural choices, the approach to a possible recovery begins with a detailed knowledge of the structure, through the analysis of documents, testimonies of the time and the architect's concept. Subsequently, the analysis of the current state of the structure, focuses on the presence of asbestos and methods of remediation of this harmful material. In harmony with the architectural sign, we propose a technological, regulatory and sustainable adaptation, through s

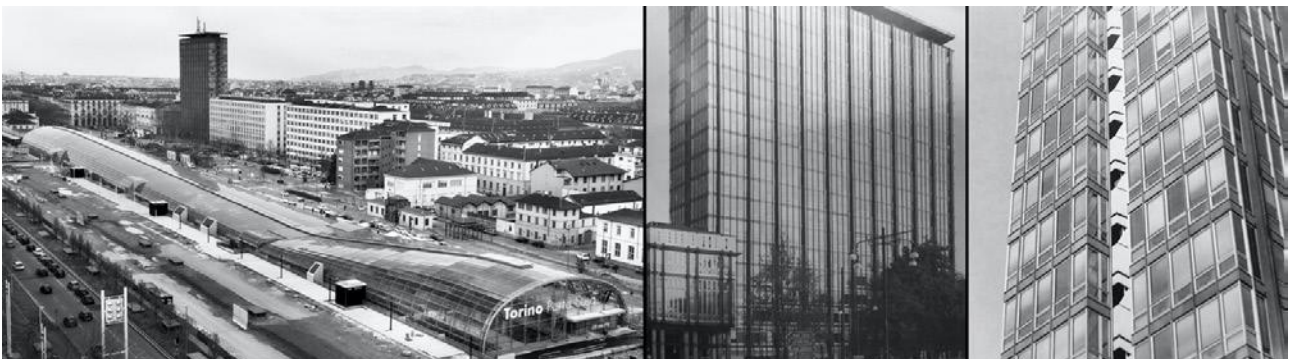
**Fig. 1** Urban context in which rises the Skyscraper Rai. The new Porta Susa Station is identified; vintage photos kept in the personal archives of Domenico Morelli and Tullio Finzi, by Riccardo Moncalvo and Ferdinando Ruffa - © 2020, Reworking of the authors.

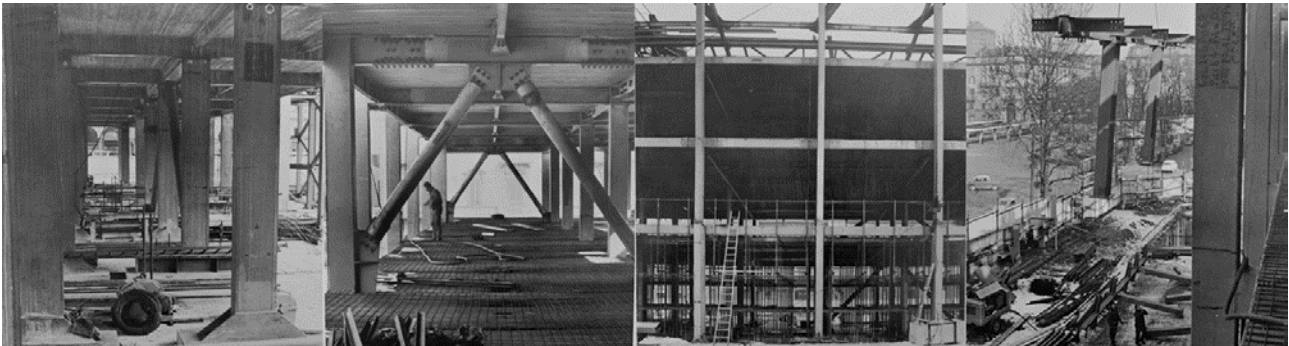
Of the entire building, the skyscraper’s supporting structure, in particular, is an interesting solution from an engineering point of view. The rectangular plan has two lines on the head and a lateral appendix that forms the glass tower of the double flight of stairs. The structural mesh provides a quadruple row of pillars, linked to the transverse beams: 11 vertical frames placed at a distance of 5.00 meters from each other, are bolted to the main and secondary beams; the floor is made of corrugated sheet welded to the secondary beams, with steel mesh and a concrete jet of hot water equal to 4 cm. To absorb the horizontal stresses due to the considerable height, transverse diaphragms and bracing structures were also provided, which absorb the wind thrust from the facades and distribute it to the foundations. At the base of these structures, at the foot of the windward frames, an anchoring system with pre-compression cables has been studied, to ensure the whole structure to the ground and avoid any detachments of the column with the support surface. The internal columns have flanges, welded in the workshop, to which are bolted the main and secondary beams. In the outer node, however, the perimeter beam is set back 16 cm to have the external columns completely exposed: in this way, the connection of the main beams with the pillars is made by bolting through a T-shaped stump welded in the workshop (Fig. 3).

**Fig. 3** In sequence: bases of the columns of the intermediate frames and of the steel skeleton against the wind; detail the diagonals of the brace frames which are in annular sections and which have been assembled by means of bolting in place; front view of the various stages of assembly (assembly, frame, slabs and jet slabs); lifting of the main beam assembled at the foot of the work. Vintage photos kept in the personal archives of Domenico Morelli and Tullio Finzi, by Riccardo Moncalvo and Ferdinando Ruffa - © 2020, Reworking of the authors.

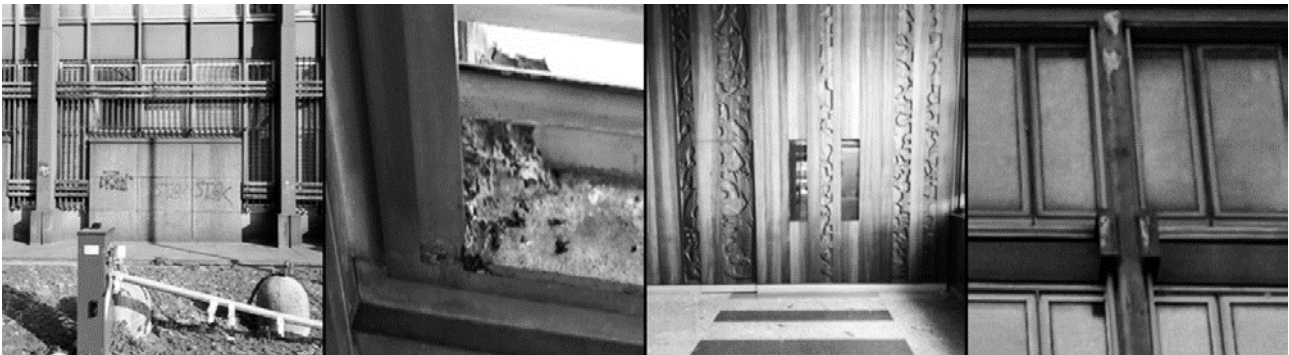
the constructive characters, in detail, they modified the architectural sign. The structure in prefabricated steel of the fire escape, placed in front of the skyscraper, in correspondence with the sleeve of Via Ruffini, for which the old staircase designed by Morelli in prefabricated steel grids has been decommissioned, to comply with stringent safety regulations and ensure a suitable and more efficient escape route in case of danger. The few maintenance works on the facades, which took place over the years, were carried out with no attention to the original materials. From careful observation, we could observe chromatic discrepancies and widespread degradation phenomena that affect the stone cladding (with smog and chemical agents), the grates of the ground floor (rust red colour and therefore oxidized), the iron struts and the transoms of the facade (Fig. 4): the metal profiles show evident signs of superficial wear and detachment of the varnishes, as well as punctual phenomena of oxidation, mainly due

to the action of environmental factors (pollution, atmospheric agents, humidity, etc.) and the natural ageing process of the components that make up the facade cladding. In the interior, the aluminium curtain-wall frames have serious sealing problems due to the deterioration of rubber gaskets, resulting in widespread infiltration problems, punctual corrosion, impregnation of ceiling panels and bulging of the floor.

**Fig. 4** Elements of detail degradation of the building: the outdoor area, an aluminium frame, the boiserie in the entrance hall, the curtain wall.

In the eventual recovery, it would be desirable a careful restoration of these artefacts and their prudent protection.
