# Heritage Problems, Causes and Solutions

Calogero Bellanca and Susana Mora Alonso-Muñoyerro

## CHAPTER 8. WALLS: CONSTRUCTIVE SYSTEMS, PROBLEMS, CAUSES AND SOLUTIONS

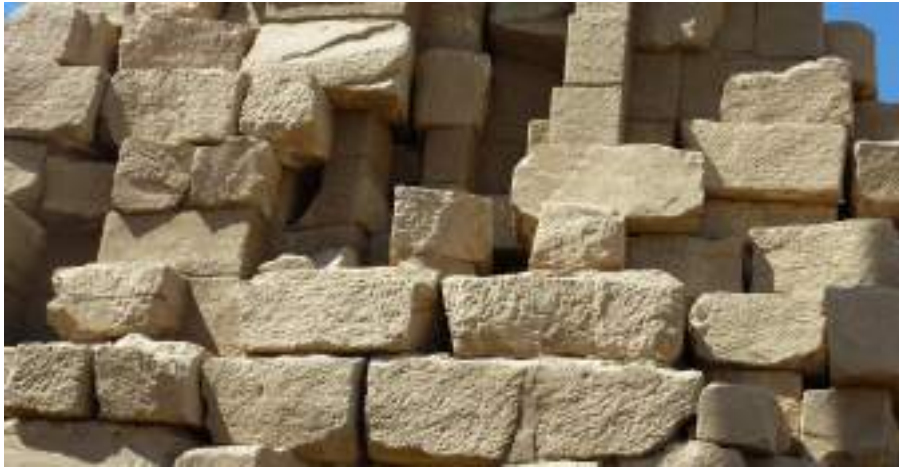
Fig. 3. From J. Ashurst, *Conservation of Ruins*, Routledge, Oxford 2006, p. 80.

Ashlar masonry consists of carefully dressed stones with accurate bedding and fine joints of 3 mm thick. This is the best type of stone construction. It is ensured that the sizes of individual stones are in conformity with the general proportions of the wall in which they are placed. It is further divided into the following types:

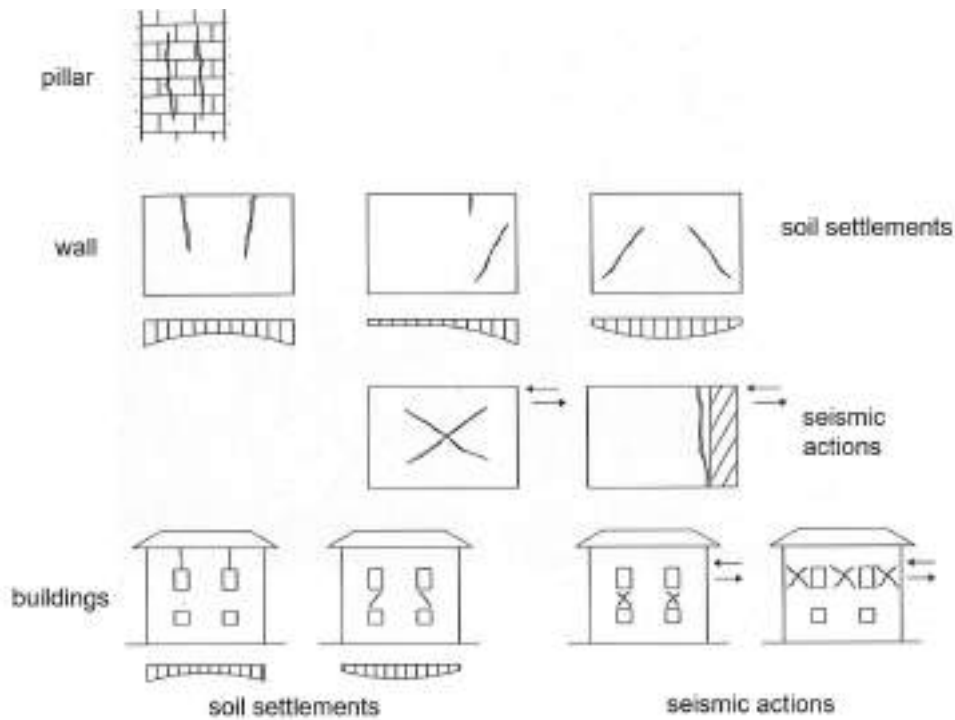
Fig. 14. From G. Croci, *Conservazione e restauro strutturale dei beni architettonici*, Utet, Torino 2011, p. 121.

**DAMAGES AND DEFORMATIONS IN A WALL STRUCTURE**

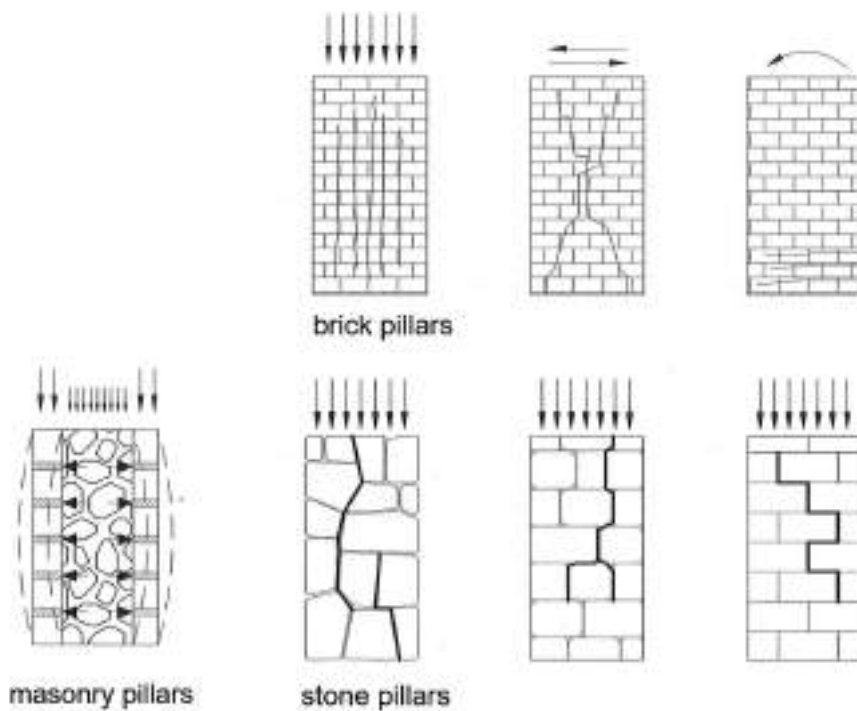
Fig. 15. From G. Croci, *Conservazione e restauro strutturale dei beni architettonici*, Utet, Torino 2011, p. 123.

**POSSIBLE CRACKS IN MASONRY PILLARS SUBJECT TO CRUSHING PHENOMENA**

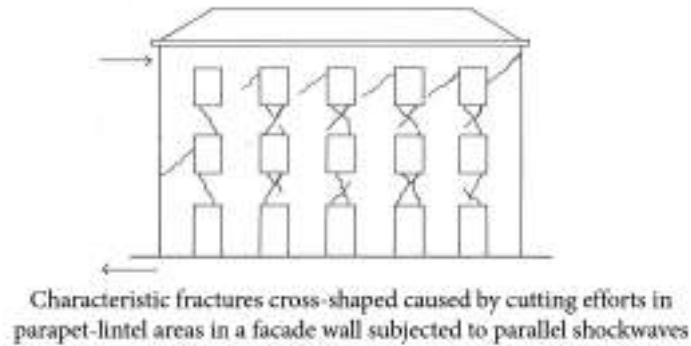
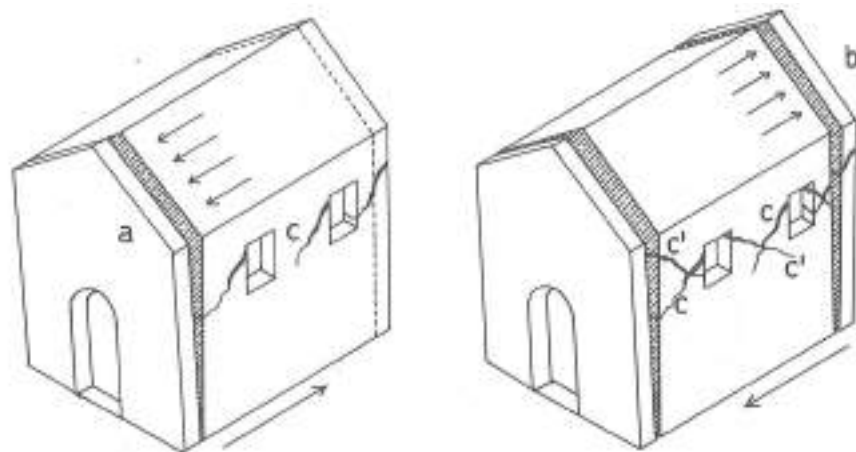
Fig. 17. From G. Croci, *Conservazione e restauro strutturale dei beni architettonici*, Utet, Torino 2011.

Thrust in one direction: detachment of the facade **a** and formation of fractures **c**.  
Thrust in the opposite direction: detachment of the wall **b** and shear cracks **c'**.

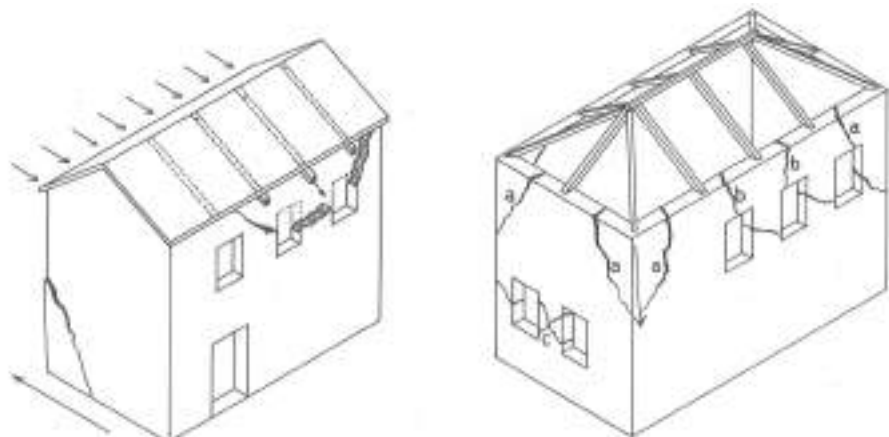
Fig. 18. From G. Croci, *Conservazione e restauro strutturale dei beni architettonici*, Utet, Torino 2011.

Detachment of a part of the façade due to puncture of the trusses. The corner areas can resist if the orthogonal walls are well connected to each other.

a) Corner damages caused by the action of the diagonal struts in a building with a spine wall; b) from the inertial forces of the wall and from the transverse struts of the roof; c) from the alternating shear actions.

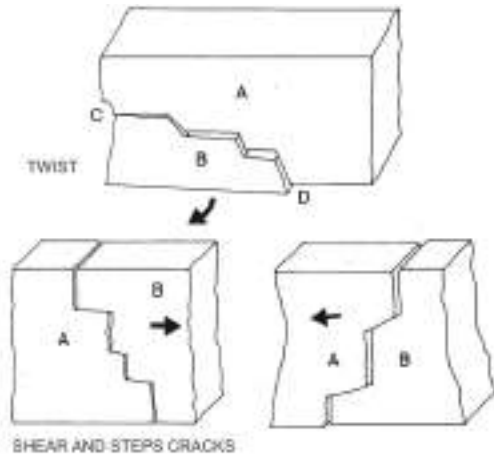
Fig. 19. From G. López Collado, *Las Ruinas en Construcciones Antiguas*, Miján, Artes, Gráficas, Madrid 1985, p. 54.

Edge Movements:

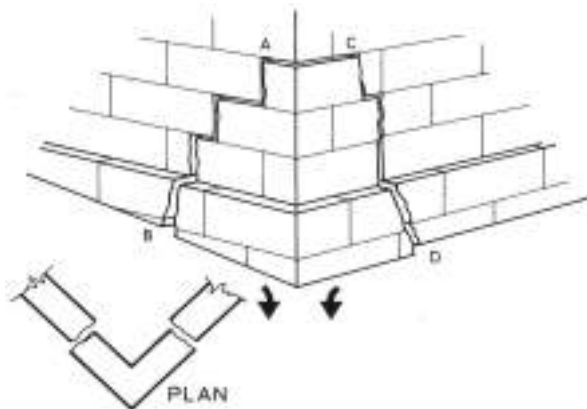
Fig. 20. From G. López Collado, *Las Ruinas en Construcciones Antiguas*, Miján, Artes, Gráficas, Madrid 1985, p. 63.

Edge Movements: Corner Settlement  
Combination of movement in two orthogonal planes

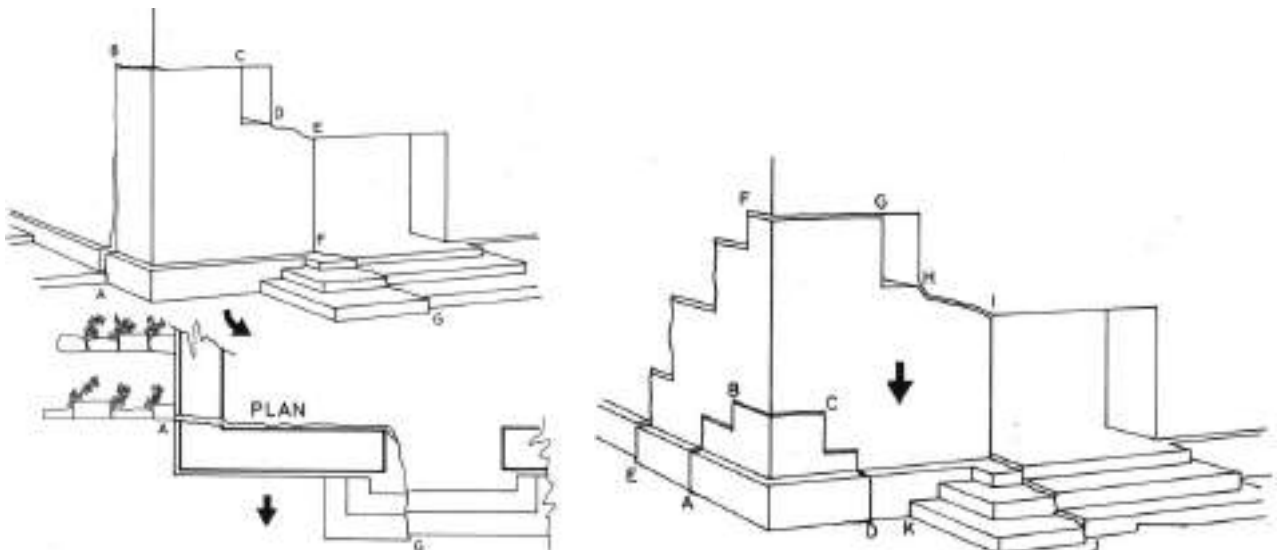
Fig. 21. From G. López Collado, *Las Ruinas en Construcciones Antiguas*, Miján, Artes, Gráficas, Madrid 1985, p. 66.

Edge Movements: Footing Settles and Leans  
Combination of movement in two orthogonal planes with shear and step cracks.

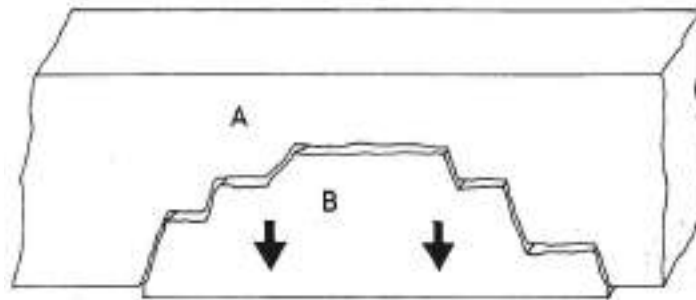
Fig. 22. From G. López Collado, *Las Ruinas en Construcciones Antiguas*, Miján, Artes, Gráficas, Madrid 1985, p. 54.

Internal Movements: Differential Settlement  
Caused by weight and small differential settlement below load

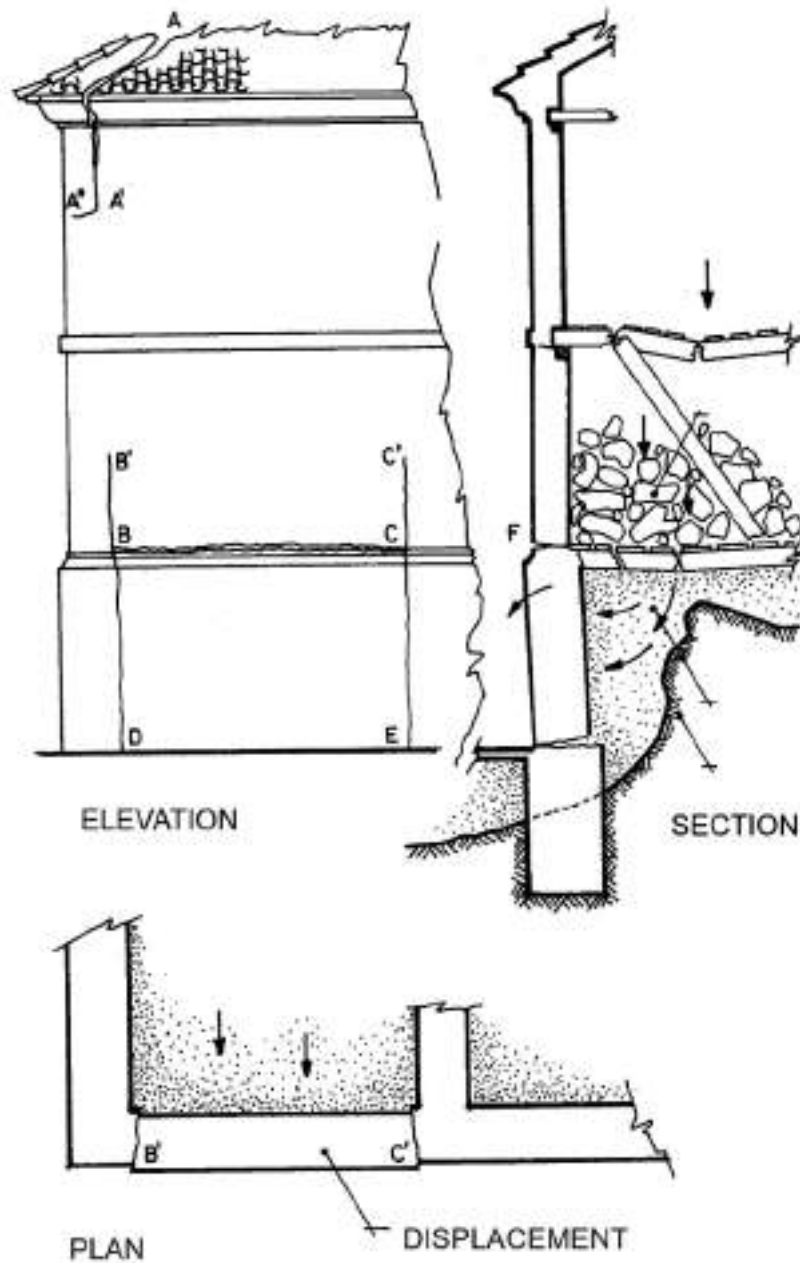
Fig. 23. From G. López Collado, *Las Ruinas en Construcciones Antiguas*, Miján, Artes, Gráficas, Madrid 1985, p. 56.

Internal Movements:  
Wall is uniformly pushed and displaced with vertical shear cracks

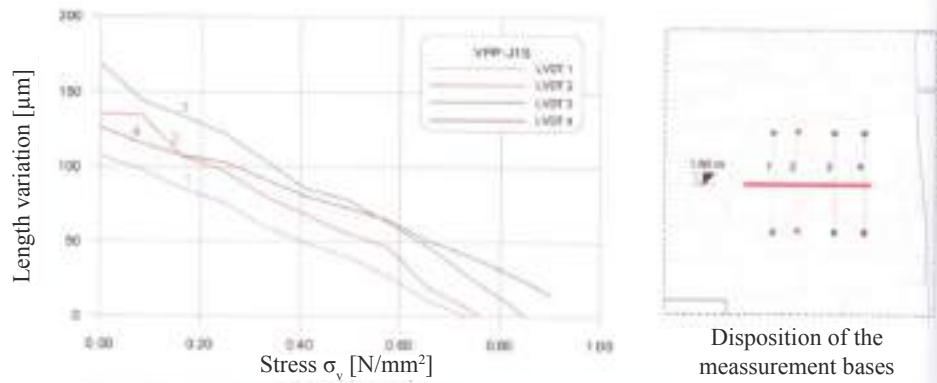
Fig. 25. From F. Doglioni, G. Mirabella Roberti, Venezia. *Forme della costruzione, forme del dissesto*, Libreria Cluva Editrice, Venezia 2011, p. 208.

The vertical displacements are read with the flat jack inserted in the masonry. The hydraulic system is connected to a small tub inserted in the masonry.

Test VPP-J1S. Trend of the distance between the mixture bases as a function of the applied effort.

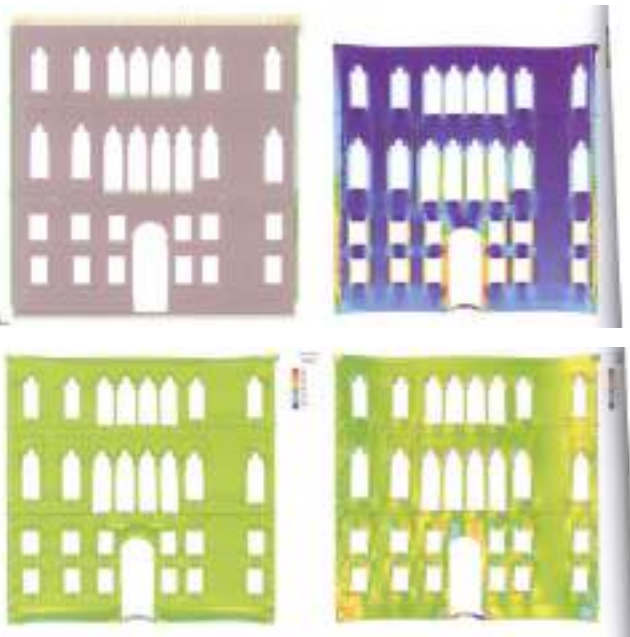
Fig. 29a. Stress in vertical direction. From F. Doglioni, G. Mirabella Roberti, *Venezia. Forme della costruzione, forme del dissesto*, Libreria Cluva Editrice, Venezia 2011.

Fig. 29b. Stress in horizontal direction. From F. Doglioni, G. Mirabella Roberti, *Venezia. Forme della costruzione, forme del dissesto*, Libreria Cluva Editrice, Venezia 2011.

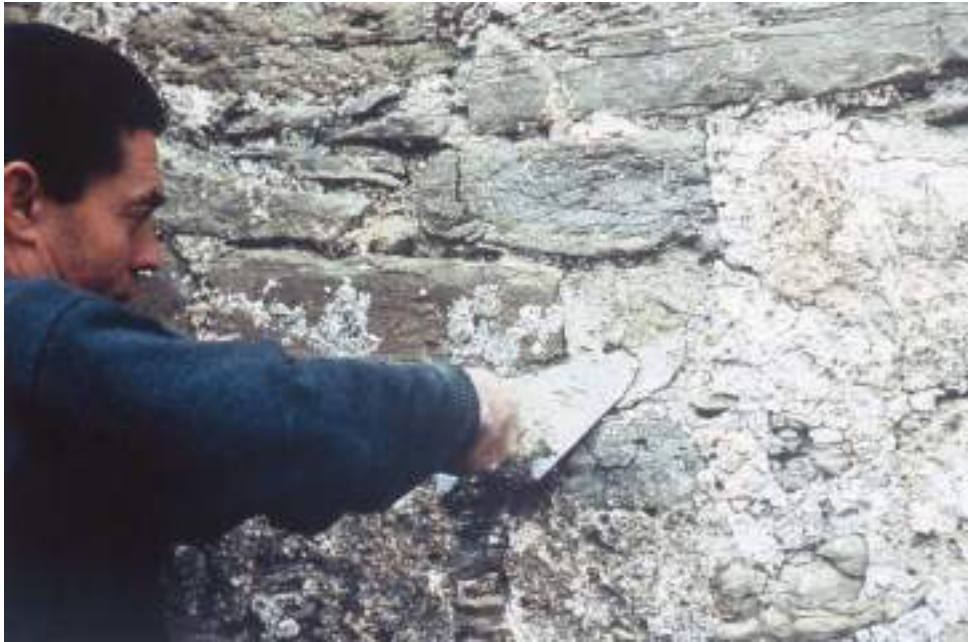
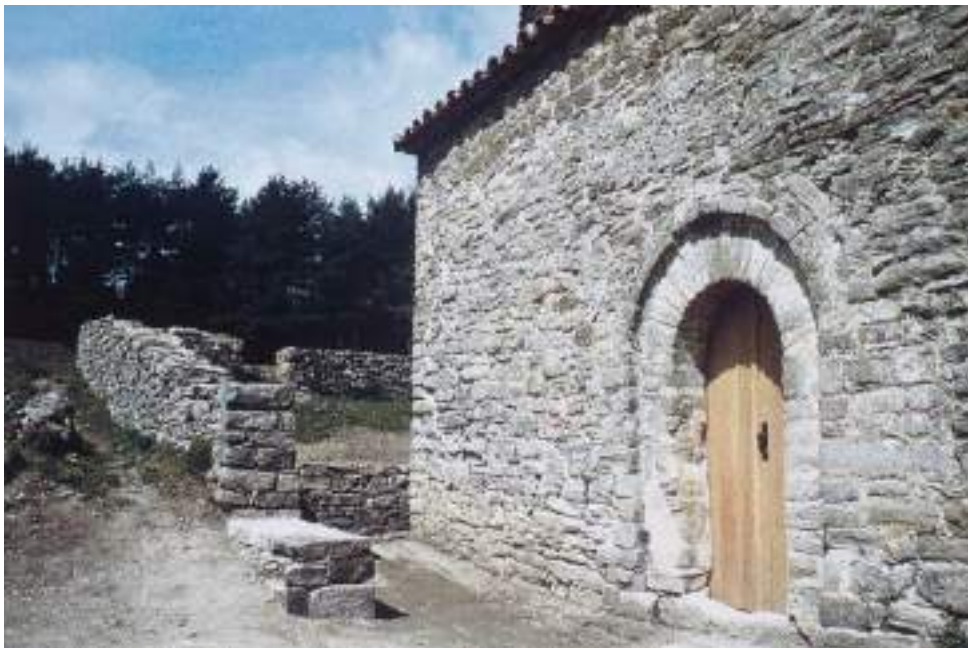
Fundamental solution to consolidate a wall. The joints must be cleaned where the masonry is fixed, eliminating the mortar in bad conditions. Generally we use a similar material or with similar characteristics of hardness, porosity, elasticity, etc. But it may be aesthetically very different looking for its formal differentiation. Sometimes it is delimited when it is carried out on a surface to be considered.

Fig. 32. Delimited *stuffed*. Antoni González. Barcelona. Photo by Susana Mora, 1993.

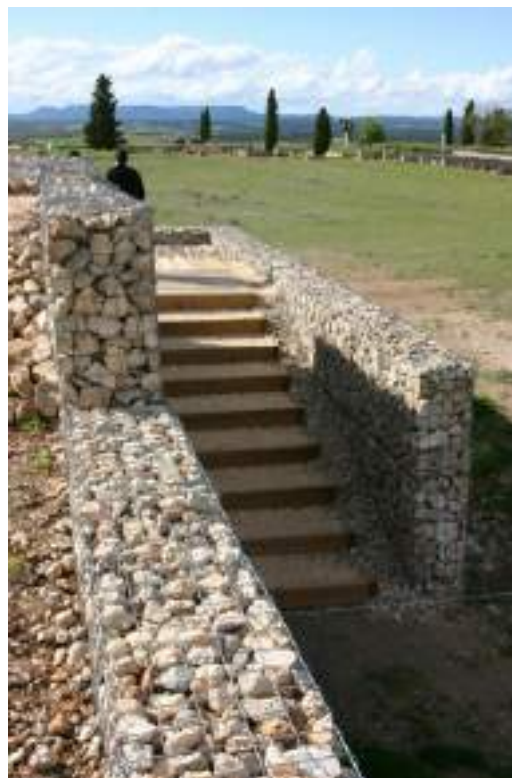
- Slope mortar
- Sacrificial layer
- Stone gabions

Fig. 34. Sacrificial mortar, Clunia, Burgos. Photo by Susana Mora, 2011.

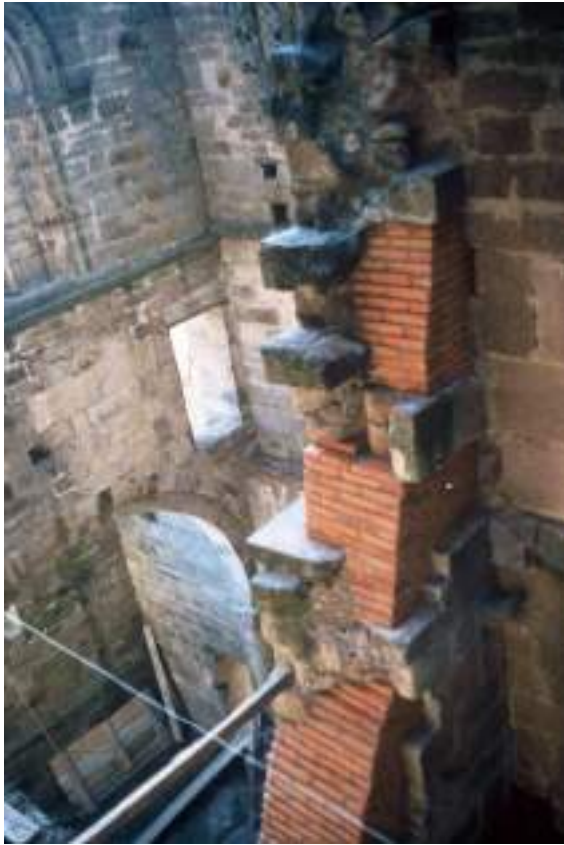
Fig. 38. Buttress, Carracedo Monastery, León, 1990. Restoration by S.P. Arroyo and Susana Mora.

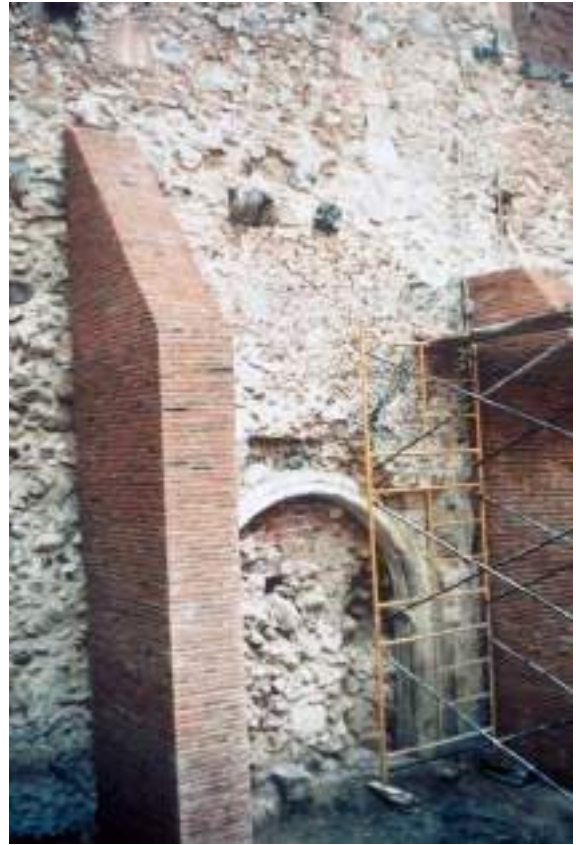
Fig. 39. Buttress, S.P. de Arlanza, Burgos, 1989. Restoration by S.P. Arroyo and Susana Mora.

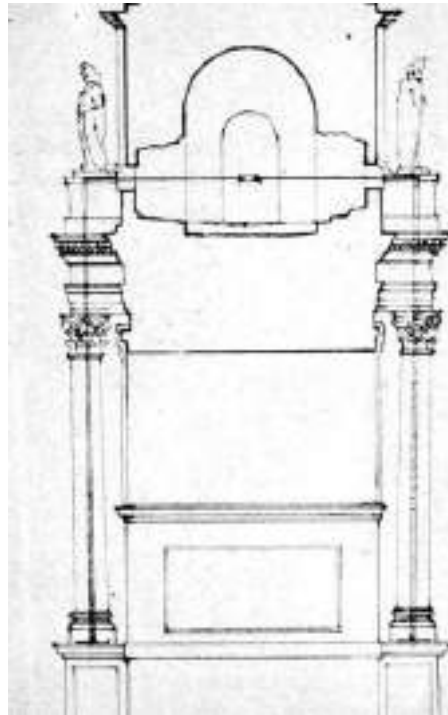
Fig. 44. Costantino Arch, Rome. From C. Ceschi, *Teoria e storia del restauro*, Bulzoni, Roma 1970, p. 129.

Restoration has insert reinforcements and still acts inside the columns.

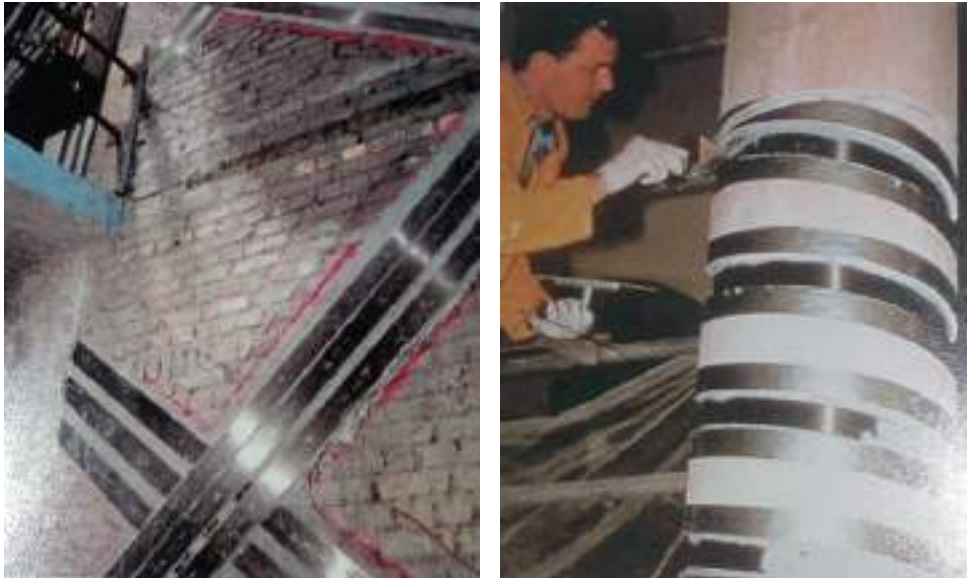
Figs. 56, 57. From F. De Cesaris, “Materiali e strutture”, n. 12, 2017, p. 78.

Use of carbon fiber as laminates in reinforcements for pillars and walls and aramidica fiber laminates in reinforcement of walls and pillars.

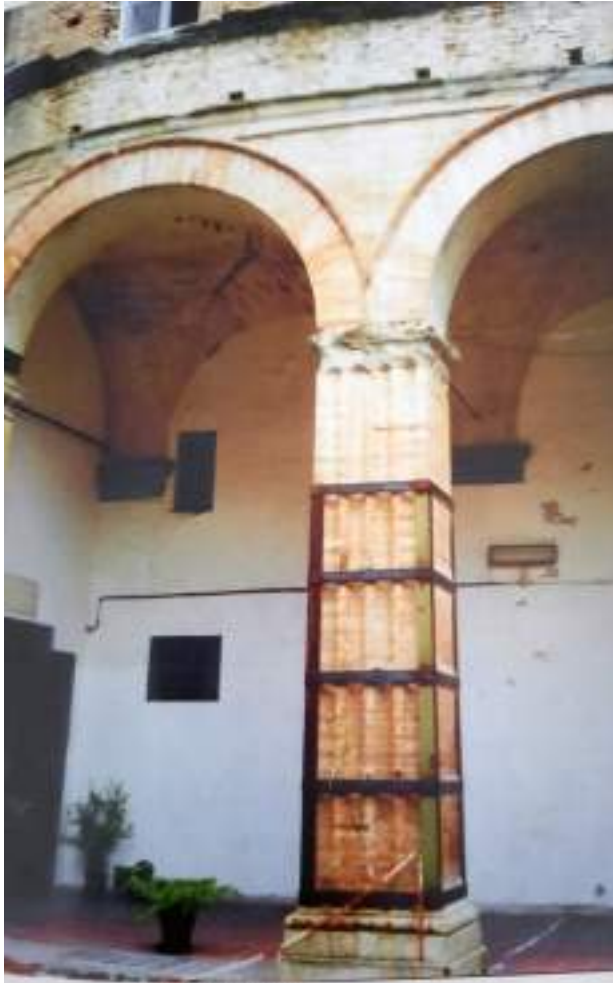
Fig. 62. On the left: Traditional bracing reinforcement. From G. Carbonara, *Atlante del restauro architettonico*, vol. II, Utet, Torino 2004, p. 565.

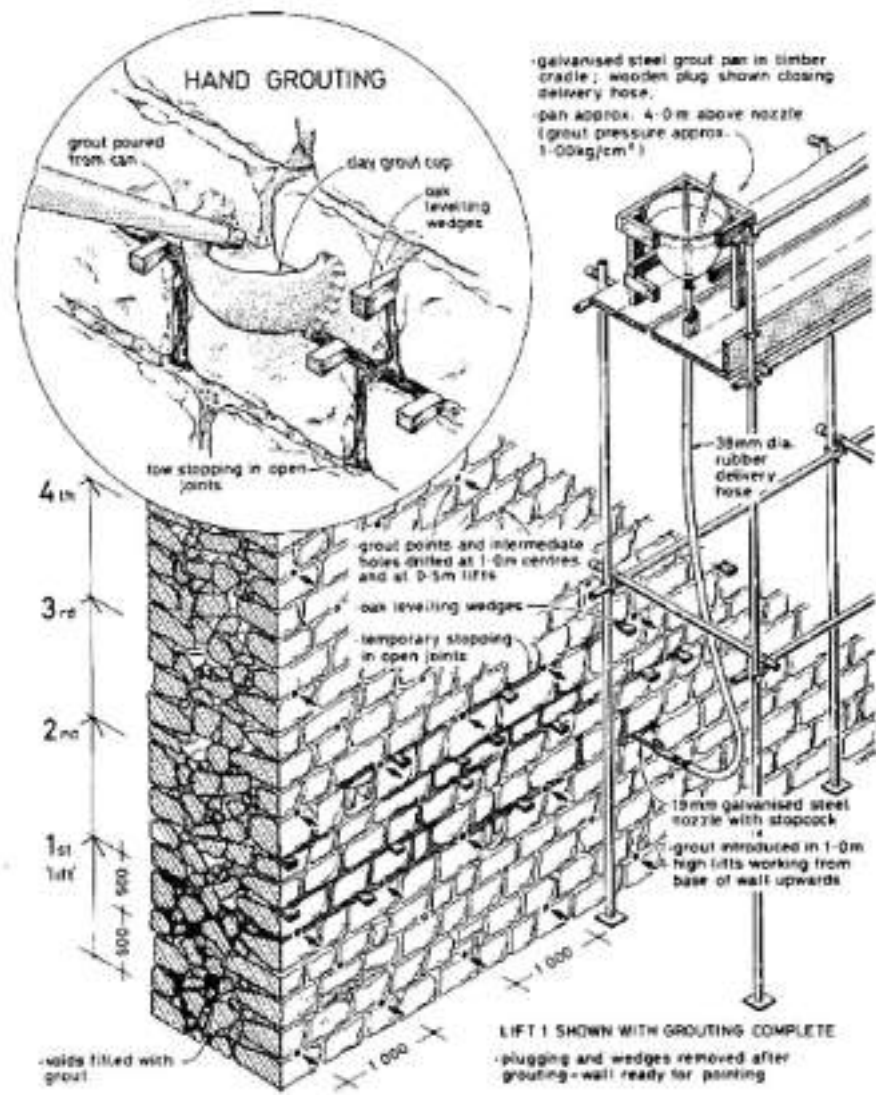
Fig. 66. From J. Ashurst, *Conservation of Ruins*, Routledge, Oxford 2006, p. 175.

The objective is to improve the properties in terms of continuity and resistance. The technique consists in the injection of a liquid consistency mortar, in order to fill gaps and fissures, restoring the mechanical capacity to the construction.

- Injection control
- Grout density
- Washing inner leaf

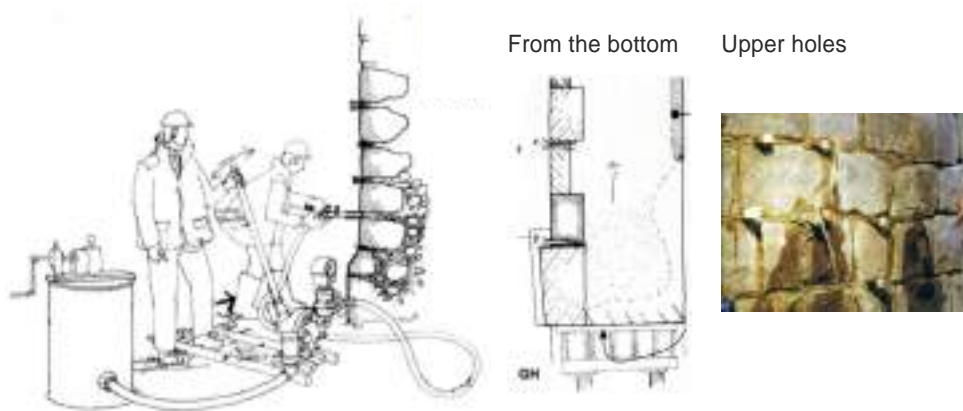
Fig. 67. From J. Ashurst, *Conservation of Ruins*, Routledge, Oxford 2006, p. 187.

- Constructive system
- Pressure
- Injection control
- Grout density
- Washing inner leaf

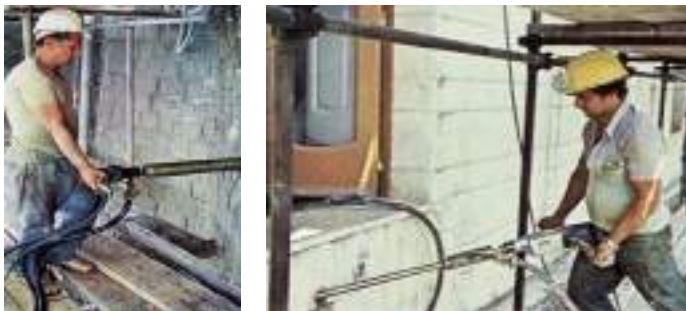
- Constructive system changes
- Static / Hyperstatic
- Expulsion of the bars
- Homogeneous systems
- Compatibility

Fig. 68. Reinforced. Problems in Paestum. From F. Lizzi, *The static restoration of monuments*, Sagep Publisher, Genova 1982.
