HISTORIC CARTOGRAPHY OF L'AQUILA CITY AS A SUPPORT TO THE STUDY OF EARTHQUAKE DAMAGED BUILDINGS

Abstract

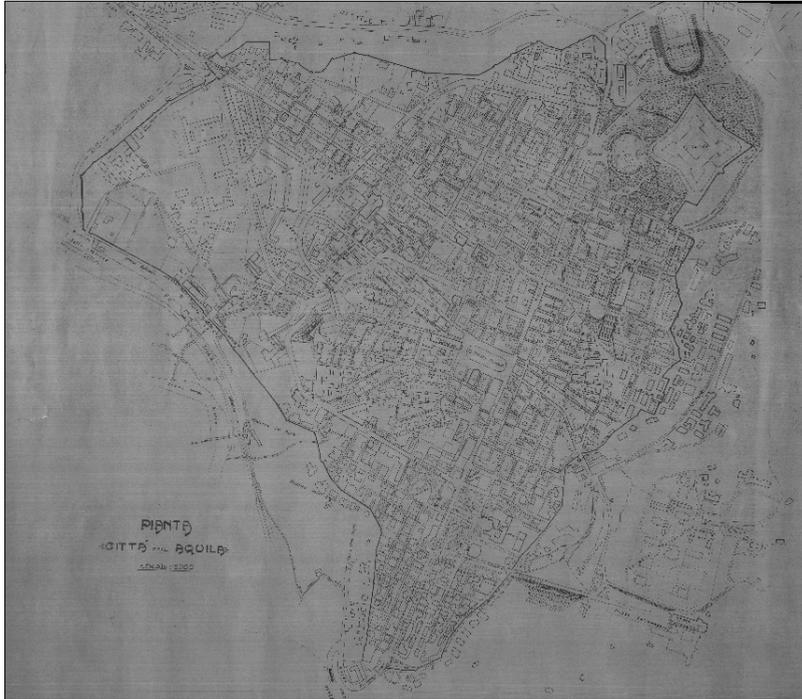
Fig. 2. Historical map that represents the center of the city L'Aquila.

This map defines the area that includes the historical center of L'Aquila. The test area is contained in the historic city walls, with an area of 1.2 km². This map is undated, and for this reason we tried to figure out what years it was, considering the buildings in it represented. Observing the map's layout, and we can hypothesize that the map was drawn between 1930-1940, that are approximately the years in which the building methodologies changed deeply.

In this work was considered a 1:2000 historical map that represents the center of the city (**Fig. 2**).

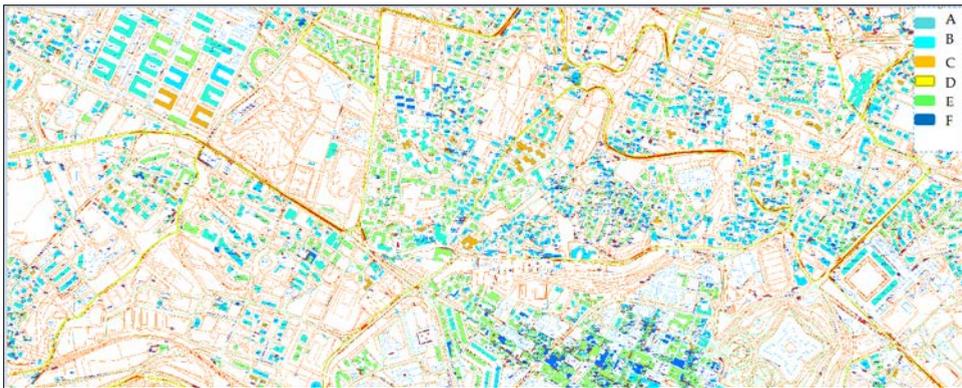
Another map used in this work is the map of fitness for human habitation (**Fig. 3**) (Comune L'Aquila); on it we can clearly distinguish two different types of territory: an area heavily populated, predominantly characterized by buildings of 1700, and an area of more recent construction where the degree of human activity is lower.

Fig. 3. The map of fitness for human habitation.

On the basis of the results of the surveys carried out by qualified technicians under the coordination of the Civil Protection Department, the maps of fitness for human habitation have been realized as shown in the underlying figure. The original vector maps were not available so mosaic of some pdf file was performed in Q-GIS environment; the map, originally 1:2,000 scale referred to CASSINI-SOLDNER projection, was projected in UTMWGS84- ETRF89.

The evaluation of fitness for human habitation executed during the first emergency period following the event of 6th April 2009, is a preliminary estimation whose main goal was to establish if the buildings struck by the earthquake can be used without risking human life (Baiocchi et al. 2012, Baiocchi et al. 2012). The surveys were performed using technical form, to make the evaluations of different surveyors as homogeneous as possible to allow an immediate digitalization and statistic treatment of the data. The result of the judgment of fitness for human habitation had to fit in one of the six possible categories specified in the chart, where "usable" intends "building suitable for human habitation":

- A. Building usable;
- B. Building temporarily unusable (everything or part): but usable after some intervention, which makes it usable in all of its parts, without danger for the residents;
- C. Building temporarily unusable, to be investigated further: when building presents characteristics that make the evaluation uncertain;
- D. Building partially unusable: the state of certain portions of the building could cause elevated risk for their occupants;
- E. Building unusable due to structural, non structural, or geotechnical risks; and
- F. Building unusable due to serious external risk, in absence of consistent damage to the building: for example, an undamaged building contiguous to a building that could collapse.

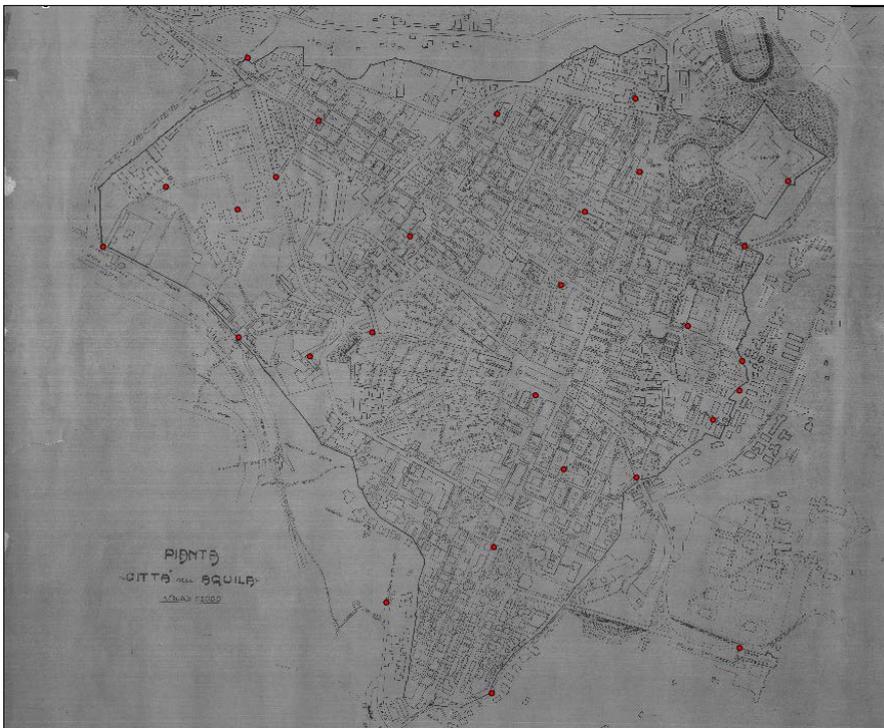
For this reason a Real Time Cinematic (RTK) GPS/GNSS differential mode was used; this mode allowed acquisition of collimable points points on the ground with centimeter accuracy, without being too demanding in terms of time and costs. As it's well known, the GPS-RTK differential technique makes use of a single reference station, fixed on a vertex of known coordinates, located close to the receiver user; measurements of phase, in fact, are faster if calculated in real time referring to a near station because the integer solutions of the phase ambiguity is reached earlier. In this case 27 points distributed on the map (**Fig. 4**) were measured referring to the permanent station of Monticchio (AQ02).

Fig. 4. Distribution of points on the historical map.

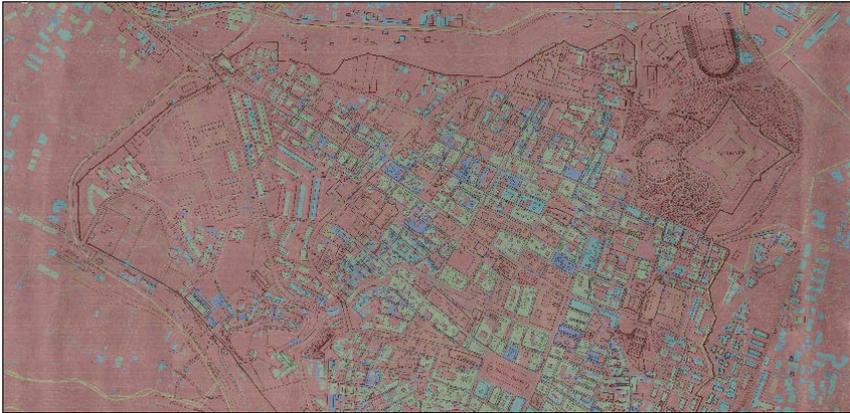
Obtained the georeferenced map, this has been overlapped with the map of fitness for human habitation (**Fig. 7**).

Fig. 7. Overlapping of the historical map with the map of fitness for human habitation.

At this point overlapping the map of fitness for human habitation and the historical map we can distinguish between new buildings and old buildings, so to study if there is a correlation between a building methodologies and the damage suffered by the building.

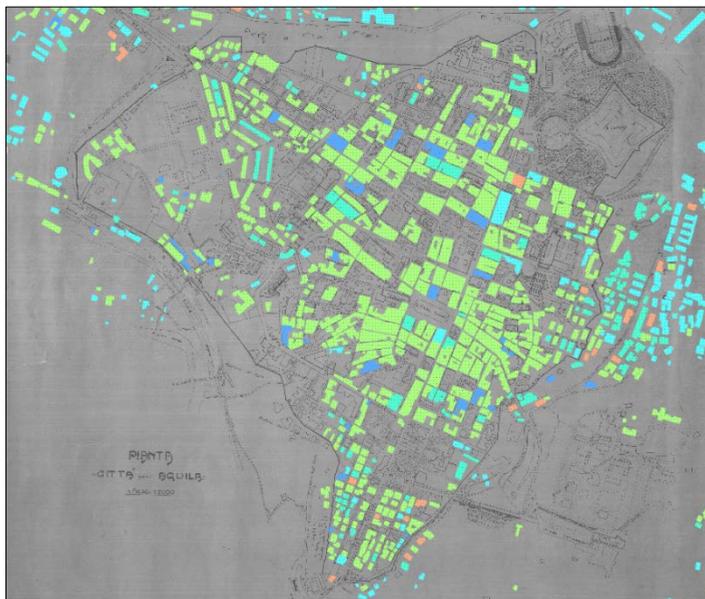
Within Qgis was then possible to vectorize the polygons according to the classification (**Fig. 8**).

Fig. 8. Vectorization of the buildings according to the classification within QGIS.
