Fragility Analysis Based on Damaged Bridges during the 2021 Flood in Germany

Alessandro Pucci [1,*], Daniel Eickmeier [2], Hélder S. Sousa [1], Linda Giresini [3], José C. Matos [1] and Ralph Holst [2]

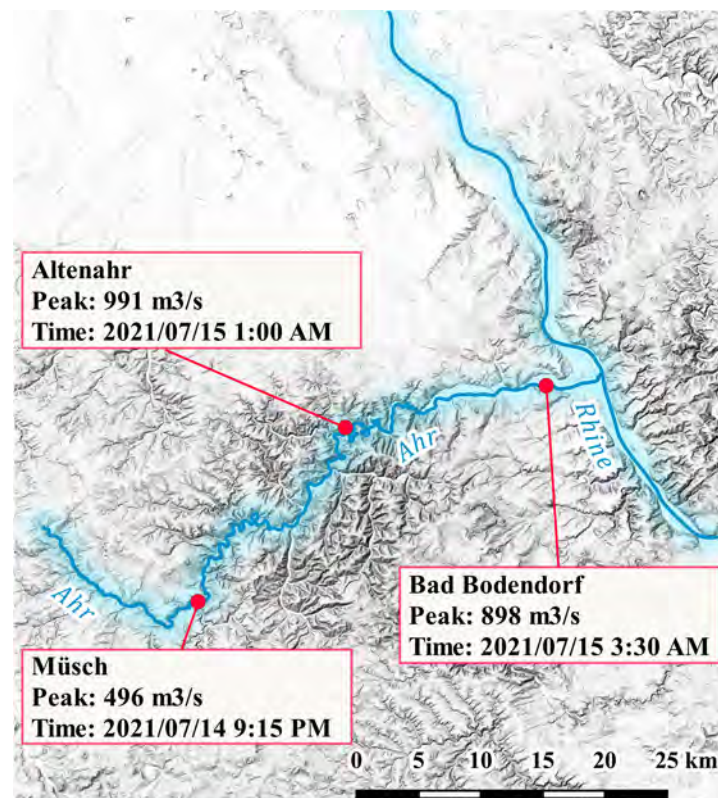
Before that event, the river gauge at Altenahr for a period of 100 years was estimated at 241 m^3/s and through a regression it can be assumed to have been 265 m^3/s for 200 years, with a R^2 = 0.99 (using discharge values for return periods of 2, 5, 10, 20, 25 and 50 years). However, as per Figure 2, the 2021 event's peak reconstructed by LfU was estimated at 991 m^3/s [52]. This discrepancy posed additional open questions regarding the treatment of flood events, including the suitability of extreme value distributions and the role of inline structures in producing backwater effects when debris accumulation occurs. Concerning the first question, the highest discharges that occurred in the Ahr river were estimated to be 1200 m^3/s at Dernau in 1804 and about 600 m^3/s at Altenahr in 1910 [53]. Interestingly, these events were not included in the flood risk assessment of the local authority, which is debatable from a risk management perspective, given that in 2021 similar values were registered, as per Figure 2 [6]. On the other hand, these rare events, if examined using the extreme value theory, would have led to return periods of about 10^8 years, highlighting a limit of these statistical models [54]. The other issue concerns anthropogenic reductions to the river's cross-section (e.g., parking lot in Altenahr) and bridges, causing increased water levels upstream [6]. Most notably, the interaction between bridges and drifting debris often caused clogging, resulting in a damming effect [55].

Figure 2. Spatial and temporal evolution of the peak discharge along the Ahr river according to the preliminary data from LfU [52].

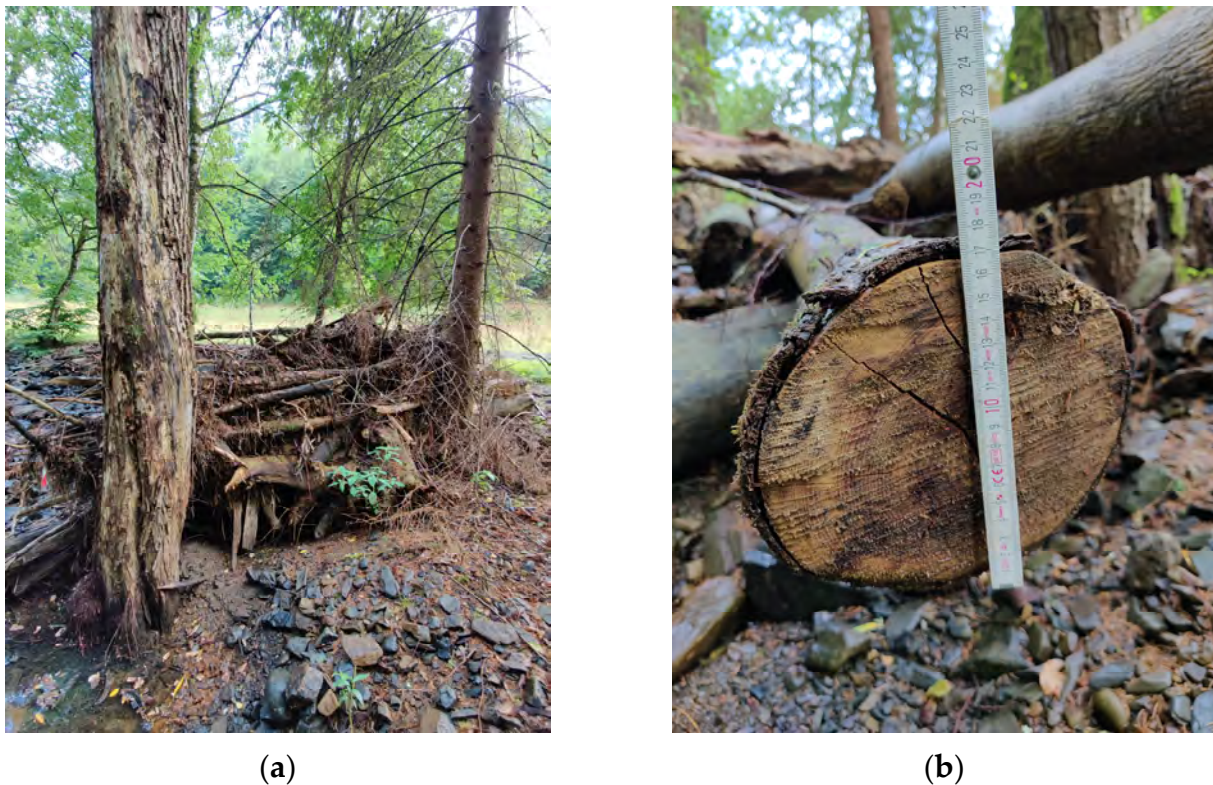
This condition is visible in the upper part of the Ahr basin, where small streams still hold significant amounts of sediment and carry wood logs, as shown in Figure 3. This situation is not isolated, as in Germany, erosion rates easily exceed acceptable amounts [56]. Ultimately, the mobilization of driftwood is responsible for bridge clogging, increasing horizontal water thrust against decks and piers [57].

Figure 3. Debris damming in Eichenbach, tributary of the Ahr river: (**a**) lengths of carried wood logs of up to 15 m; (**b**) average diameter of carried logs (17 cm). Pictures taken by the first author.

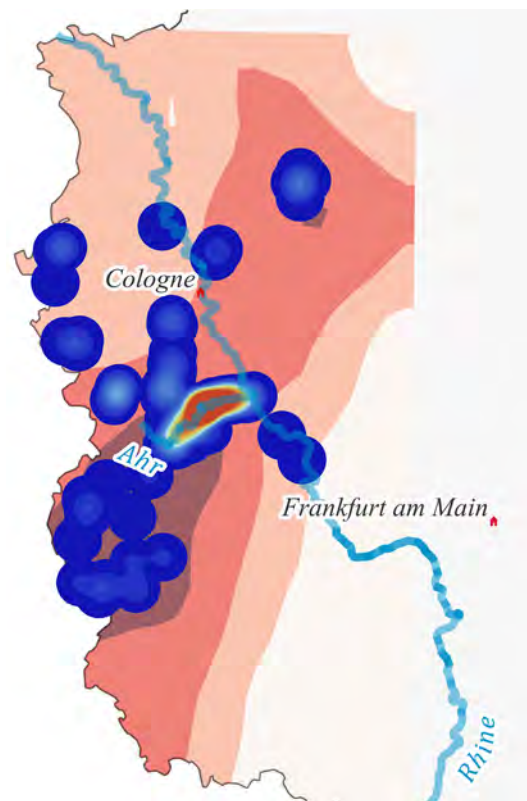
Figure 4. Spatial kernel density estimation of damaged bridges (blue to red dots). The Ahr valley was the most affected area. It can also be seen that the upper part of the river basin was affected by the greatest hydrologic loads (darker red on rain map: rainfall height $\geq$ 90 mm), inducing high hydraulic force along the stream. The other highlighted areas represent the accumulated daily precipitation, with values ranging between 50 to 90 mm (red), 30 to 50 mm (lighter red region). Daily accumulated precipitation (combined microwave–IR) 0.1 deg. (GPM GPM_3IMERGDF v06), 14–15 July 2021 [48]. Base map from NUTS250 [50], river shapefile from Waterbody-DE [51].

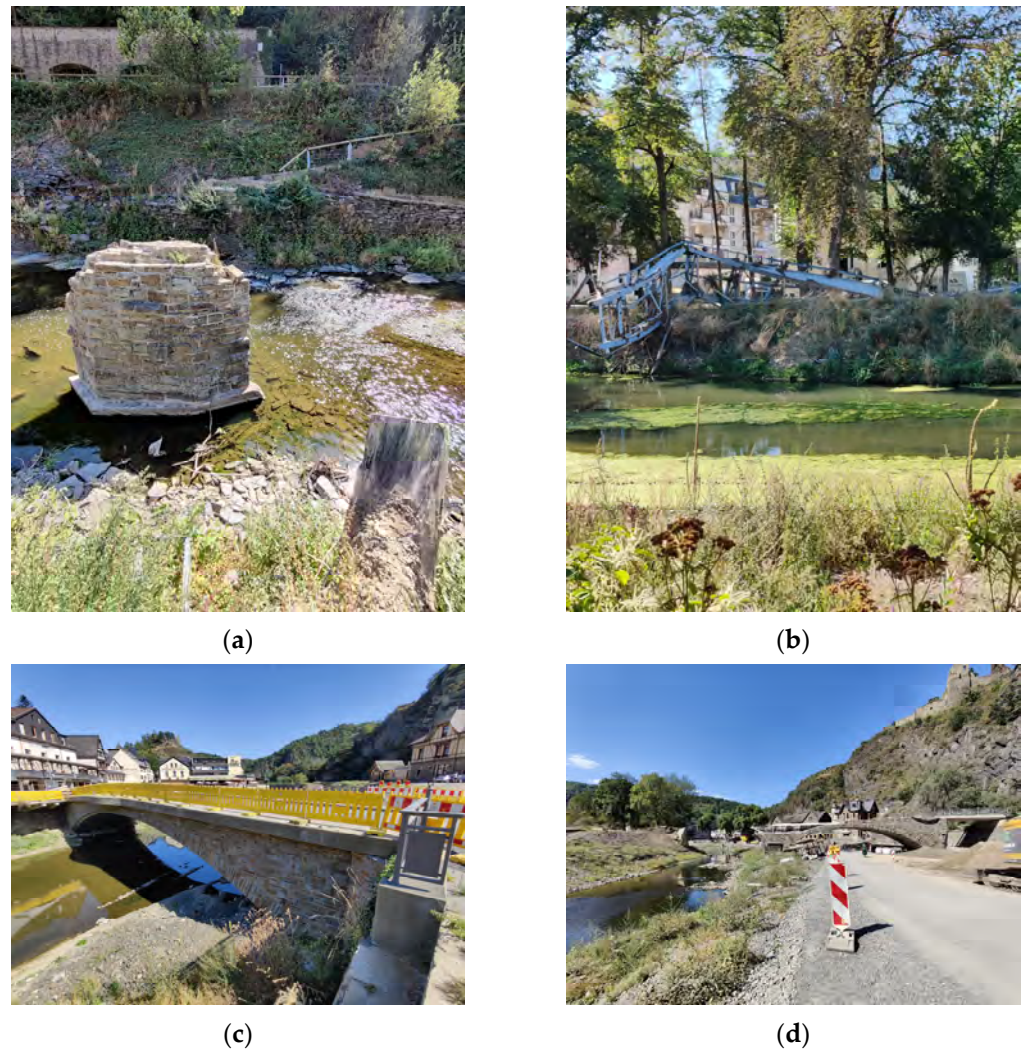
Figure 6. Surveyed overtopping mechanisms: (**a**) remaining pier of a dragged wooden deck; (**b**) girder of a dragged steel deck; (**c**) damaged railing due to overtopping; (**d**) combination of overtopping and scour, with the latter being responsible for triggering the failure. Pictures taken by the first author.

Figure 6a shows the remaining instream pier of a wooden bridge, whose deck was found about 5 km downstream, while Figure 6b shows the steel deck of a footbridge dragged downstream a couple hundred meters from its original location.

From these two examples, one can observe that only lightweight decks suffered from dragging, but evidence in the aftermath of the flood showed that mixed steel–concrete road decks and a steel deck of a railway bridge also suffered from dragging [46]. During the 2021 flood, the hydraulic force against decks caused damage to all structures, with a clear trend: beam bridges with simply supported spans showed a higher vulnerability to dragging when compared to arch bridges. Indeed, no arch bridges that were overtopped experienced a full collapse. Severe damage was observed for masonry arch bridges, including the removal of infill material, carriageways and railings. Nevertheless, their failure was eventually only triggered by scour, as seen in Figure 6d. Overtopped arch bridges built in reinforced concrete sustained minor damage compared to masonry bridges, mainly to railings and parapets, as seen in Figure 6c.

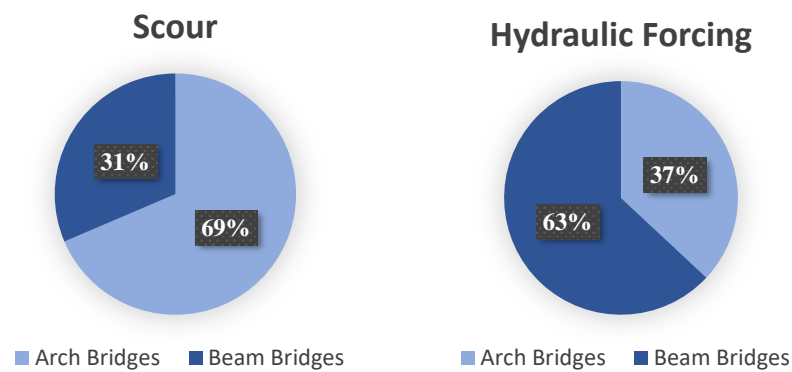
Figure 7. Percentages of arch and beam bridges with respect to the two damage mechanisms.

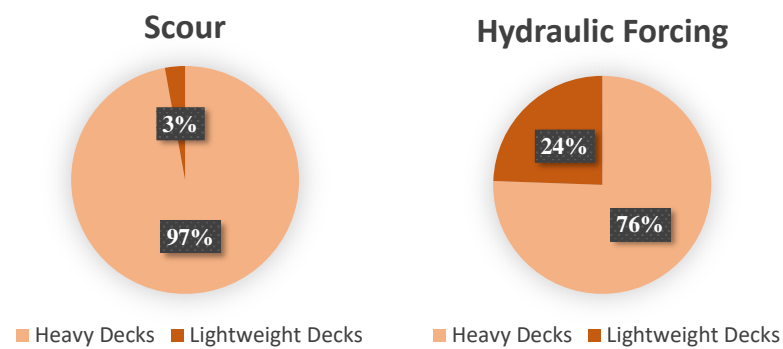
Figure 8. Percentages of heavy and lightweight bridge decks with respect to the two damage mechanisms.

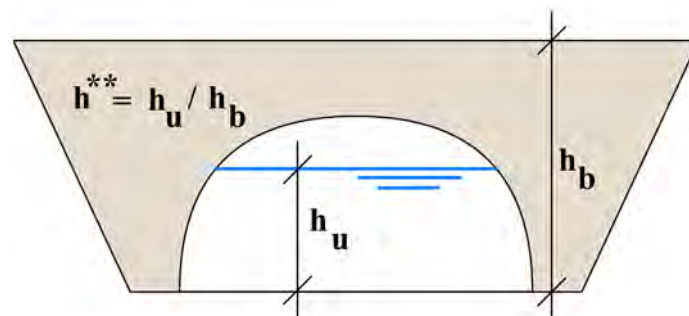
Figure 9. Definition of h^{**} as fragility intensity measure.

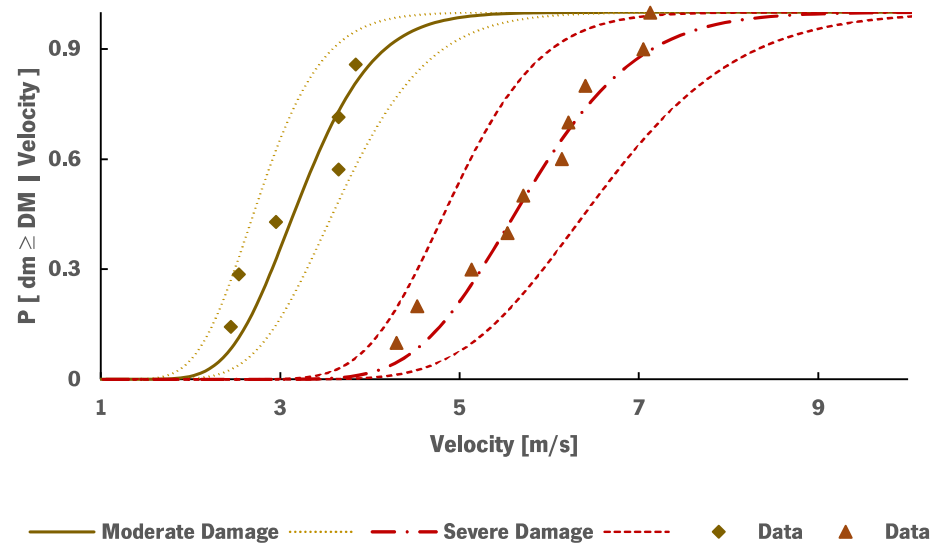
Figure 10. Confidence intervals for the moderate and severe damage states. Velocity data considering only arch bridges. The 95% confidence intervals are highlighted together with the mean value of the fitted distribution.

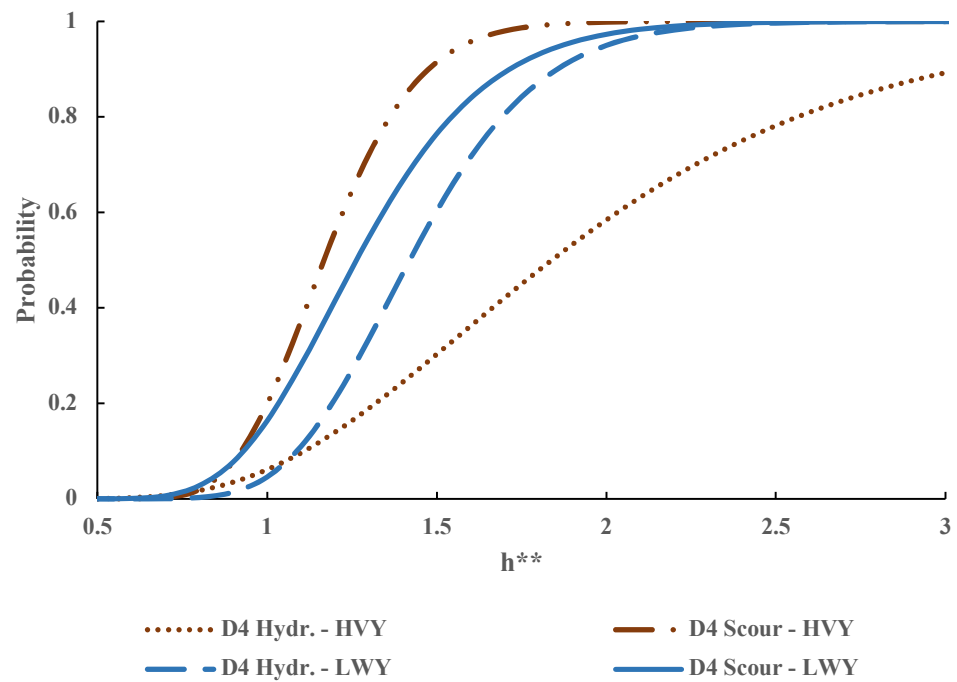
The chart in Figure 11 shows the probability severe damage in both lightweight and heavy decks for the two failure modes. Scoured bridges exhibited higher probabilities of being damaged in both lightweight and heavy decks, compared to the hydraulic force failure mode. Nevertheless, the behavior was similar for both damage mechanisms when the deck was not overtopped ($h^{**} < 1$). This confirmed that such damage was not influenced by the deck material but by other factors associated with different failure mechanisms, such as the scouring of instream piles. For $h^{**} > 1$, there were differences among lightweight and heavy decks under scour, but these were still minor when uncertainties were included (i.e., 5% and 95% confidence intervals) and are not represented in Figure 11 for the sake of clarity but are shown together with the velocity as IM in Figure 10.

Figure 11. Fragility curves for severely damaged heavy (HVY) and lightweight (LWY) bridge decks under scour and hydraulic force (Hydr.) scenarios.

Indeed, when the confidence bands (5–95%) are included, the biggest difference between scour and hydrodynamic mechanisms was observed for heavy decks in the overtopping interval ($h^{**} > 1$). Thus, heavy decks had less probability of being severely damaged at high water stages compared to when scour occurred. The same also happened for lightweight decks, but the curves overlap when considering the confidence bands. Differences also existed when damage caused by high water stages were considered. As

expected, lightweight decks exhibited greater probabilities of being severely damaged compared to the heavier ones.

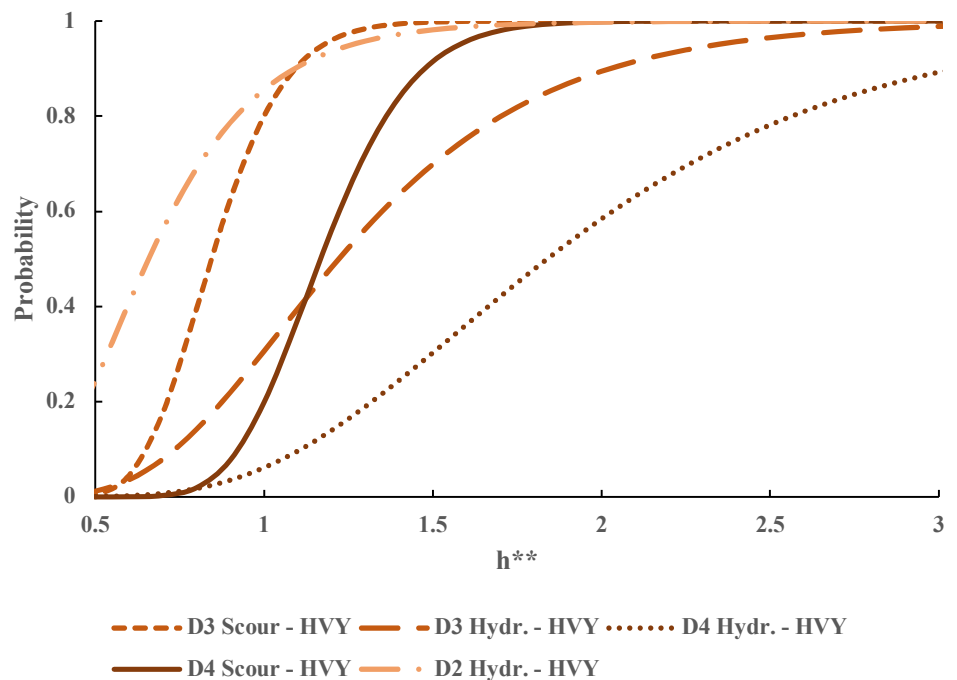
Figure 12. Fragility curves for heavy bridges (HVY) under scour and hydraulic force (Hydr.) scenarios accounting for all the damage levels.

When slight and moderate damage levels were considered, there were only heavy decks, as seen in Figure 12. Hence, lightweight structures exhibited only severe damage, as they were less robust to hydraulic force. Consequently, Figure 12 shows sequential damage states for heavy decks only, subjected to the same failure mechanisms. As expected, the behavior for heavy decks under scour was more severe than that under the hydraulic force damage mechanism. At low water stages, slight damage was more likely to occur. The damage level was also a function of debris carried by the flow, but the lack of data did not allow us to assess the impact of this factor on the fragility model.

Another result concerned the lack of slight damage under scour events. This confirmed that erosion is a moderate to severe problem for heavy decks. An important aspect is that when these bridges are overtopped ($h^{**} = 1$), there is an 80% probability of observing a moderate to severe damage in case of scour, while the probability reduces to 36% in cases of water thrust, as a damage mechanism is triggered.

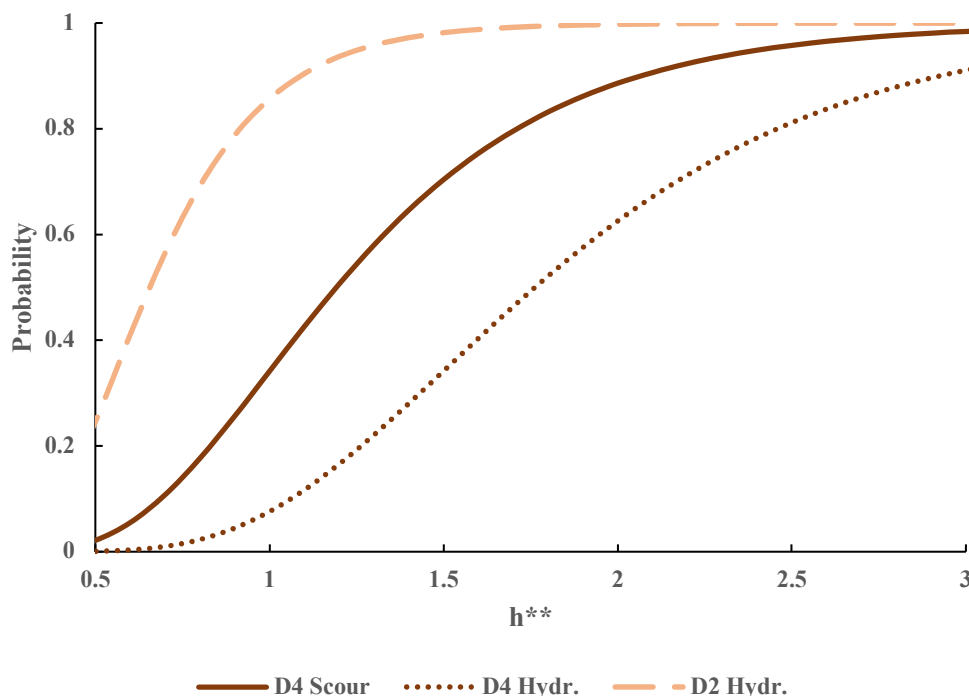
For the second cluster, beam structures, including trusses and box-girders, were separated from arch bridges. Figures 13 and 14 present the results for beam and arch bridges, respectively. By looking at Figure 13, it is shown that among beam bridges, moderate damage is missing. Then, combining the fragilities for bridge material and typology, it was identified that the moderate damage for heavy decks in Figure 12 only occurs in arch bridges. A common feature among the results is the severity of the scour mechanism, which led to higher damage probabilities for a given h^{**}.

Figure 13. Fragility curves for beam bridges under scour and hydraulic force (Hydr.) mechanisms.

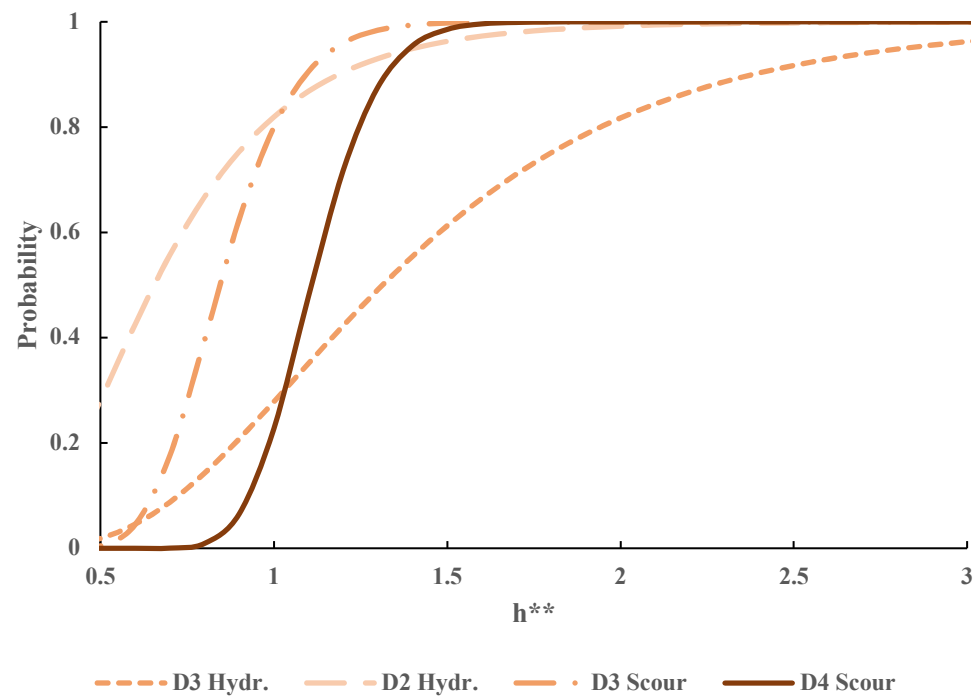
Figure 14. Fragility curves for arch bridges under scour and hydraulic force (Hydr.) scenarios.

Another observation concerns the absence of arch failures due to hydraulic force mechanism, as per Figure 14. Then, the severe damage caused by hydraulic force in Figure 12 is attributable to beam bridges. This opens up a major issue on whether arch bridges do experience collapse due to water thrust, and which hydraulic force component (drag or uplift) causes the most damage. While for the dragging action there is agreement among studies and data, concerning the uplift component, the studies by Falconer et al. [74] and Majtan, Cunningham and Rogers [75] are in disagreement with those of Jempson [76], Kerenyi et al., [77], Oudenbroek et al., [57] and Dean [78]. Indeed, Falconer et al. and Majtan, Cunningham and Rogers suggested a positive uplift mechanism for the arch, called upthrust, while flume experiments on hydrodynamic forces on bridge decks from the other authors reported negative uplift coefficients for most of the submergence ratios encountered in floods. However, the dynamic effect is mitigated by the Archimedes' thrust, which may eventually become predominant at higher submergence ratios, because of less negative dynamic uplift at higher water stages. The collected evidence from the bridges damaged in the 2021 flood in Germany are compatible with a positive drag and a negative uplift, as none of the arch bridges exhibited the failure mechanism described in Falconer et al. but instead suffered damage due to the combined effect of wood clogging and drag force. In this regard, the main problem is the high blockage of an arch against the flow, resulting in considerable drag, contributing to the removal of backfill and leaving the arch itself standing against the flow [79]. In addition, the impact of hydraulic force against the intrados often causes slight damage, i.e., masonry and mortar detachments, exposed rebars and parapets, among others. This phenomenon is shown in Figure 14, where slight damage occurred in partially submerged arch bridges, $h^{**} < 0.5$.
