SEISMIC BEHAVIOUR OF ORDINARY MASONRY BUILDINGS DURING THE 2016 CENTRAL ITALY EARTHQUAKES

Sorrentino L., Cattari S., da Porto F., Magenes G., Penna A.

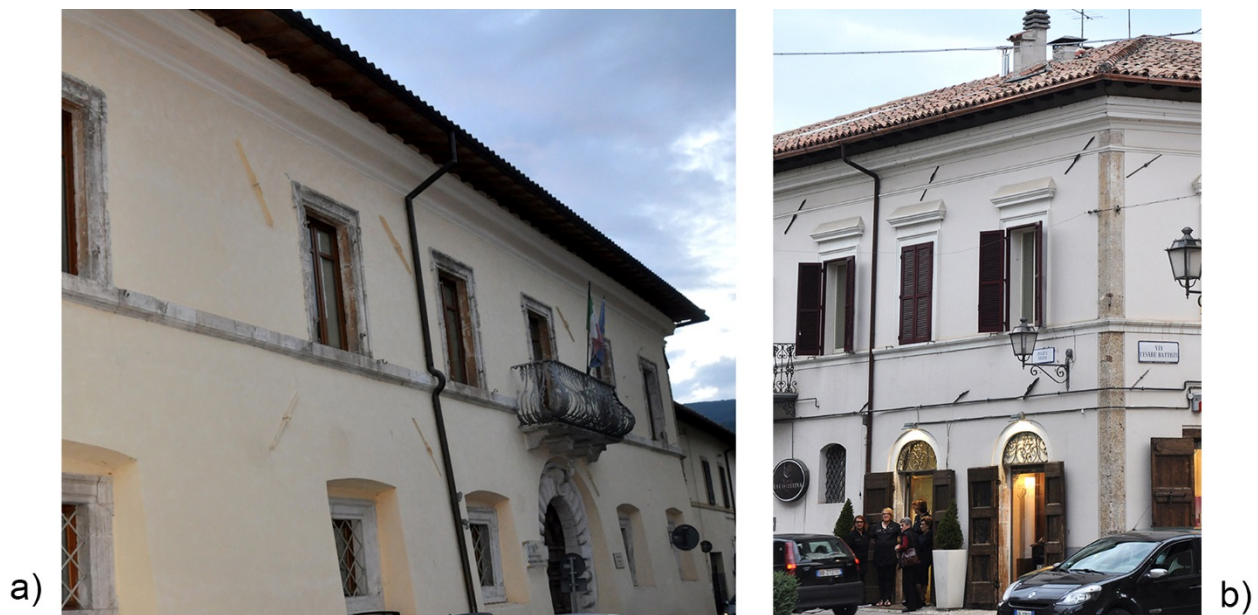
The maximum height of constructions was limited to two storeys and 8.5 m at the eaves. These limitations applied also to damaged buildings to be repaired, so only undamaged or very lightly damaged third floors were preserved. As a matter of fact Norcia presents lower rise buildings (Fig. 3a-b) compared to other Italian historical centres and to the other municipalities most damaged by the 2016-2107 seismic sequence (Table 2). The girders of roofs and floors had to rest on the whole cross section of the walls, to which they had to be connected by metal anchors (Fig. 3a-b). Tie rods were compulsory when existing vaults were preserved at ground storeys. At the upper storey vaults were always forbidden and in the case of substantial repair works or new constructions they were permitted only in the basement. The minimum thickness of vaults was set to 250 mm or 1/18 of the radius, whichever the largest. Solid masonry had to connect wall and vault up to 1/3 of the rise. The recommendations in the building code were clearly inspired by the survey led by father Secchi, to which participated also architect Luigi Poletti, who performed several structural repair works after major earthquakes (Sorrentino et al. 2008).

In 1979 Norcia has been hit by another earthquake, but damage was located in different portions of the historical centre compared to 1859 (Reale et al. 2004). This difference indicates that repaired buildings performed satisfactorily but also that the demolition of historical buildings to create the space for the new avenue, corso Sertorio, produced façades not connected adequately to pre-existing structures.

Fig. 3. Norcia. Two-storey buildings, tapered wall thickness, systematic use of tie rods. a) via Cavour, b) piazza Giuseppe Verdi.

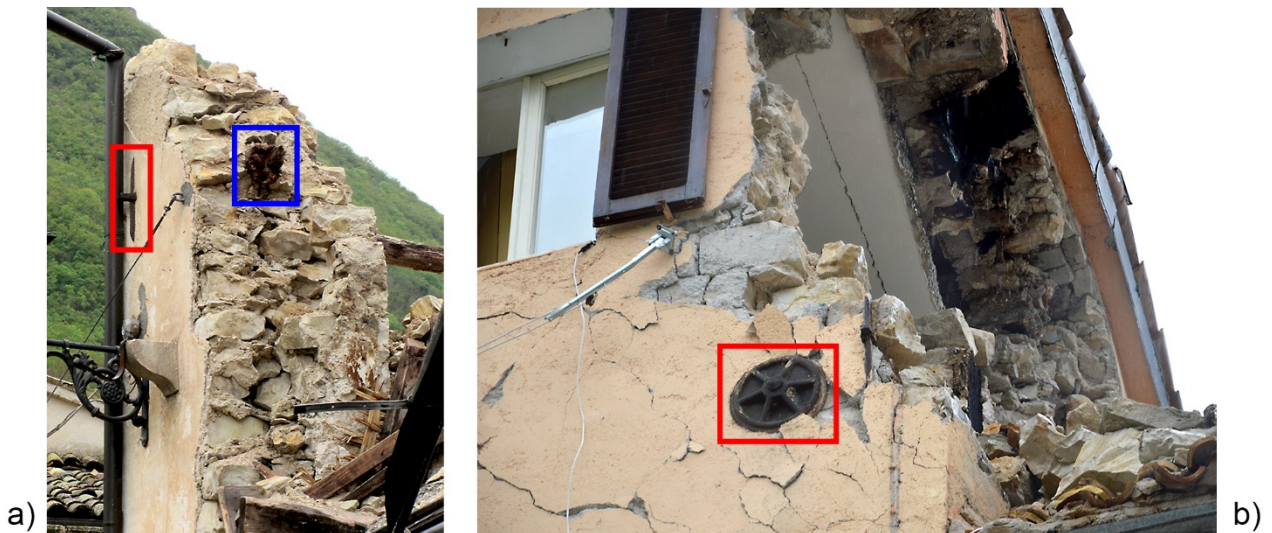
Fig. 4. Timber tie rods (blue frame) and steel wall anchors (red frame) in Castelsantangelo s/N: a) Via Parco della Riformazione, b) via delle Mura Castellane.

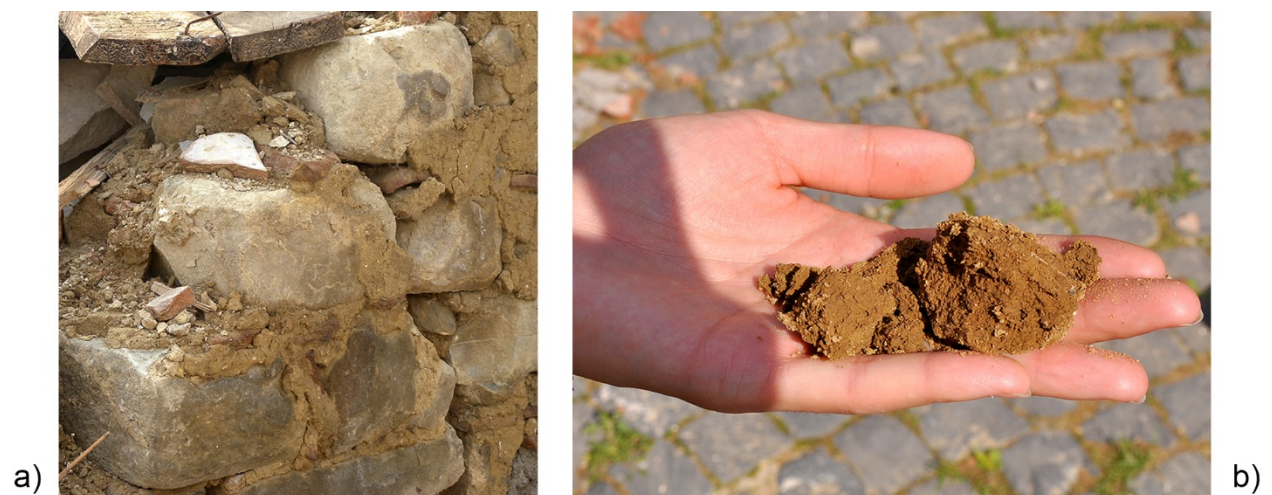
Fig. 5. Mud mortar in: a) Accumoli, Illica, and b) Amatrice, Sant' Angelo.

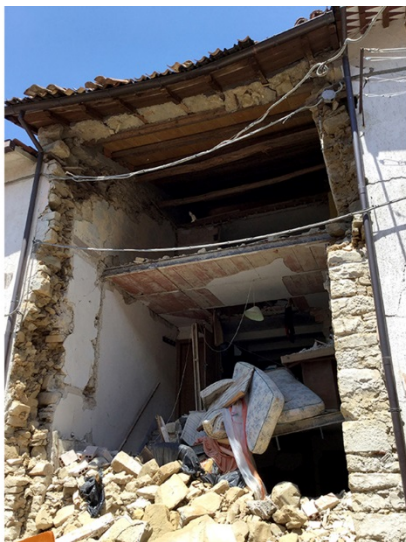
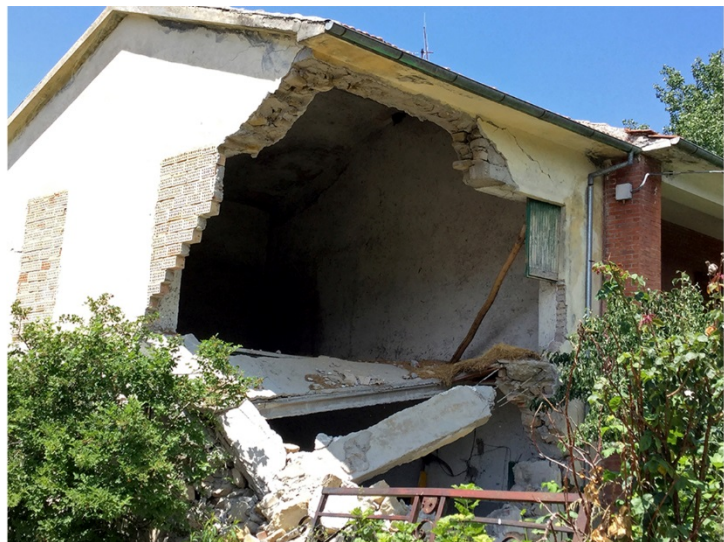
Fig. 6. a) I-beam and hollow clay block floor, Amatrice, Retrosi; b) Precast reinforced concrete beams and hollow clay block floor, Amatrice, Moletano.

These mortar characteristics could at least partially explain the performance found after the 24th August event, worse than that of the 2009 L’Aquila Earthquake. Additionally, several experiments show that undressed natural stone with proper mortar can have substantial seismic strength (e.g., Magenes et al. 2014; Silva et al. 2014; Giaretton et al. 2017). If disintegration due to poor masonry quality occurs any modelling of building response becomes unreliable (Sorrentino et al. 2017). As shown in Fig. 13, when masonry has such a low strength even the systematic use of steel ties is ineffective. When combined with a reasonable quality masonry, steel ties certainly contributed to preventing collapse (Fig. 3, Fig. 8). Nevertheless, besides the low masonry quality, the limited presence of connections in many buildings, the reduced strength of lateral walls compared to large-units wall intersections (Fig. 14), as well as the presence of intermediate floors having scarce diaphragm effect, poor details at the bearings, and no connections to the walls parallel to beams, should be recalled (Fig. 6).

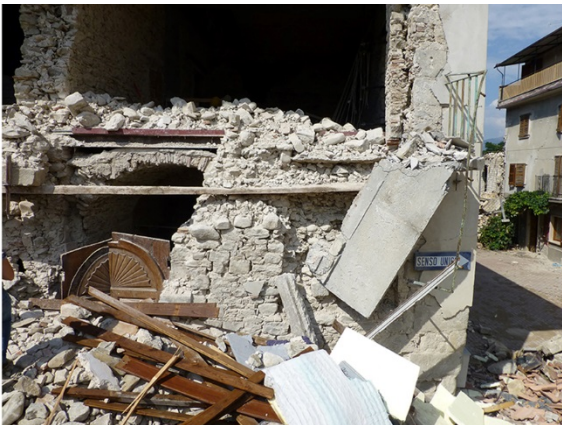
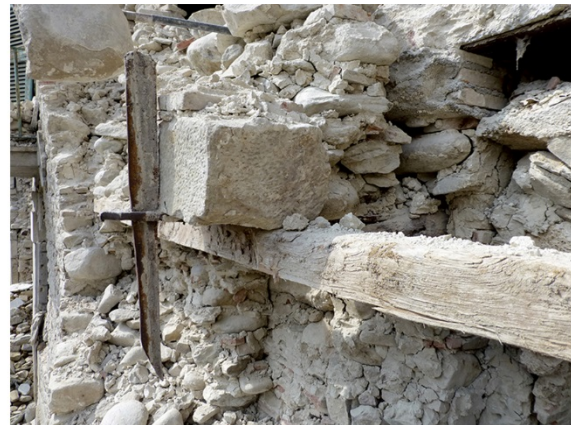
Fig. 7. Iron wall anchor of timber tie, Amatrice, via Roma. a) General view; b) Close up of a wall anchor.

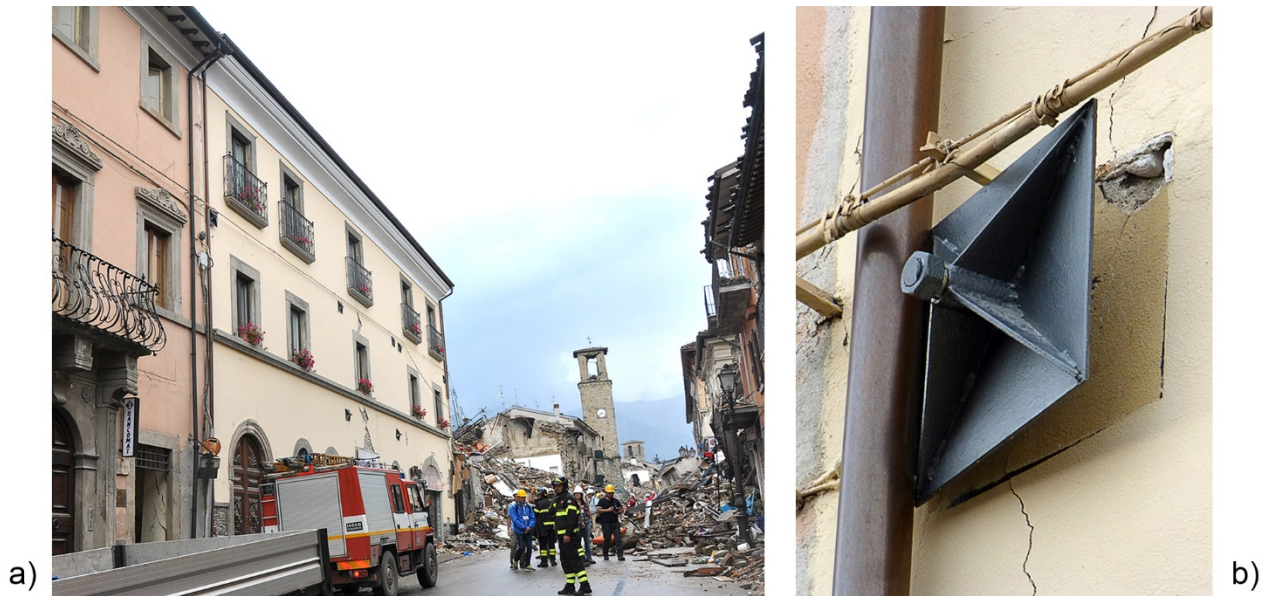
Fig. 8. Steel tie rods in the lightly coloured building, Amatrice, corso Umberto I. a) General view; b) Close up of a wall anchor.

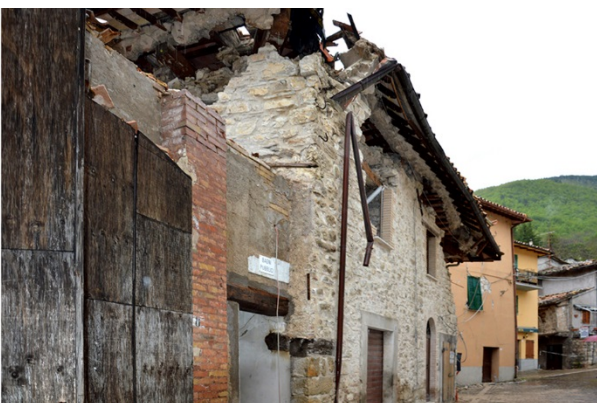
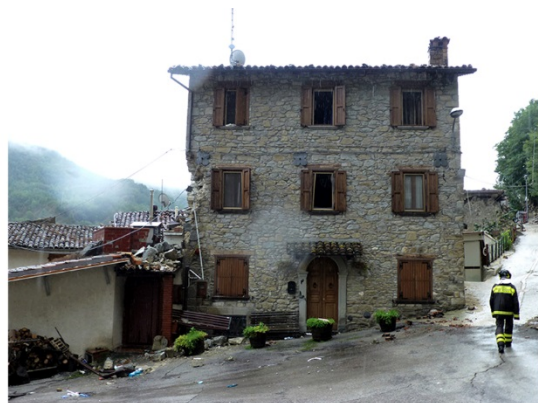
Media attention immediately after the August event blamed buildings with original roofs replaced with reinforced concrete structures. After being compulsory in case of structural interventions for more than two decades after the 1976 Friuli and 1980 Irpinia Earthquakes, building codes assumed a more careful approach after the performances observed in the 1997-1998 Umbria-Marche sequence (Penazzi et al. 2000). The current seismic swarm has shown again similar responses, with complete collapses of buildings under still monolithic roofs (Fig. 15a) or local effects associated to the compressive failure or out-of-plane response of masonry at the contact with reinforced concrete ring beams. However, there are several examples, such as that in Fig. 13 and in Fig. 16a, of very high damage despite the original timber structures were not replaced. On the opposite side of possible performances there are several cases, such as that of the house in Fig. 15b, which have a replaced reinforced concrete roof but no visible damage. Similarly, there are examples of houses with a timber roof that survived the earthquake (Fig. 16b), especially if timber elements were properly designed and connected to walls (Senaldi et al. 2014). Therefore, it seems that although replacing a timber roof by a reinforced concrete roof has been motivated by past lack of confidence in the original structural, rather than real limitations, such intervention alone cannot explain most of the observed collapses. These failures seem related to a very poor quality of masonry, especially of the mortar (Fig. 12), frequently combined to low maintenance conditions of timber roofs and lack of proper connections in traditional structures.

Fig. 16. Timber roofs: a) Castelsantangelo sul Nera, via B. Vittazzi, b) Arquata del Tronto, Pescara del Tronto.
