II Fabre Conference – Existing bridges, viaducts and tunnels: research, innovation and applications (FABRE24)

Half-joints degradation: analysis of some case studies

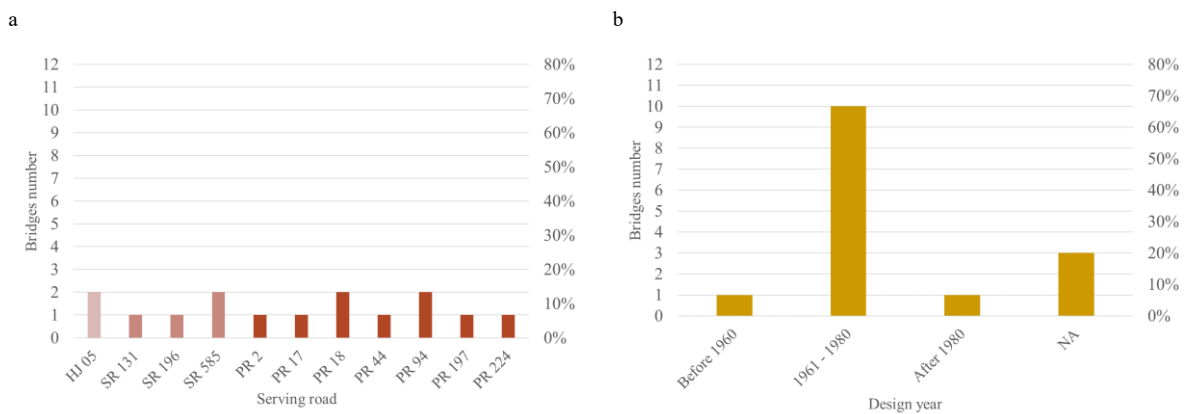
Fig. 3. (a) Bridges number per Highway Junction (HJ), State Road (SR) and Provincial Road (PR); (b) bridges number per several design year ranges.

At first, it is important to describe the main properties of the considered bridges, for better identifying the half-joints typologies under consideration. Details of the studied bridges are reported in Fig. 3 and Table 1. In particular, Fig. 3a reports the serving road, indicative of the bridge strategic importance. While Fig. 3b depicts the bridges number distributed in four design years ranges, that are: before 1960, 1961-1980, after 1980, and Not Available (NA). In the
