Analytical Investigations of XIX–XX Century Paints: The Study of Two Vehicles from the Museum for Communications of Frankfurt

This work is focused on the study of the protective paints of two vehicles belonging to the Museum für Kommunikation in Frankfurt and used by the German postal service at the turn of the two centuries. The first one is a cart for telecommunications services and is dated approximately 1920–1940 (Figure 1). This cart was constructed in the Reichspost era and was continuously used by the postal service also during the German Democratic Republic (GDR). The cart was found in the garden of a former postal employee in 2015. It was partially sunk into the ground, where it presumably stood for decades after having been taken out of service.

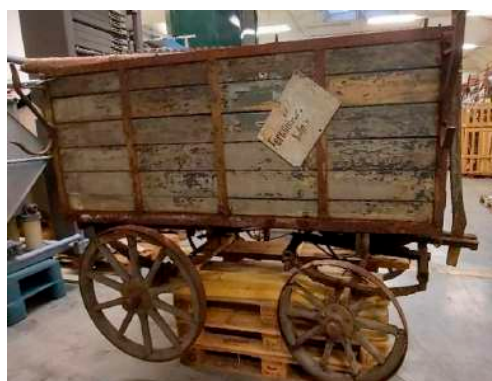
Figure 1. Image of the cart for telecommunication service.

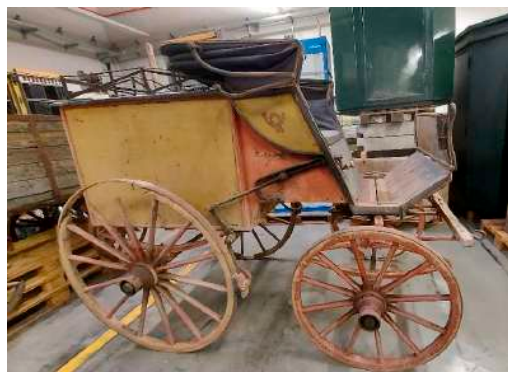
The second vehicle is a carriage of the German postal service, dated around 1880 (Figure 2). The carriage was found in 1999 when the King's family house was demolished. It is currently stored at the Museum für Kommunikation in Frankfurt. It has been probably used for the postal service between Schramberg and Rottwell until 1910.

Figure 2. Image of the carriage of the family King.

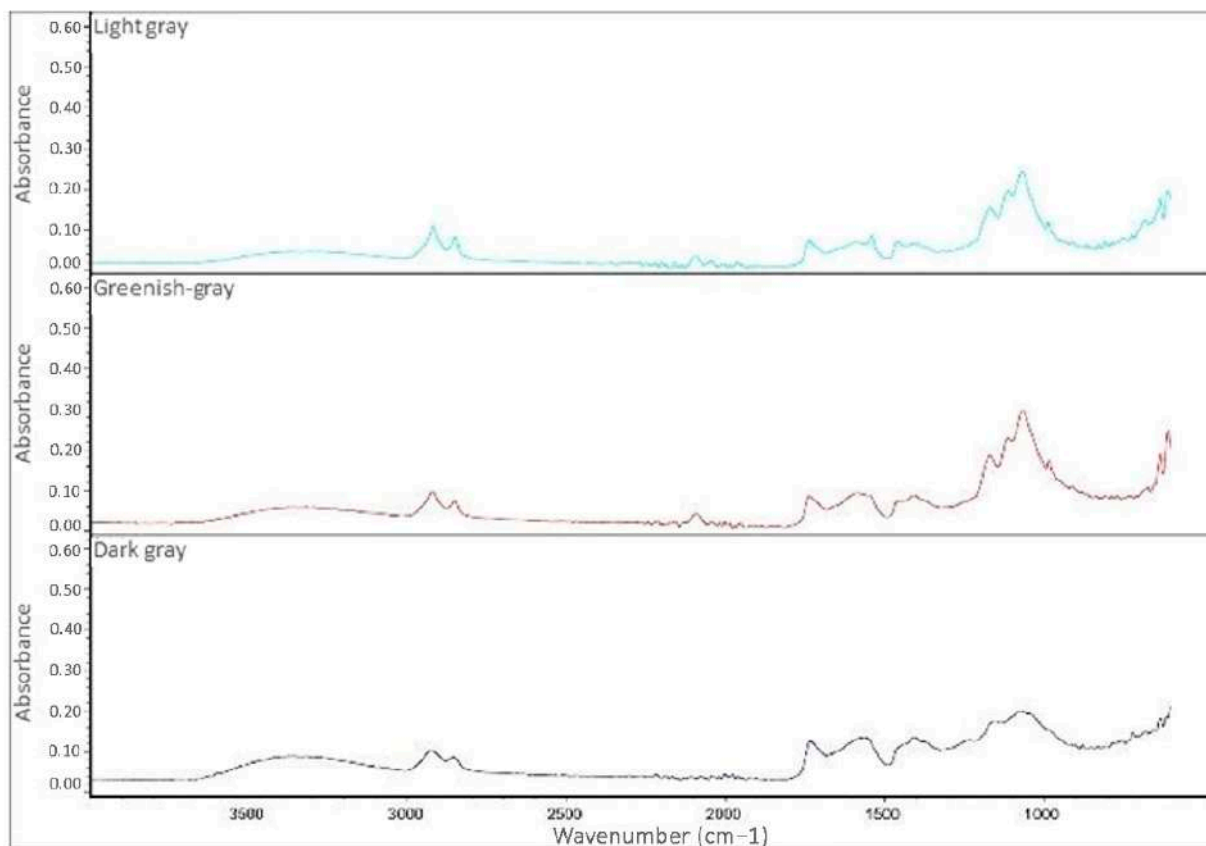
Figure 12. FT-IR ATR spectra of the three grey paints of the cart.

The main difference is in the bands at 1400 and 870 cm^{-1} , which are almost completely absent in the black paint of the carriage and the paints of the wagon. These bands can be linked to the presence of carbonates, which are therefore found in greater amounts in the yellow and red paints of the carriage compared to its total or almost absent in the grey-black paints. The interpretation of spectra allowed for the assignment of the following bands [35–43]:

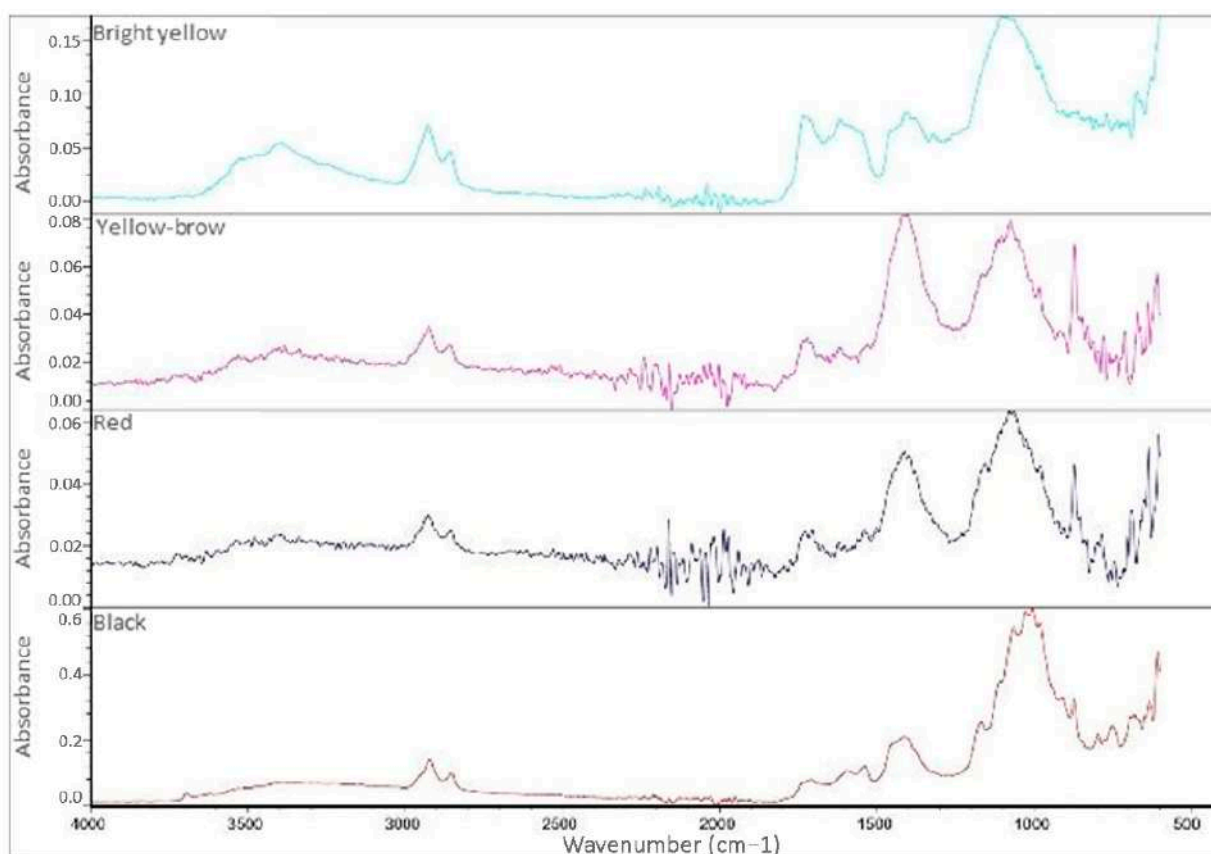
Figure 13. FT-IR ATR spectra of the colored paints of the carriage.

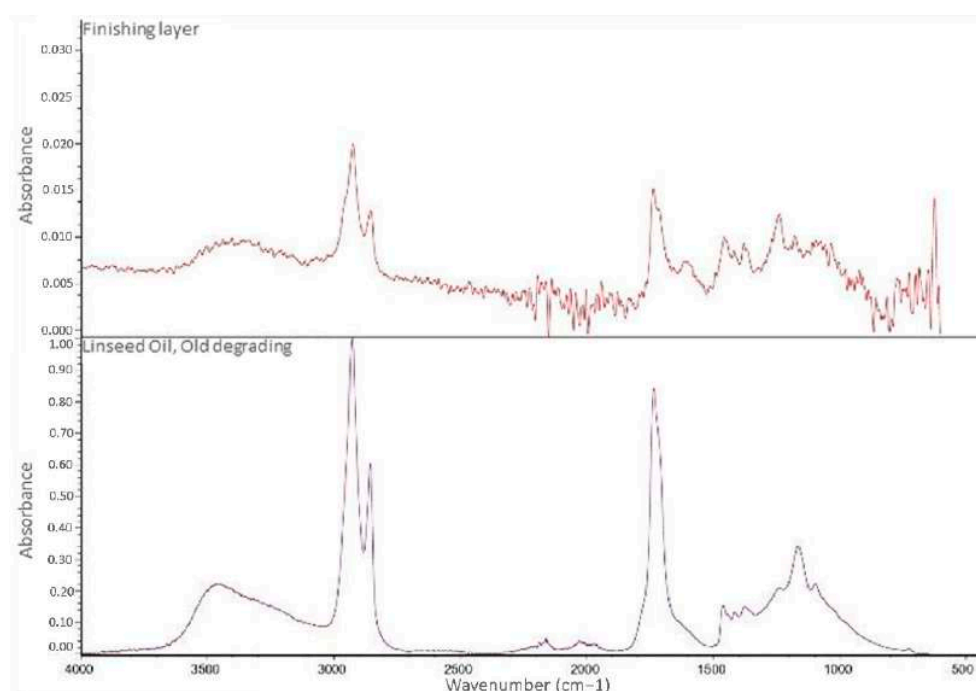
The analysis of the finishing layer present on the surface of the carriage required the extraction of the finishing layer from the sample with methyl ethyl ketone (MEK). The spectrum acquired on the extracted materials showed the characteristic bands of an oil-based component and carboxylates, similar to the spectra collected on the colored paints (Figure 14).

Figure 14. FT-IR ATR spectrum of the finishing layer extracted using MEK (**above**) and the spectrum of degraded linseed oil (**bottom**).
