# Sonic tomography of the stone pillars of a 17<sup>th</sup> century church

L. Zanzi<sup>1</sup>, A. Saisi<sup>2</sup>, L. Binda<sup>2</sup> & E. Cardarelli<sup>3</sup>

Pulse sonic tests were applied to 8 massive stone pillars of a 17<sup>th</sup> century church (S.Nicolò all'Arena at Catania, Italy). The data were processed to obtain 28 tomographic sections showing the distribution of the elastic wave velocity within the tested pillars. The results of the tests are compared in order to check the morphology and the state of damage of the pillars. A preliminary frequency analysis of the data seems to indicate that these experiments can be used to extract the energy absorption distribution.

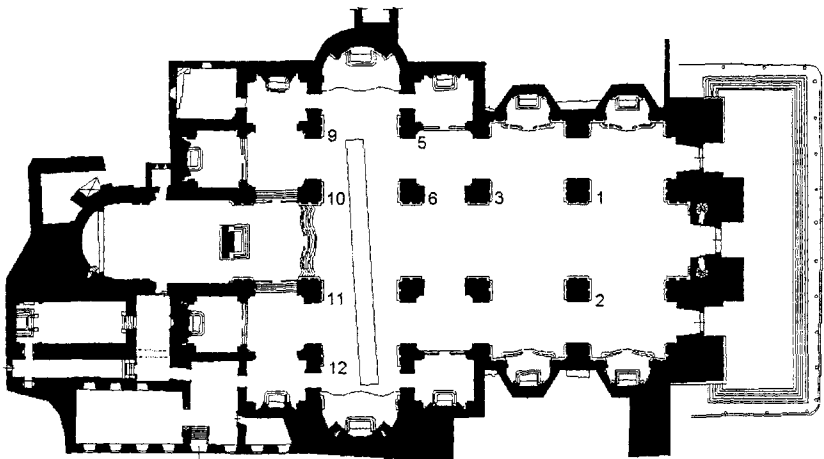
Fig. 2. Localisation of the tested pillars.

The two most damaged pillars at the entrance of the church (pillars 1 and 2 of Fig. 2) have been investigated with much care: five horizontal sections at different heights plus vertical sections have been executed on each pillar.

The very low velocities that have been found in the pillars 1 and 2 confirm the need of urgent preservation actions. From an external observation, the masonry texture seems, in fact, very poor, characterised by the presence of the so called "incoccio".
