## Performance of a school hosted within a historical complex affected by the 2016 seismic sequence

Luigi Sorrentino<sup>a</sup>, Marco Pepe<sup>a</sup>, Domenico Liberatore<sup>a</sup>, Patrizia Trovalusci<sup>a</sup>

*Keywords: Structural damage, Non-structural damage, Cloister type complex, Teramo*

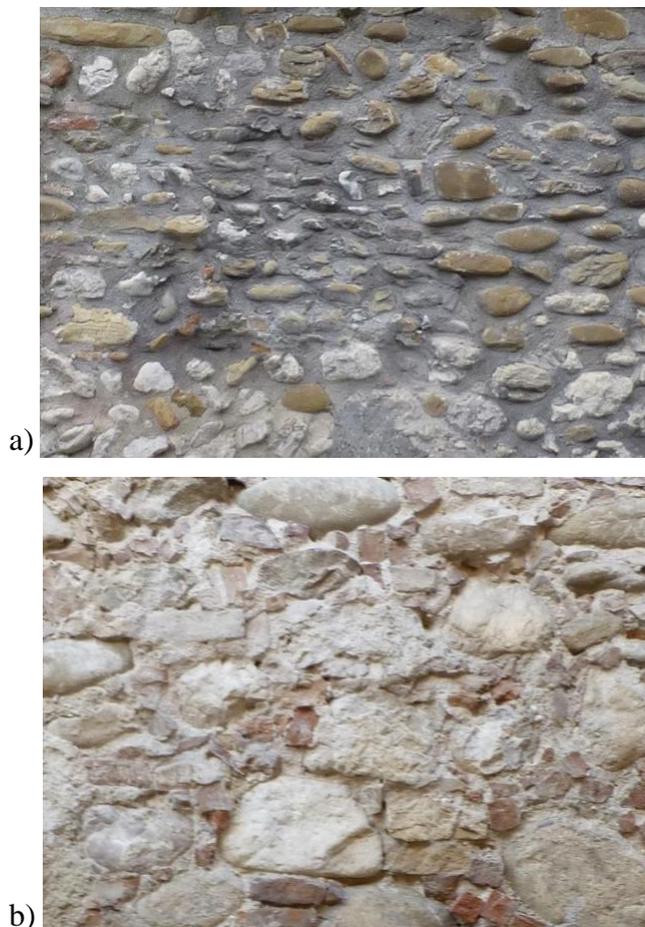
The aggregate is made of unreinforced masonry with rubble or approximately dressed natural stone units (Figure 6) or solid clay bricks. The cloister has monolithic natural stone columns and corner brickwork pillars at ground floor, octagonal brickwork pillars at first floor.

Figure 6. Some masonry samples of the aggregate. a) Ground floor, via Sant'Antonio (Figure 1), b) Basement floor, dwelling, façade on via Stazio

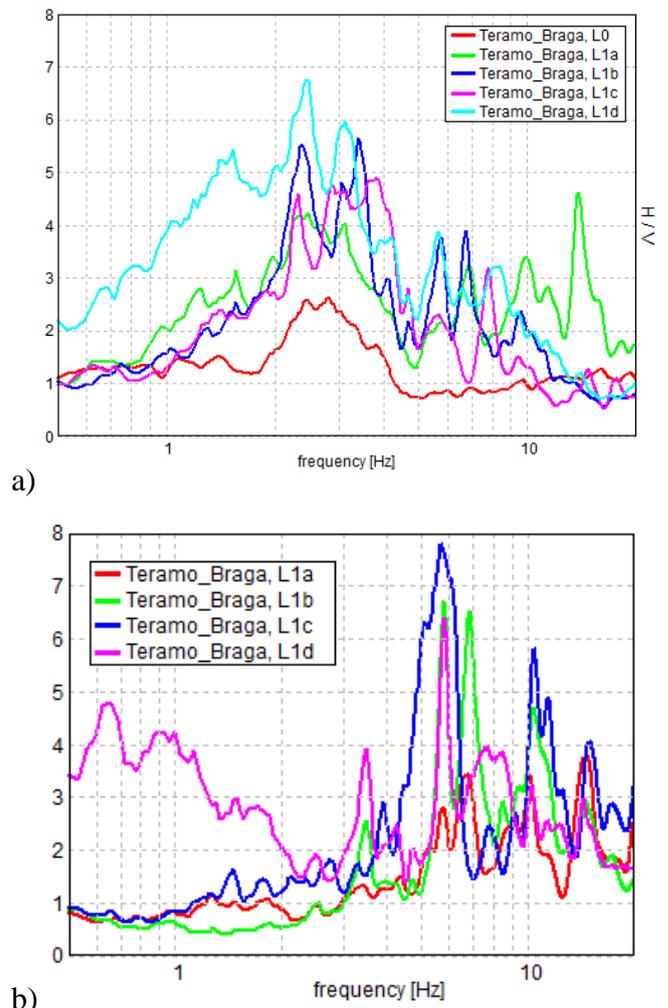
Figure 7. a) Average Horizontal to Vertical Spectral Ratios of the five acquisition locations (Figure 1-Figure 2). b) Standard spectral ratio of first floor locations with respect to ground floor location (direction parallel to via Stazio)

Eigen-frequencies have been identified according to a peak-picking procedure, performed on spectral ratios plots, either the Standard Spectral Ratio (Fäcke et al. 2006) or the Horizontal-to-Vertical Spectral Ratio (Nakamura 1989) are commonly used. In Figure 7a the ratio of average horizontal spectral values to vertical spectral value are presented. The largest amplifications are observed around 2.5 Hz, with slight variations possibly related to the articulated shape of the aggregate and the large cloister. In the same region maximum amplification of the ground is observed. In order to remove this effect the standard spectral ratio, horizontal component of elevated acquisition point with reference to corresponding component of ground acquisition point, is performed in Figure 7b. Maximum amplifications are observed about 5.5 Hz, a value where however a minimum of ground spectrum is observed. Additional records at ground floor, especially below acquisition points L1b-d would help investigate further this controversy.
