NEW ZEALAND CONTRIBUTIONS TO THE GLOBAL EARTHQUAKE MODEL'S EARTHQUAKE CONSEQUENCES DATABASE (GEMECD)

ABSTRACT

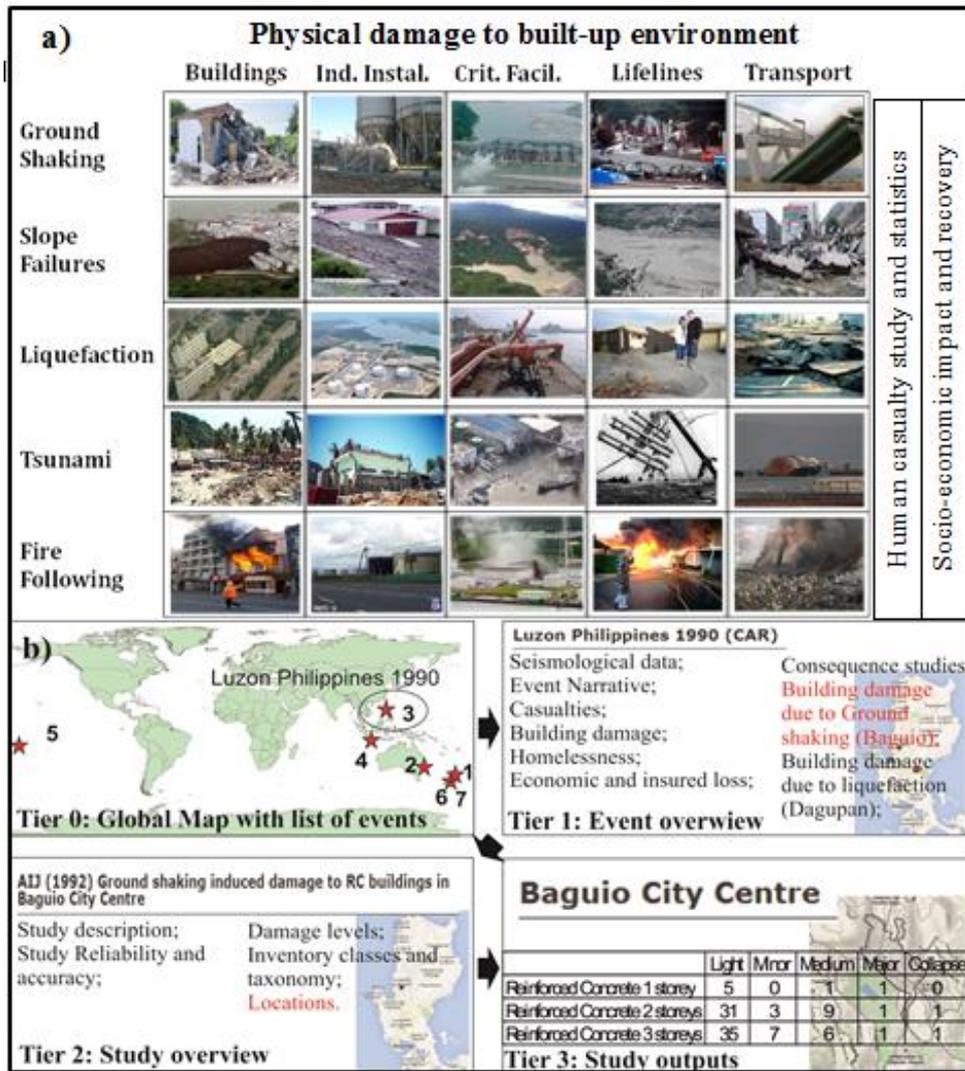
Figure 1: GEMECD framework a) earthquake consequences matrix (modified from Pomonis and So [5], So et al [6]); b) GEMECD tier structure.

GEMECD first placed emphasis on collecting and collating data and studies on building damage induced by ground shaking. In the years to come, the aim is to have a broader coverage and collect further aspects of earthquake-induced consequences, including: consequences from earthquake-induced secondary hazards (with special focus on geotechnical hazards, tsunami and fire following) on buildings, critical facilities, infrastructures and lifelines; human casualty studies; and, socio-economic impact as a whole (Figure 1).

A tiered database structure composed of four tiers, from Tier 0 to Tier 3, is used to present the earthquake consequences data (Fig. 1) included in GEMECD, namely:

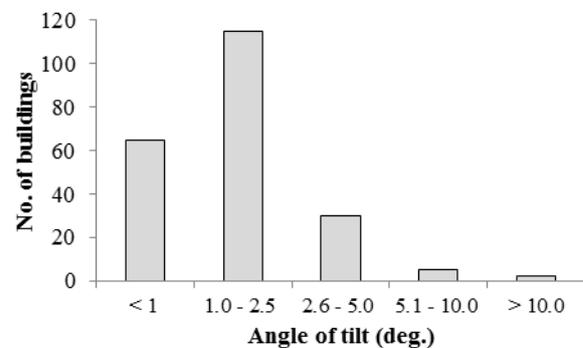
Figure 3: Degree of building tilt in liquefied areas in Dagupan City, as in GEMECD, Tier 3 (adapted from Tokimatsu *et al.* [17]). The inventory class represents 1-5 storey RC buildings.

Tokimatsu *et al.* [17] inspected approximately 300 RC buildings of 1 to 5 storeys and 250 low-rise wooden houses in both the liquefied and non-liquefied areas of Dagupan city centre. The boundaries of the damage survey are drawn as those reported in the original paper [17]. The damage statistics show the damage distribution for 217 RC buildings, 1-5 storeys (aggregated data) located in liquefied areas according to the degree of building tilt: <1, 1-2.5, 2.6-5.5, 5.6-10.0, >10.0 degrees (Figure 3); and to the extent of building settlement: <25, 25-50, 51-75, 76-100, >100 cm (Figure 4).

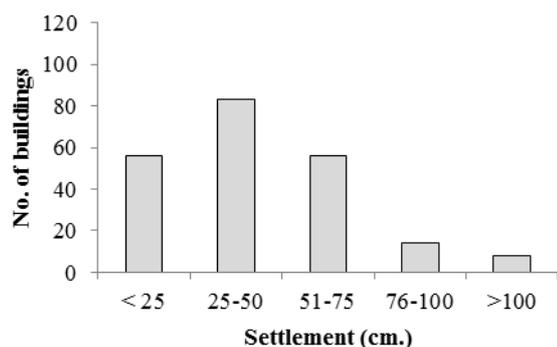
Figure 4: Extent of building settlement in Dagupan City as in GEMECD, Tier 3 (adapted from Tokimatsu *et al.* [17]). The inventory class represents 1-5 storey RC buildings.

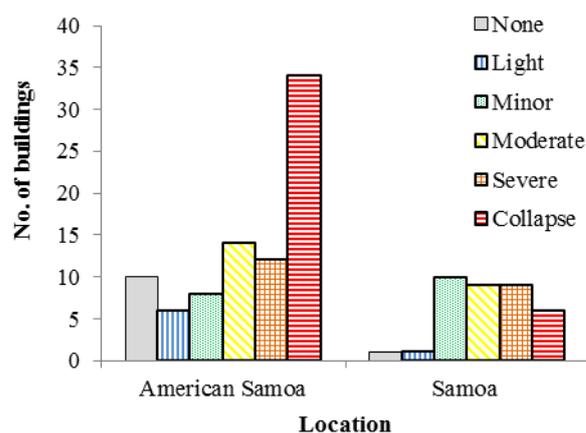
Figure 5: Damage to masonry residential buildings in Samoa and American Samoa during the 2009 Samoa tsunami as in the GEMECD, Tier 3 (adapted from Reese *et al.* [19]).

The earthquake consequence studies investigated the damage to buildings induced by the ensuing tsunami. Of the two studies available for this event, one study is based on the damage survey carried out by a reconnaissance team from New Zealand [19], which investigated, among others, 120 masonry residential buildings distributed within 12 villages (aggregated data) in Samoa (Island of Upolu, 6 villages) and American Samoa (Island of Tutuila, 6 villages). The field survey's location is represented by point coordinates in GEMECD and has been obtained from Google Earth. Six qualitative damage levels were adopted to classify the observed damage, namely: none, light, minor, moderate, severe, and collapse. The island level aggregated damage statistics are shown in Figure 5.

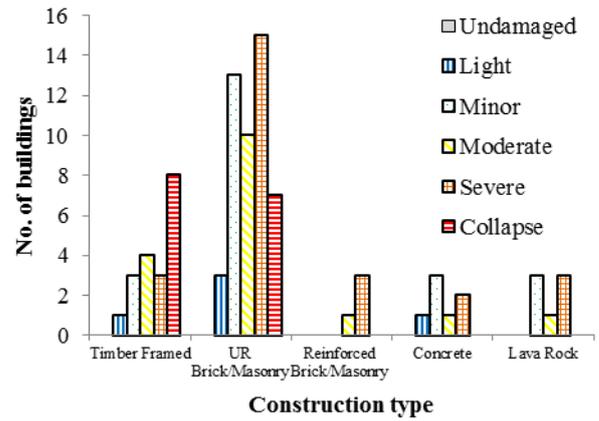
Figure 6: Damage levels observed for different building types located on the Samoan Island of Upolu, as reported in GEMECD, Tier 3 (adapted from ITST Samoa [20]).

affected villages/sites in Samoa (Island of Upolu) to explore the nature of the tsunami and its impact on the Island of Samoa [22]. During the surveys a total of 92 buildings of different construction types were inspected within 6 villages (represented as coordinate points in GEMECD). The damage survey results were presented for 85 buildings (aggregated data) belonging to five different construction types (i.e. timber framed, unreinforced brick masonry, reinforced brick masonry, concrete and lava rock). Five damage states were adopted to classify the observed damage, namely: light, minor, moderate, severe, and collapse. The damage statistics are reported in Figure 6.

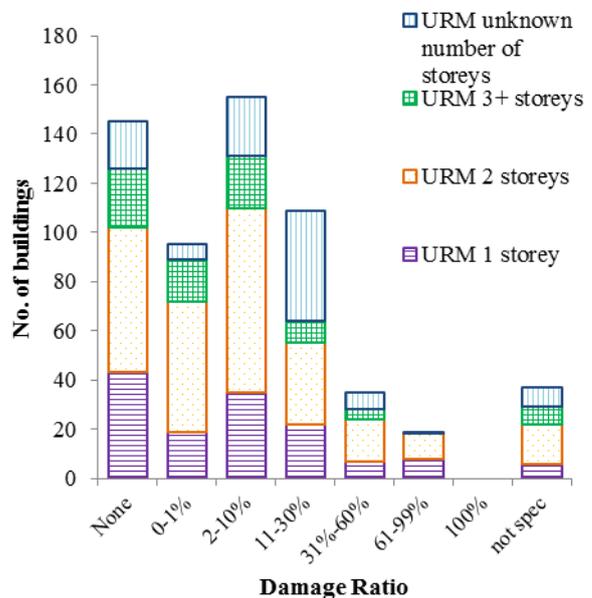
Figure 7: Damage ratios observed for URM buildings located within the CCC boundaries during the Sept 4, 2010 earthquake (adapted from Ingham and Griffith [23]).

The second study, that investigates building performance due to ground shaking, shows the damage statistics obtained for 595 URM buildings located within the CCC boundaries (aggregated data) as reported by Ingham and Griffith [23]. The damage statistics are reported according to the damage ratios collected during the BSE procedures. The damage ratios could be better interpreted as representing the extension of damage with respect to the volume of the building (% of building damage) rather than the ratio of repair cost vs. replacement cost excluding contents. It is important to note that these values are estimations of the inspecting engineers, based on a Level 1 and Level 2 (exterior and interior) assessment. The damage statistics reported in the GEMECD (Figure 7) have been extracted from the raw data provided by the authors. In Figures 8 and 9 photo examples of damage observed in URM buildings are shown.

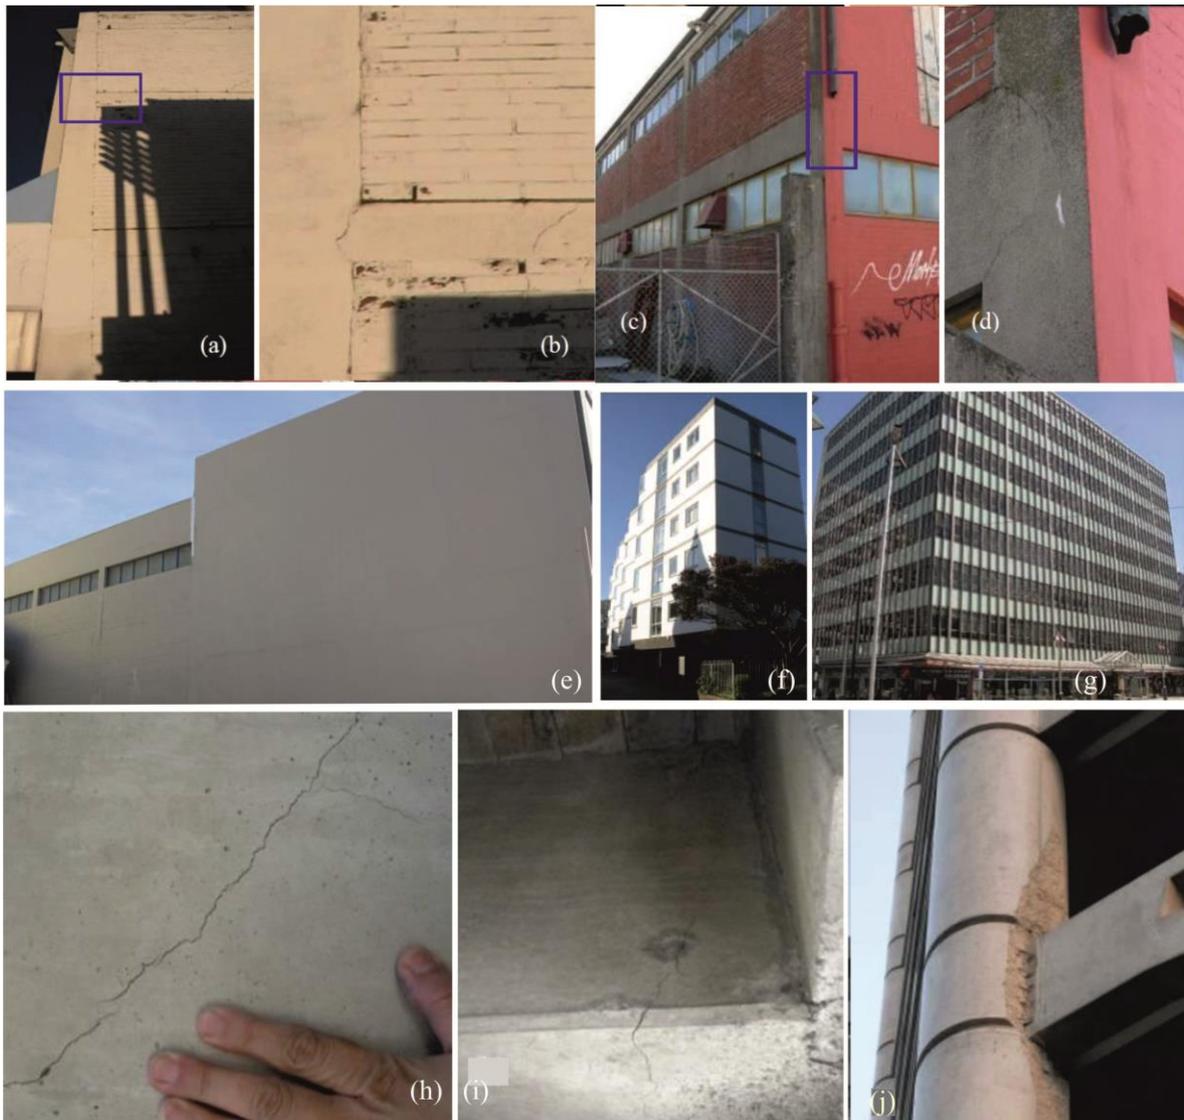
Figure 8: The damage types were observed during the Sept 4, 2010 Darfield earthquake: (a, b) Flexural cracks at the beam ends and diagonal cracks in the masonry infill observed in a three storey RC frame building with clay brick infill walls, built in the 1950s-60s; (c, d) low-rise RC frames with joint shear cracking; (e) separation cracks of the infills and RC frame observed in a low-rise pre-1970s RC frames with masonry infill walls; (f, g) mid-rise pre-1970s RC buildings with no apparent damage; (h) shear diagonal cracks on modern (post-1980) thick shear walls; (i) beam plastic hinges observed in a twelve storeys RC frame building built in 1980s and (j) damaged gravity frame observed in a fourteen storey RC core walls building with perimeter gravity frame, built in 1980s. Photos from Kam et al. [21].

One of the aforementioned studies reports the distribution of Building Safety Evaluation (BSE) tagging (green, yellow and red) for 717 RC buildings (as at Sept. 20, 2010) as shown in Kam *et al.* [21]. The 717 RC buildings belong to four different structural types (RC frame, RC shear wall, Tilt-up concrete and RC frame with masonry infill) and are located within the Christchurch City Council boundaries (aggregated data). The placard data are based on the Christchurch City Council (CCC)/Civil Defence BSE form [20]. The data are shown in Table 5. Some examples of damage that occurred to RC buildings are shown in Figure 8.

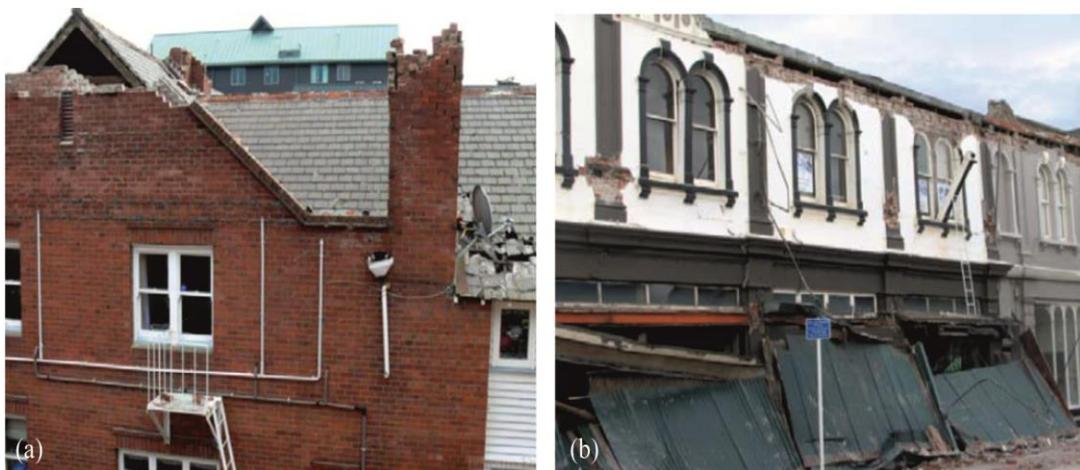
Figure 9: (a) Examples of chimneys and gable wall and (b) parapet failure observed in clay brick URM buildings during the Sept. 4, 2010 Darfield earthquake (photos from Ingham and Griffith [26]).

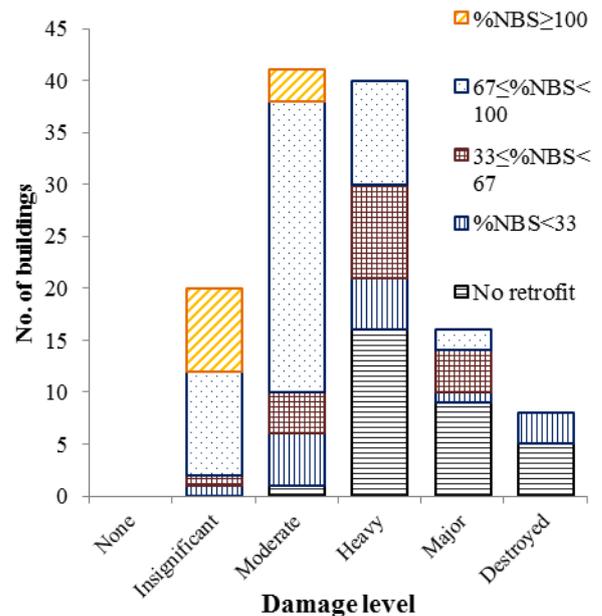
Figure 11: Damage levels (ATC 38/13) observed for 125 URM buildings during the Feb 22, 2011 Christchurch earthquake. The buildings are grouped according to the %NBS (adapted from Ingham and Griffith [27]). The data are available in GEMECD.

Ingham and Griffith [27] investigated the behaviour of strengthened and non-strengthened clay brick unreinforced masonry in the CBD of Christchurch. More specifically the two studies derived from this report show the performance of 368 URM buildings according to the type of earthquake strengthening namely: Type A, Type A&B, No retrofitted, and Unknown (Type A retrofits include gable restraints, wall-to-diaphragm anchorage, and roof and floor diaphragm improvement; Type B retrofits include strengthening techniques that sought to strengthen masonry walls and/or introduce added structure to supplement or replace the earthquake strength provided by the original unreinforced masonry structure among which the most common are steel moment frames and steel brace frames; No retrofitted refers to building that are non retrofitted and Unknown refers to building for which the earthquake retrofitting is unknown or absent), and the performance of 125 clay brick URM buildings according to the percentage of the New Building Standard (%NBS, as per NZSEE2006 guidelines on assessment of existing buildings) evaluated using the Initial Evaluation Procedure, IEP [22] (Figure 11). In both studies the damage level observed is classified according to the ATC38/13 damage scale.

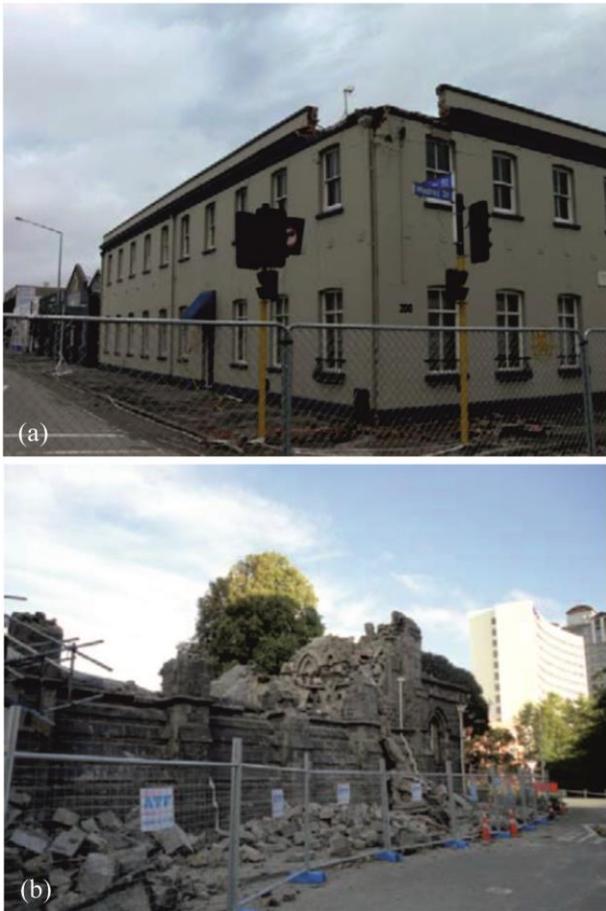
Figure 12: (a) External view of failed parapet at corner; (b) collapse of the Stone Chamber of the Canterbury Provisional Chambers building. Photos from Ingham and Griffith [26].

In Figure 12 examples of damage sustained by URM buildings are shown.

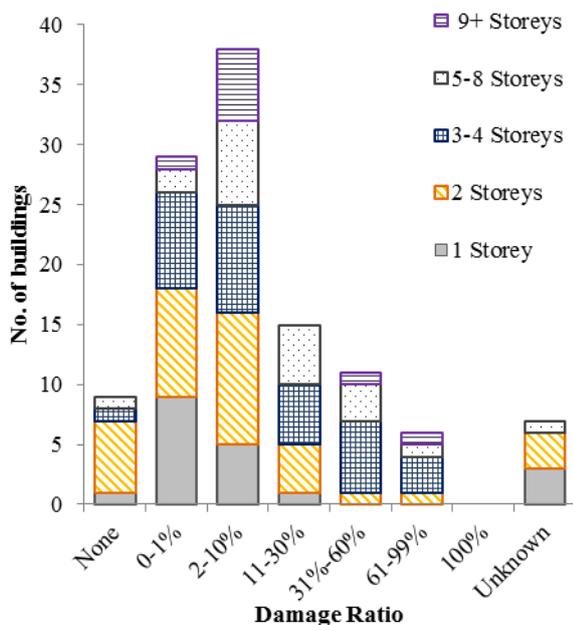
Figure 13: Damage ratios observed for RC buildings built before 1979 during the Feb. 22, 2011 earthquake (adjusted from Kam and Pampanin [28]). The data are available in GEMECD, Tier 3. The damage ratios were adapted from the Christchurch City Council (CCC) database, Civil Defence Building Safety Evaluation (BSE) data and authors field inspection (as at June 12, 2011).

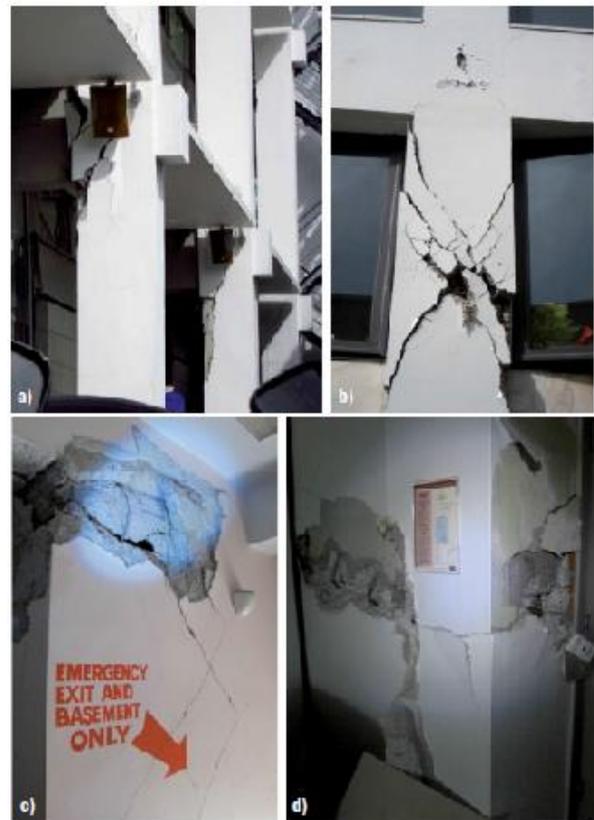
Figure 14: Pre-1970s RC building brittle failure mechanism: a) near collapse of a frame/wall building with beam-column joint failure; b) short column shear and beam-column shear damage; c) lightly reinforced 1950 RC wall compression failure; d) shear/axial failure of composite RC wall/steel columns system (photos from Kam and Pampanin [29]).

Kam and Pampanin [28] provide an overview on the seismic performance of the main building types in the Christchurch CBD with emphasis on the RC buildings (also analysed in more detail in Kam and Pampanin [29] and Kam *et al.* [30]) namely: RC frame, RC shear wall, tilt-up concrete and RC frame with masonry infills. Damage statistics are also available for timber framed, reinforced masonry, URM and steel frame buildings. The damage statistics imported in GEMECD report the damage ratios (see previous section for its definition and limitations) adapted from the Christchurch City Council (CCC) database, Civil Defence Building Safety Evaluation (BSE) data and authors' field inspection (as at June 12, 2011). The damage statistics have been extracted from the raw data provided by the authors and are presented according to the period of construction (i.e. pre-1970s, 1980s, 1990-2010, unknown) and number of storeys (i.e. 1, 2, 3-4, 5-8, 9 or more, unknown). The period of construction of RC buildings was defined on the basis of the issuing of key versions of the NZ seismic loading and material design standard. Figure 13 shows the damage ratios - RC buildings built before 1979. In the original paper the damage statistics are reported according to the placard colour. Figures 14 and 15 show some photos on the type of damage observed in RC buildings.

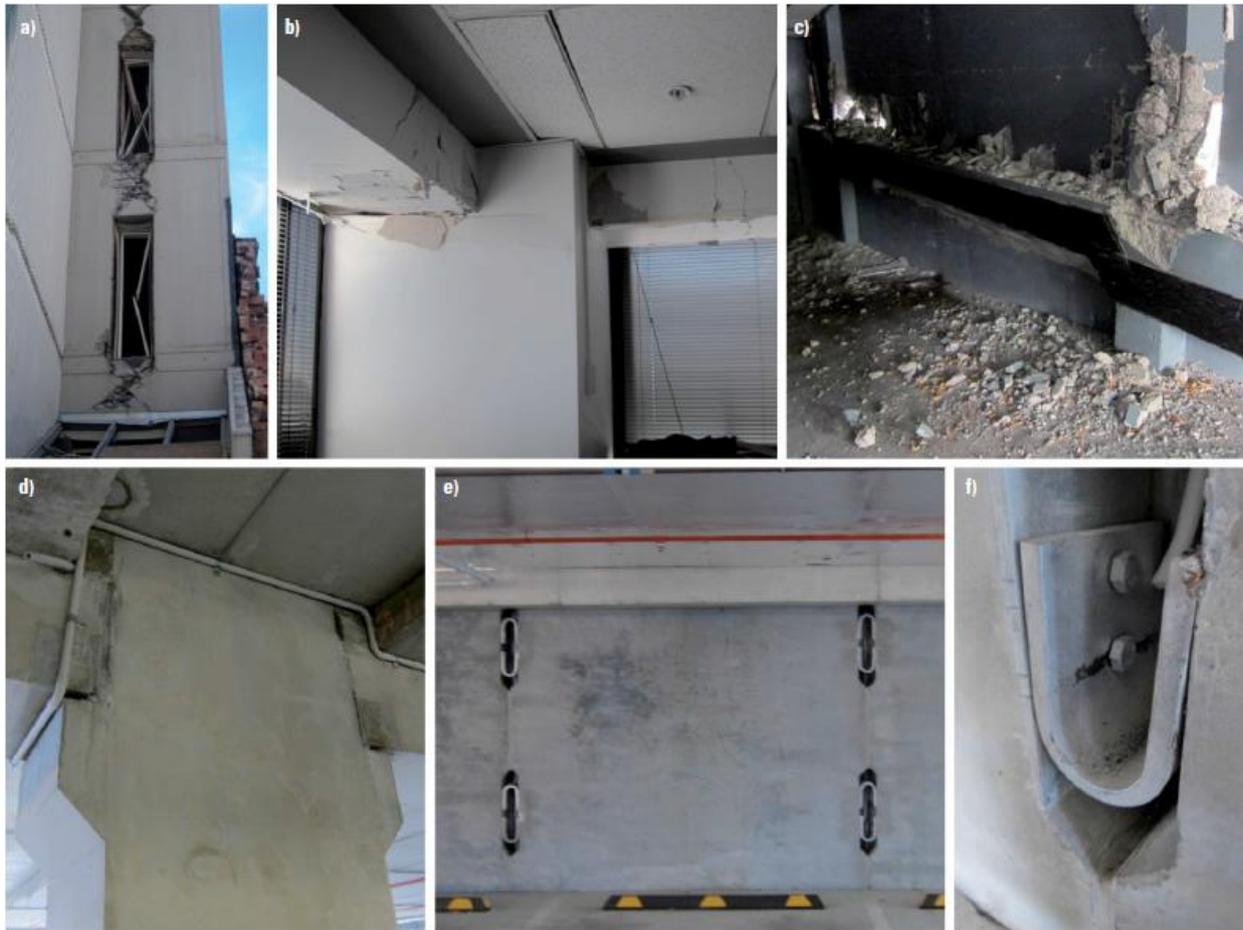
Figure 15: Ductile-response RC systems: a) coupling beams of 1960s coupled-walls building; b) beam plastic hinges on 1980s perimeter RC frames building; c) ductile behaviour of 1980s RC walls building and d–f) “low-damage” PRESSS post-tensioned frames building built in 2010 (photos from Kam and Pampanin [29]).

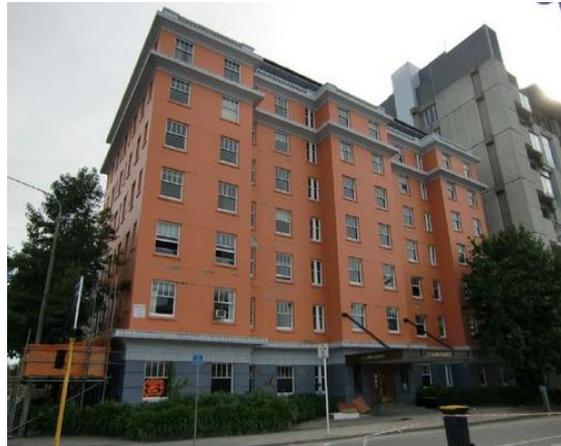
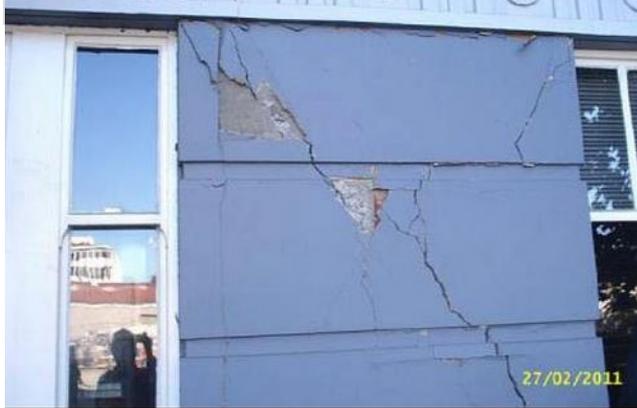
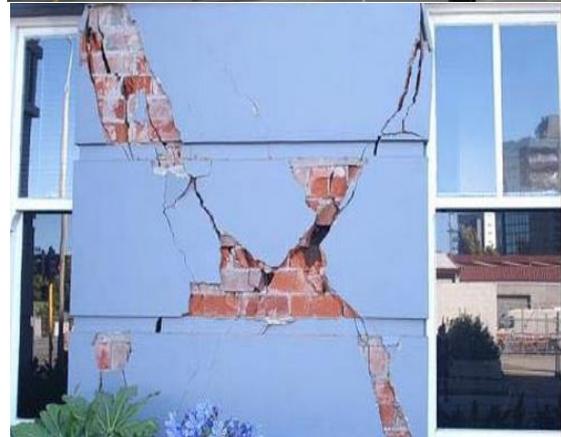
Location name	St Elmo Courts
Address or location	St Elmo Courts, 47 Hereford Street
Geometry (long/lat)	POINT(172.6309204 -43.5319099)
Damage description:	
STRUCTURAL DAMAGE:	Shear cracks in some columns at ground level; Reinforcement is exposed at certain locations.
NON STRUCTURAL DAMAGE:	Significant infill wall damage, which may further create out-of-plane instability if not fixed/repared/strengthened and may jeopardize the global stability of the whole structure.
GEOTECHNICAL DAMAGE:	Minor liquefaction at the corner next to new Christchurch City Council building.
Overall damage (EMS-98)	Heavy damage.
Comments	Yellow tagged, Demolished.

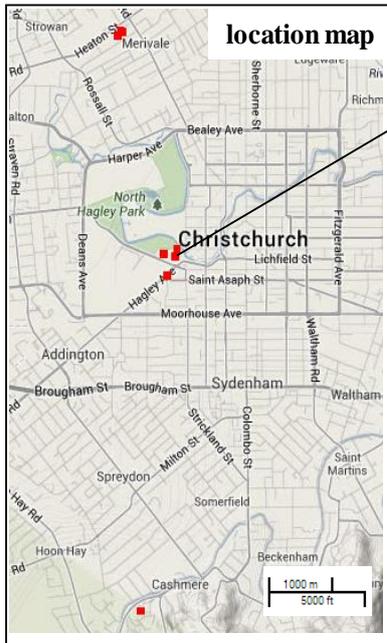
Parkside building, Christchurch Hospital, 2C Riccarton Avenue Christchurch

Damage description: Liquefaction caused severe flooding in the basement, resulting in major losses to support services. There was some minor structural cracking (though later inspections indicated that these cracks were sometimes far more severe than they appeared), as well as widespread non-structural damage to suspended ceilings, pipe- and duct-work (especially where it passed through joints and firewalls), and wiring. The building experienced damage across separation joint and firewalls and there was also significant cosmetic damage to partition walls. Parkside lost power for one and half hours. The lifts were out of action and major cracks were noted in the stairwell to the department.

Figure 17: Damage to critical facilities study; damage sustained by the Parkside building (Christchurch Public Hospital) during the Feb 22, 2011 earthquake. Photos and damage description are available in GEMECD.

Furthermore for the 2011 Christchurch earthquake a study of critical facilities and infrastructure is also available, which describes the damage sustained by three main hospitals/hospital complexes in Christchurch, namely: the Christchurch Public Hospital, The Princess Margaret Hospital and the St. George Private Hospital. Only the main buildings of each hospital have been considered and have been geocoded one by one in Google Earth. The study merges information from miscellaneous sources: conference papers [33-34] and reports [35], personal communication by authors of those reports, and personal communication by hospital staff. In the study a comprehensive damage description is available for all the buildings, along with a detailed characterization of the building structural types and the seismic design standard used for some of them. For each building an overall damage grade has been assigned (based on available damage descriptions and photographs) according to the EMS-98 damage scale [25] and the GEM building taxonomy. An example of the study for one of the hospital buildings is shown in Figure 17. A superior rating has been assigned to all the fields of the study reliability rating.

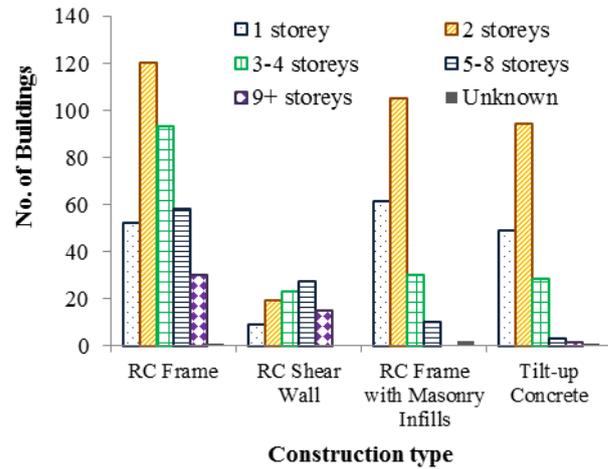
Figure 18: Distribution of Reinforced Concrete buildings within the Christchurch CBD according to the main structural type and number of storeys (adjusted from Kam and Pampanin 2011 [28]).

Figure 18 and 19 report the 4 classes of RC buildings described in Kam and Pampanin [28-29], and in Kam *et al.* [30], namely RC Frame, RC Shear Wall, RC Frame with Masonry Infill and Tilt-up concrete, according to the number of storeys and period of construction. Charts similar to those shown in Figure 18 and Figure 19 can be obtained for the other building types in the CBD by using data contained in GEMECD.

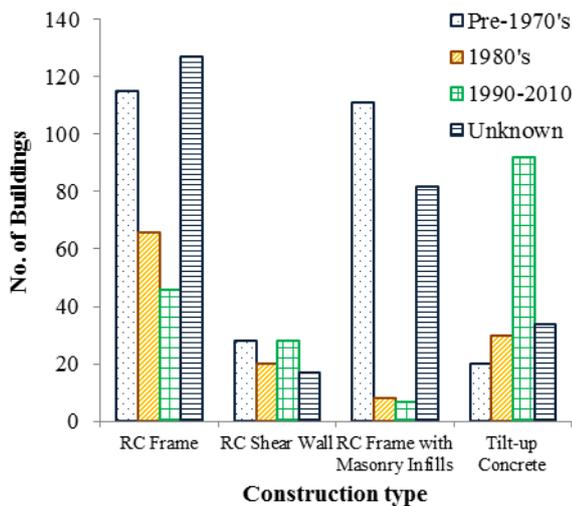
Figure 19: Distribution of Reinforced Concrete buildings within the Christchurch CBD according to the main structural type and period of construction (adjusted from Kam and Pampanin [28]).

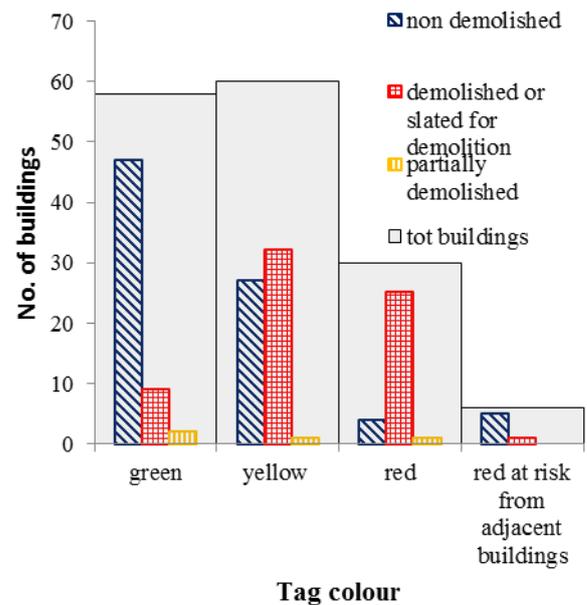
Figure 20: State of the 154 buildings inspected by Pampanin *et al.* [31-32]. The demolished or partially demolished buildings have been either observed in Google Earth or identified from the CERA demolition list, as at April 2014 [39].

Moreover from the data collected in GEMECD it is possible to consider the percentage of demolished buildings given the tag colour (herein described), the overall damage assigned to each building according to the EMS 98 [25], and the building structural type. This information is contained in the study of 154 buildings inspected by Pampanin *et al.* [31-32], that includes information about the building state as at April 2012 (the demolished or partially demolished buildings have been either observed in Google Earth or identified from the CERA demolition list, as at April 2014 [39]) in addition to a detailed damage description and building structural type at an individual level. The 154 buildings are grouped in GEMECD according to the tag colour: green tagged (58), yellow tagged (60), red tagged because at risk from adjacent buildings (6) and red tagged due to sustained damage (30). Of the 58 green tagged buildings in the study, 9 were demolished or slated for demolition (15.5%) and 2 were partially demolished (3.4%); of the 60 yellow tagged buildings 32 (53.3%) were demolished or slated for demolition, and 1 was partially demolished (1.6%); of the 30 red tagged buildings due to sustained damage, 25 (83.3%) were demolished or slated for demolition, and 1 (3.3%) was partially demolished; while of the 6 red tagged buildings at risk from adjacent buildings 1 (16.6%) was demolished or slated for demolition (Figure 20).

Correlations between demolitions and building structural type or overall damage assigned according to the EMS 98 [25] can be defined from this study.
